**STRUCTURAL DEFECTS REPORT,
BUILDING A, BERKLEY WORKS,
PRIMROSE HILL, LONDON NW1 8XY.**

RPH Engineering
Consulting Civil and Structural Engineers
Manor House
Westdown EX34 8NH

DATE; 12^h September 2024

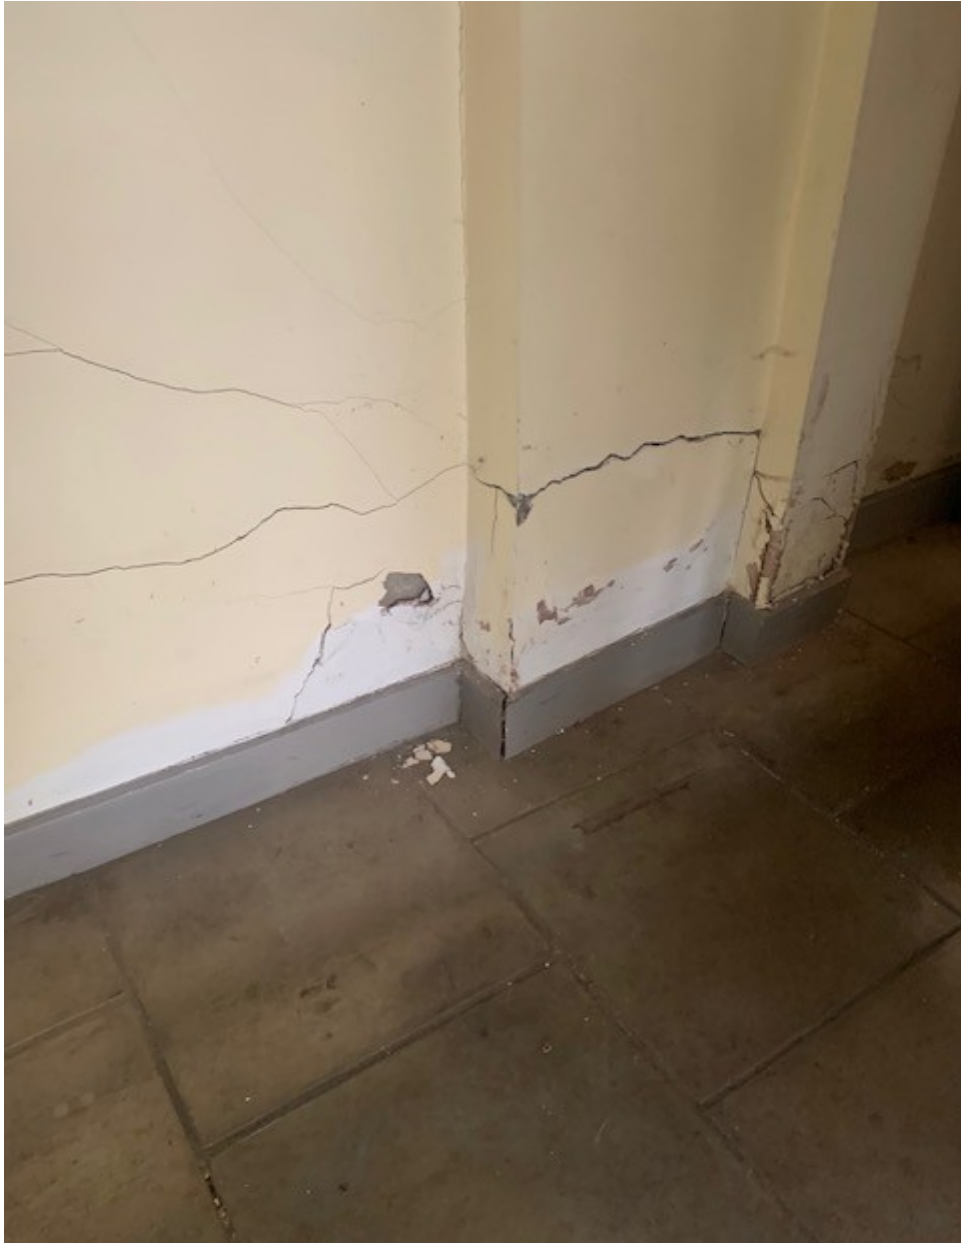
The building in question is a two storey 19th century mews building under a pitched tiled roof. The walls are solid 9" masonry and are likely founded on relatively shallow stepped masonry footings. The external wall forms the boundary to the next door property No.3 Berkley Road. According to a 1996 report the ground level at the neighbouring garden is one metre higher, thus this boundary wall retains the soil at number 3 Berkley Road. As there was no access to the neighbouring property at the time of the survey we were unable to assess the damage at this lower section of wall that retains the boundary. The section of the wall visible from inside is showing signs of substantial cracking and damage. As can be seen from the attached photos and plan there is a large tree adjacent with the trunk of the tree approximately 300mm from the wall. The base of the trunk and the roots are now pushing on and dislodging the foundations which is causing the wall to crack and be out of plumb at this location[photo attached].

Damage to the external boundary wall

The first and best option will be to employ a tree surgeon to remove the tree and the roots and make good afterwards. The footings will be rebuilt in reinforced concrete to allow for the collapse of soil once the roots are removed. We recommend a builder should be in attendance when the tree is removed to deal with any issues arising.

The second option would be to reconstruct the wall in reinforced concrete with similar foundations of sufficient depth. I would only recommend this if all other avenues are exhausted.

In the meantime while these issues are being resolved, the cracks should be monitored for spread on a regular basis to ensure the condition of wall is not worsening.

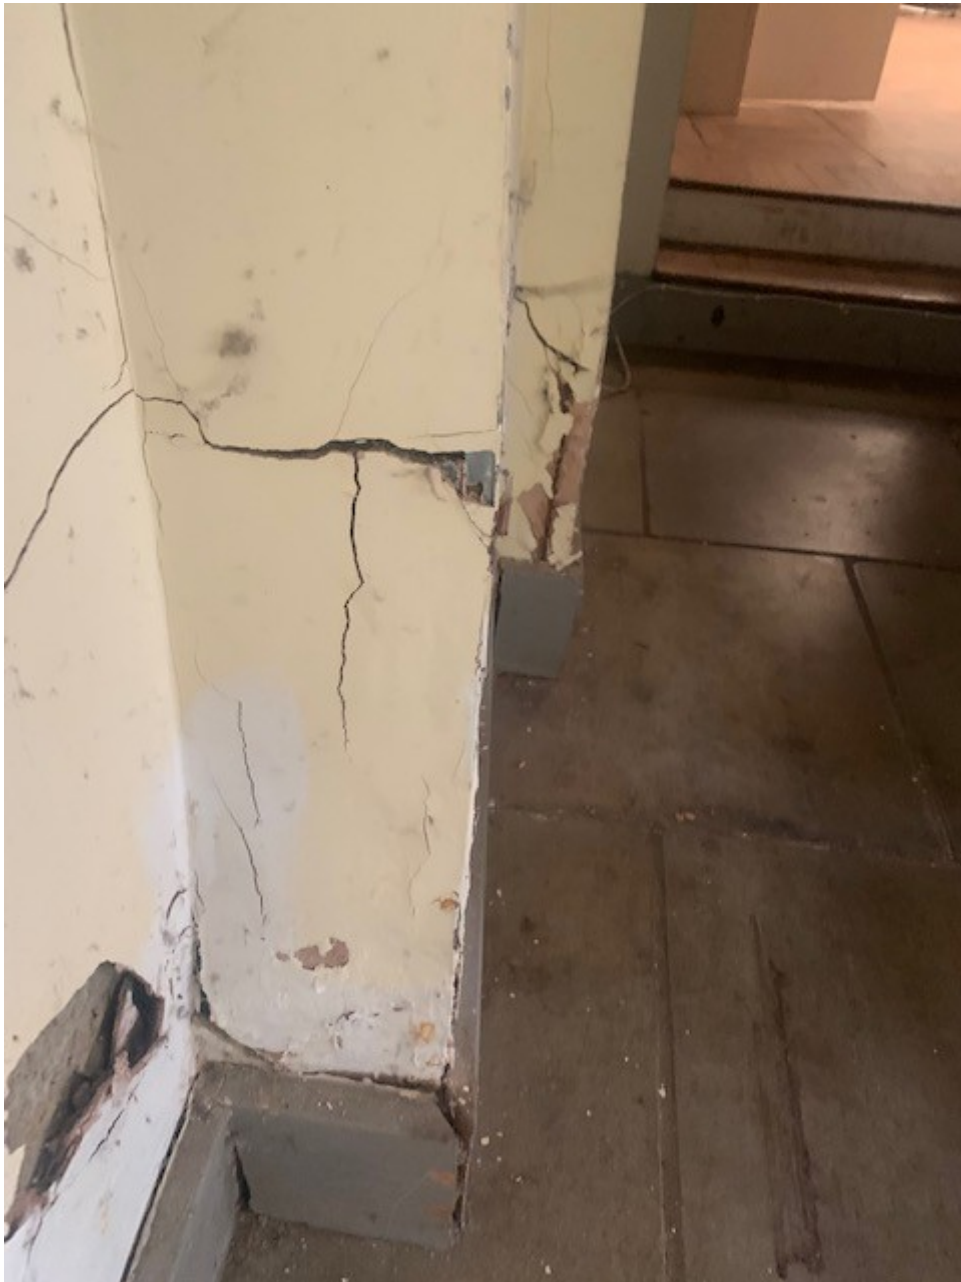
side view on damage to external boundary wall

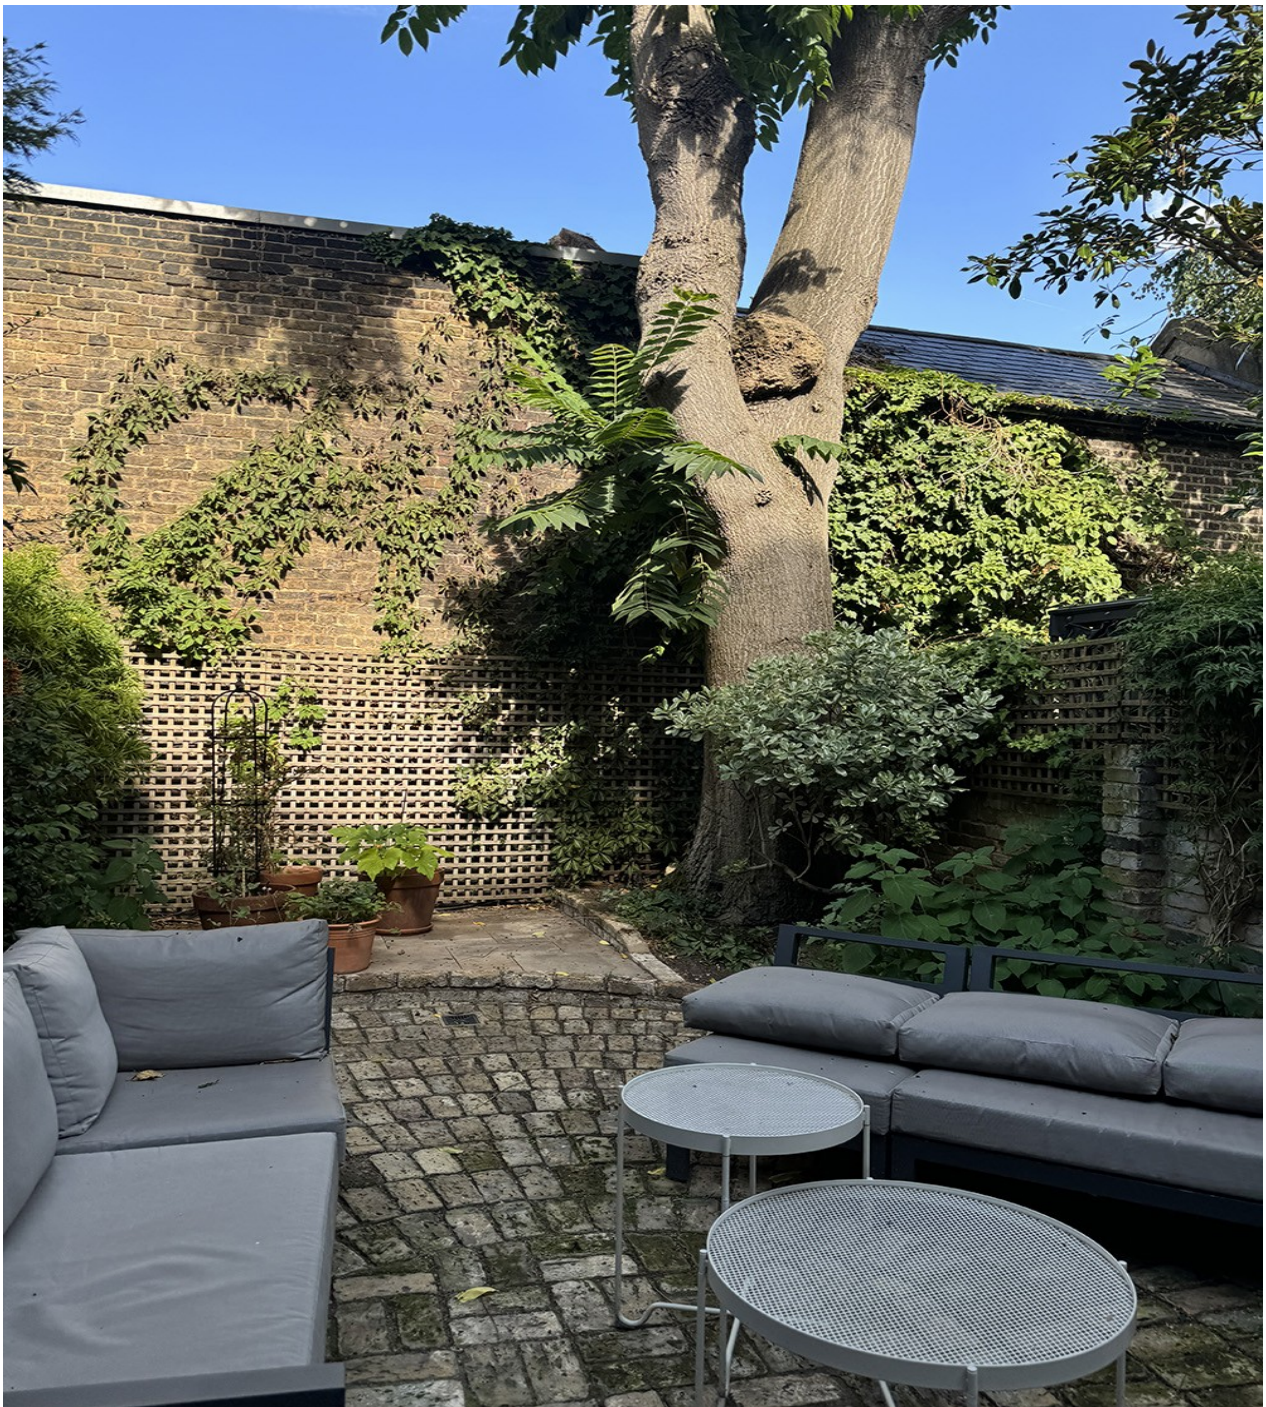
We attach a page from the report on the tree that was commissioned in 1996. The tree was identified as Tree of Heaven and at the time was 18 metres high. At that time the wall was not damaged. The report stresses the probability of damage to the adjacent wall in the future which has now occurred. As may be seen from the photographs attached the wall in question is severely cracked at the base, due to pressure from the tree trunk and roots. We understand that this tree is the subject of a tree preservation order, however although we cannot say that the stability of the wall is currently in question, this wall is severely damaged and if the cracks continue to widen the wall will be in danger, and the stability of the structure will be compromised. Discussion should be entered in to with the appropriate Council department to remove the preservation order.

Recent view from the neighbours property
