5 DENMARK STREET, LONDON

Consented works implemented to date

WORKS UNDERTAKEN TO DATE

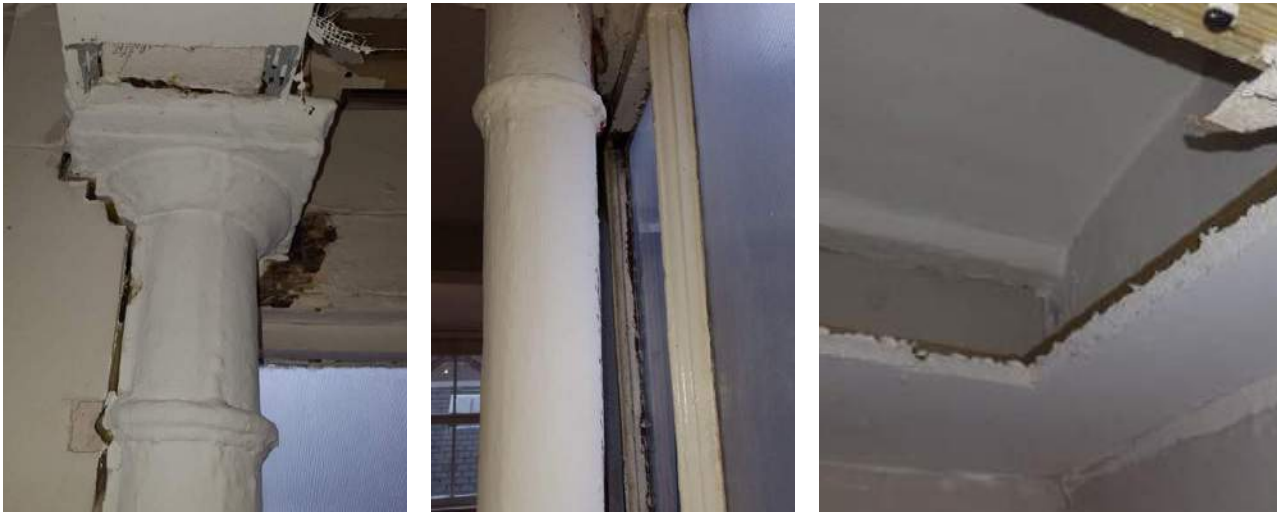
Opening up works at second floor ceiling level shows evidence of existing masonry vaults concealed behind the ceiling void. This is seen in the right-hand photograph below. These have been plastered over and painted. The proposal would look to retain these and expose as a feature of the refurbished second floor. The ambition would be to remove the plaster and expose the concrete or brickworks vault beneath. It also proposes exposing the existing down-stand steel beam which supports secondary beams that support masonry vaulted roof. The existing steel column will be ‘freed’ from its existing wall condition adjacent the window by the new infill to the side which allows for the new stair to the extension above.
