PANOPTIC
DESIGN CONSULTING

Structural Inspection Report

**35 Barn Field
Upper Park Road,
Belsize Park,
NW3 2UU**

Structural Inspection at 35 Barn Field, Belsize Park

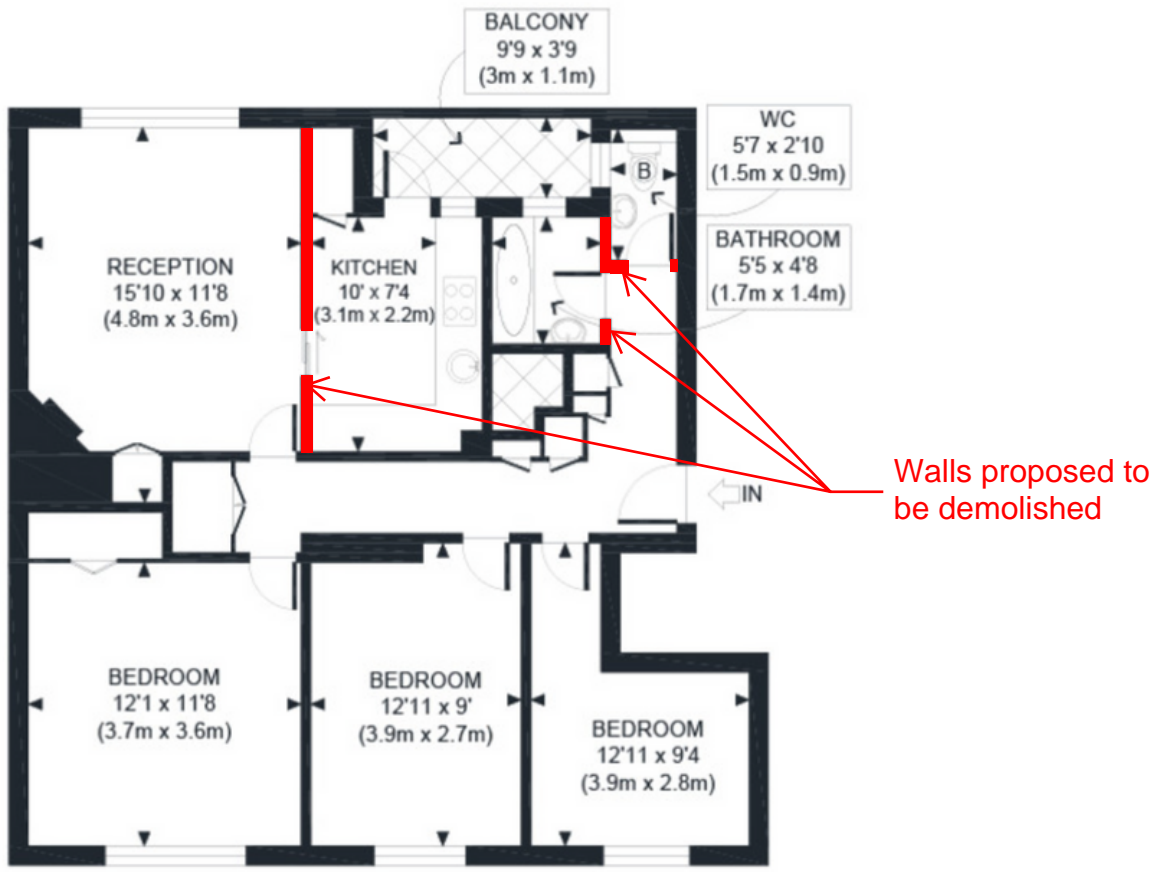
Flat 35 Floor Plan

The internal walls that are proposed to be demolished form the partition walls within the flat between the living room and kitchen; between the toilet and bathroom; and between the hallway and bathroom. Refer to Appendix A for the sketch plans.

- The wall between the bathroom and corridor, and the wall between living and kitchen are assumed to be non-loadbearing and not contributing to the overall stability of the building.
 - Thus, we would conclude that it is acceptable for these walls to be demolished.
- The wall between the bathroom and toilet is assumed to be party load bearing where it meets the external wall as it may be supporting the downstand beam.
 - We would therefore recommend further investigations are carried out on this wall by removing the finishes at the top of the wall to confirm whether the wall on the internal side of the downstand is loadbearing or not. Overall, we are of the opinion that the wall can be trimmed back up to the downstand only, to ensure support for the downstand is not removed.

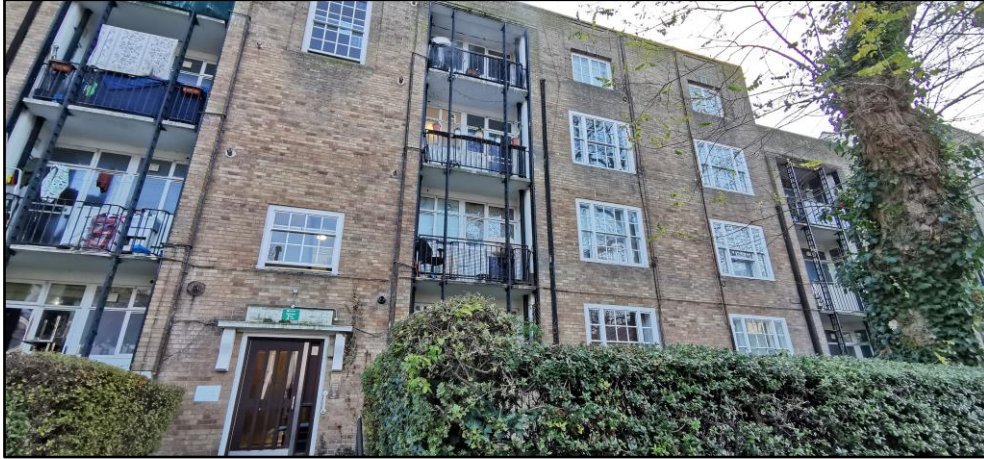
The property is a three-bedroom flat located at the ground floor of a three and four-storey residential building. The building is brick clad and assumed to be constructed circa mid-1900s.

Photo 1: Front elevation of apartment block

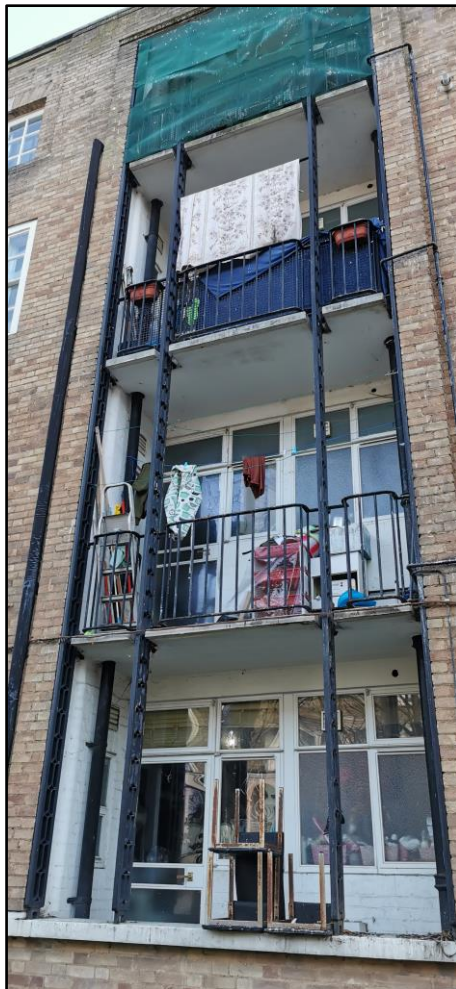
Photo 2: External view of inset balcony

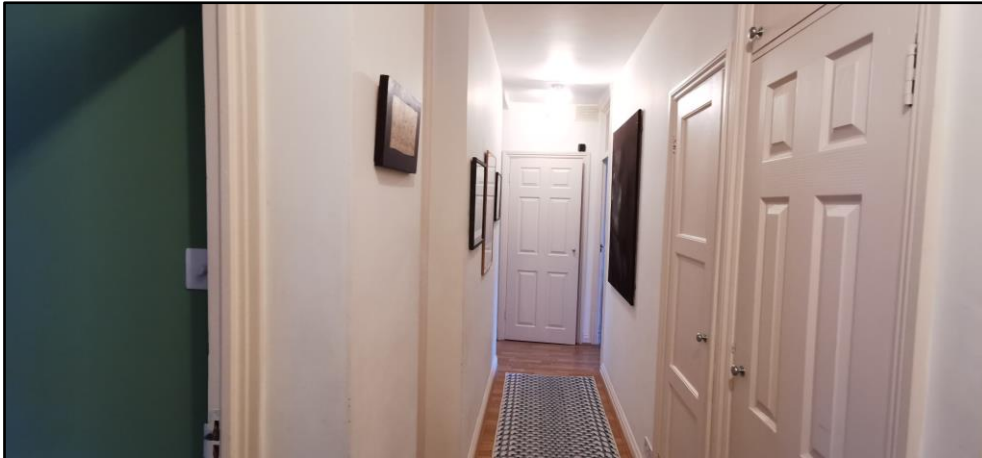
The wall running along the corridor/hallway adjacent to the bedrooms was covered in finishes, however it appears to be solid and was measured as circa 250mm wide.

Furthermore, the internal 250mm wide corridor wall adjacent to the bedrooms appears to be the widest internal solid wall measured. Therefore, it is assumed that this is the primary internal loadbearing wall which acts as an intermediate support on which the floor slab spans front to back of the property.

Photo 3: Flat corridor leading towards living room, showing bedroom side wall (left) and kitchen side wall (right)

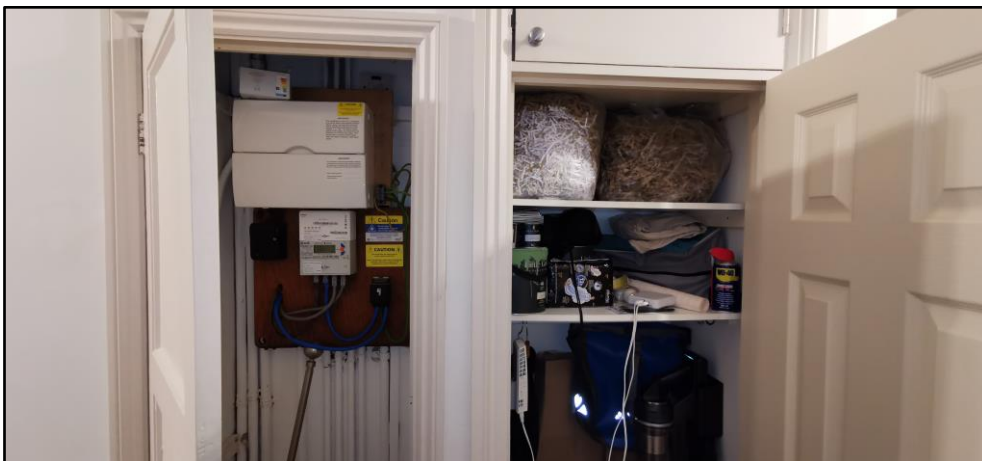
The wall running along the corridor/hallway wall adjacent to the kitchen has several openings for storage cupboards, and was generally covered in finishes. The construction of the top 300mm of the wall was visible from within the electrical cupboard as blockwork on three sides (including the main corridor wall), and brickwork of circa 150mm wide on one side. Part of the slab above was also visible through a void in this cupboard as concrete, and it was noted there appears to be a gap between the slab soffit and blockwork, with what appears to be a soft joint / compressible fill material at the top of the brickwork part of the wall. It was also noted that there was no lintel over the electrical riser cupboard door, only blockwork continuing over.

Photo 4: Openings to cupboards in corridor wall on kitchen side

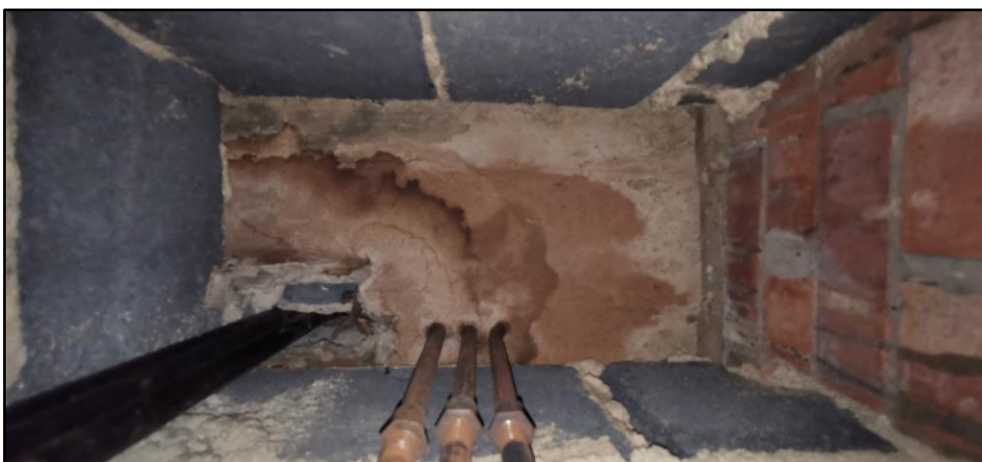
Photo 5: Wall structure visible above electrical cupboard

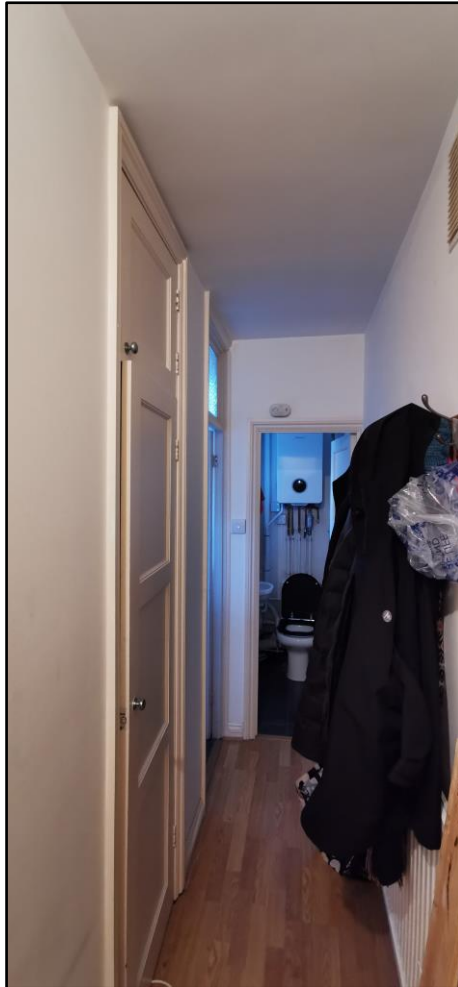
Photo 6: Flat corridor leading to bathroom with bathroom side wall (left) and toilet wall at the end

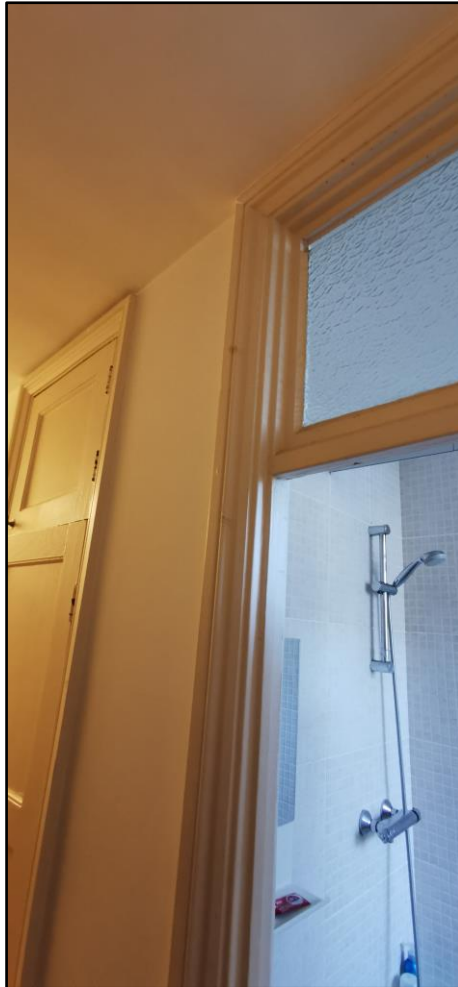
The wall between the bathroom and corridor was measured as circa 80mm wide, and sounded of blockwork similar to the walls mentioned above.

Photo 7: Wall between corridor and bathroom proposed to be removed

We would recommend that the walls are demolished carefully, and should any support/tying of the walls to the surrounding structure be found, that further advice / guidance should be sought to confirm that the full extents of the walls are non-loadbearing.

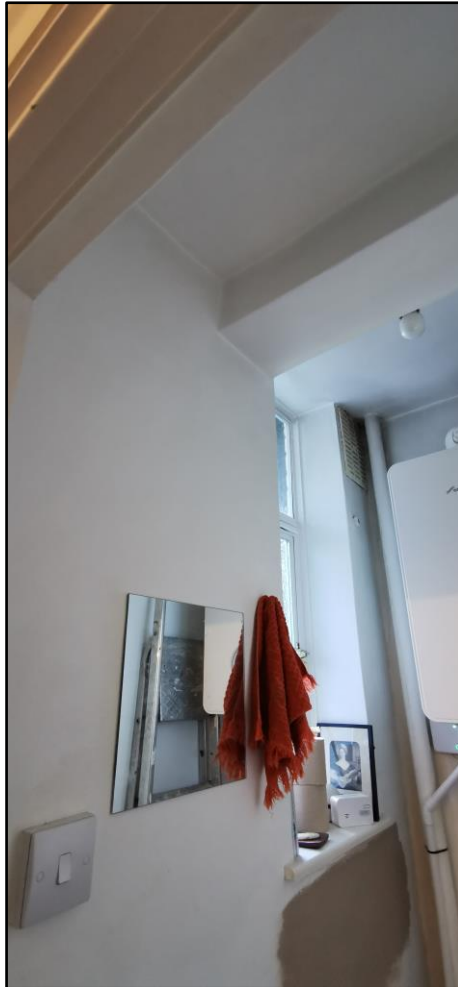
The wall between the bathroom and toilet sounded of solid masonry and measured as circa 150mm wide. Furthermore, a downstand was noted above the toilet, which appears to align with the external wall framing the inset balcony, indicating this may be a downstand beam supported on this wall.

Photo 8: Downstand above toilet room in line with external wall of inset balcony

Care should be taken to not damage / demolish / alter the existing building structure, i.e. downstand beams and existing floor slab.

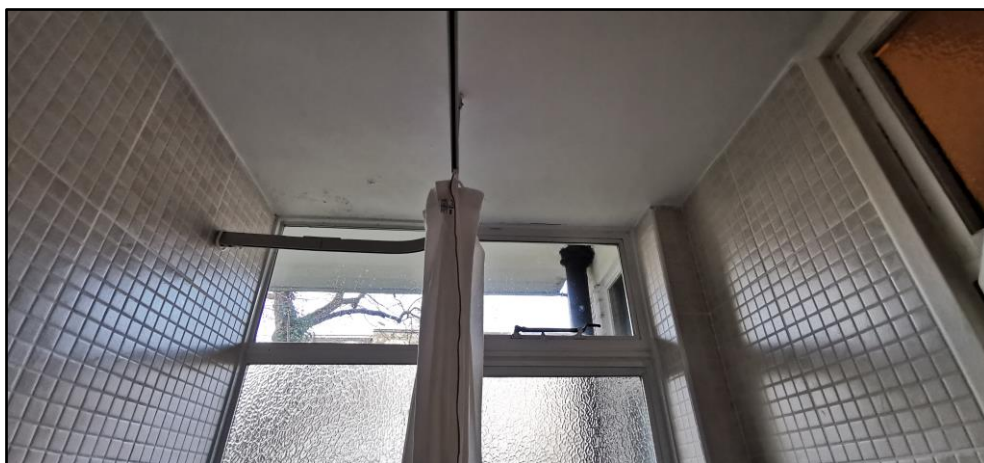
Photo 9: Front wall of bathroom overlooking inset balcony

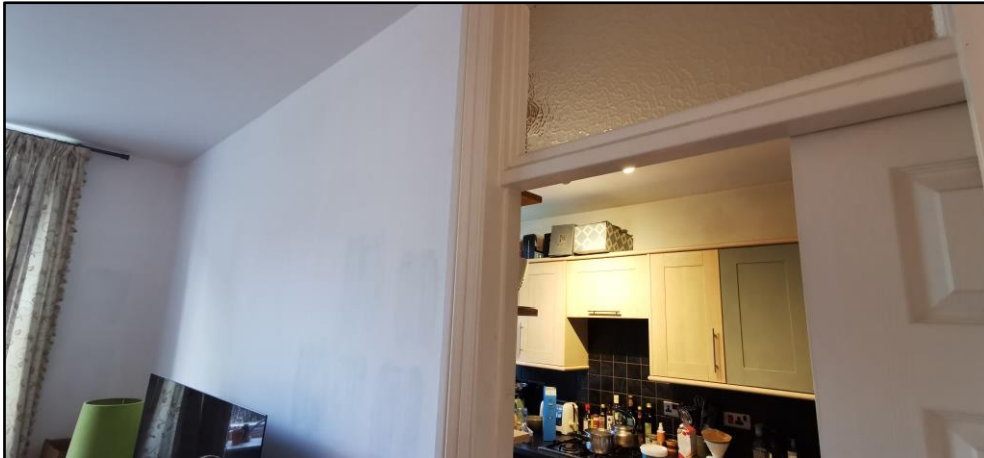
The wall between the living and kitchen sounded to be of blockwork construction, and was measured as circa 100mm wide.

Photo 10: Wall between kitchen and living room with full height opening proposed to be demolished
