RE: 35 Barn Field - Structural Inspection Report

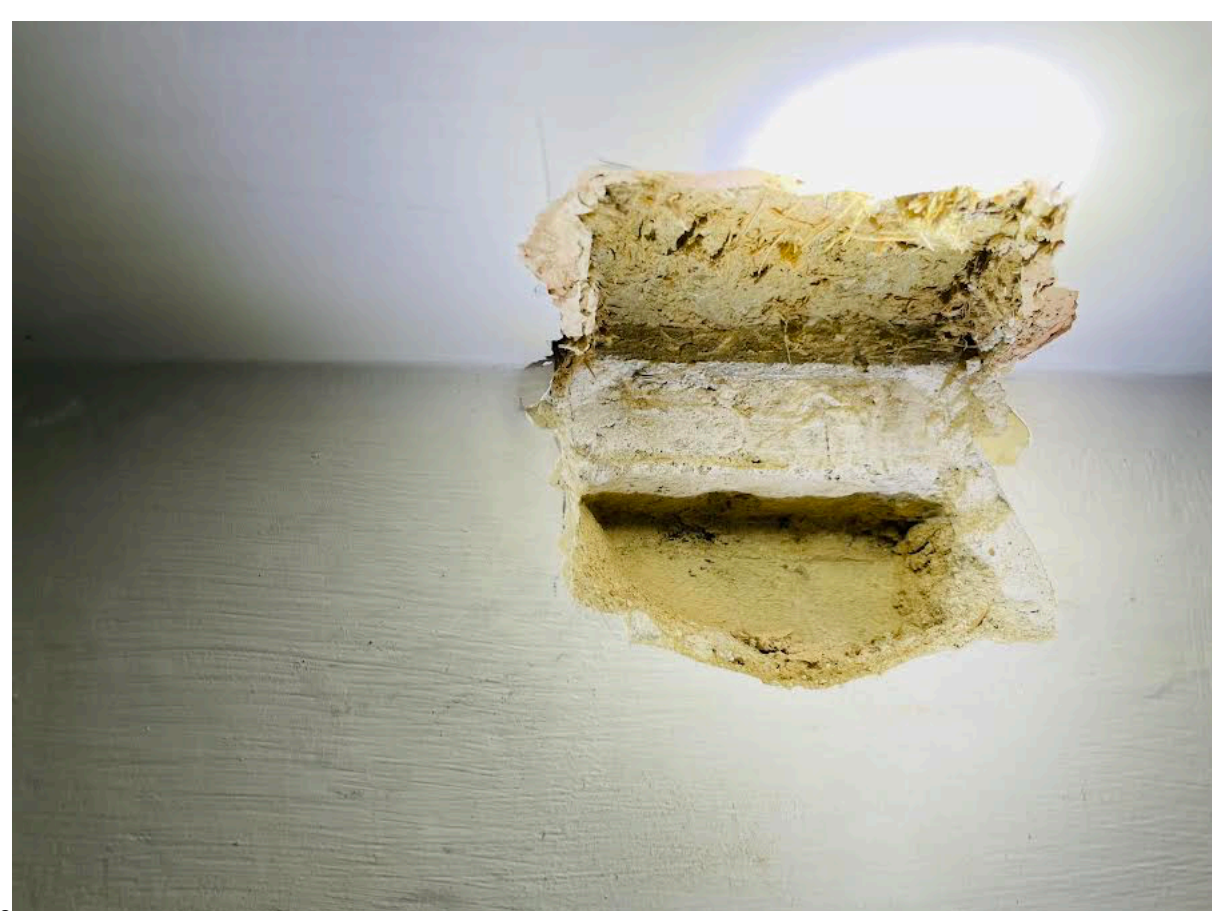
Thanks for the photos, they do all look like there is a soft joint at the top of the walls (appears to be a layer of compressible fill material). Therefore we are comfortable that the walls in question are not loadbearing.

Photo of wall between toilet and bathroom

We would recommend that these walls are still removed carefully by the builder to ensure there are no instances of direct bearing of the slab above onto the walls, as these have only been reviewed from localised opening-up and photos.

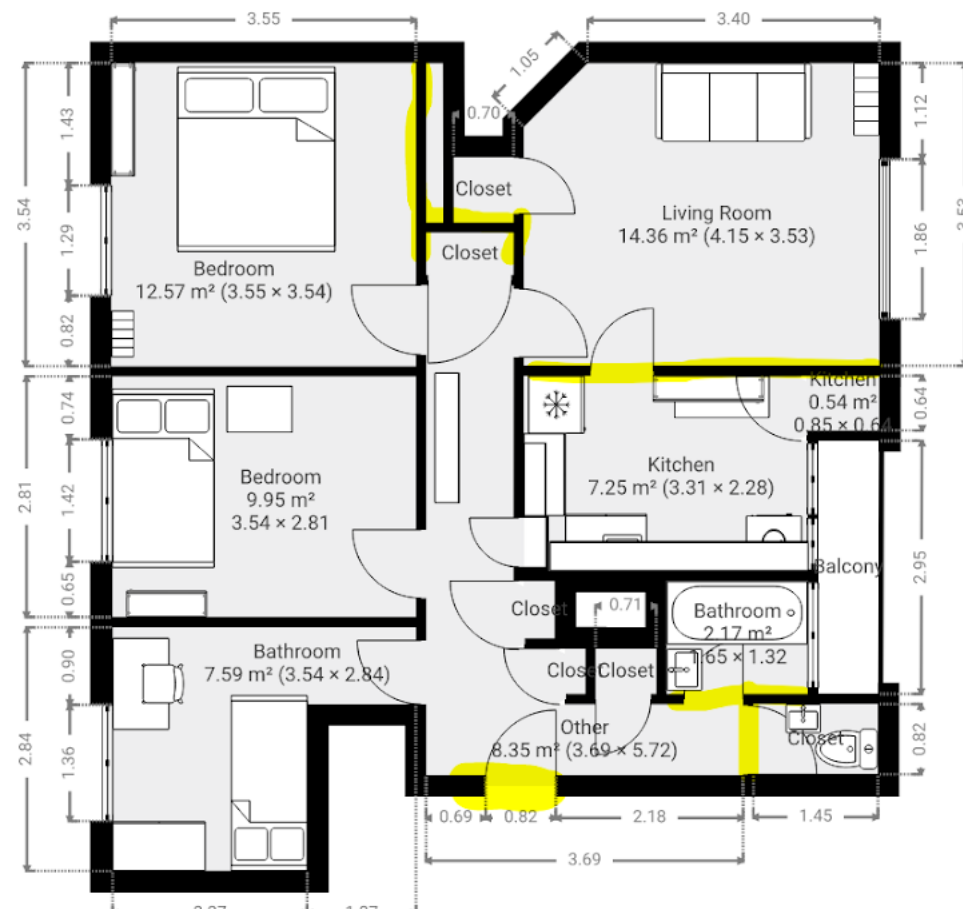
I have reviewed the updated proposed layout and our issued report and photos taken during the site visit. I understand from the below and the proposed layout that the walls highlighted in yellow below are proposed to be demolished? Would you also be planning to demolish the existing downstand above the toilet (in the attached photo)?
