**Tree Condition Survey**  
**for the Duke of Hamilton, Hampstead**  
**30<sup>th</sup> September 2024**

**Completed by Stephanie Mason**

**Ben Mason Arb Ltd, 38 Palesgate Lane, Crowborough East Sussex, TN6 3HF**

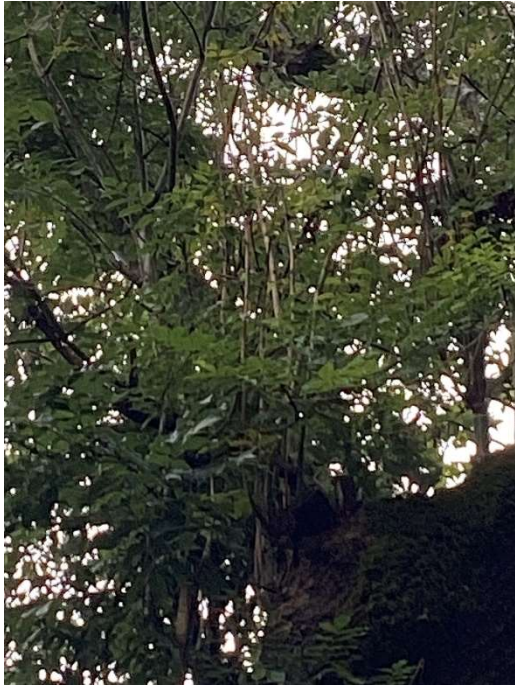
1 Epicormic growth

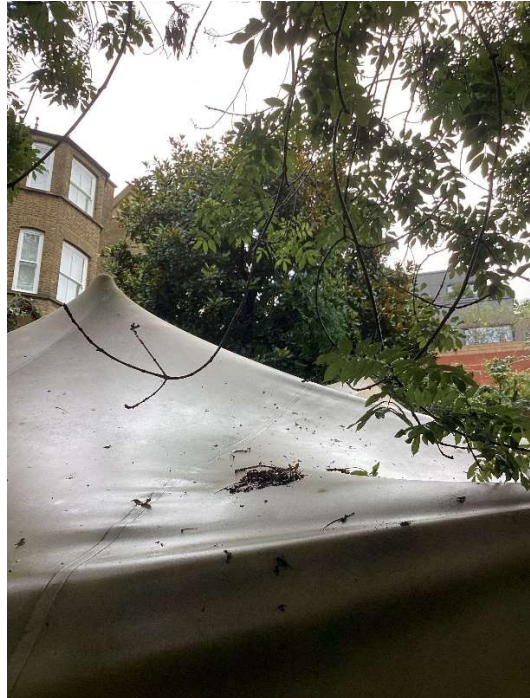
2 Dieback of leaves

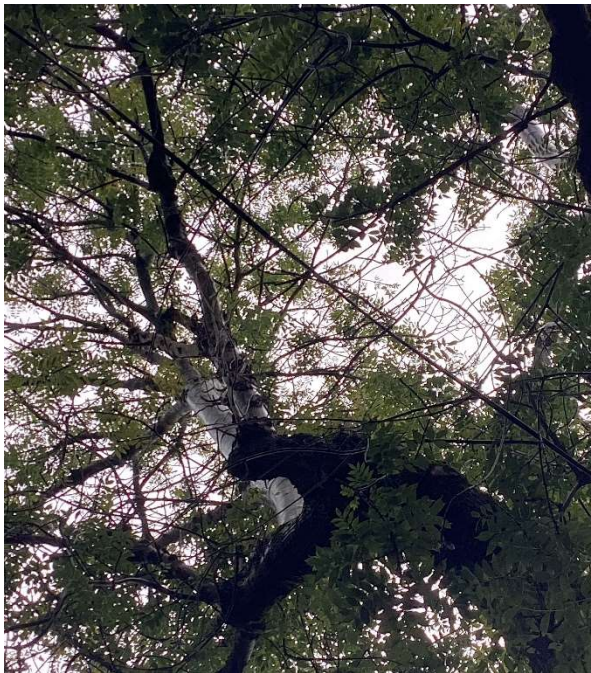
3 Dieback of leaves / sparse Canopy

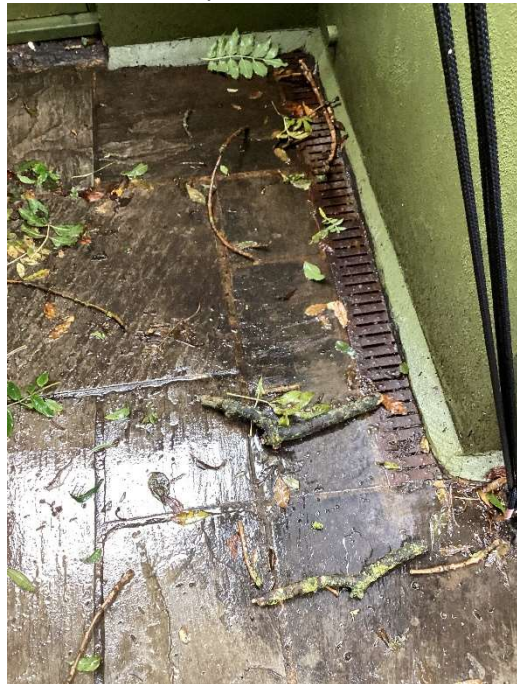
4 Debris in courtyard

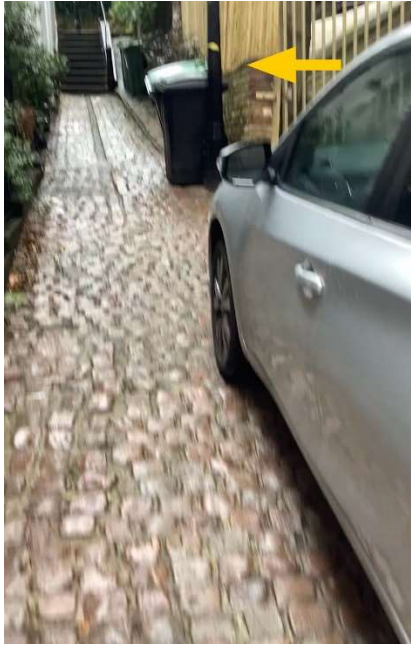
5 Access (Arrow shows where access narrows next to tree)

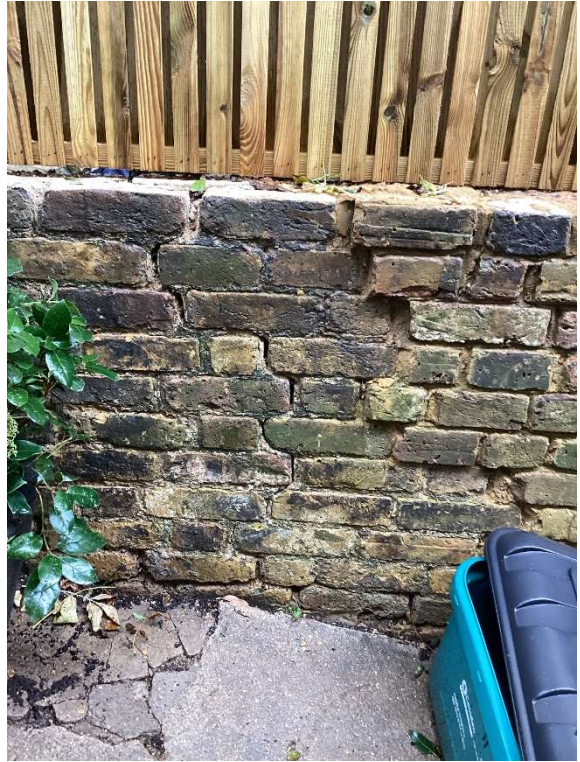
6 Cracked boundary wall

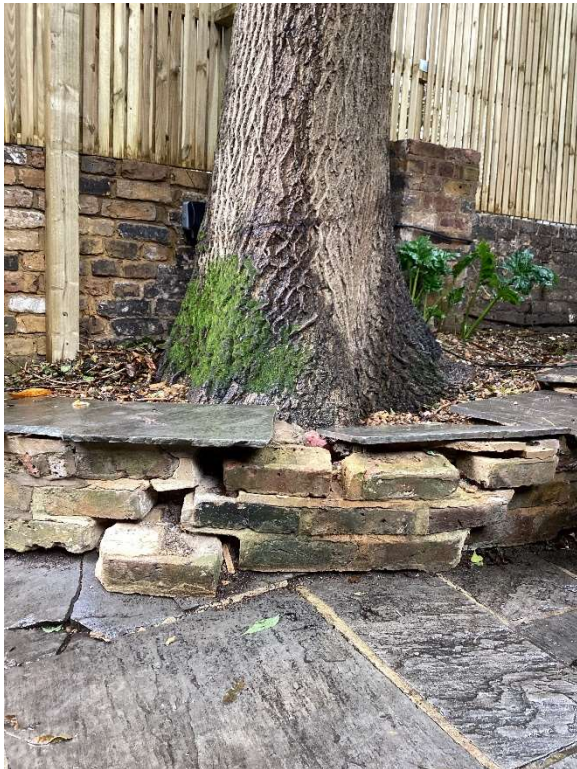
7 Lower wall
