Maria Fidelis Old School Building

Contamination Verification Report

Document No. 1CP01-MDS_ARP-EV-REP-SS08_SL23-990037

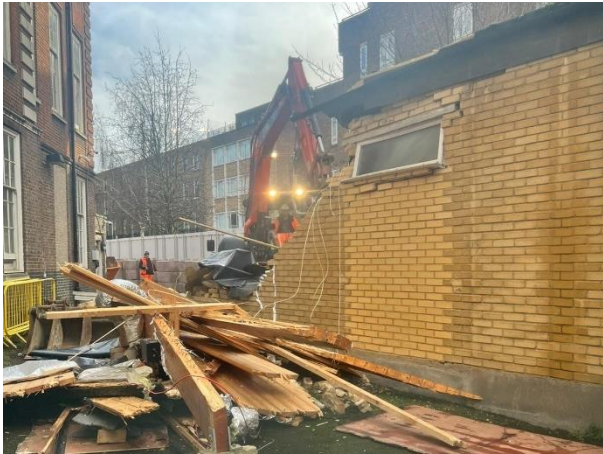
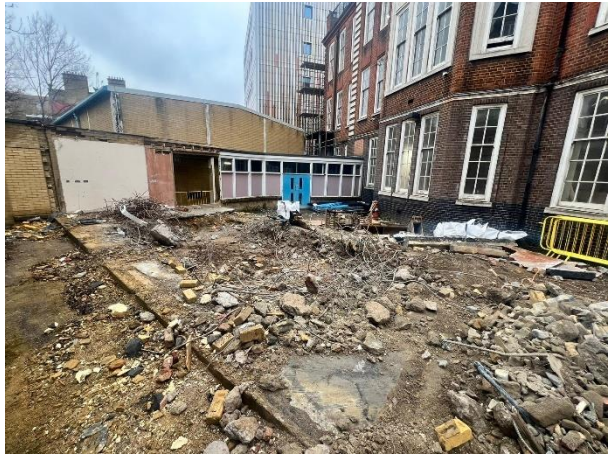
<p>Demolition of the gym annex building in March 2024.</p>	<p>Demolition of the gym annex building in March 2024.</p>

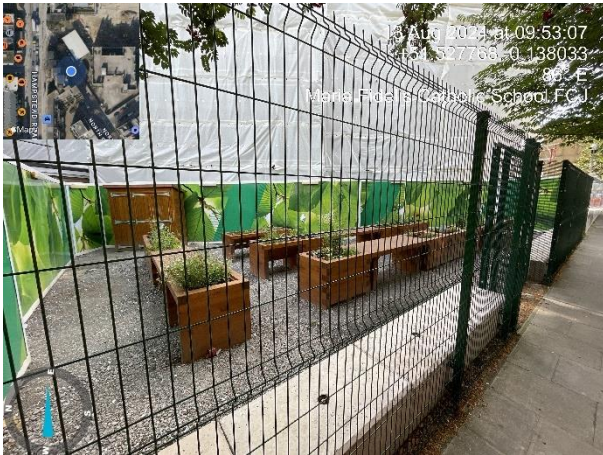
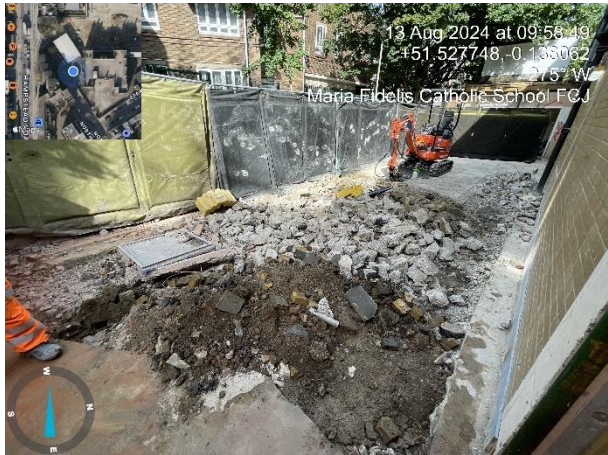
<p>Implemented meanwhile garden space. Photo taken on 13 August 2024.</p>	<p>Excavation works at TEP community hub entrance on 13 August 2024 for installation of new concrete slab and footings.</p>

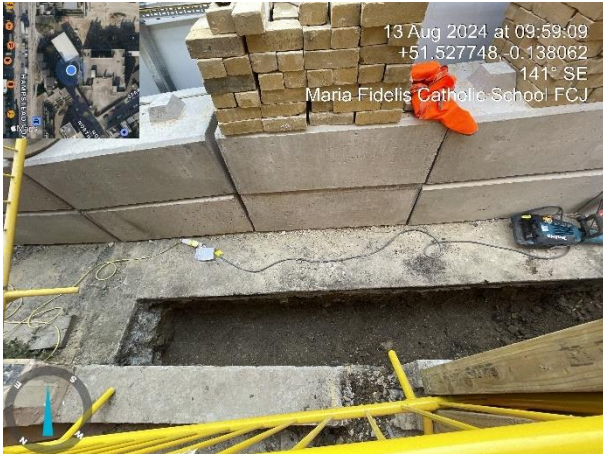
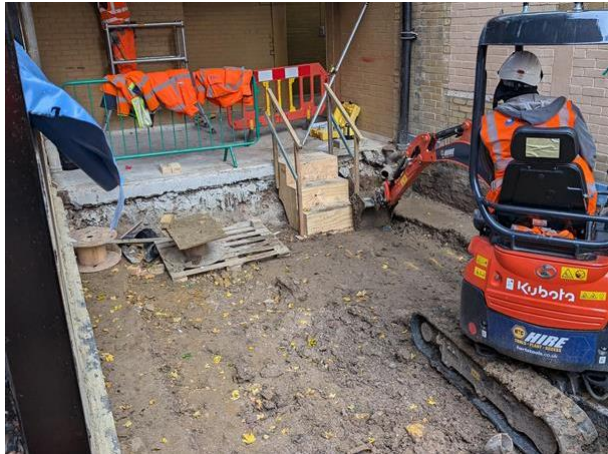
<p>Excavation works on 13 August 2024 for installation of drainage runs and manholes.</p>	<p>Backfilling at TEP community hub entrance on 17 October 2024.</p>

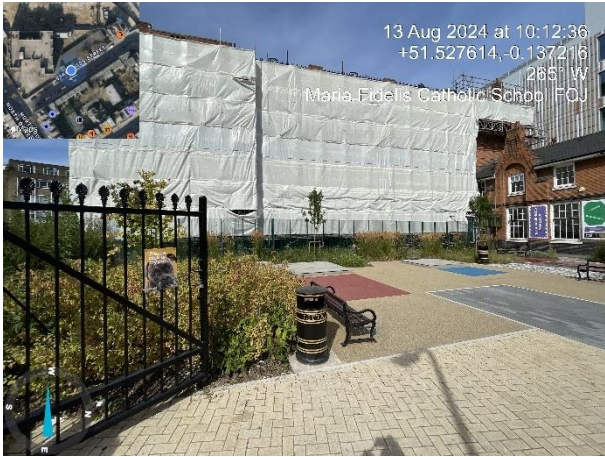
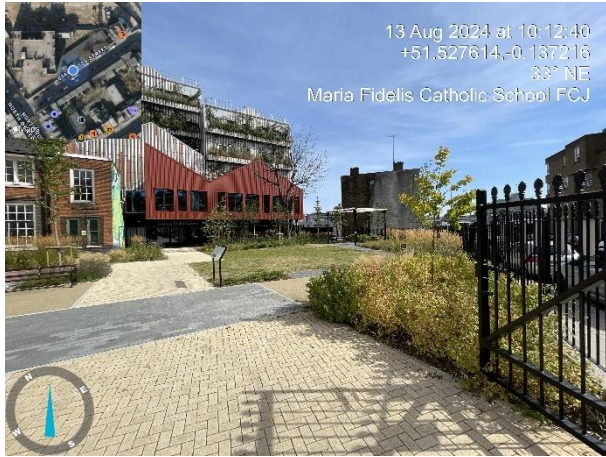
Photo of Starcross yard taken on 13 August 2024 towards the west.	Photo of Starcross yard taken on 13 August 2024 towards the north.

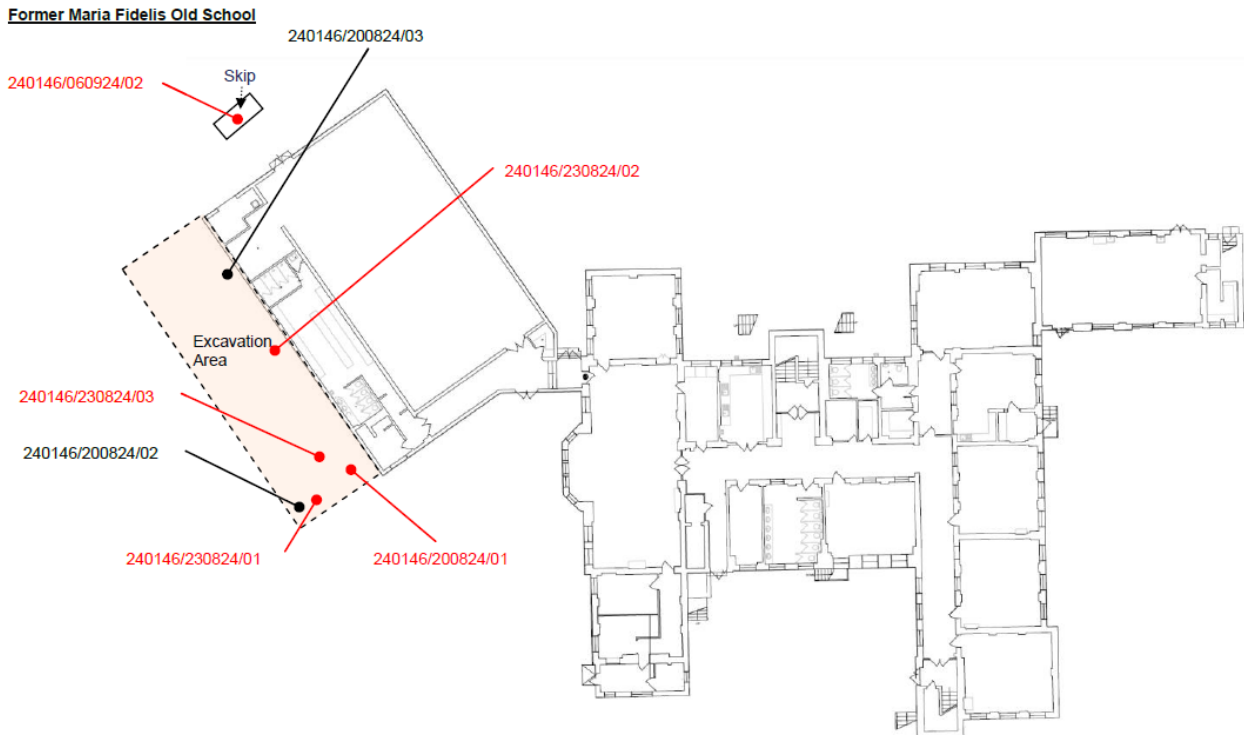
Figure 2: Area where the ACM was encountered and the sampling locations

analysis results with sampling location plan and photographs of the samples are provided in Appendix A. The asbestos removal works were identified as licensable works, and the Health and Safety Executive (HSE) was notified through an ASB5 form which is provided in Appendix A. Area where the ACM was encountered and the sampling locations are shown in Figure 2.

4.5.12 A plan of work for the licensed asbestos removal is provided in Appendix A. The plan of work indicates an excavator would be used to excavate and load wheelbarrows with the excavated soils potentially containing AIB debris. DCUK would be in attendance during the excavation works to carry out a watching brief and to handpick the debris where required. Where AIB debris is found, the debris is required to be bagged in asbestos bags and the soil to be raked and inspected. The plan of work requires the removal work to be undertaken within a respirator zone under locally controlled conditions and with dust suppression using a handheld pump sprayer. The works area is required to be fenced off with appropriate signage posted. Further analysis of the excavated area is required through digging of trial holes and collecting validation soil samples to confirm all ACM is removed from site.

4.5.13 The licensed asbestos removal works were undertaken between 13 September and 7 October 2024. A completion certificate was issued by DCUK on 9 October 2024 and is provided in Appendix A. As stated on the completion certificate,

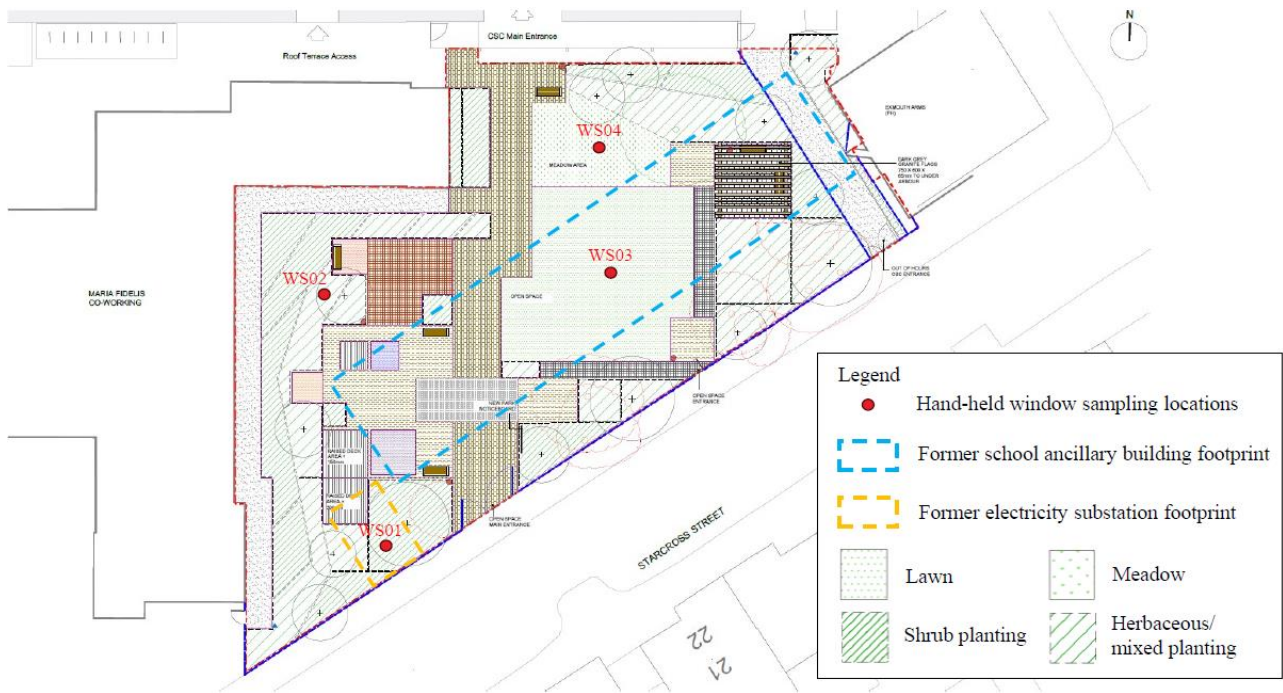
Figure 3: Proposed soil sampling location plan

- 4.5.26 LBC confirmed that no new drainage was installed as part of the landscaping works. Surface water runoff is diverted away from buildings and into new planting beds through designed ground levels.
- 4.5.27 MDjv is planning to undertake a ground investigation at Starcross yard in early 2025 to verify the soft landscaping implementation at the yard. The ground investigation will comprise soil sampling at four locations covering lawn, meadow, shrub planting and herbaceous/ mixed planting areas. The proposed soil sampling location plan is shown in Figure 3.

4.5.28 Findings of the ground investigation will include evidence of the depth and chemical testing certificates for the topsoil and subsoil at Starcross yard. This will be presented in a ground investigation factual report and submitted as part of an addendum to this report.
