Memorandum

To	Chris Ray, YOO Capital
Copy	Andy Ball, Ian Crossley, Gary Earl
From	Thomas Holt
Office	London
Date	14 January 2025
File/Ref	CW000014 Saville Theatre
Subject	Initial Intrusive Investigations – Observations and Recommendations

1.0 - THE SAVILLE THEATRE 42638 - OUTLINE STEEL FRAME CORROSION INVESTIGATIONS METHODOLOGY

Project: THE SAVILLE THEATRE
135-149 SHAFTESBURY AVE, LONDON WC2H 8AH

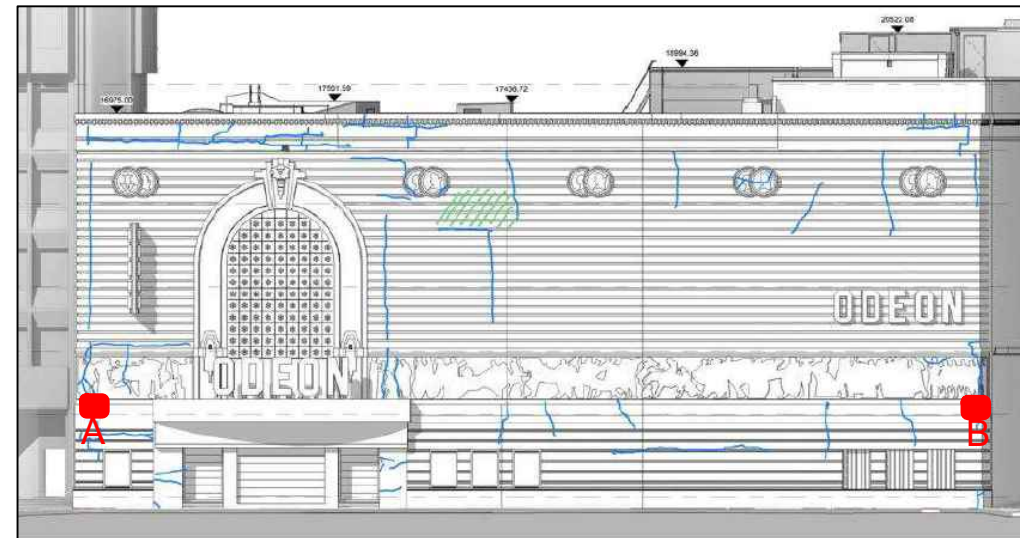
FIG.1 - ANNOTATED ELEVATION DRAWING (INGRAM CONSULTANCY FACADE CONDITION REPORT, 2022). NOTE: ORIGINAL MARK-UP SHOWING LOCATION OF CRACKING VISIBLE. SWL RED ANNOTATION SHOWS PROPOSED LOCATIONS FOR INITIAL INVESTIGATIONS.

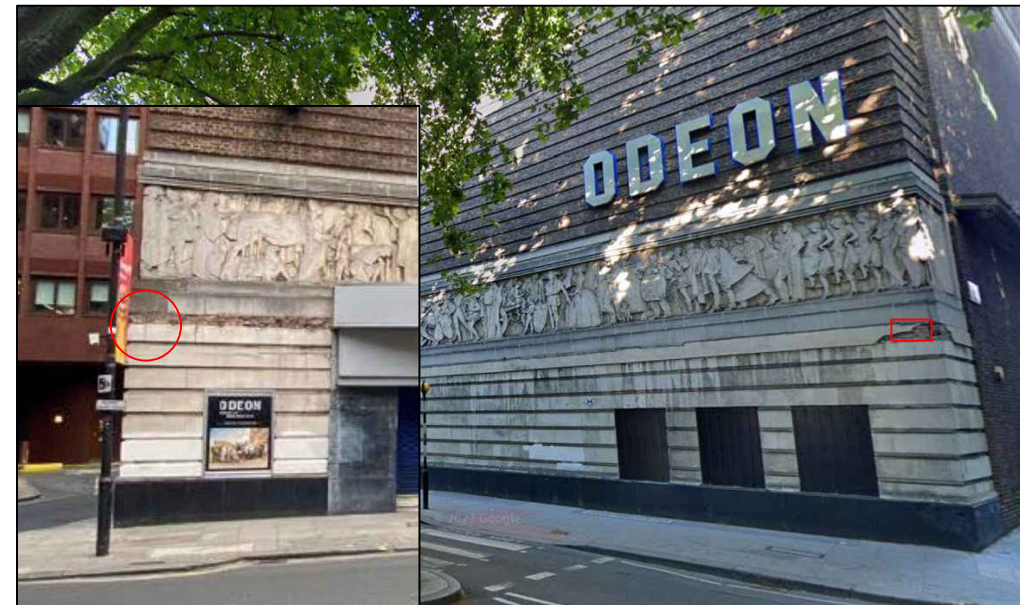
STEP 1 INVESTIGATIONS: WE ARE PROPOSING TO EXPOSE STRUCTURAL STEELS FOR INVESTIGATION VIA THE REMOVAL OF INDIVIDUAL BRICK UNITS (ACROSS APPROXIMATE 300X300MM AREAS) TO THE NORTH AND SOUTH OF THE EAST ELEVATION FACING SHAFTESBURY AVENUE. PLEASE REFER TO FIGURE 3 WHICH SHOWS AN EXAMPLE IMAGE OF A PROPOSED LOCATION. THE BRICKWORK IN THE PROPOSED LOCATIONS COMPRISES SIMPLE BACKING BRICK UNITS, LOCATED BEHIND A FORMER RENDERED BAND COURSE. THERE IS EXISTING FAILURE TO THE RENDER IN THIS LOCATIONS EXPOSING THE CORE BRICKWORK.

FIG.2 / FIG.3 - STREET-VIEW PHOTOGRAPH OF SUBJECT ELEVATION / CLOSE-UP OF PROPOSED INVESTIGATION AREA A. NOTE: SWL RED ANNOTATION SHOWS PROPOSED LOCATIONS FOR INITIAL INVESTIGATIONS.

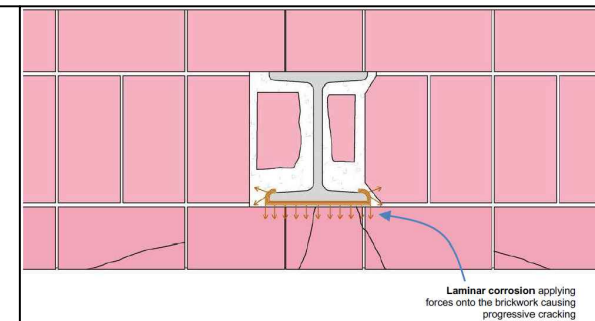
FIG.5 - DRAWING SHOWING LAMINAR CORROSION OF STRUCTURAL STEELS AS A DETERIORATION MECHANISM CAUSING THE FRACTURE OF ADJACENT MASONRY UNITS (INGRAM CONSULTANCY FACADE CONDITION REPORT, 2022).
