**Internal Paint Assessment**  
**at**  
**25 Neal Street, London, WC2H 9PR**

Report produced by: Richard Williams MRICS  
FOR AND BEHALF OF : Heritage Consulting Chartered Surveyors

**Report Date – REV C 22<sup>nd</sup> January 2025**

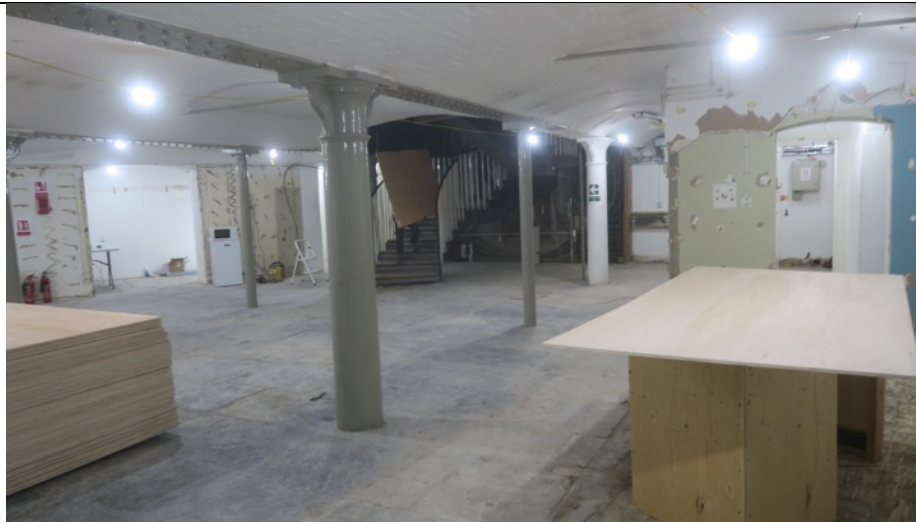
Cellar area to No.25 Neal Street retail unit with painted finish retained.

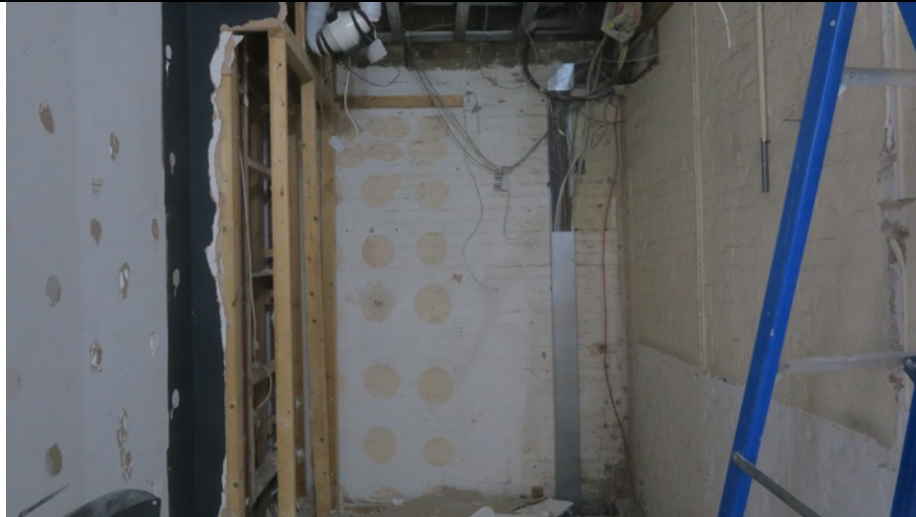
1<sup>st</sup> floor to No.25 Neal Street former changing room area with retained painted finish.

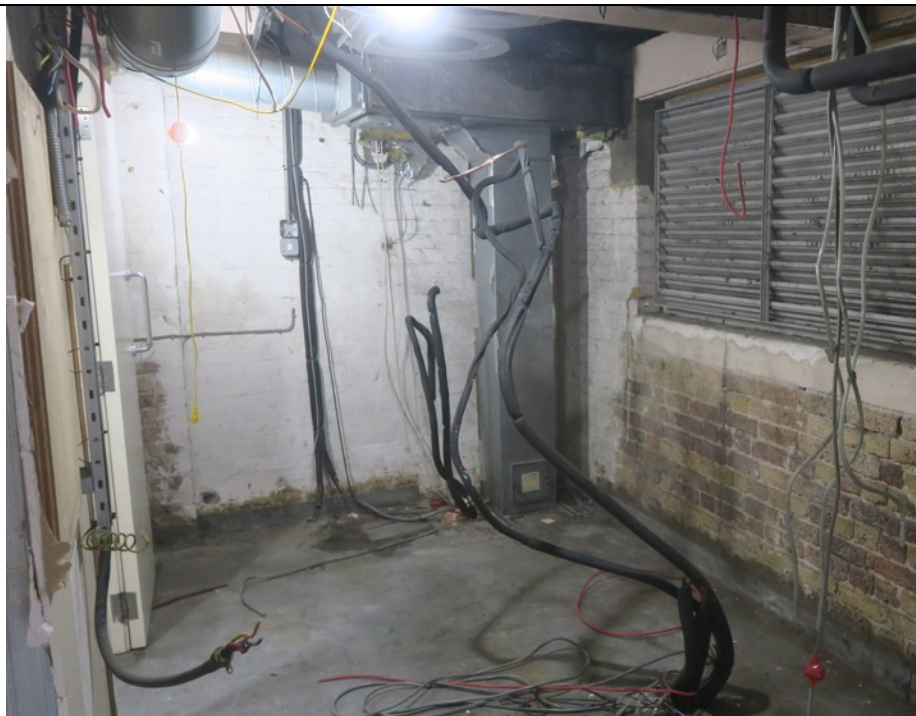
1<sup>st</sup> floor to No.25 Neal Street former service riser / staff area with retained painted finish.

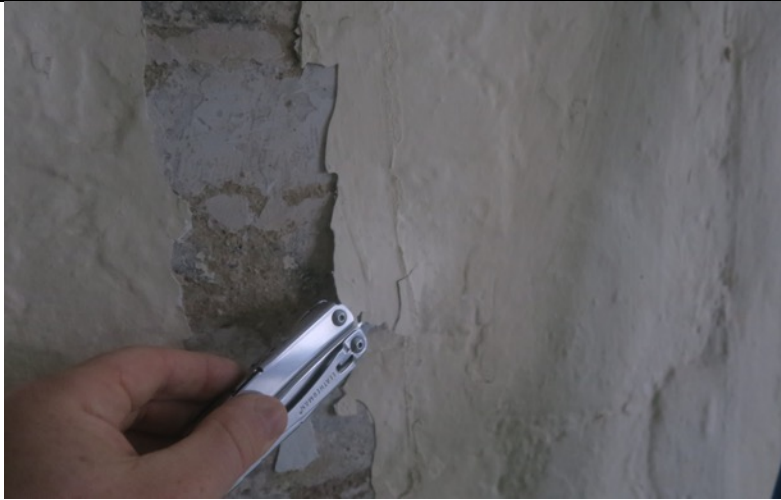
The existing retained paint has formed a brittle “crust” over the masonry indicating it is a fairly modern acrylic type paint, and not a historic limewash or oil based paint. Sample areas were removed with a knife and the paint is fairly easy to remove from the substrate using a knife or basic scraper.

<p>Paint removed for sampling with a knife. The paint is brittle and is fairly easily removable with a knife / scraper.</p>

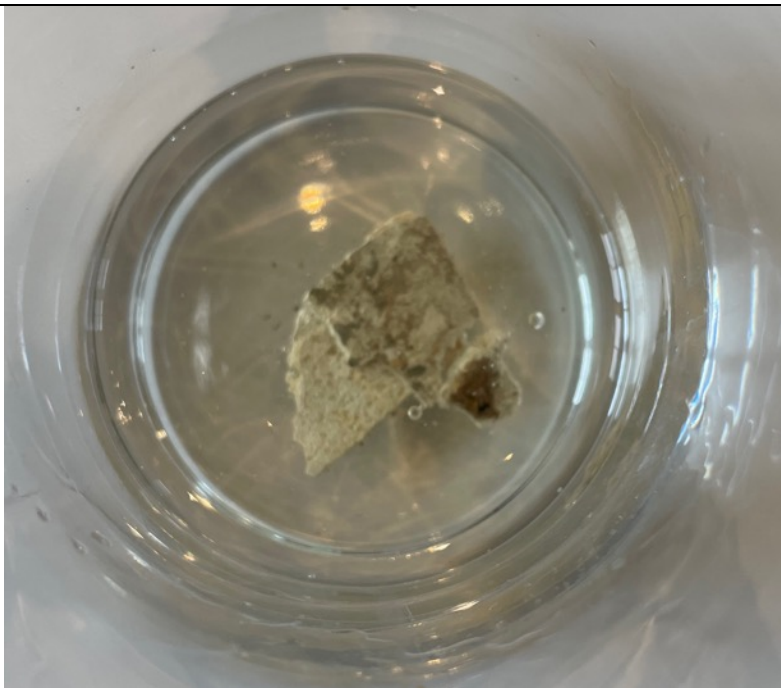
<p><u>Test 1 - Acid</u></p> <p>The paint samples are not dissolvable in acid and do not contain any lime or limewash.</p>

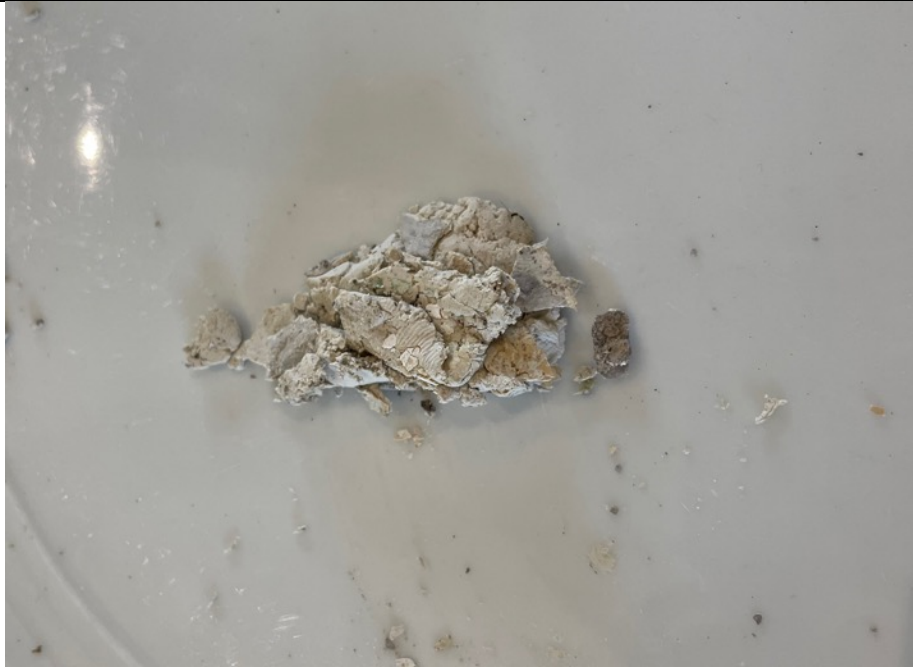
<p><u>Test 2 – Alkaline Poultice</u></p> <p>Peelaway or Kling Strip type paint stripper within a “poultice”.</p> <p>The paint samples are dissolvable and soften in an Alkaline Poultice.</p>

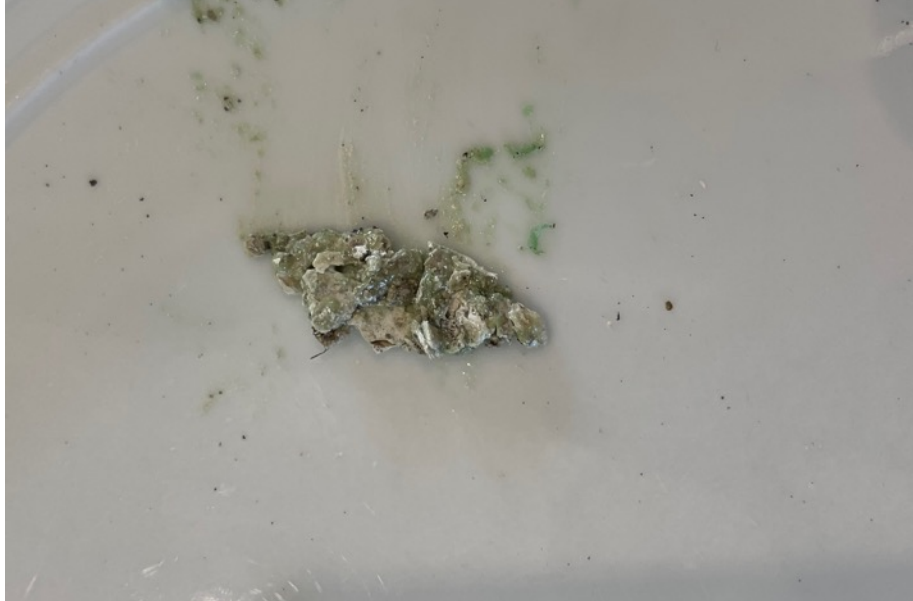
<p><u>Test 3 – Light Duty Solvent Paint Stripper (Bio Degradable)</u></p> <p>Tavek 201 or similar. Note this is a LIGHT duty bio degradable version.</p> <p>The paint samples are dissolvable in light duty solvent stripper.</p>

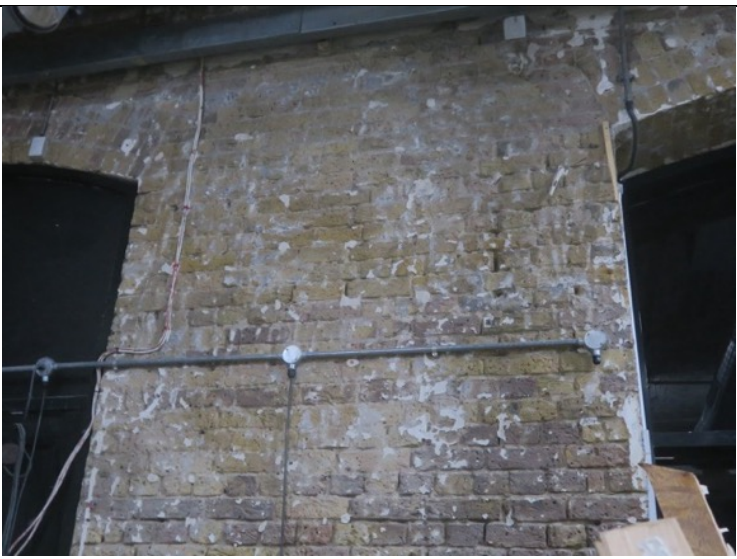
The paint removal has been undertaken poorly and there are lots of remnants of the paint left on the masonry. There is evidence of paint left in strips abutting the windows and evidence of mechanical damage to the masonry. The finish is not cohesive with removal only being undertaken around previous tenant shop fittings.

The mechanical damage to the masonry has occurred due to the approved grit blasting of the paint from the external walls, evidenced by the fairly “rough” removal, pitting and erosion of brick faces and strips of paint being left adjacent damageable items such as window frames.

<p>Remnants of paint left on masonry from grit blasting.</p>

To areas where paint has been removed (approved in 2004) the approved removal method of grit blasting has caused damage to the masonry. For the avoidance of doubt any future grit / shot blasting or mechanical abrasion to the masonry should not be undertaken as this will cause further damage.

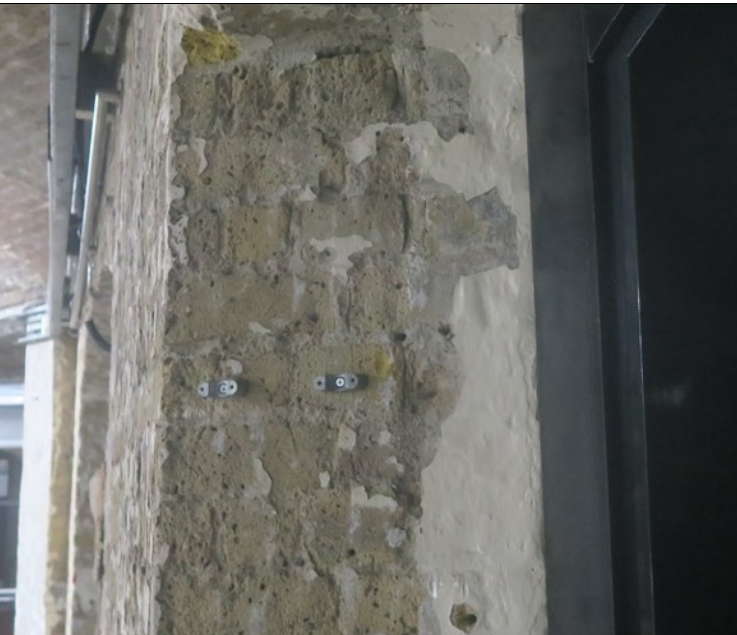
<p>“Strips” of paint left adjacent window frames and abrasion and damage notes to brick faces.</p>
