# Defects Report

Brick planter of tree opposite 37/39 Rossendale Way

Elm Village  
Camden  
London  
NW1 0XB

January 2025

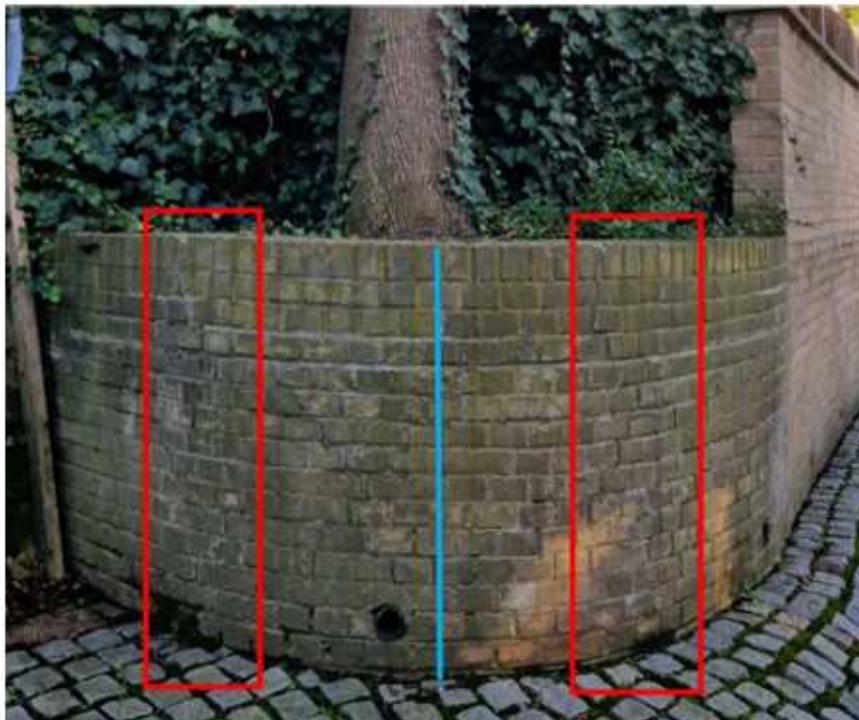
- 6.2.3 The planter has evidence of numerous previous repointing, with the latest repointing undertaken 1 to 2 years ago by a local resident.
- 6.2.4 The most significant movement is to the middle quarters of each side of the planter, as outlined in red below. Previous repointing is evident to the vertical mortar joints (perpend) which have further opened up over the last 1 to 2 years by up to 5mm at the outer edge on the top soldier course. These areas of cracking are highlighted in red below. This shows that the central half of the planter, largely between the highlighted areas, is being pushed out horizontally from the top.

- 6.2.5 The wall was observed to be approximately 21mm out of plumb over the height of the wall (19mm:1000m) at worst, in the middle, highlighted by the blue line above. Applying the middle third rule demonstrates that the wall is not at risk of structural failure from its self-weight, which would permit the wall to be up to 72mm out of plumb.

- 7.3 The planter should continue to be monitored with consideration for reinforcing the wall to prevent individual bricks falling as the movement progresses.

1. Undertake an arboriculturist assessment of the tree health and general stability, if not undertaken within the last year.
2. Reinforce the top rows of bricks using a metal strap resin fixed to the 2<sup>nd</sup> row of bricks, or with Helifix reinforcement top the 2<sup>nd</sup> and 6<sup>th</sup> beds, unless already installed.
3. Removal of the tree within the planter and replacement with a smaller and more suitable tree species that is better suited to the size of the planter and location.
4. Engagement of arboriculturist and liaison with the Tree and Landscape Officer at Camden Council to agree removal and replacement of the tree, which is expected to have a TPO. Consideration to a tree management plan for the site should be considered at the same time.

Note that the proposed metal strap reinforcement or Helifix rods should be fixed along the arc of the wall, but not to the larger walls at either side. The as the growth of the tree would not be able to be retained by this reinforcement. The proposed reinforcement is to prevent the top courses of brick from falling only. Tying into adjacent walls would likely lead to damage of these structures too.

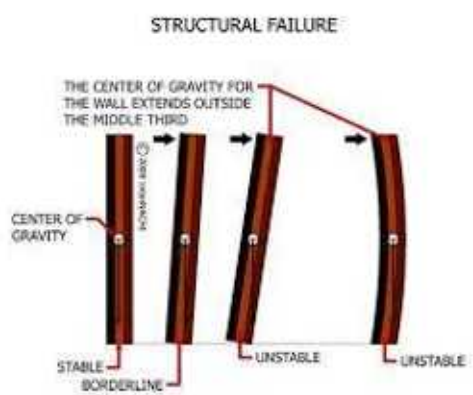
- 6.2.6 The horizontal load imposed by the tree roots is expected to be significant as it grows, but with the expansion of the brick planter accommodating this movement by the increased crack width. Therefore there is not expected to be any additional load imposed by the tree roots to contribute to the imminent collapse or failure of the wall.

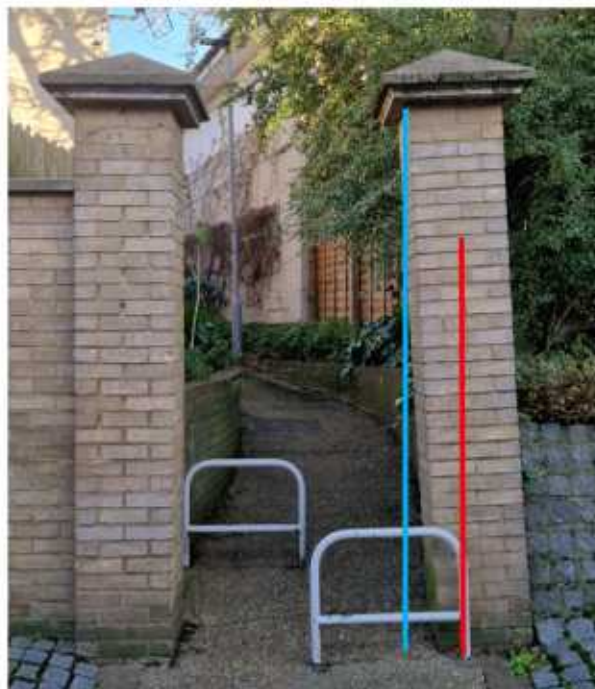
- 6.3.2 The pillar has a significant lean to the west, towards the alley and adjacent pillar.
- 6.3.3 The pillar is approximately 110mm out of plumb at the base of the cap, which is 2.6m height. This equates to approximately 42mm:1m. The centre of gravity is raised significantly above the middle of the pillar due to the concrete pillar cap on the top. Initial estimates place the centre of gravity at approximately 1.8m from ground level. Applying the middle third rule demonstrates the pillar could be up to 73mm out of plumb at 1.8m, which equates to 105mm at 2.6m.

- 6.3.4 Subject to a structural engineer's assessment, the pillar therefore appears to be at the limit of the tolerable risk of its self-weight for potential collapse.
- 6.3.5 In addition to this self-weight, there is the additional risk of wind load in the direction of the lean, which further increases the risk.
- 6.3.6 The foundations and ground beneath the pillar have not been assessed.

- 7.4 This brick pillar is of more concern. The lean is measured to be on the limit of what would be expected to be stable from its self-weight.

1. **URGENT** Access to the area should be restricted until temporary propping or remedial works can be undertaken.
2. Undertake temporary propping or remedial works. The following options are available:

- i) Remove the concrete cap at the top to reduce the weight on the top of the pillar, lowering the centre of gravity and risk of collapse. An appropriate working tower and lifting equipment would be required to achieve this.
  - ii) Fit a prop between the two piers, preventing the further movement of the eastern pillar. A prop / bridge above head height, at say 2m, could be fitted by framing out the opening.
3. In the long run, the pier should be taken down and rebuilt on foundations designed by a structural engineer.
4. Consideration should be given to including a permanent prop / bridge between the two piers to provide additional structural stability.
