30 September 2020
20-016-01-AR02

Symal House, 423 Edgware Road

BOUNDARY ASSESSMENT 10 ADAMSON ROAD, LONDON NW3 3HR

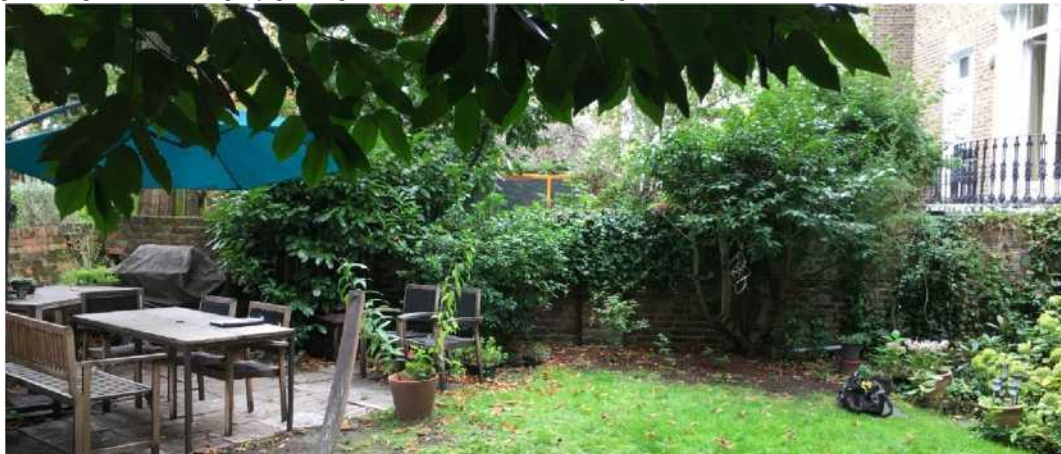
Fig. 2 Boundary between 10 and 8 - viewed from No. 10 side facing No.8

The wall has been pointed at differing times on the No.10 side. There are some areas where newer brickwork appears to have been used, however, these are beneath vegetation and may just be differential weathering. Large areas of the wall are concealed by vegetation growth including Ivy growing on and in some cases through the wall.

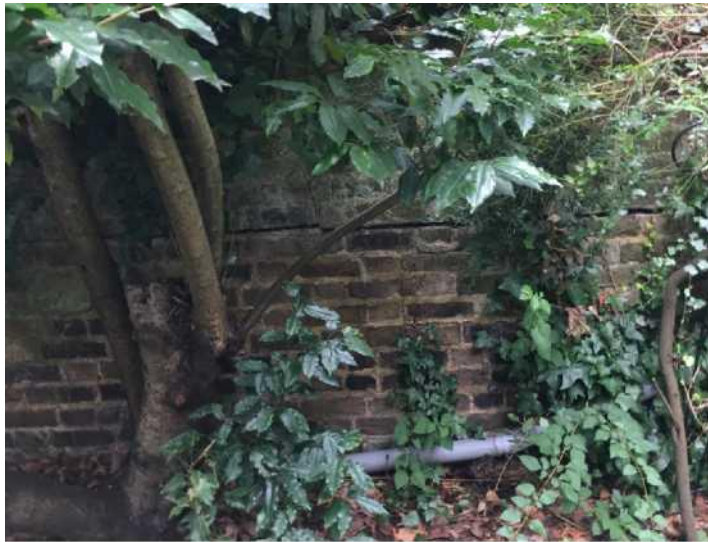
The cracking is significant and daylight is visible through some of the wider cracks confirming they extend the full thickness of the wall.

Fig 3. Horizontal open joint adjacent to tree. Note redundant rainwater pipe at low level from balcony outlet.

To limit further damage and establish the condition of the concealed areas, we recommend that the vegetation growth is carefully removed where covering the wall, this will likely reveal further areas of damage. A management plan for the adjacent trees will need to be established and the rebuilt sections of wall designed to accommodate this and likely movement.

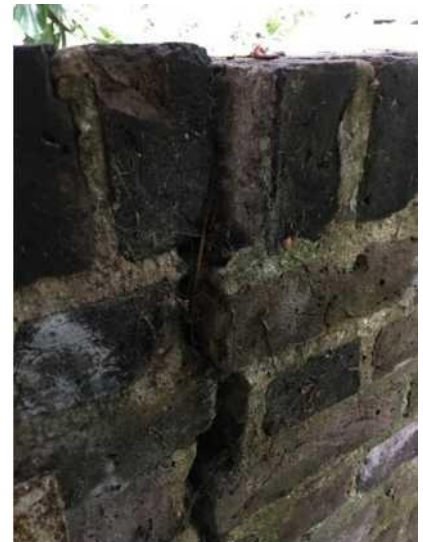
Fig 4. Vertical crack and displacement to wall approx. 3.5m from the rear boundary.

- Between the projecting pier and approximately 3.5m from the rear boundary horizontal approx. 15mm wide open joint intersects a vertical area of cracking, approx. 15mm wide through bricks and mortar joints. At this point the wall is displaced vertically and the rear section projects in the order of 15-30mm towards No. 8 (Fig 4). Close to this there is a mature shrub on the No.10 side.

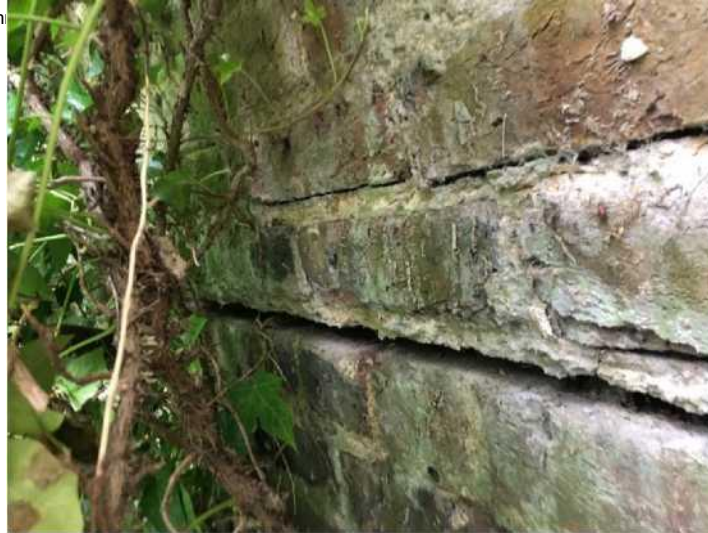
Fig 5. Horizontal open joint, crack and displacement within 3m of the rear

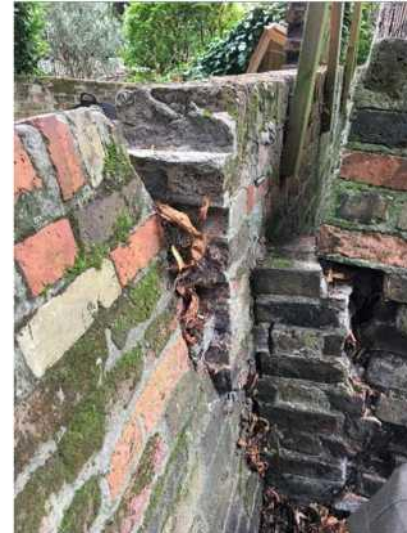
Fig 6. Facing the junction between the 10/8 élévation. Adamson Road wall and the rear wall to 58 Eton Avenue. Rear wall to Eton Avenue to the left.

- At the rear boundary junction with 53 Eton Avenue the wall is not toothed and bonded into the rear wall to the upper half. The rear wall is leaning towards No. 53 (see section described later in this report) and has left the upper part of the wall unsecured at this junction. The lower part of the wall appears to be bonded into the rear wall and has moved out towards the rear. The 8/10 wall at this point is unstable and is leaning towards No.8 (Fig 6).

There is a mature horse chestnut tree on the No.8 side adjacent to this rear corner.

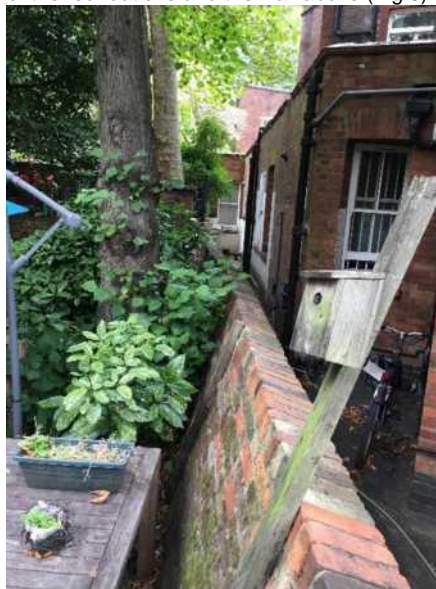
- Significant leaning of the wall towards No.58. It is difficult to get a precise measurement from the No.10 side, however, in places the wall is generally leaning between 260 - 390mm from vertical. The wall is unstable and the worst affected areas are:-
 - Adjacent to the existing tree. It appears that as the tree has matured it has grown against the wall 'pushing' it outwards. This will have been a gradual process and the wall having been built with a lime based mortar has accommodated the pressure from the tree over many years and has become distorted (Fig 7).
 -

Fig 7. Wall between No.10 and 58. Facing No. 12 with No. 58 to the right. Mature tree within the garden of No. 10 and wall leaning significantly towards No.58

The main cause of the damage appears to be from mature trees within the garden of No.10. One is growing against the wall and one has been removed from its position very close to the wall in recent years.

Freestanding walls often have shallow foundations. The growth of tree roots and subsidence in clay soils from the living tree and also heave of clay soils after the removal of the mature tree will likely have caused movement of foundations and some of the distortion to the brickwork above.

The wall is in a dangerous condition and requires taking down and rebuilding. We suggest that as an interim measure it is agreed with the neighbours to take down the wall and remove the risk whilst discussions regarding rebuilding are progressed. A temporary fence or other structure can be swiftly installed to provide security between the two properties. Given the lime-based mortar that has been used to bond the bricks, it is likely that a large proportion of the bricks can be retained and reused so we recommend that these are carefully set aside and not disposed of.

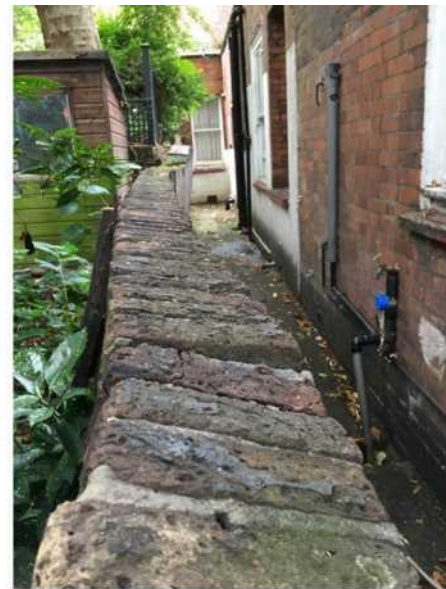
Adjacent to a tree stump to the east of the remaining tree. In addition to the leaning of the wall there is a horizontal fracture to the base of the brickwork above ground level. It appears a tree has been removed which can have an influence on the sub soils and the wall above including heave which will cause movement of the foundations and the wall above (Fig 8).

Fig 8. Wall between No.10 and 58. Facing No. 12 with No. 58 to the right. Photo taken beyond the mature tree within the garden of No. 10. Wall curved and leaning significantly towards No.58

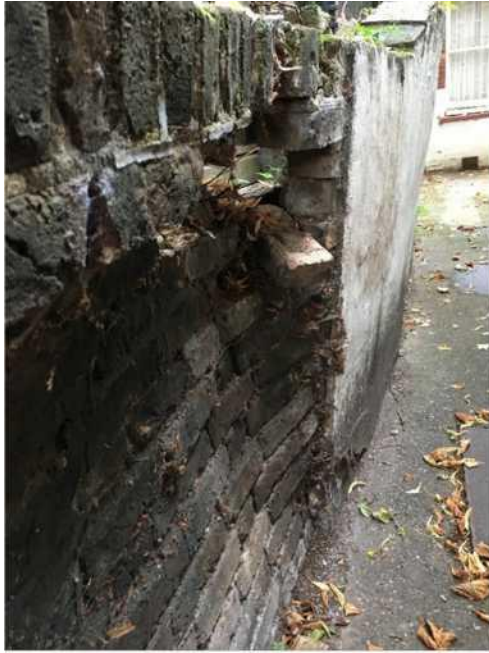
In addition to the leaning, there is a large blown area of brickwork and damage to the east, adjacent to the boundary with No.12 Adamson Road. In part of this area the wall has been rendered on the No.58 side. There are holes in the wall to this location and the bricks are loose (Fig 9).

Fig 9. Wall between No. 10 and 58, viewed from the No. 58 side facing the junction with No. 12. Blown brickwork and rendered section of wall beyond.

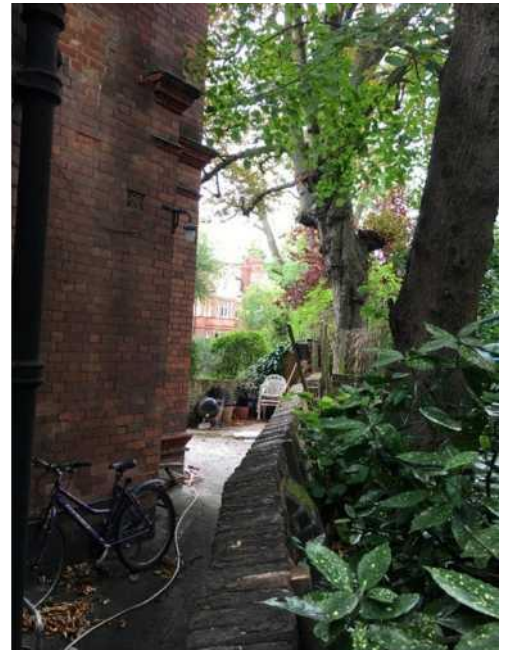
Fig 10. Wall between No. 10 and 58, viewed facing No. 8 with No. 58 to the left. Leaning and curved wall adjacent to the mature tree.

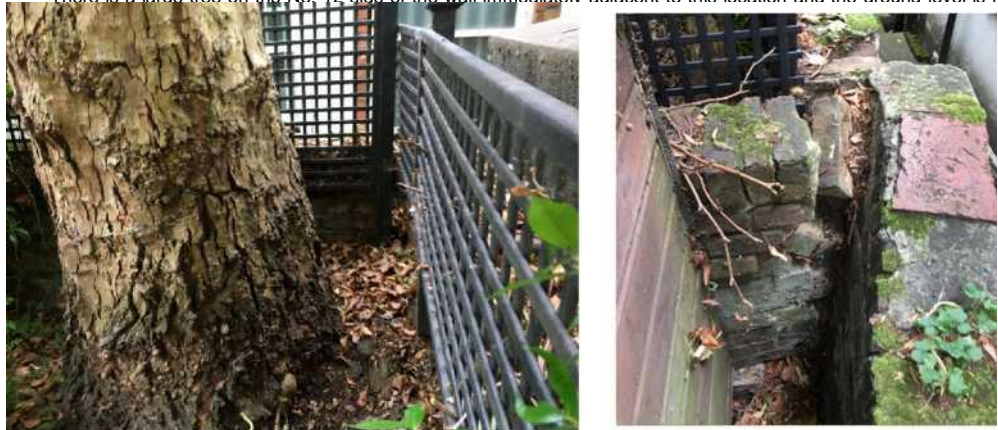
The part of the wall close to the rear wall with No.58 is largely concealed by the garden shed and a build up of leaves etc. behind. Where visible, the condition is very poor with uneven brickwork and the wall appears to have sheared at low level (Fig 14 and 15).

There is a large tree on the No. 12 side of the wall immediately adjacent to this location and the ground level is raised

Fig 14. Rear boundary between 10 and 12 - viewed from Fig 15. Rear boundary between 10 and No.12 side facing No.58 with No.10 to the right. No. 12 with No. 58 to the right.

Once the wall can be fully inspected the causes of the damage should become clear. At this stage we know that this section of wall is very close to the mature tree in the garden of No. 12 and raised ground levels on the No.12 side and it is likely that the tree is causing the damage.

- 1) **Rear section** - The extent of the damage to the rear of the wall at the junction with No. 58 and behind the shed should be established. Part of the wall will need to be rebuilt and if possible the shed should be relocated to allow for inspection and works to the wall behind.

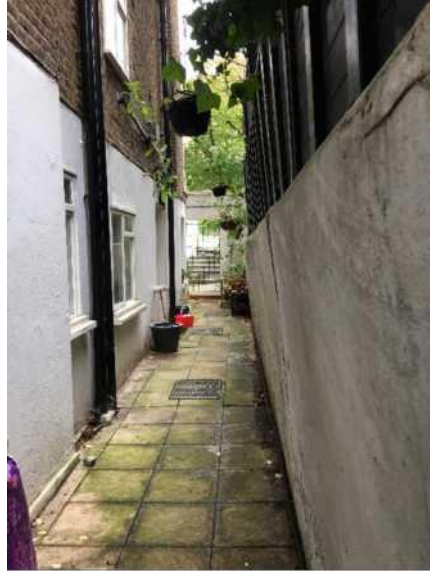
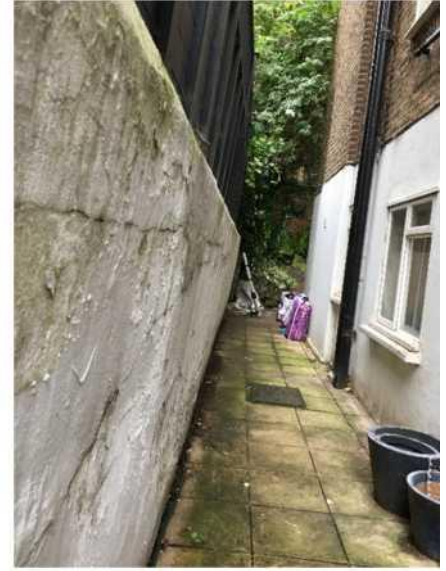
The wall including the pier to the rear of this section generally leans towards No. 10 and its condition is worse towards the rear. In some places between the top and base of the wall it leans in the order of 35mm towards the front and 140-170mm towards the rear (see fig 16 and 17).

The render is extensively cracked with some cracks up to 3mm in width. There are two predominant horizontal cracks with a vertical crack between. Towards the front the crack appears to be in the position of the ground level on the No. 12 side. This will need to be confirmed with measurement following access. At the rear the horizontal crack is lower and extends diagonally down to ground level. There is a vertical offset to the render in this area by approximately 6mm, this may reflect distortion of the structure behind.

In some areas around the cracking the render is hollow on key and has deboned from the structure behind.

Fig 16. Central section of boundary between 10 and 12 - viewed from No. 10 side facing the front and 12 - viewed from No. 10 side facing the rear with No. 12 to the right. Fig 17. Central section of boundary between 10 and 12 - viewed from No. 10 side facing the rear with No. 12 to the left.

The cracking to the render may be where there is associated cracking to the wall behind. The render will further prevent drying of the masonry beyond and so will be prone to dampness and failure as can be seen with the debonding.

Before embarking on this, we recommend that the wall's construction is investigated. This can be undertaken by removing some of the de-bonded render on the No.10 face together with careful progressive drilling to establish the materials and also thickness below ground. If this reveals a different construction, then subject to an engineers review an alternative scope of works may be possible.
