Butlers Trees LTD

ASSESSMENT OF TREES AND THEIR POSSIBLE IMPLICATION IN STRUCTURAL DAMAGE

JANUARY 23, 2025

178 Camden Road, Camden, London, NW1 9HG

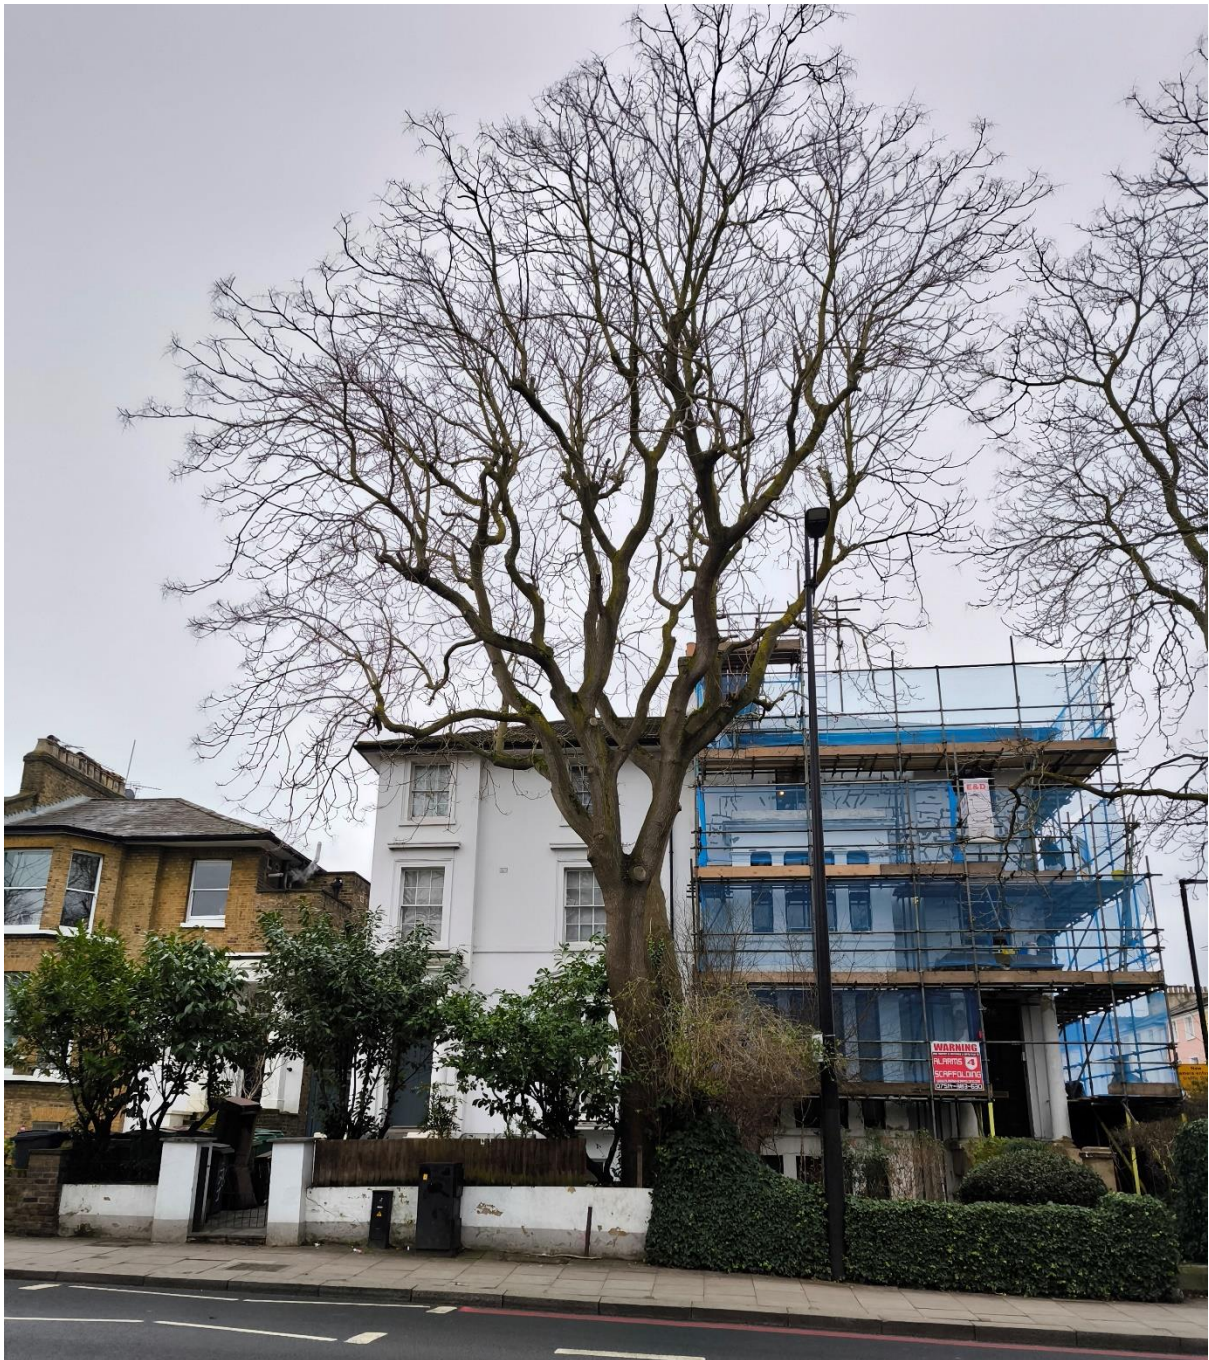
T1- T6 (right to left)

- 5.12 T1 is a large mature Tree of Heaven that sits in the north west corner of the property, adjacent to the pavement of Camden Road. It is a healthy tree with good crown vitality. It has no visible brackets or lesions on it. The tree can be seen 100m from the north along Camden Road and 50m south along Camden Road, adding to the green frontage and characteristics of the road.

- 5.13 T2 to T6 are Cherry Laurels located on the front of the property adjacent to the pavement of Camden Road. T4, T5 and T6 sit in a separate raised planter left of the gate as you walk in to the property.

- 7.1 All the trees in this report appeared healthy. Some minor pruning could be undertaken of the Cherry Laurels across the frontage to keep them from encroaching on the pavement.

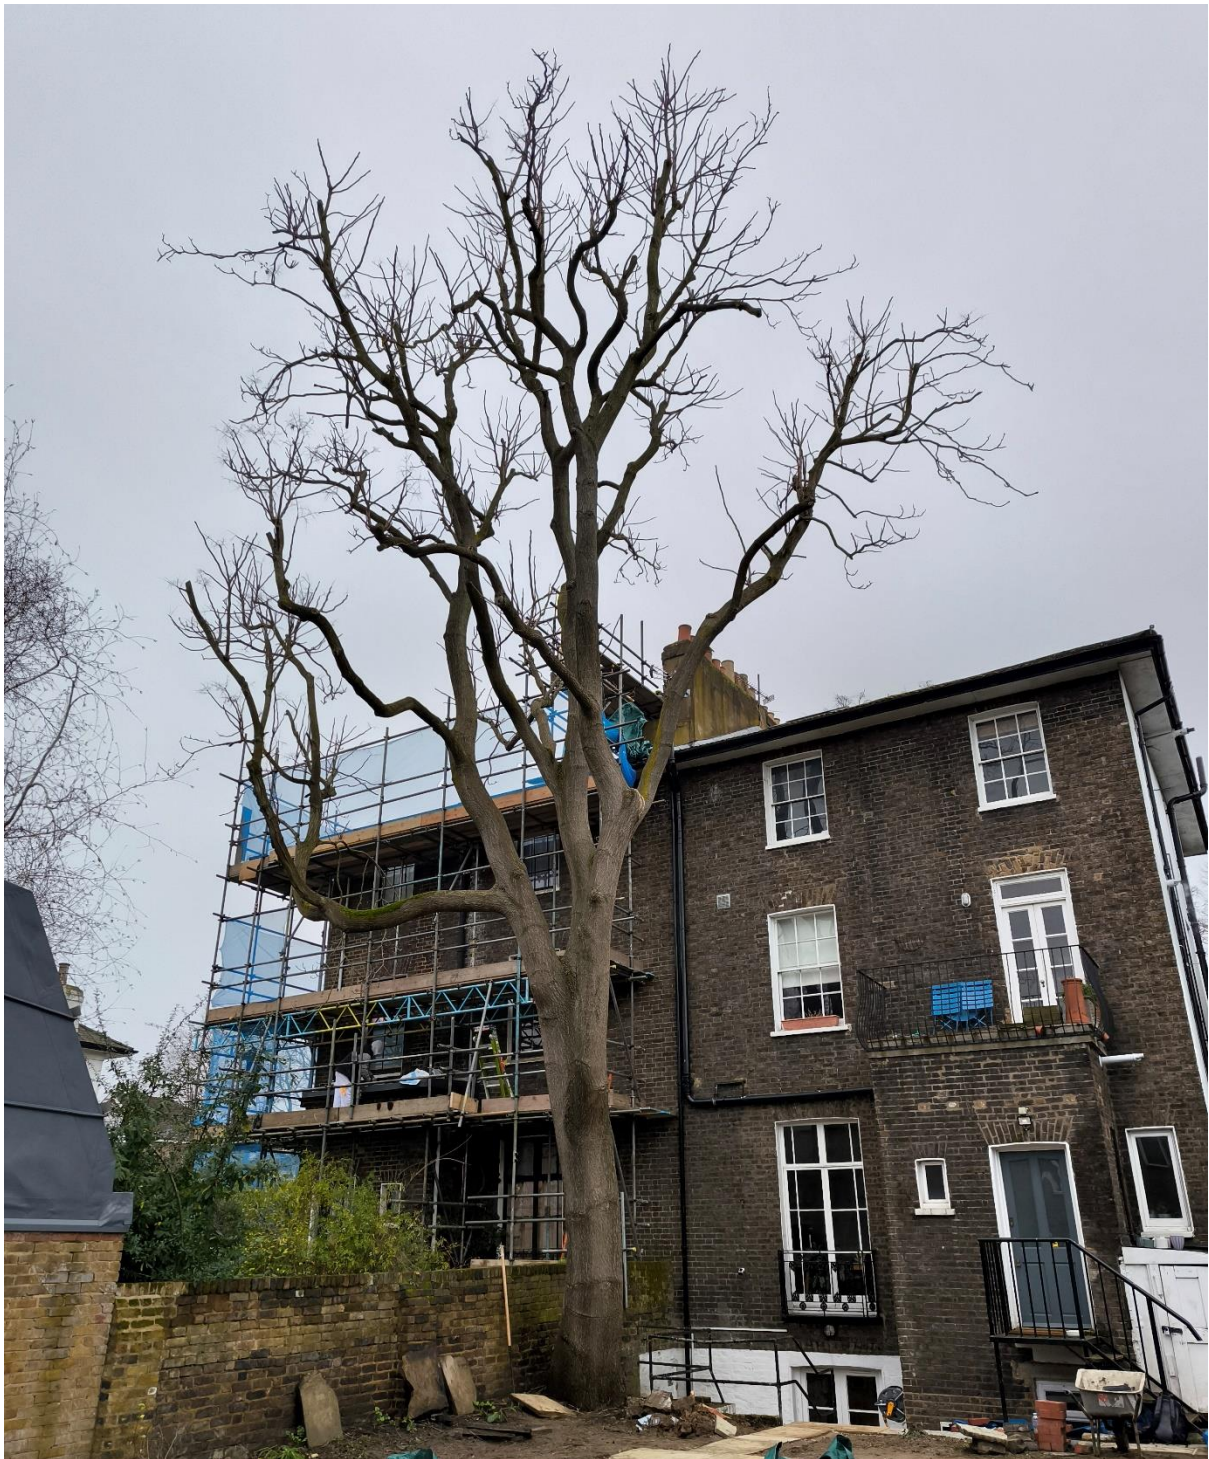
T8

- 5.14 T7, a Lilac, is in its own raised bed approx. half way along the shared boundary wall with no.180.
- 5.15 T8, another Tree of Heaven, is located in the rear garden and adjacent to the shared boundary wall with no.176. This tree has been recently reduced by approx. 30%. It has a lean of approx. 25 degrees at 1.5m away from the building towards the centre of the rear garden of no.178. There is some cracking on the shared boundary wall but this is not consistent with characteristics of subsidence or heave and appears more likely due to the growth of the tree in close physical proximity to the wall.

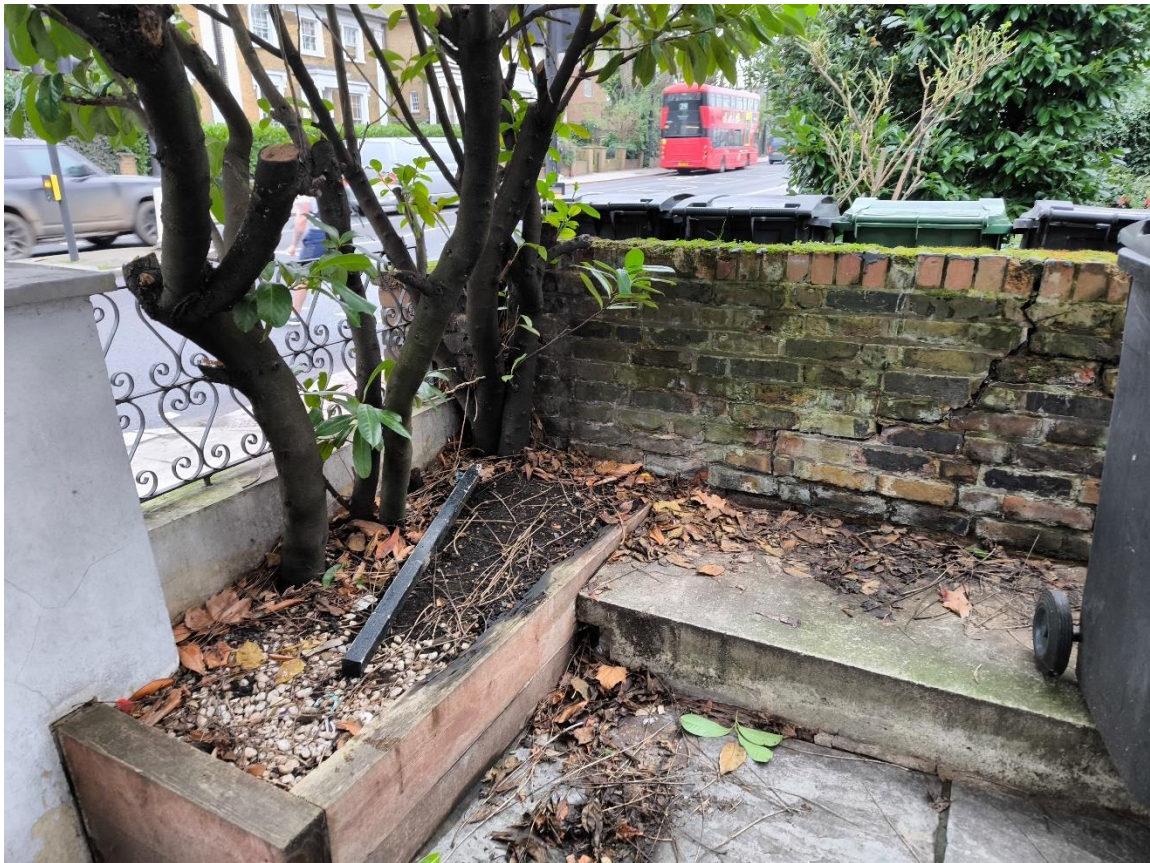
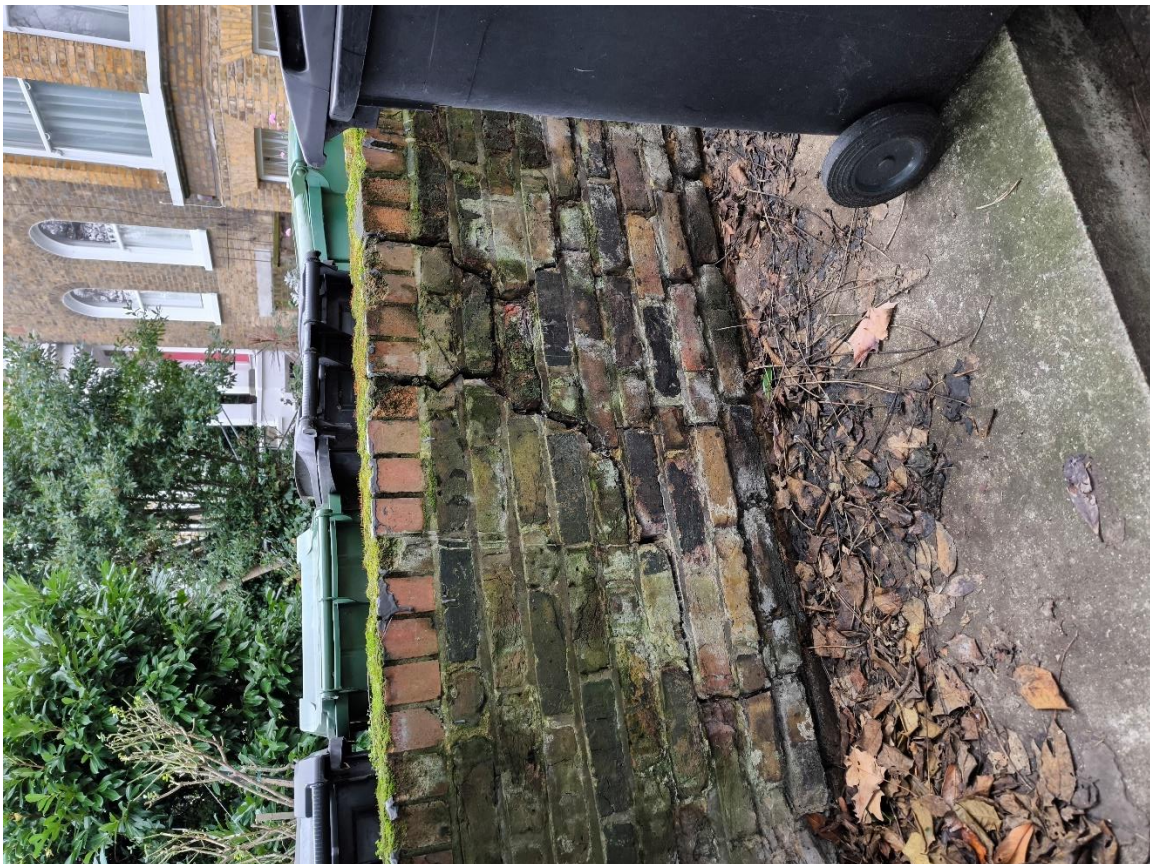
Wall next to T6

- 5.8 There are no signs of cracking on the front boundary wall adjacent to the pavement of Camden Road.
- 5.9 There is cracking evident to the shared boundary wall, close to the gated entrances of no.180 and no.178, near to T6.

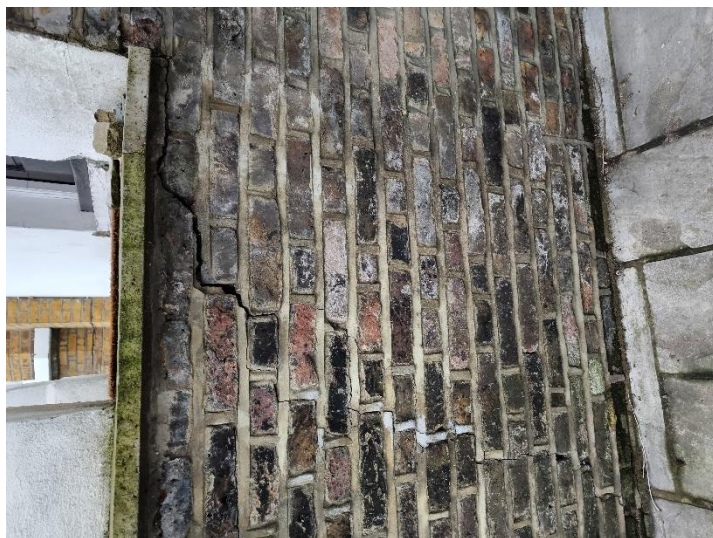
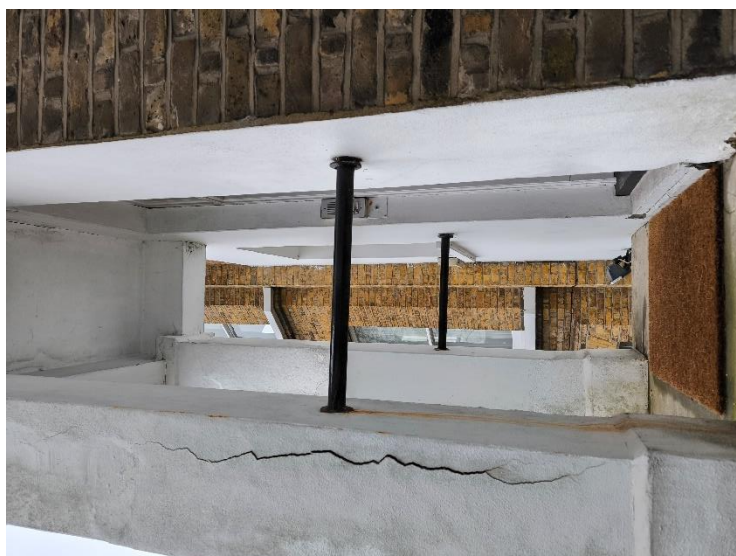
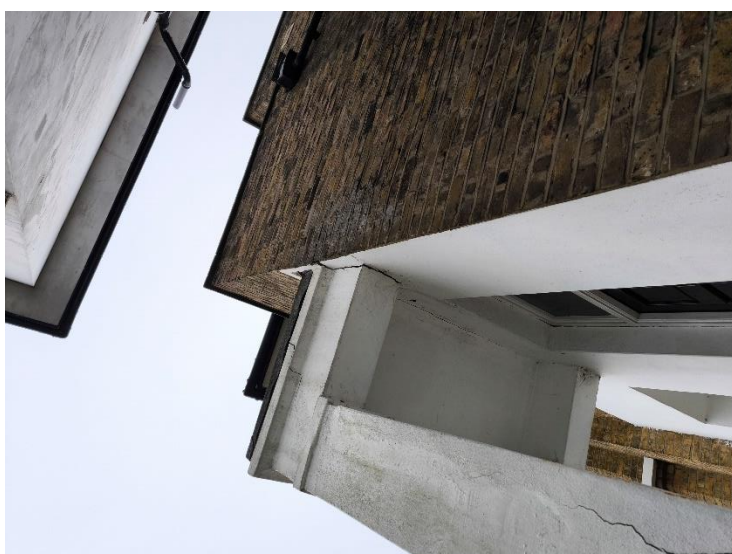
Main door entrance to no.180

- 5.10 No.180 Camden Road has a side extension on its west flank with a flat roof. The main door and stairs appear to have been moved from their original location to the extension when comparing to its semi-detached neighbour. This was approved by Camden Council in Aug 1990 under application 9003188.

- 5.11 The front part of the extension, comprising the stairs, pillars and porch area in front of the main door, have come away from the rest of extension. This can be observed from within the garden area of no.178 and can be seen in photos in the Appendix.
