## Structural Appraisal

**31, South Hill Park, Hampstead Heath, London**

Paul Owen Associates were commissioned by The Client, Mr Mark Sutcliffe, to undertake an appraisal of the property at 31 South Hill Park, Hampstead, London NW3 2ST.

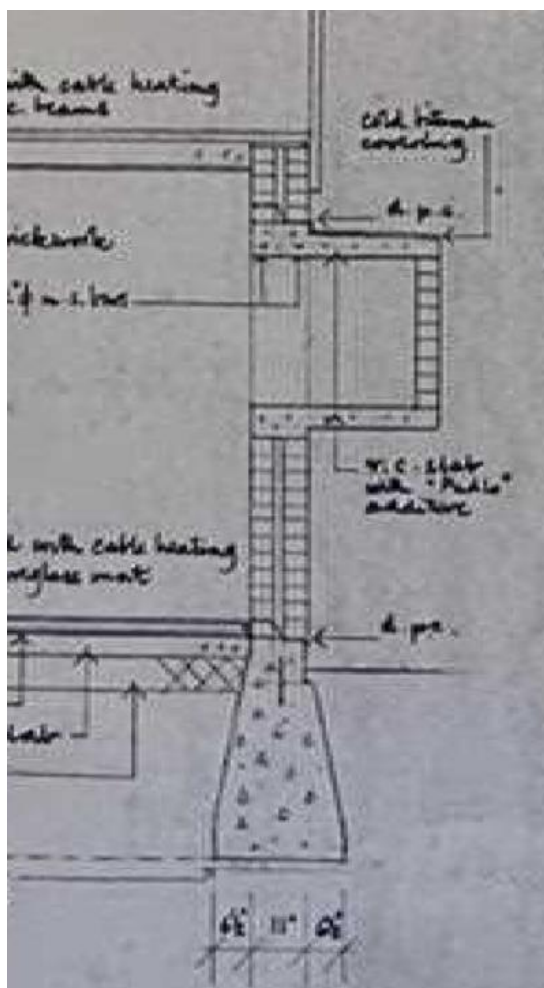
Figure 2 – Detail of Oriel Window Construction

The Oriel windows should be stable in their current condition, therefore, providing that the brickwork is built tight to the underside of the slab and the deadload of the slab is mobilised. It should be noted that the original

architectural details do not show the slab being built into the masonry (Fig 2). Further investigations are required to determine the construction at this point. Remedial measures may be required to provide sufficient resistance to the overturning forces from the oriel windows.

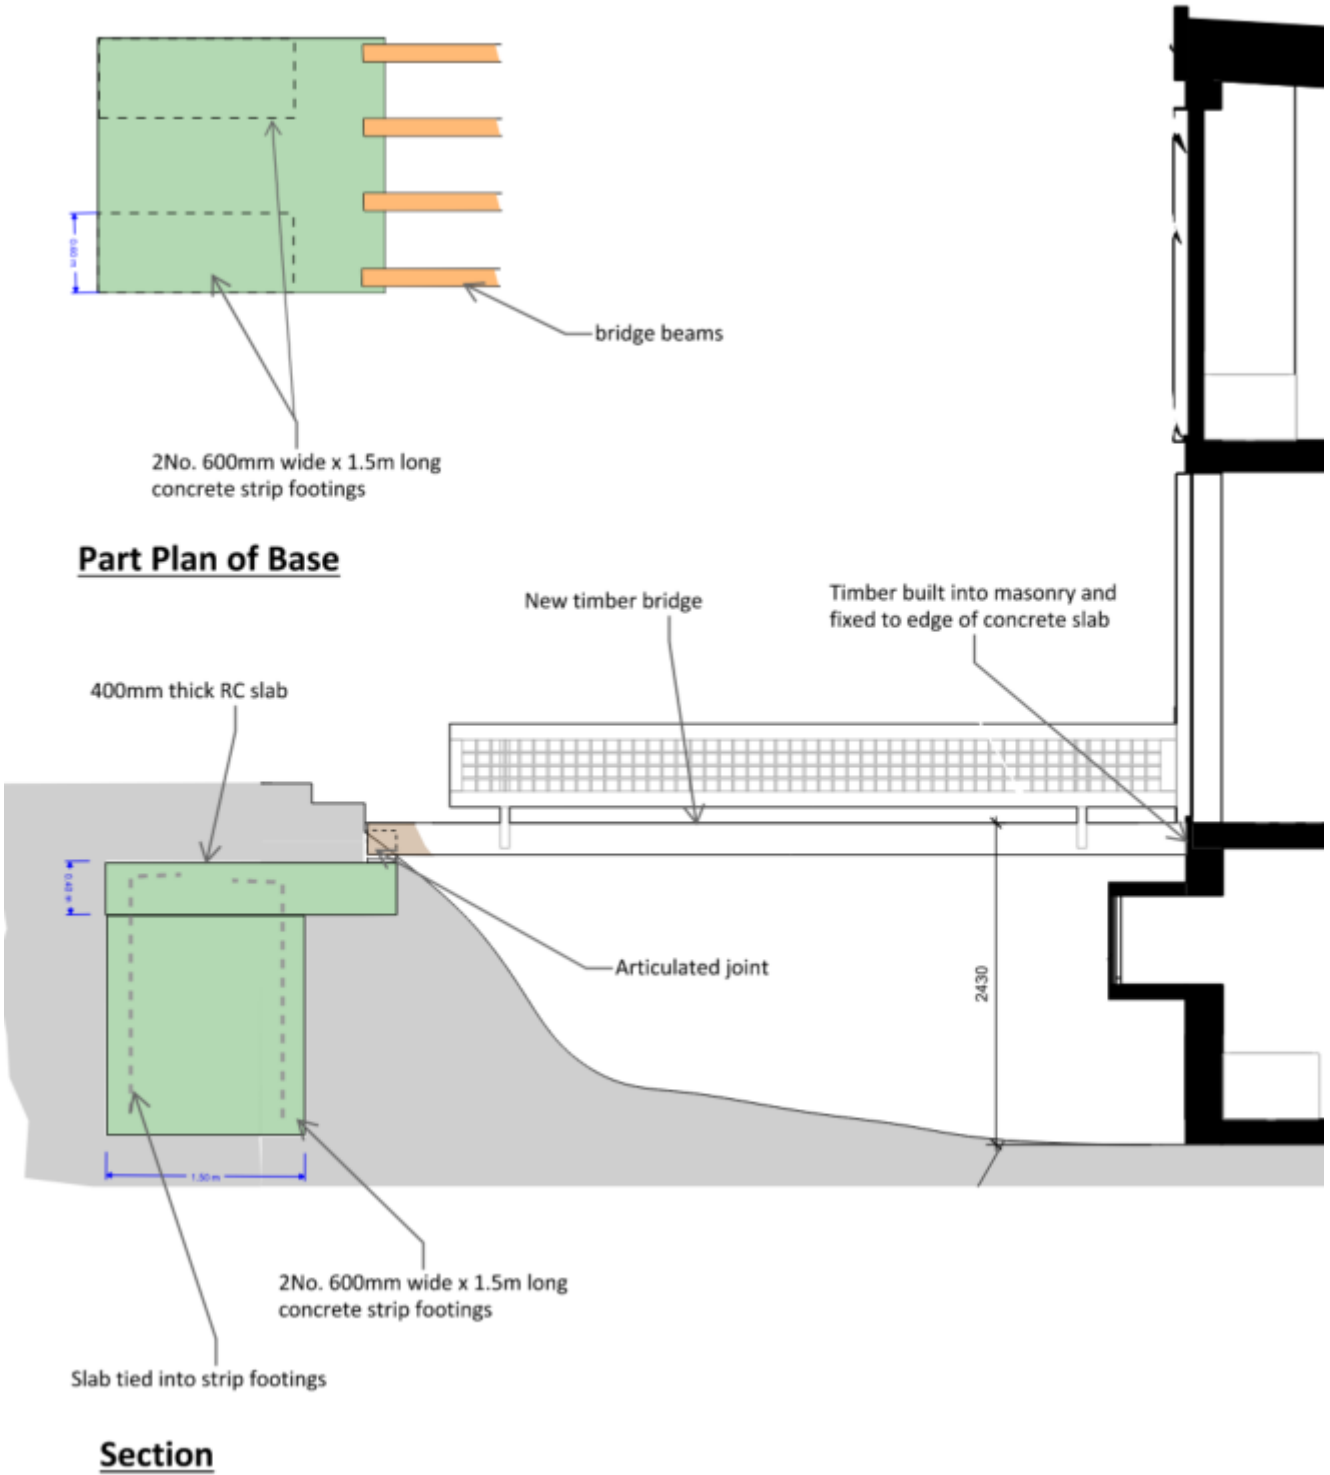
Figure 3 – Proposed Foundations for New Bridge

The bearing of the bridge at the top of the embankments should be improved to limit the settlement and lateral movement that are apparent in the existing. The settlement of the existing base is thought to be related to the instability of the embankment. To avoid such movement in the future, it is recommended to take the foundations supporting the bridge down to a level which will not surcharge the embankment.

A potential solution is shown Figure 3. Mass concrete strip footings are dug to a level below the bottom of the embankment. It is proposed to set the footings back from the face of the embankment so that they can be safely excavated. A reinforced concrete slab would be cast on top of the strip footings which would cantilever beyond the footings to support the bridge bearing. As previously discussed, an articulated sliding joint to the bridge bearings would be provided to limit the lateral forces that can be applied to the house through the bridge beams. The bearing of the bridge at the house end is proposed to bear directly onto the outer leaf of the brick wall. Restraint details may be provided between the bridge beams and the concrete slab to transfer lateral forces into the diaphragm of the first floor slab.

Re-construct the bridge bearing on the garden side with foundations that do not rely upon the stability of the embankment. At this stage, assume mass concrete strip footings supporting a cantilevered reinforced concrete slab, with the detail to be developed at a later design stage.
