This report describes the findings of a desk study carried out by Geotechnical and Environmental Associates Limited (GEA) on the instructions of Faithful+Gould, on behalf of London Borough of Camden, with respect to the redevelopment of the site through the demolition of the existing buildings and subsequent construction of a number of mixed-use buildings of between six storeys and 24 storeys mixed use buildings, providing 350 new homes and mixed employment space, including areas of external hardstanding and communal soft landscaping. The purpose of the work has been to determine the history of the site, to assess the potential for contamination, to provide preliminary information on the expected ground conditions and to provide preliminary information on foundation options with regard to the proposed development of the site.

Geotechnical and Environmental Associates Limited (GEA) has been commissioned by Faithful+Gould, on behalf of London Borough of Camden, to carry out a desk study at 120-136 Camley Street and 3-30 Cedar Way, London N1C 4PG.

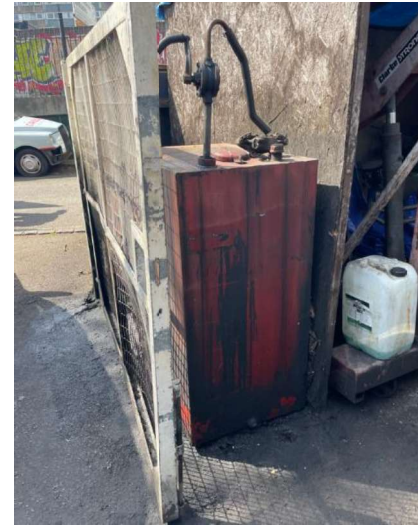
Left: Above ground storage tank with visible staining in roughly the centre west of site

In addition, above ground storage tanks were identified in both site areas during the site walkover, including surface staining of the hardstanding. The tanks, drums and vehicle storage represent possible localised sources of hydrocarbon contamination. The hydrocarbon contamination represents a possible source of soil vapour.

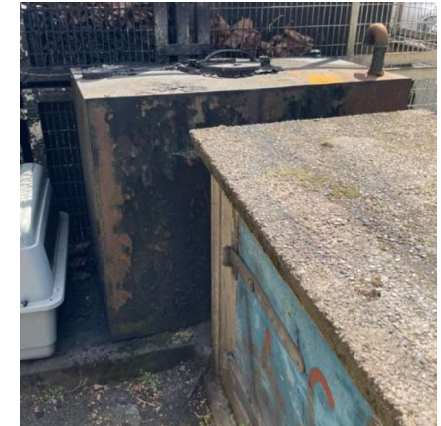
Above: Above ground storage tank with visible staining towards the north of the site

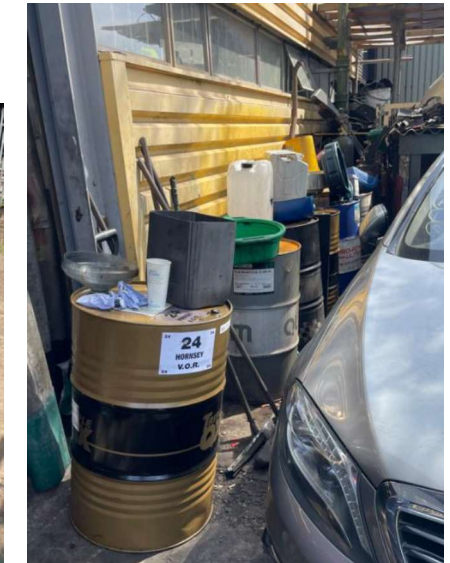
Right: One example of drums observed across much of the northern half of the site

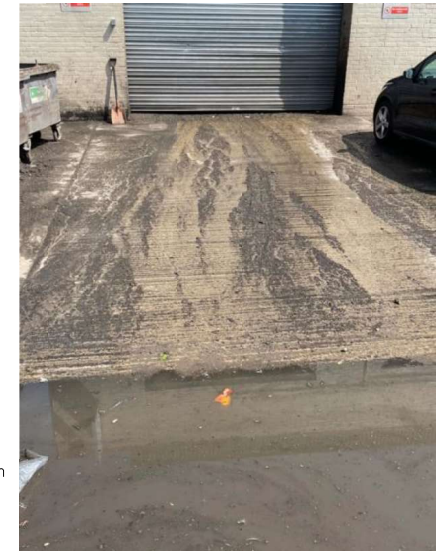
Right: Liquid and mud on surface from northern most Veolia unit

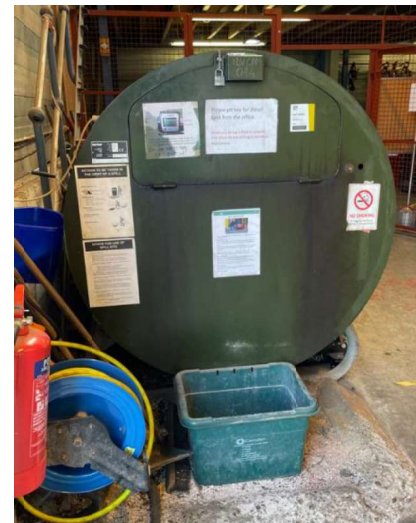
2500 litres above ground gas oil diesel tank within the Idverde unit, to the south of the shutter door.
