Tree Structural Integrity Report

15 Akenside Rd,
London
NW3 5BT

GD.240769.R

Submitted on 7th November 2024

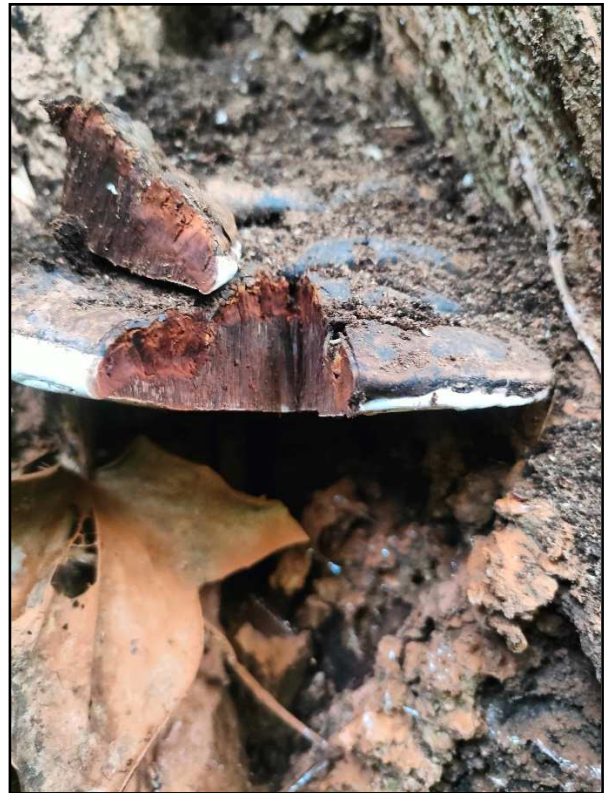
The presence of desiccated and mature fungal fruiting bodies suspected to be either Artist's Fungus (*Ganoderma applanatum*) were found attached to the west buttress and East side of stem (5.5 metres) of Robinia

Figure 3: Image of the fungal fruiting body (*Ganoderma applanatum*) attached to the Base Of Robinia

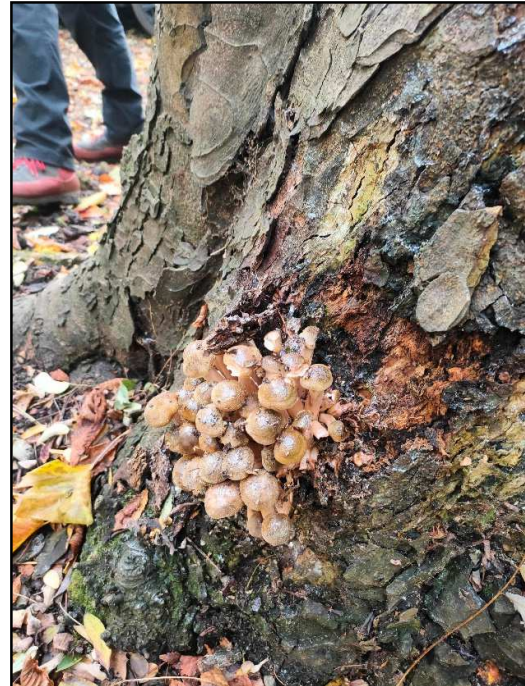
The presence of fungal fruiting bodies suspected to be Honey Fungus (*Armillaria mellea*) were found attached to the main stem, buttresses and root system of nearby Horse Chestnut tree

Figure 4: Image of Honey Fungus Fruiting Body on Neighbouring Chestnut

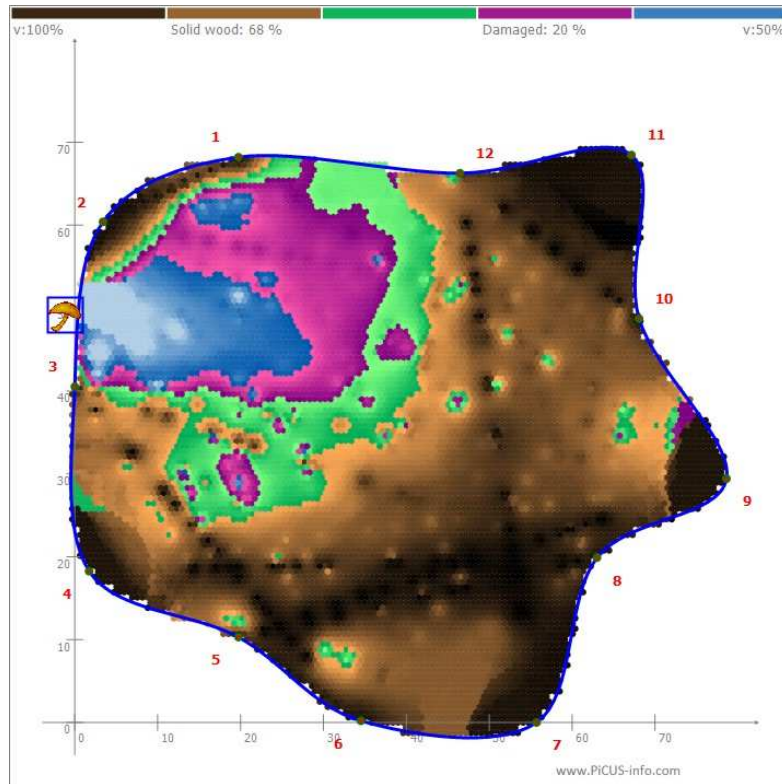
Figure 6: Image of PiCUS® Sonic Tomograph at 80 Centimetres Ht. on Robinia

The Tomogram test depicts that at 80 centimetres above ground level 20% of the wood as indicated by the blue/pink colours returned the slowest rate of soundwave transmittance, whilst 68% as indicated by the brown colour returned the fastest transmittance. The remaining 22% as indicated by the green coloured areas of the image is considered to have moderate rate of soundwave transmittance.

The blue / pink areas with the slowest soundwaves are interpreted as regions where wood is suspected to be decayed.

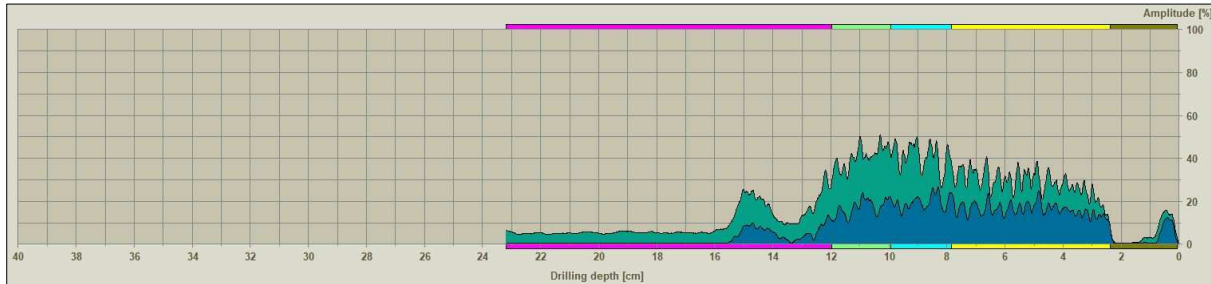
Test 01: 80.00 cm height, tree stem, between sensors 1 & 12

Test 1 reveals that beyond the initial sapwood there is a minimal amount of intact heartwood, with no distinct reaction zone of increased resistance as the drill encountered the area of degraded wood. A slight peak in resistance at 15 cm may indicate a previous reaction zone that has been breached by fungal activity. The absence of a strong defensive response suggests that further decay is likely, potentially leading to the formation of an open cavity from the west.

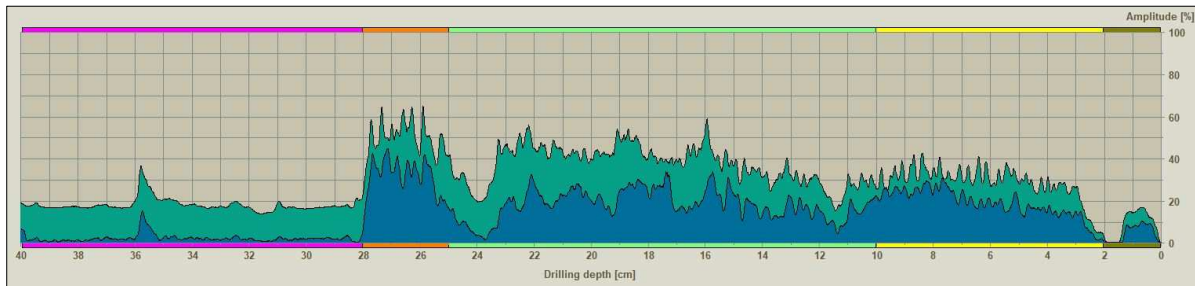
· Test 02: 80.00 cm height, tree stem, at sensor 5

Test 2 presents a similar pattern to Test 1 but the decay appears to be less advanced. The peaks in amplitude between 25 and 27cm indicates a possible reaction zone; however, the subsequent decrease and irregularity in resistance within the non-functional wood, compared to Control Test, suggest that the reaction zone may be compromised, and decay is progressing.

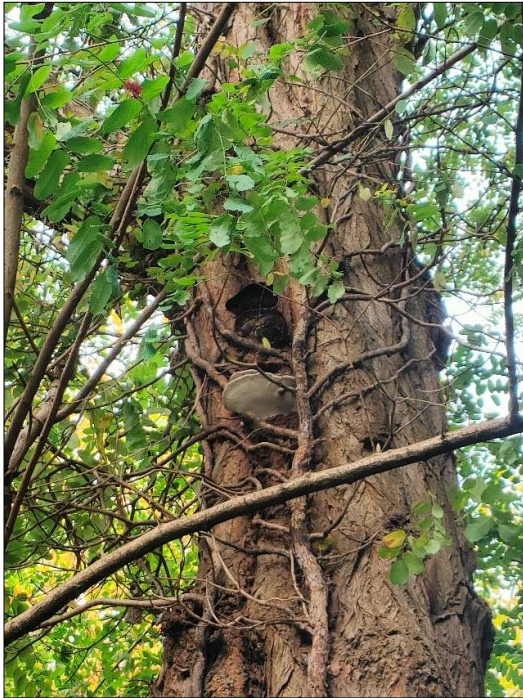
Feature No.1		
Location	Main Stem at 5.5m	Description of Feature & Additional Information on Location
Cardinal Compass Point	East	Multiple <i>Ganoderma</i> fruiting bodies attached to the main stem resulting in the formation of functional units on both sides of colonized area
Crown Tier (Upper, Middle, Lower)	Lower	
Crown Layer (Outer, Inner, Centre)	Center

Figure 9: Image of *Ganoderma* brackets attached to the stem

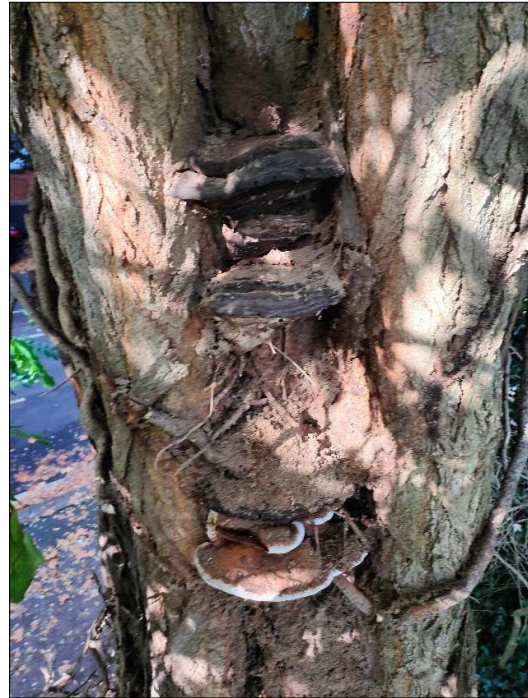
Figure 10: Photo taken during the aerial inspection, showing image of colonised are of stem by *Ganoderma* fungi

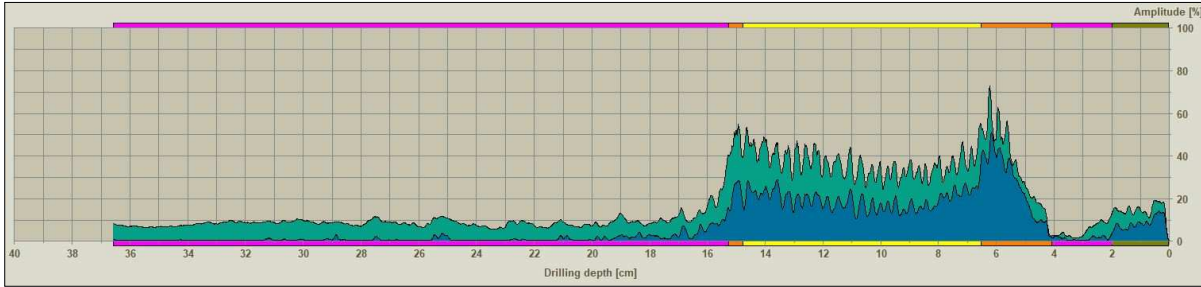
Test 03: 5.5 metre height, tree stem, north

Tests 3 showed an initial peak in resistance between 4cm and 6cm however no distinct reaction zone present as the drill encountered advanced decay beyond a depth of 14cm.

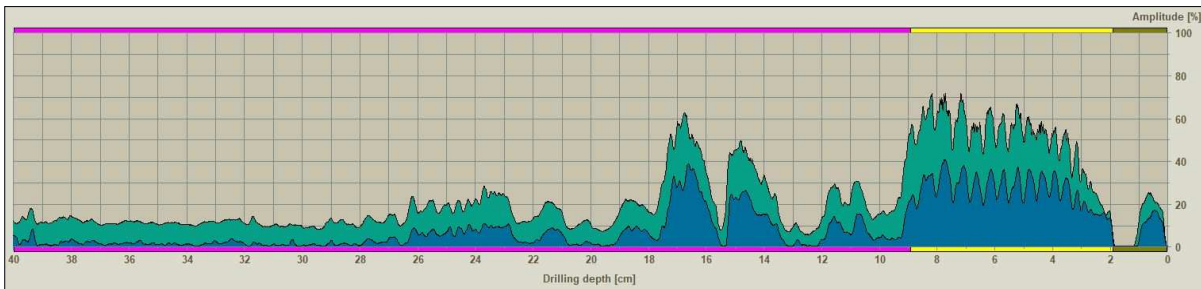
Test 04: 5.5 metre height, tree stem, east

Test 4 also showed no distinct reaction zone prior to the drill encountering advanced decay beyond a depth of 9cm. Secondary peaks in amplitude between 14 and 18cm indicates a possible previous reaction zone; however, this has since been compromised, allowing for progression of the decay.

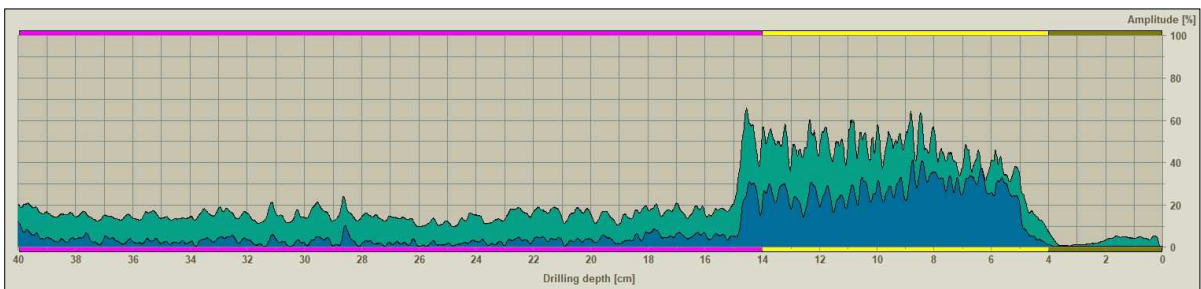
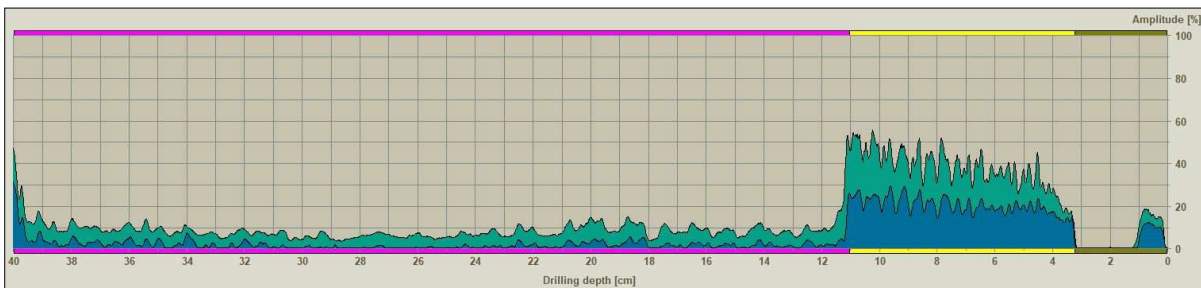
All four of the resistance micro drill test results indicates that at the 5.5m test plane there is a significant amount of internal decay present. The non-functioning heartwood has been significantly degraded with only a portion of the outer sapwood remaining intact.

Test 5 & Test 6 both showed good resistance through the initial sapwood however encountered advanced decay beyond 14 cm and 11cm respectively.

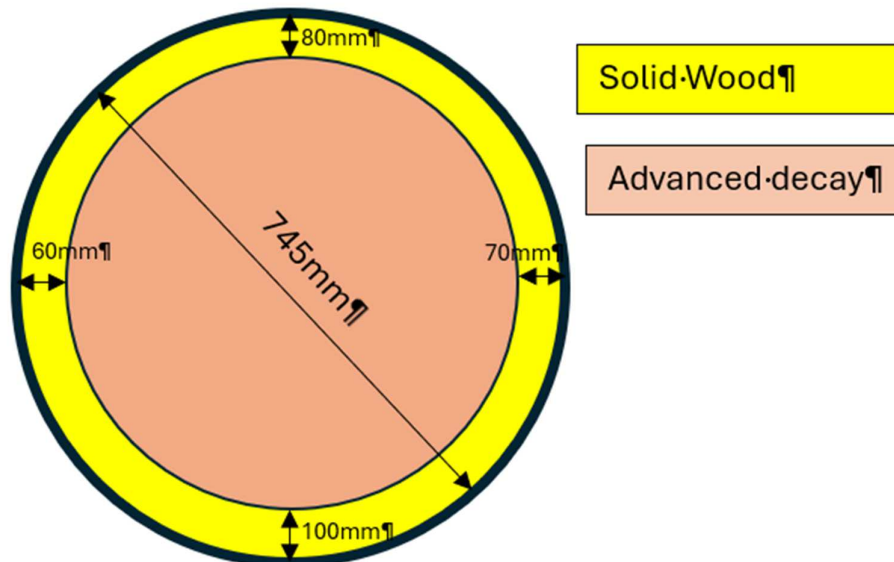
Below is an artistic illustration of the findings indicating the extent of decay identified by the drill results. As shown in the image the residual wood at the 5.5 metre test plane measures an approximate average thickness of 77.5 millimetres where the main stem has a radius of 372.5 millimetres. This accounts to an approximate 24% of the solid wood remaining.

Figure 11 Representation of IML-RESI Powerdrill® test results in 2 dimension graphic

Testing of the lower stem revealed that the presence of the pathogen *Ganoderma* had resulted in a degree of internal decay but had not significantly compromised the structural integrity of the stem at this point. However further testing during the aerial inspection identified that the at a height of 5.5 meters the main stem had been significantly compromised by internal decay with residual sound wood reduced to approximately 24%.

In light of this I have recommended that the tree is removed to ground level.

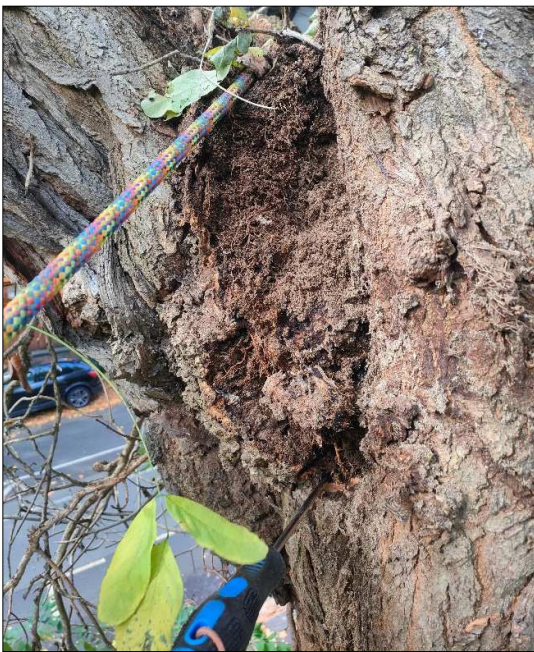
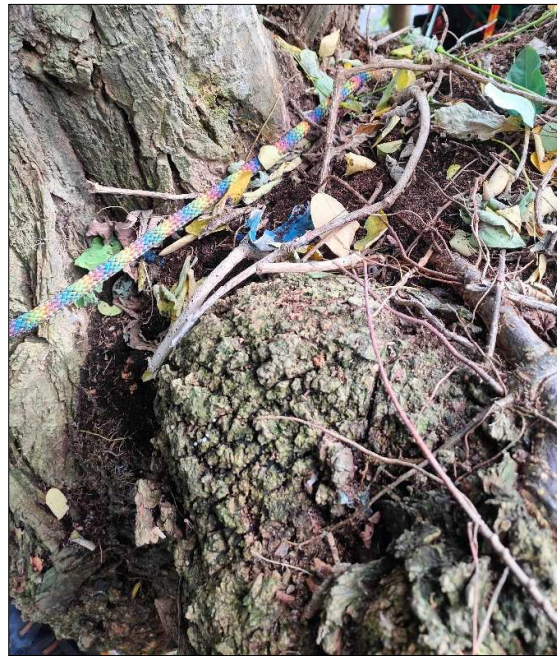
Feature No.2		
Location	Main stem at 6.0m	Description of Feature & Additional Information on Location Poorly attached Scaffold limb with buildup detritus.
Cardinal Compass Point	South	
Crown Tier (Upper, Middle, Lower)	Lower	
Crown Layer (Outer, Inner, Centre)	Center

Figure 11: Image of probing location of the junction

Figure 12: Image of buildup detritus in the junction

The assessment of Feature 02 indicated that attachment at this junction has been significantly compromised by the presence of damaged and decaying wood. The buildup of detritus around the union limited the ability to fully evaluate the structural integrity of the junction, however probing revealed multiple void spaces between the limb and stem. These voids may indicate separation or degradation within the junction.

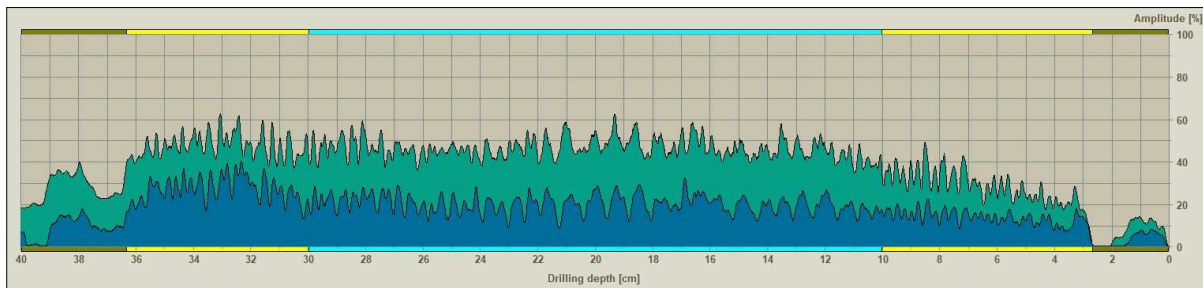
Test 07: 800.00 cm height, co-dominant stem, north to south

Test 07 Indicated good timber strength throughout the test profile.

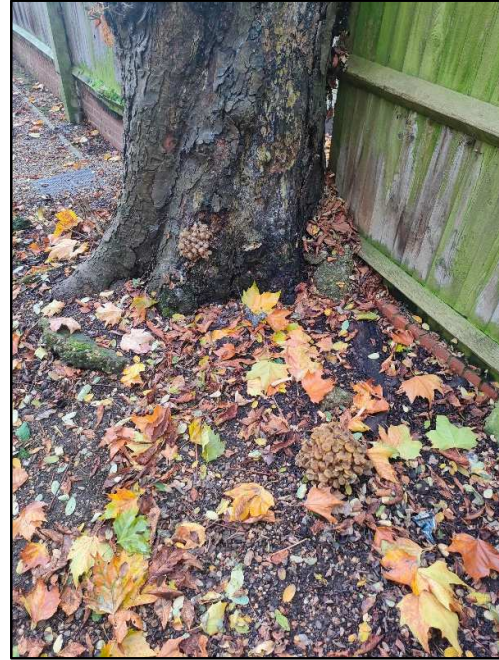
Figure 14: Image showing Honey Fungus on nearby Horse Chestnut

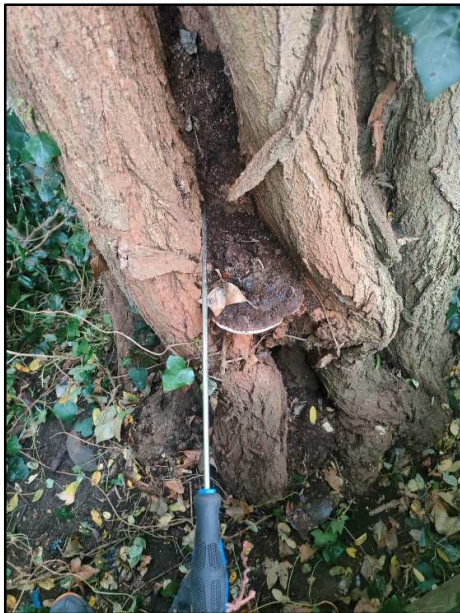
Figure 15: Image showing Ganoderma bracket at the base of the tree

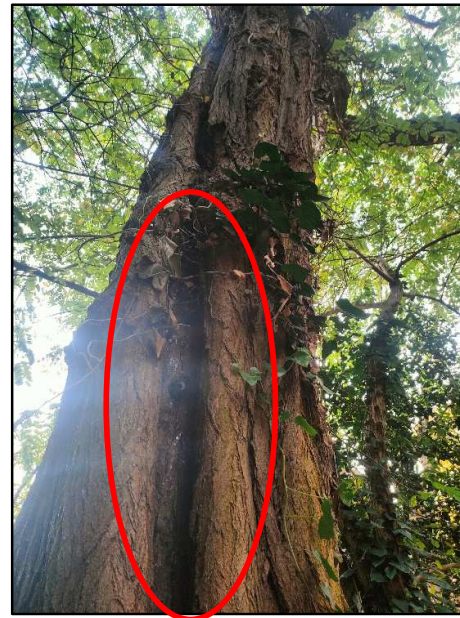
Figure 13: Image showing rib creation next to dysfunction section of the stem
