Santos Timber

Arboricultural survey and management recommendations

Report reference TAP001 14/02/2025

This report has been compiled to record all trees within the ownership boundaries of Three Acres Pre School, NW3 2YH In order to minimize risk, compile works recommendations and apply the recommendations to a regime, creating a short term management plan for the site.

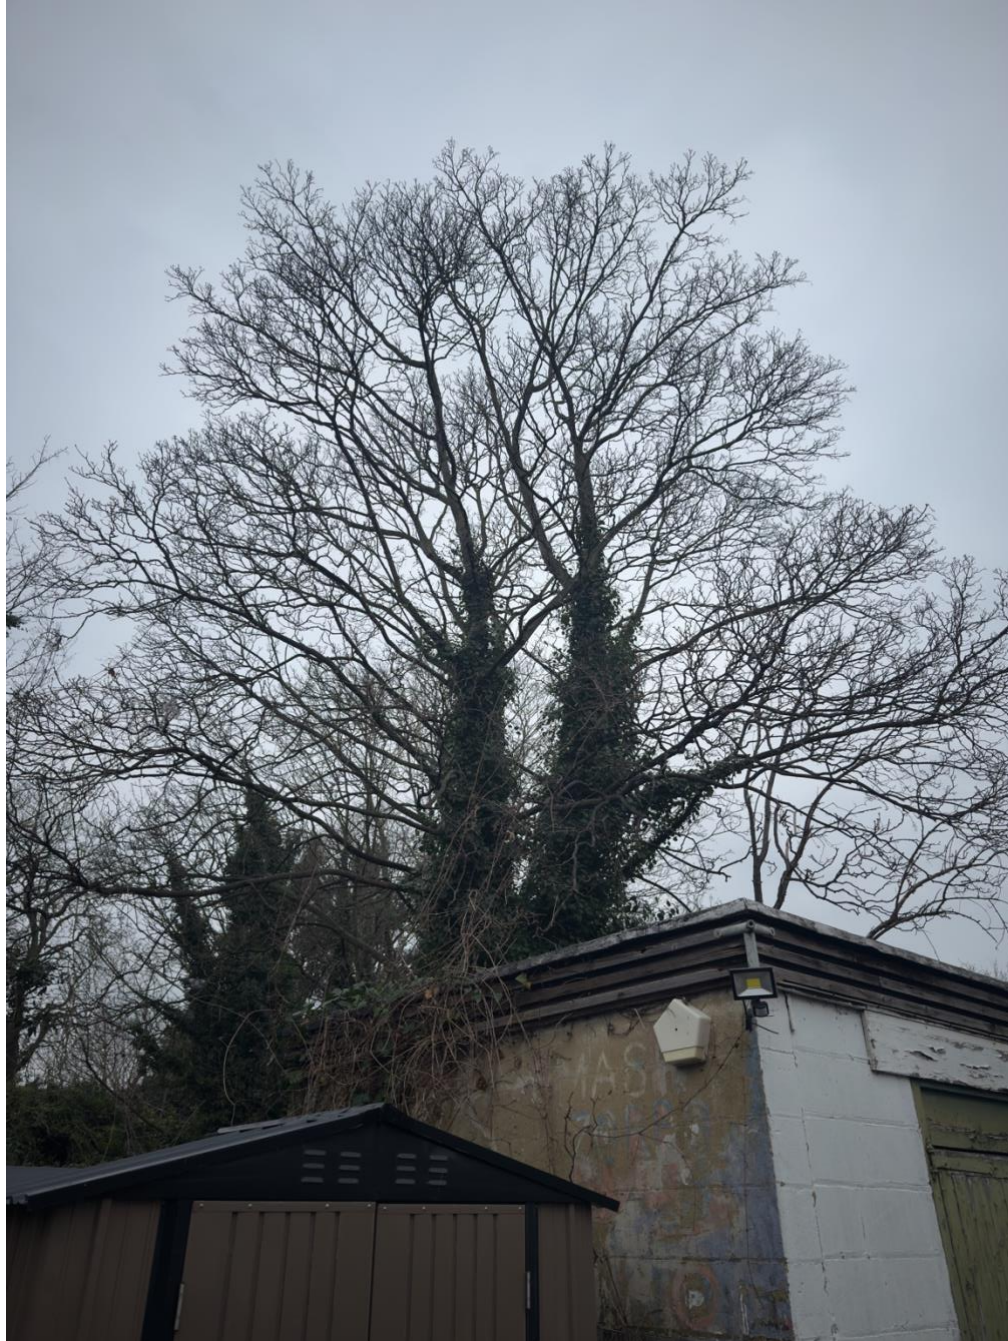
| Tree Reference Number | Tree Species | DBH (mm) | Age | Height | Crown spread | Condition | Recommendations | Comments |
|---|---|---|---|---|---|---|---|---|
| T1 | Acer pseudoplatanus | N/A | mature | 12m | 6m | good | Crown reduce and strip ivy, deadwood | Lift lower crown off building |

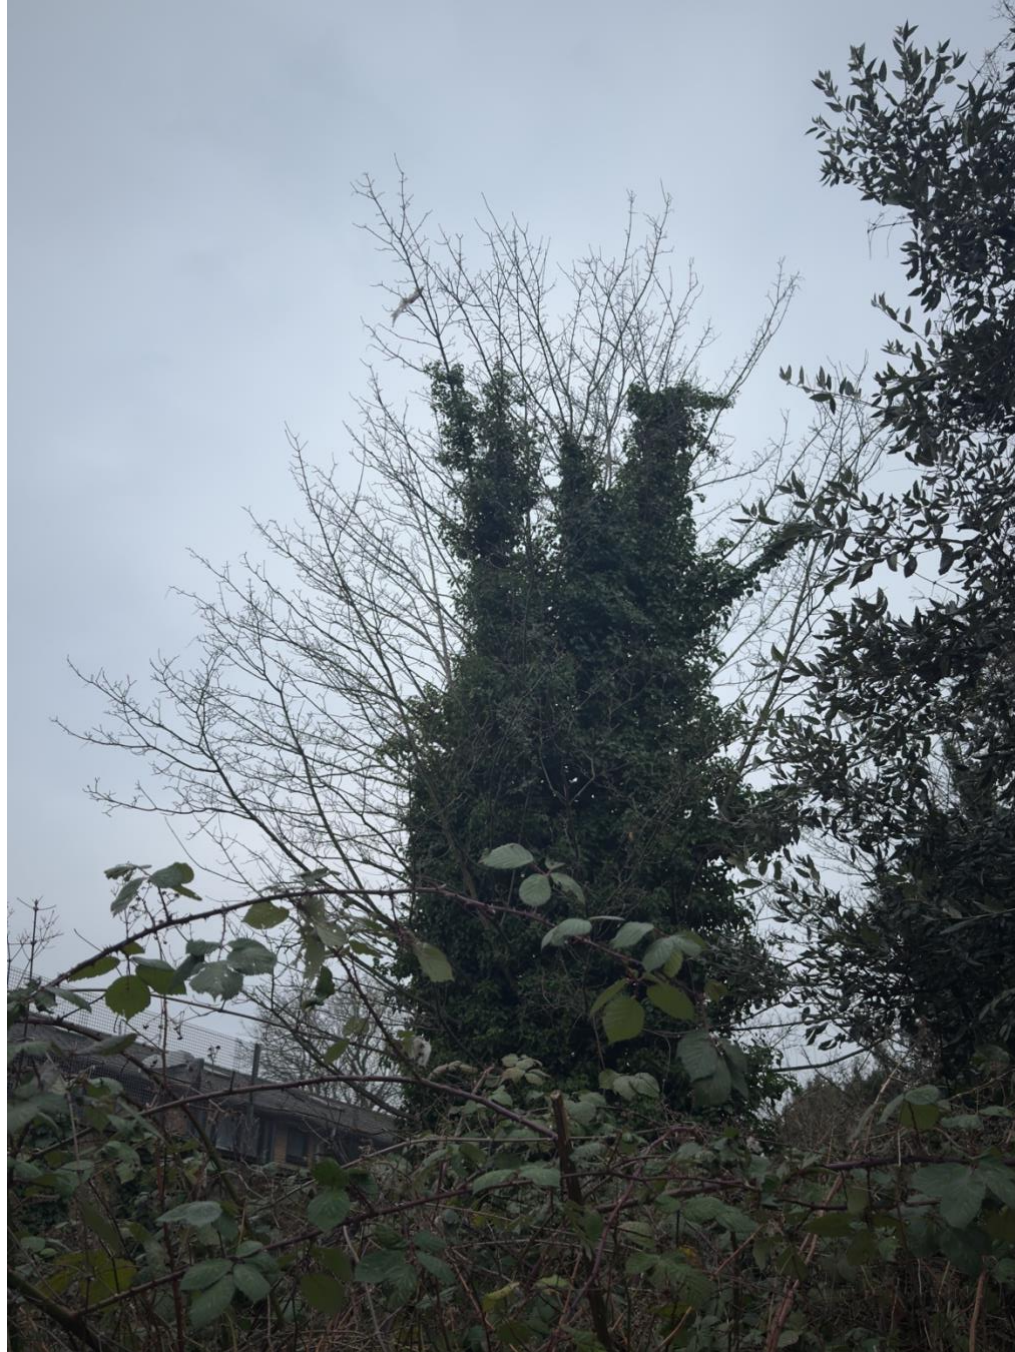
| Tree Reference Number | Tree Species | DBH (mm) | Age | Height | Crown spread | Condition | Recommendations | Comments |
|---|---|---|---|---|---|---|---|---|
| T2 | Fraxinus excelsior | N/A | young | 12m | 3m | Good | Strip ivy, deadwood | |

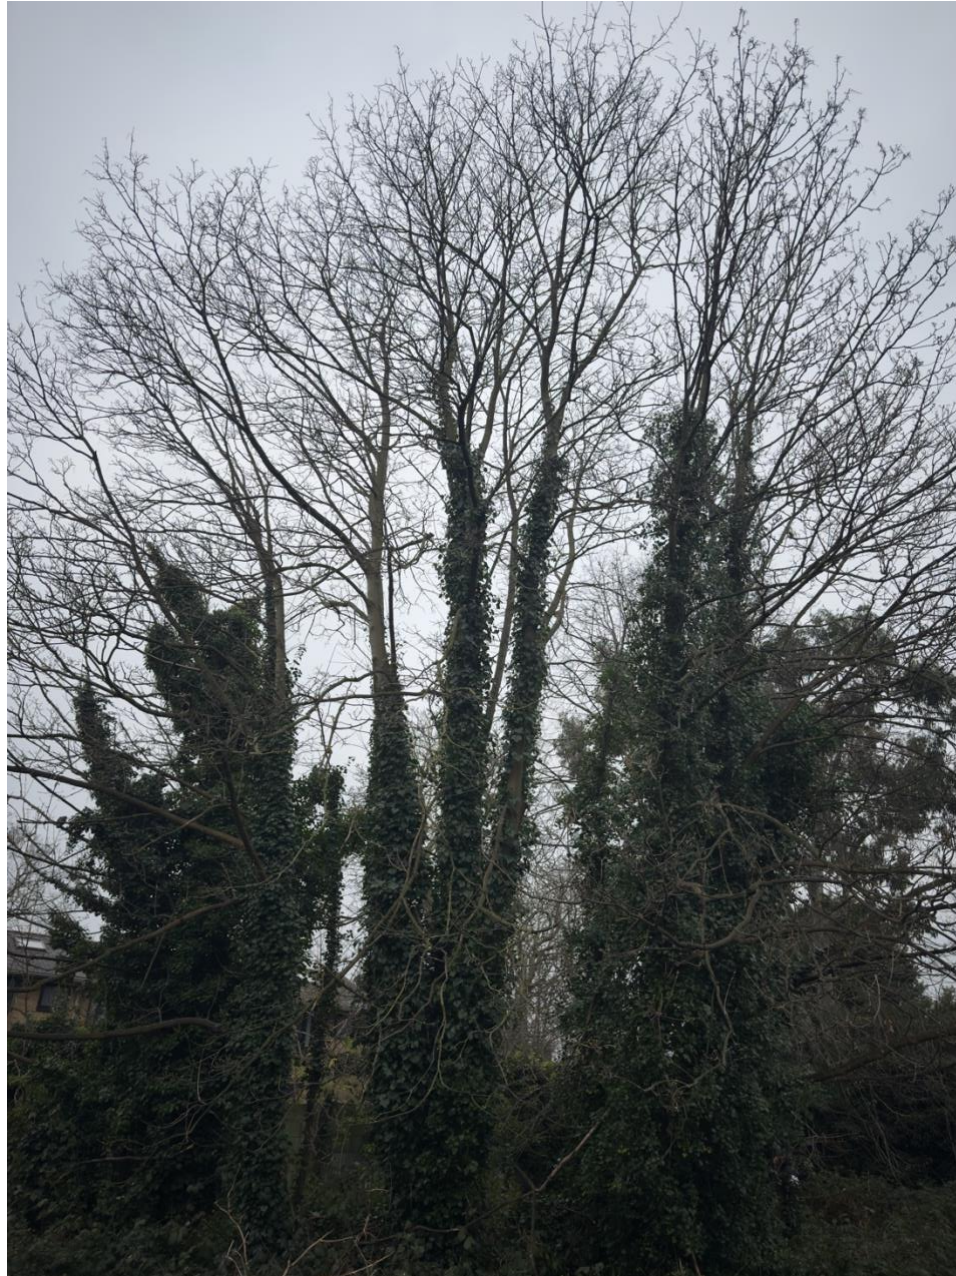
| Tree Reference Number | Tree Species | DBH (mm) | Age | Height | Crown spread | Condition | Recommendations | Comments |
|---|---|---|---|---|---|---|---|---|
| T3 | Group of sycamores | N/A | mature | 20m | 10m | good | Crown reduce, Deadwood, strip ivy | |

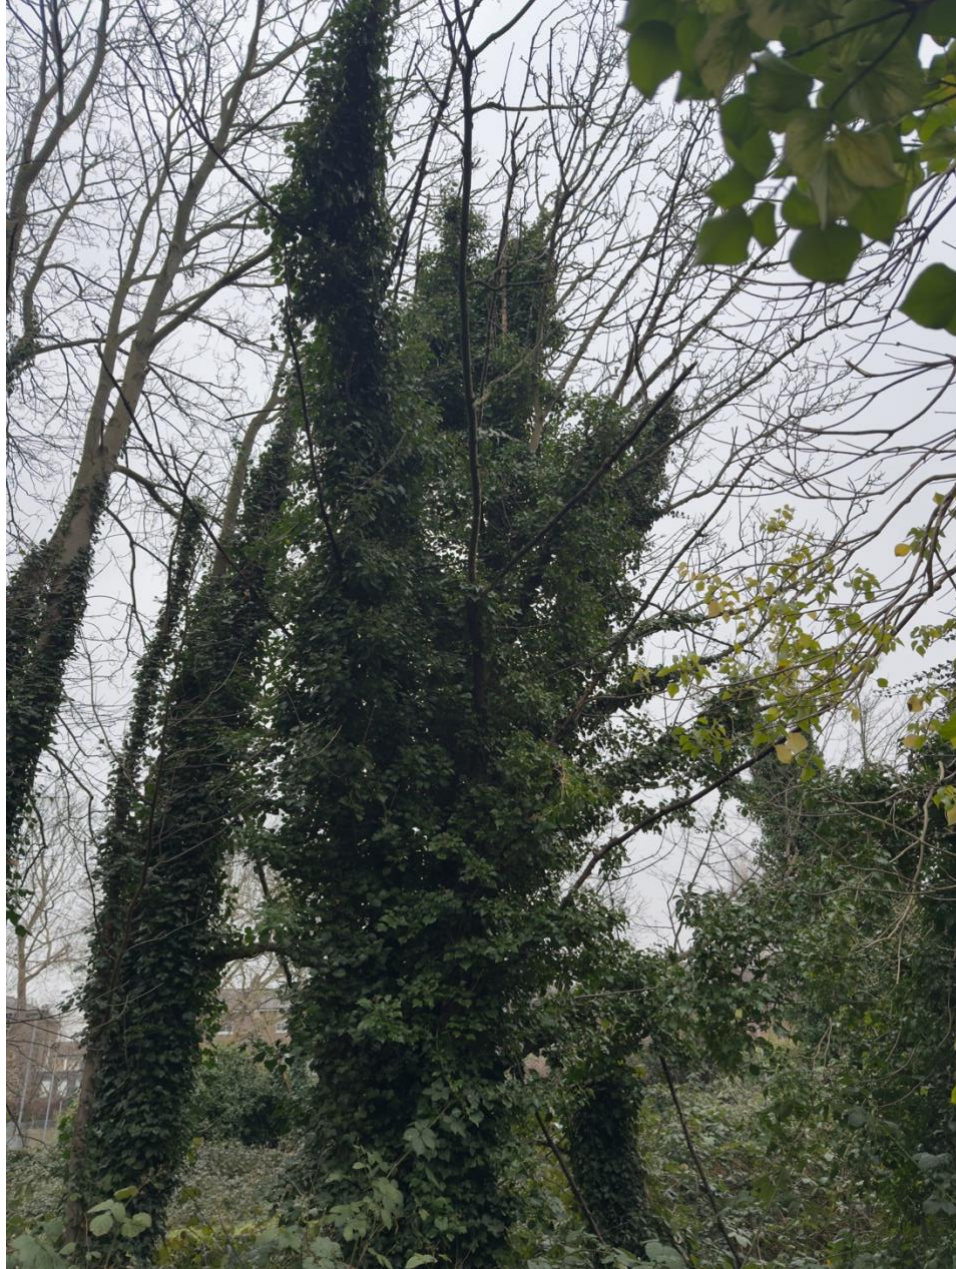
| Tree Reference Number | Tree Species | DBH (mm) | Age | Height | Crown spread | Condition | Recommendations | Comments |
|---|---|---|---|---|---|---|---|---|
| T4 | Sycamore | N/A | young | 10m | 2m | Majority dead | Fell to ground level | Majority of crown is dead |

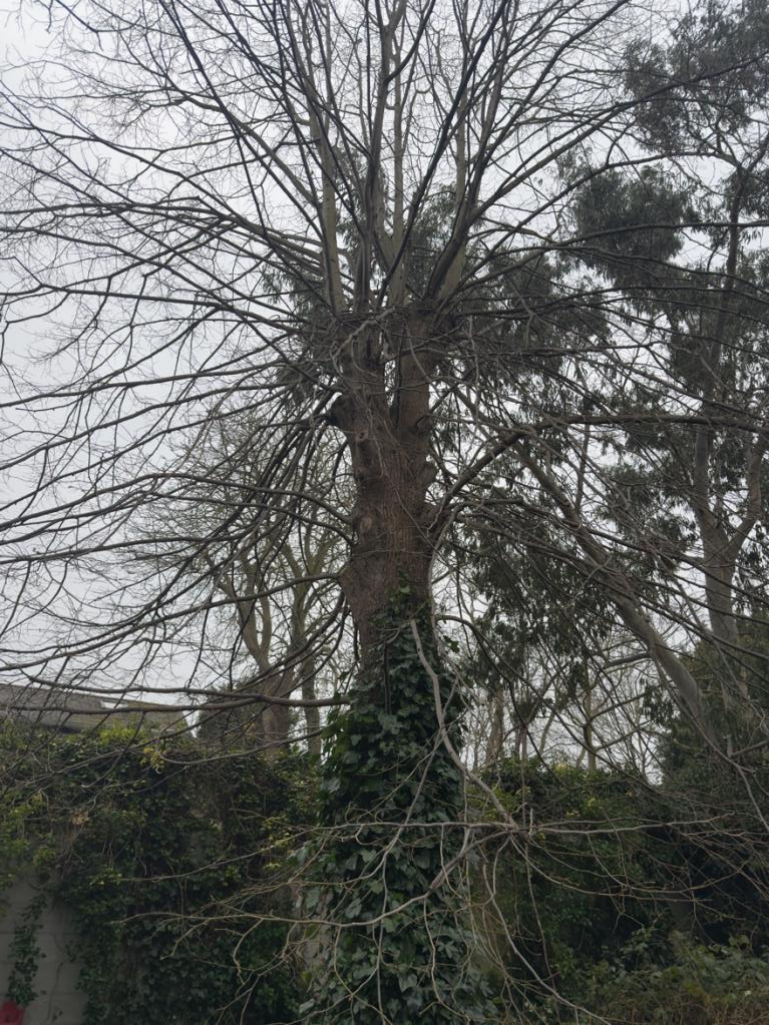
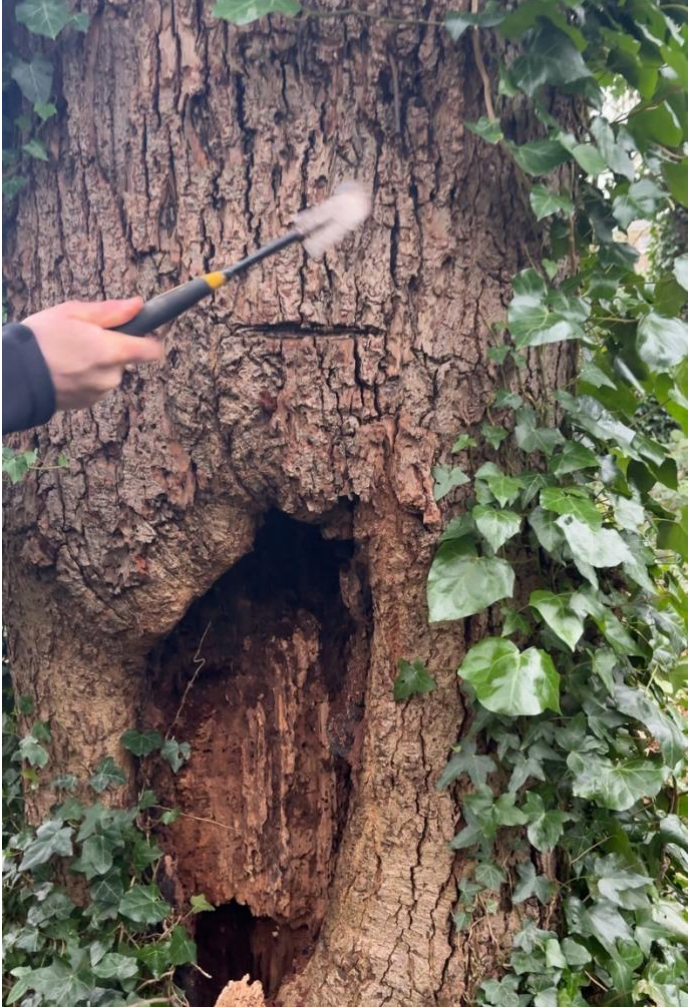
| Tree Reference Number | Tree Species | DBH (mm) | Age | Height | Crown spread | Condition | Recommendations | Comments |
|---|---|---|---|---|---|---|---|---|
| T5 | Lime | N/A | Mature | 18m | 5m | Base is completely rotten | fell to ground level | Hollow resonance throughout base and 70%rotten |

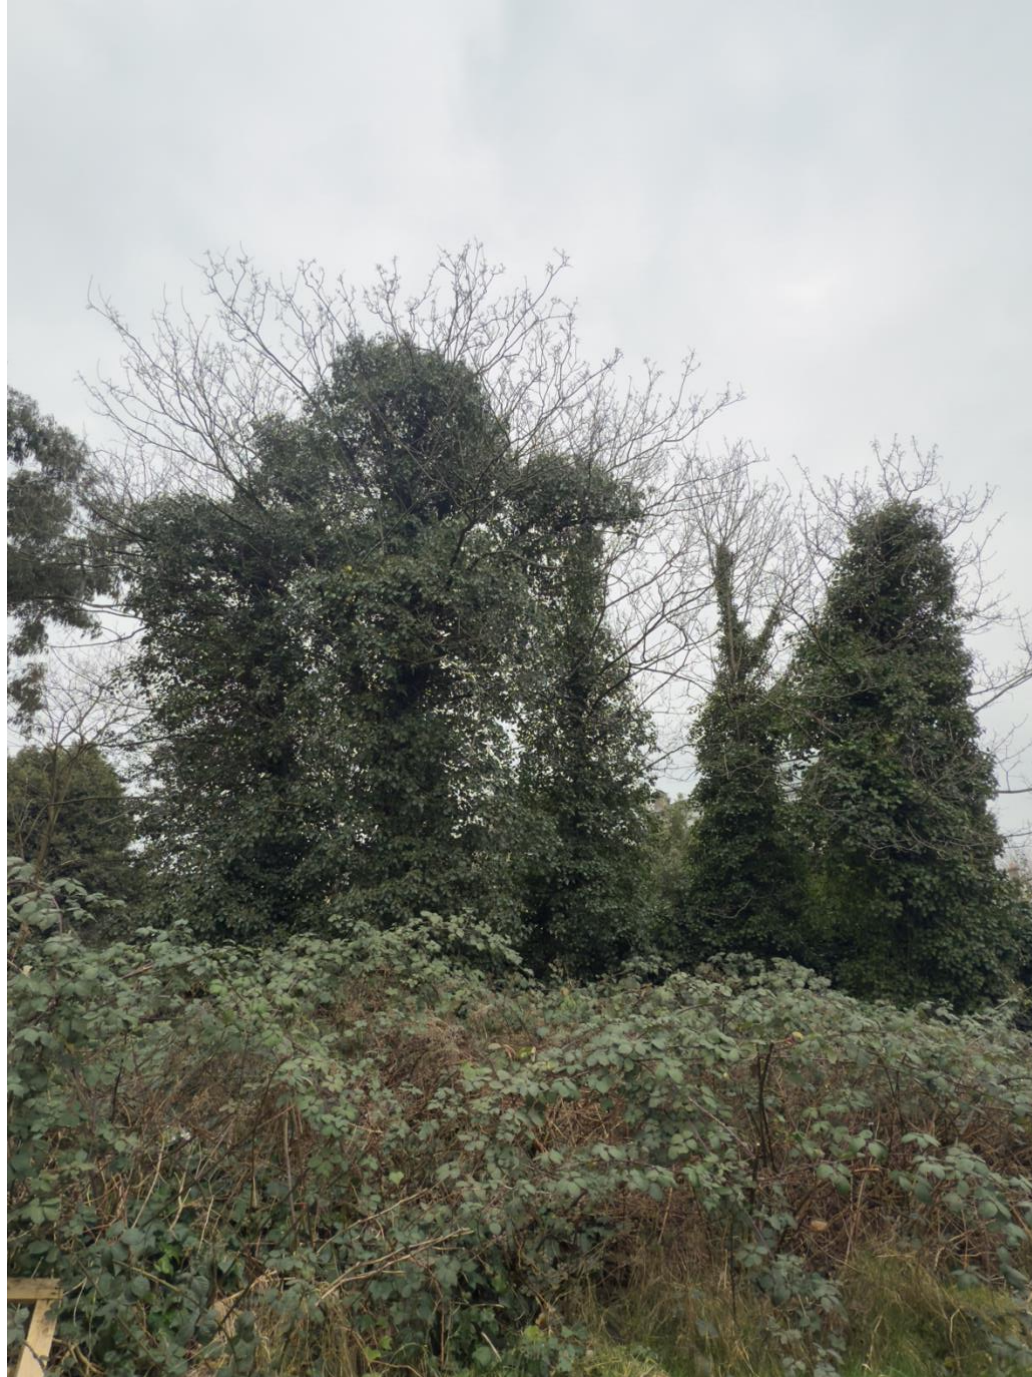
| Tree Reference Number | Tree Species | DBH (mm) | Age | Height | Crown spread | Condition | Recommendations | Comments |
|---|---|---|---|---|---|---|---|---|
| T6 | Group of sycamores | N/A | young | 14m | 10m | Good | Strip ivy and deadwood. Crown reduce | |

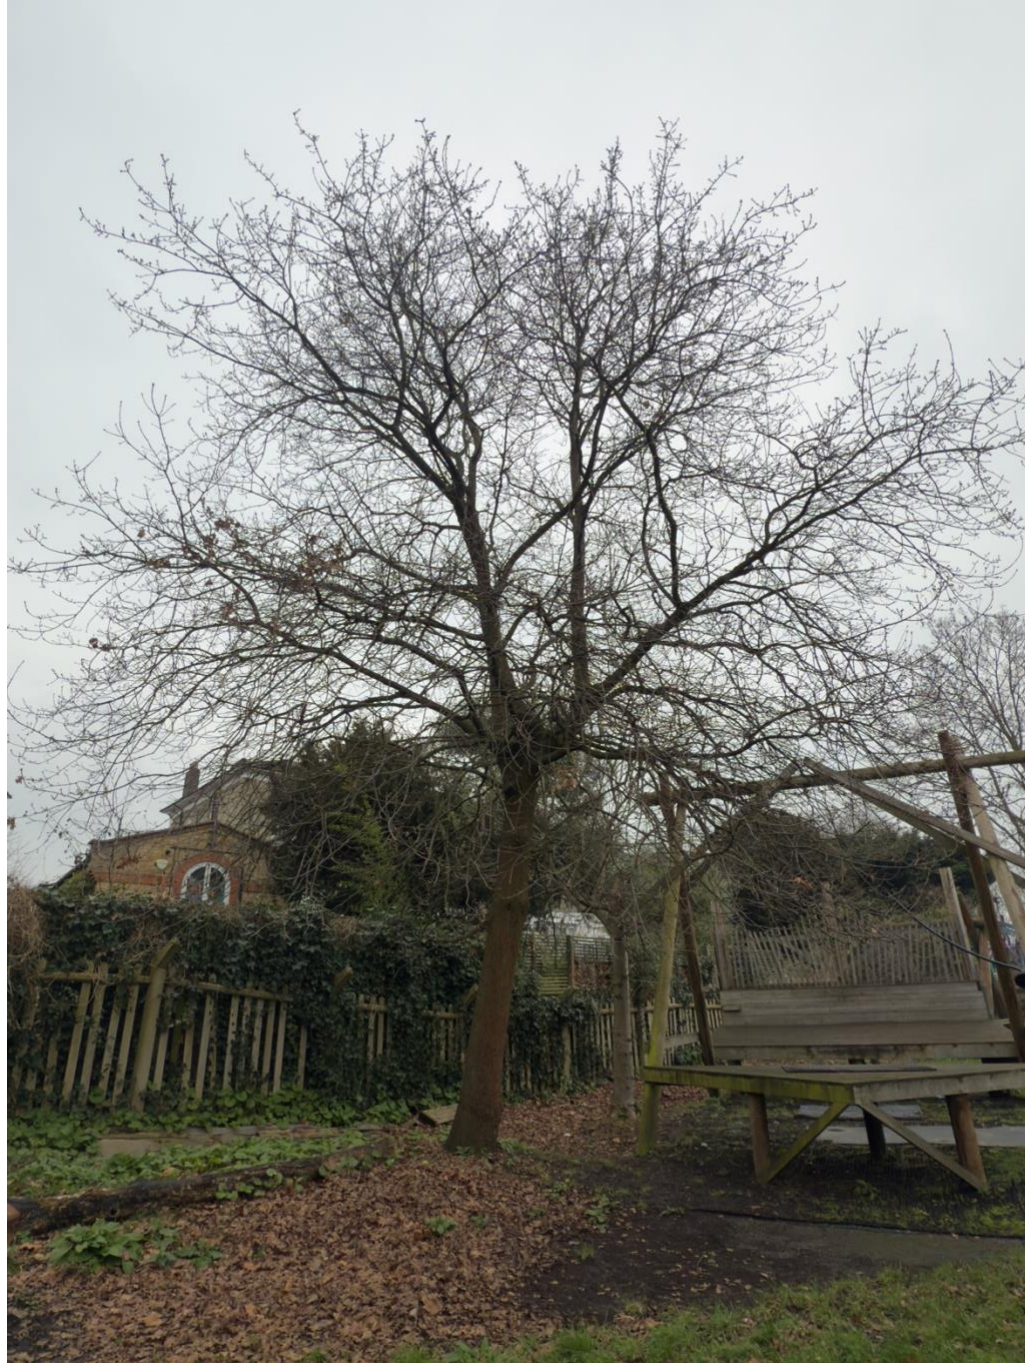
| Tree Reference Number | Tree Species | DBH (mm) | Age | Height | Crown spread | Condition | Recommendations | Comments |
|---|---|---|---|---|---|---|---|---|
| T7 | Oak | N/A | young | 10m | 6m | Good | Reduce crown, deadwood | |

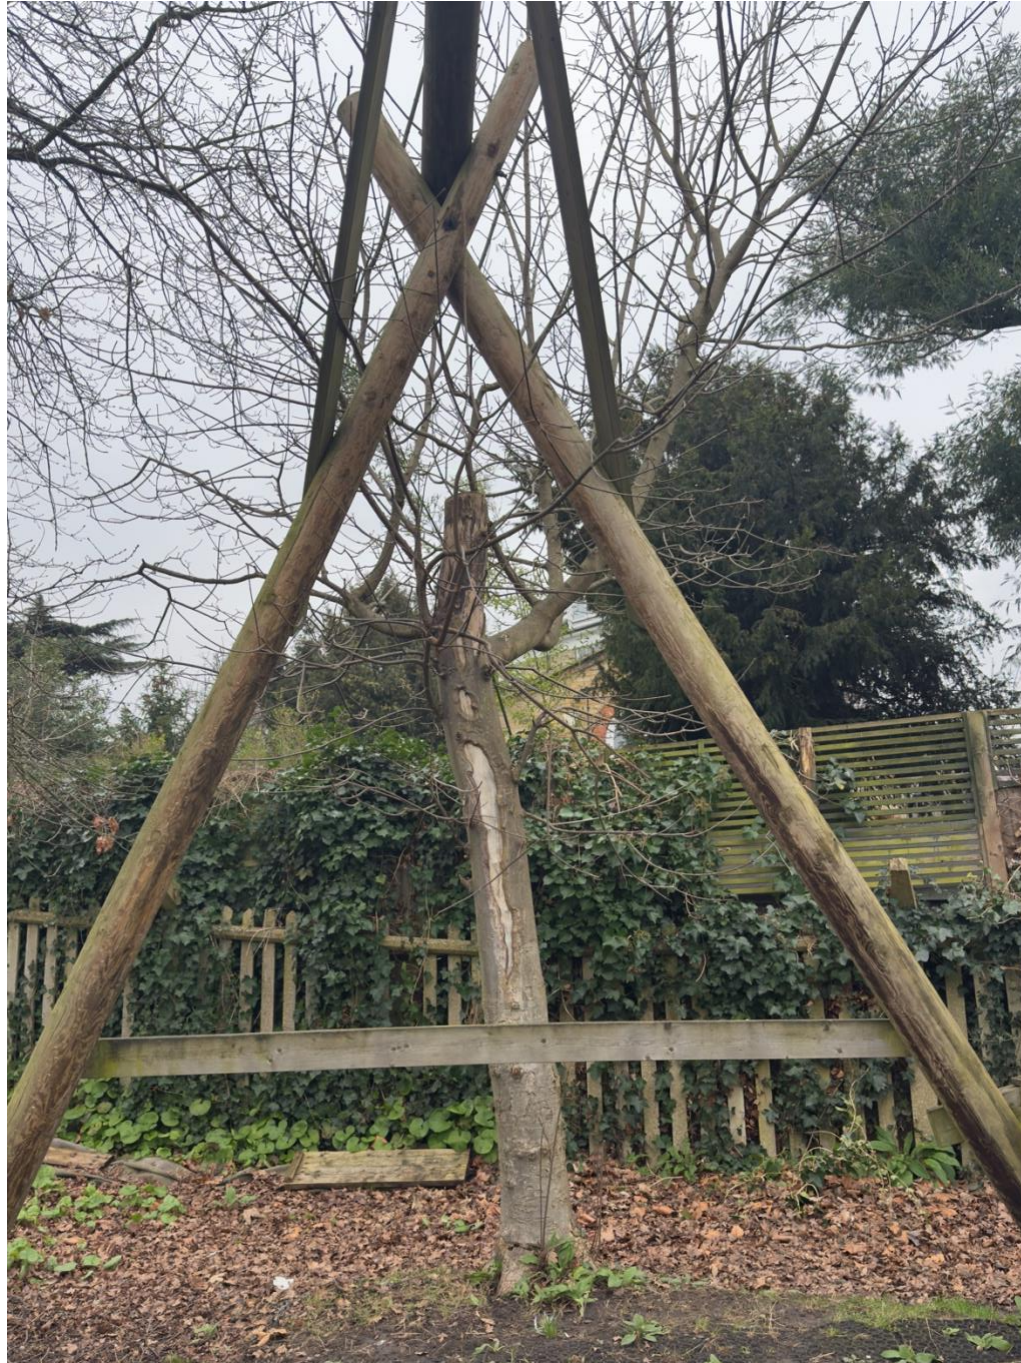
| Tree Reference Number | Tree Species | DBH (mm) | Age | Height | Crown spread | Condition | Recommendations | Comments |
|---|---|---|---|---|---|---|---|---|
| T8 | Ash | N/A | young | 6m | 3m | Really poor | Fell to ground level | Previous pollard / Potentially associated with dead and decay |

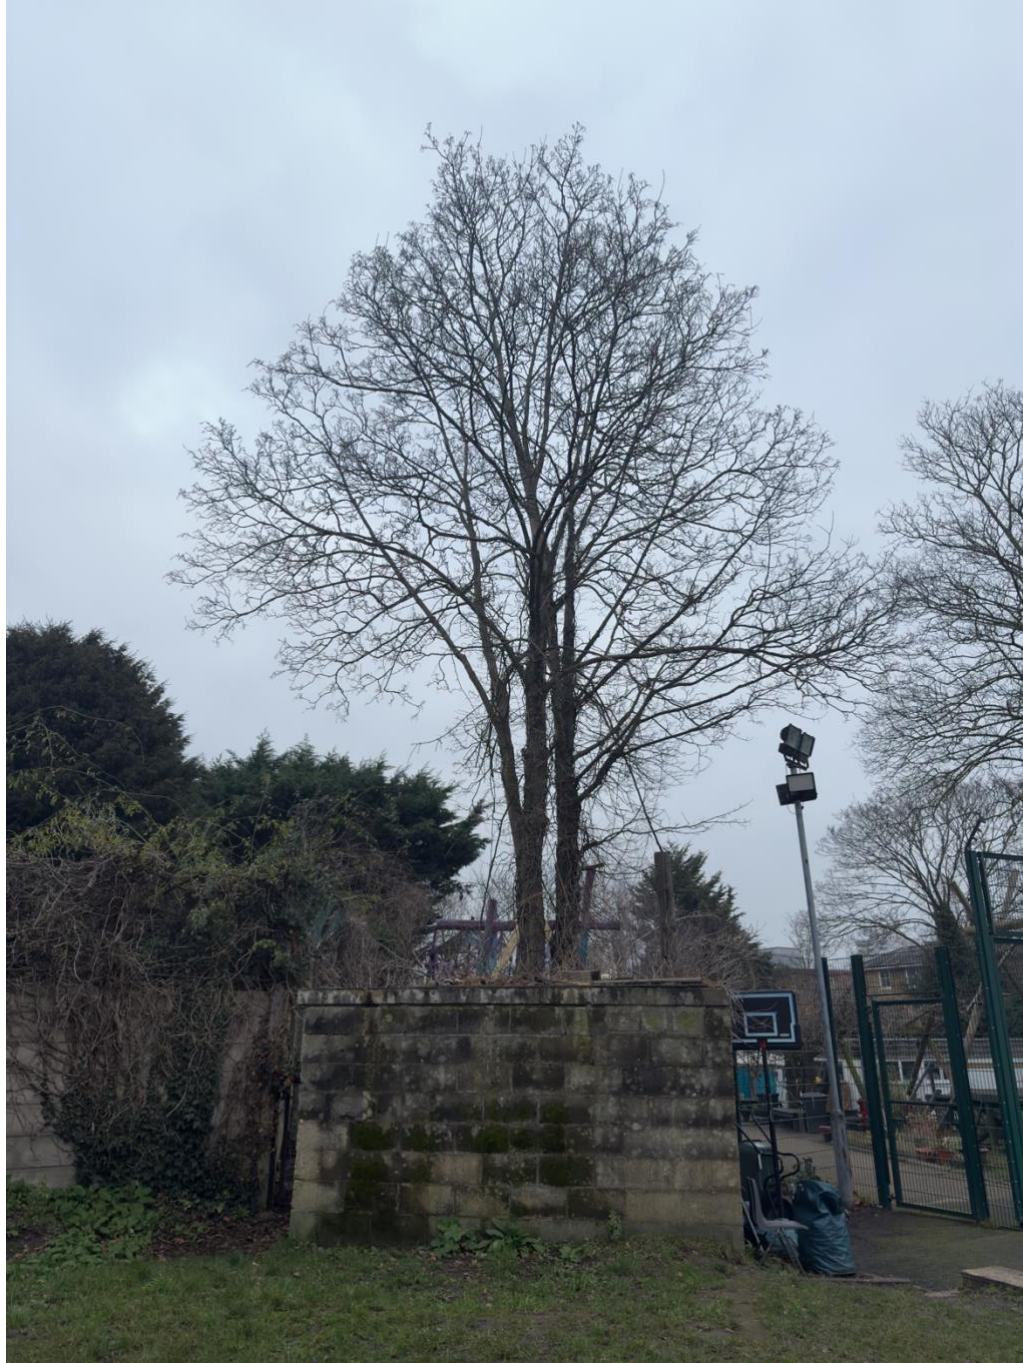
| T9 | Sycamore | N/A | Semi-mature | 15m | 6m | good | Crown reduce, Deadwood and strip ivy | |

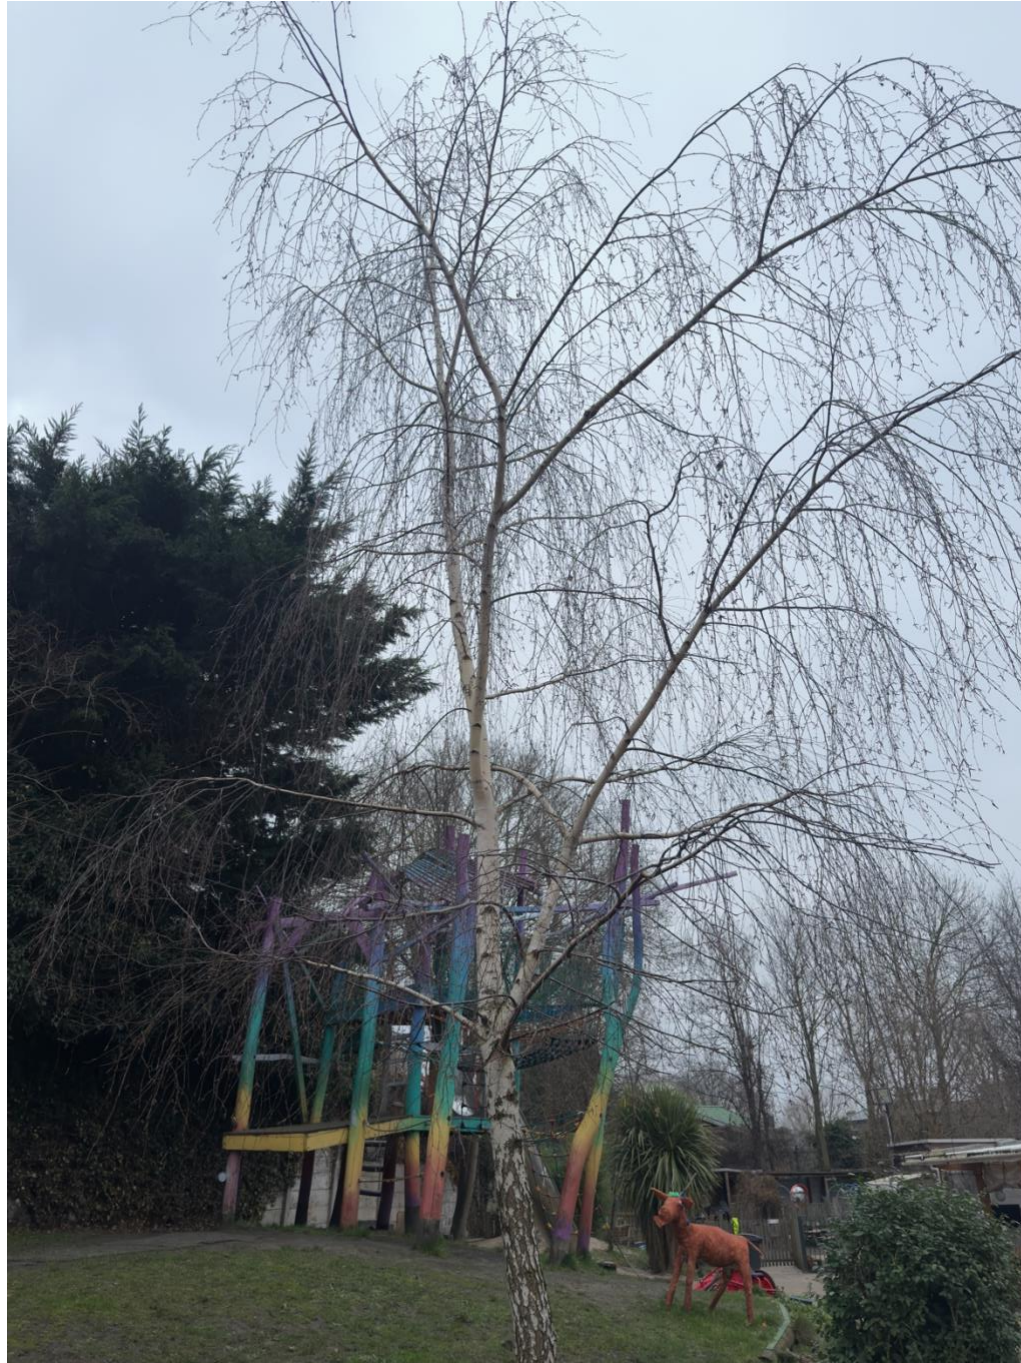
| T10 | Silver birch | N/A | young | 7m | 3m | good | Crown reduce to balance crown | |

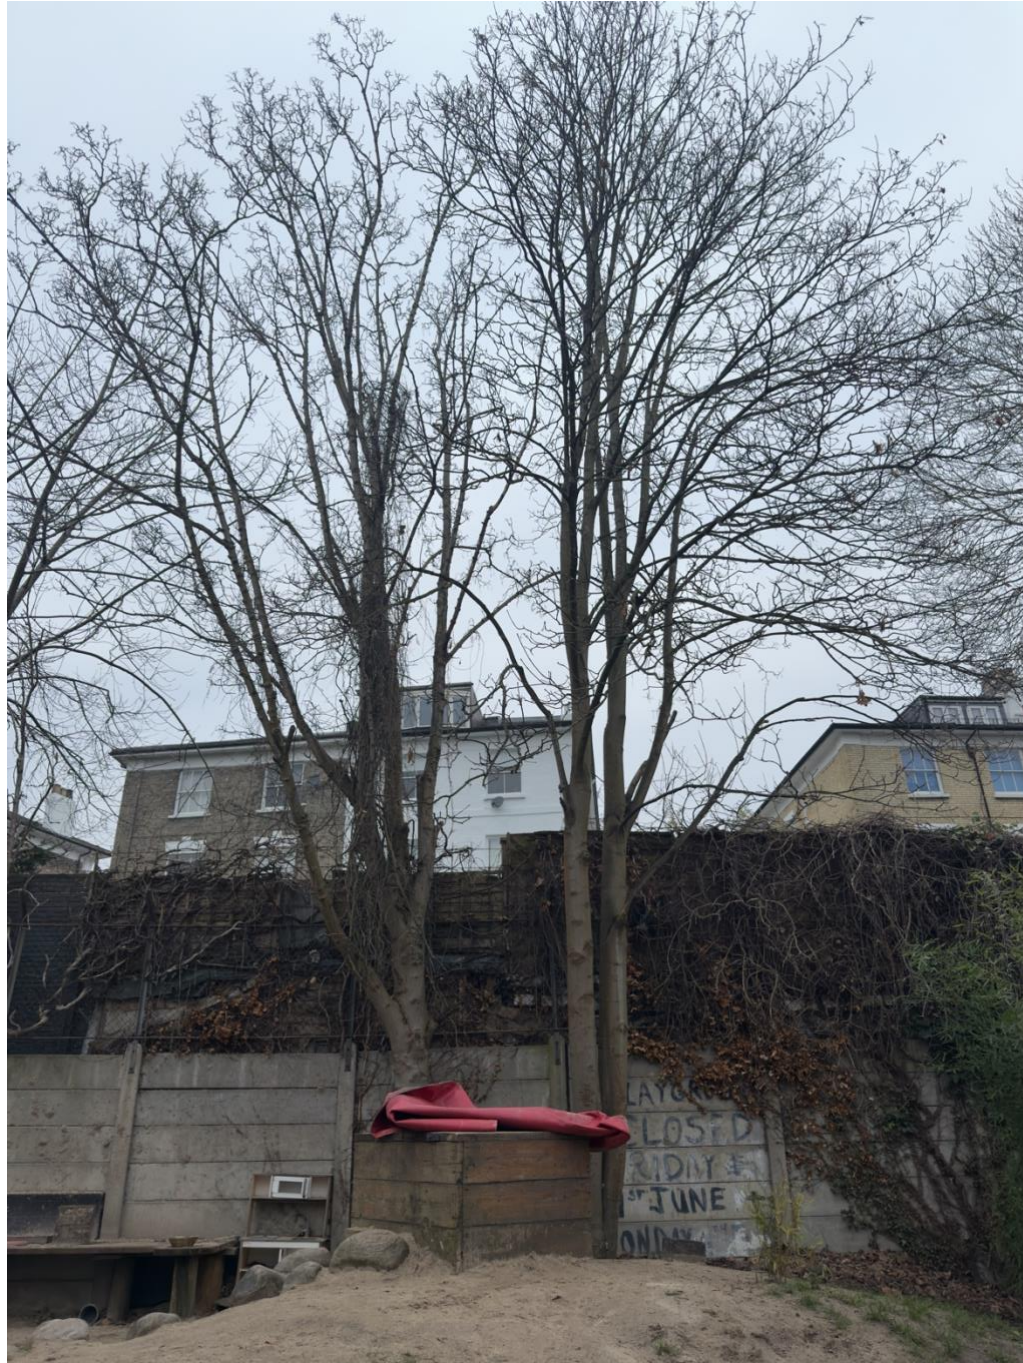
| T11 | Group of sycamores | N/A | young | 13m | 6m | Good | Crown reduce, Deadwood, strip ivy | |

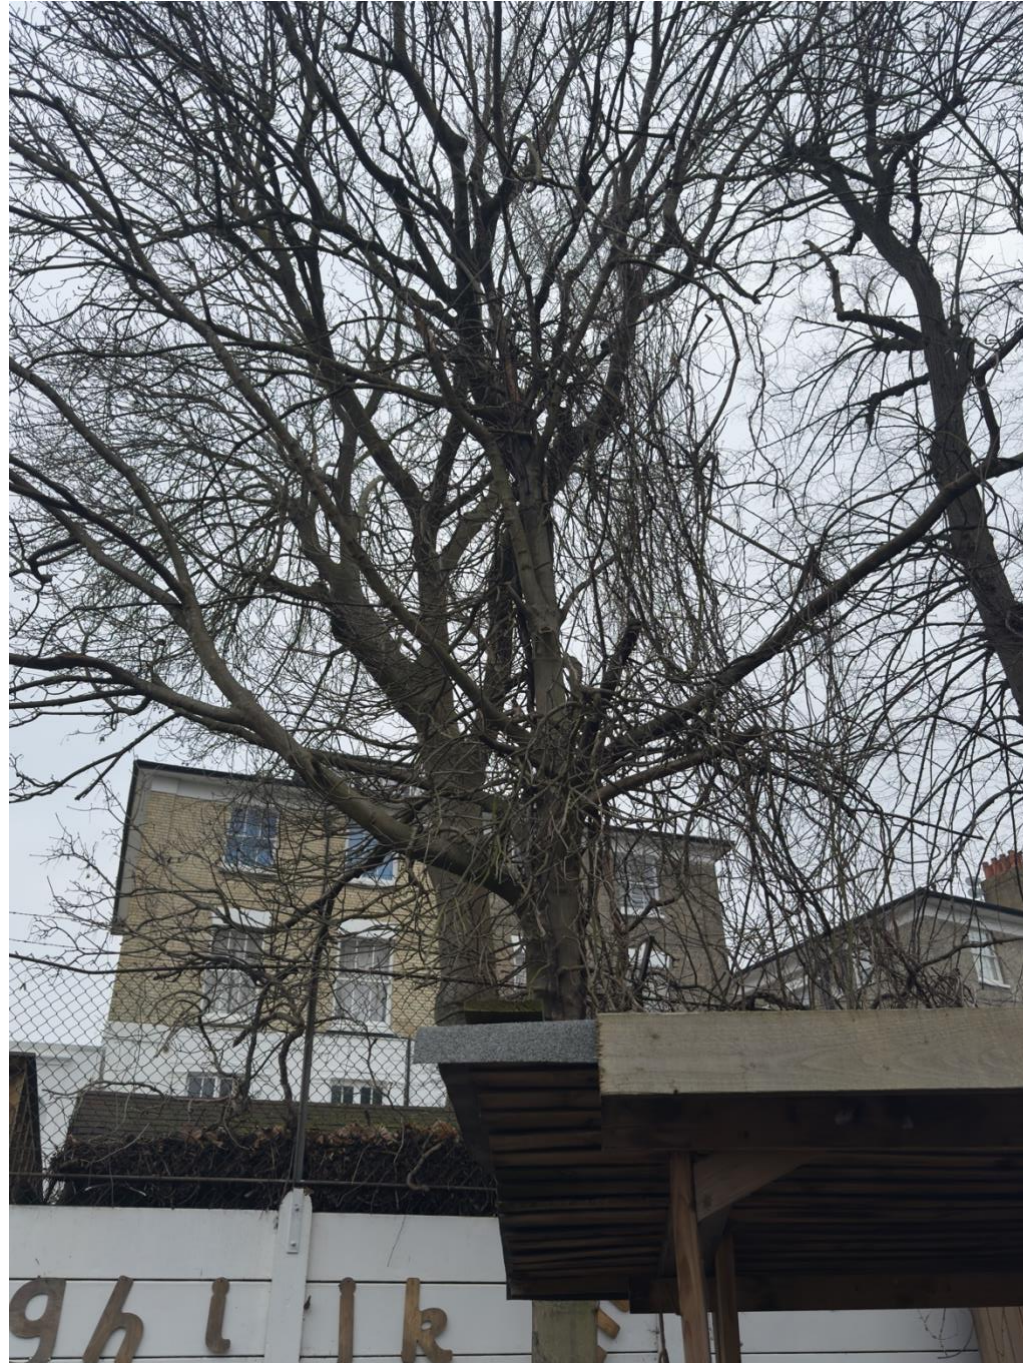
| T12 | Sycamore | N/A | young | 11m | 5m | Very poor | Fell to ground level. | Tree has significant dead and is over a play structure |

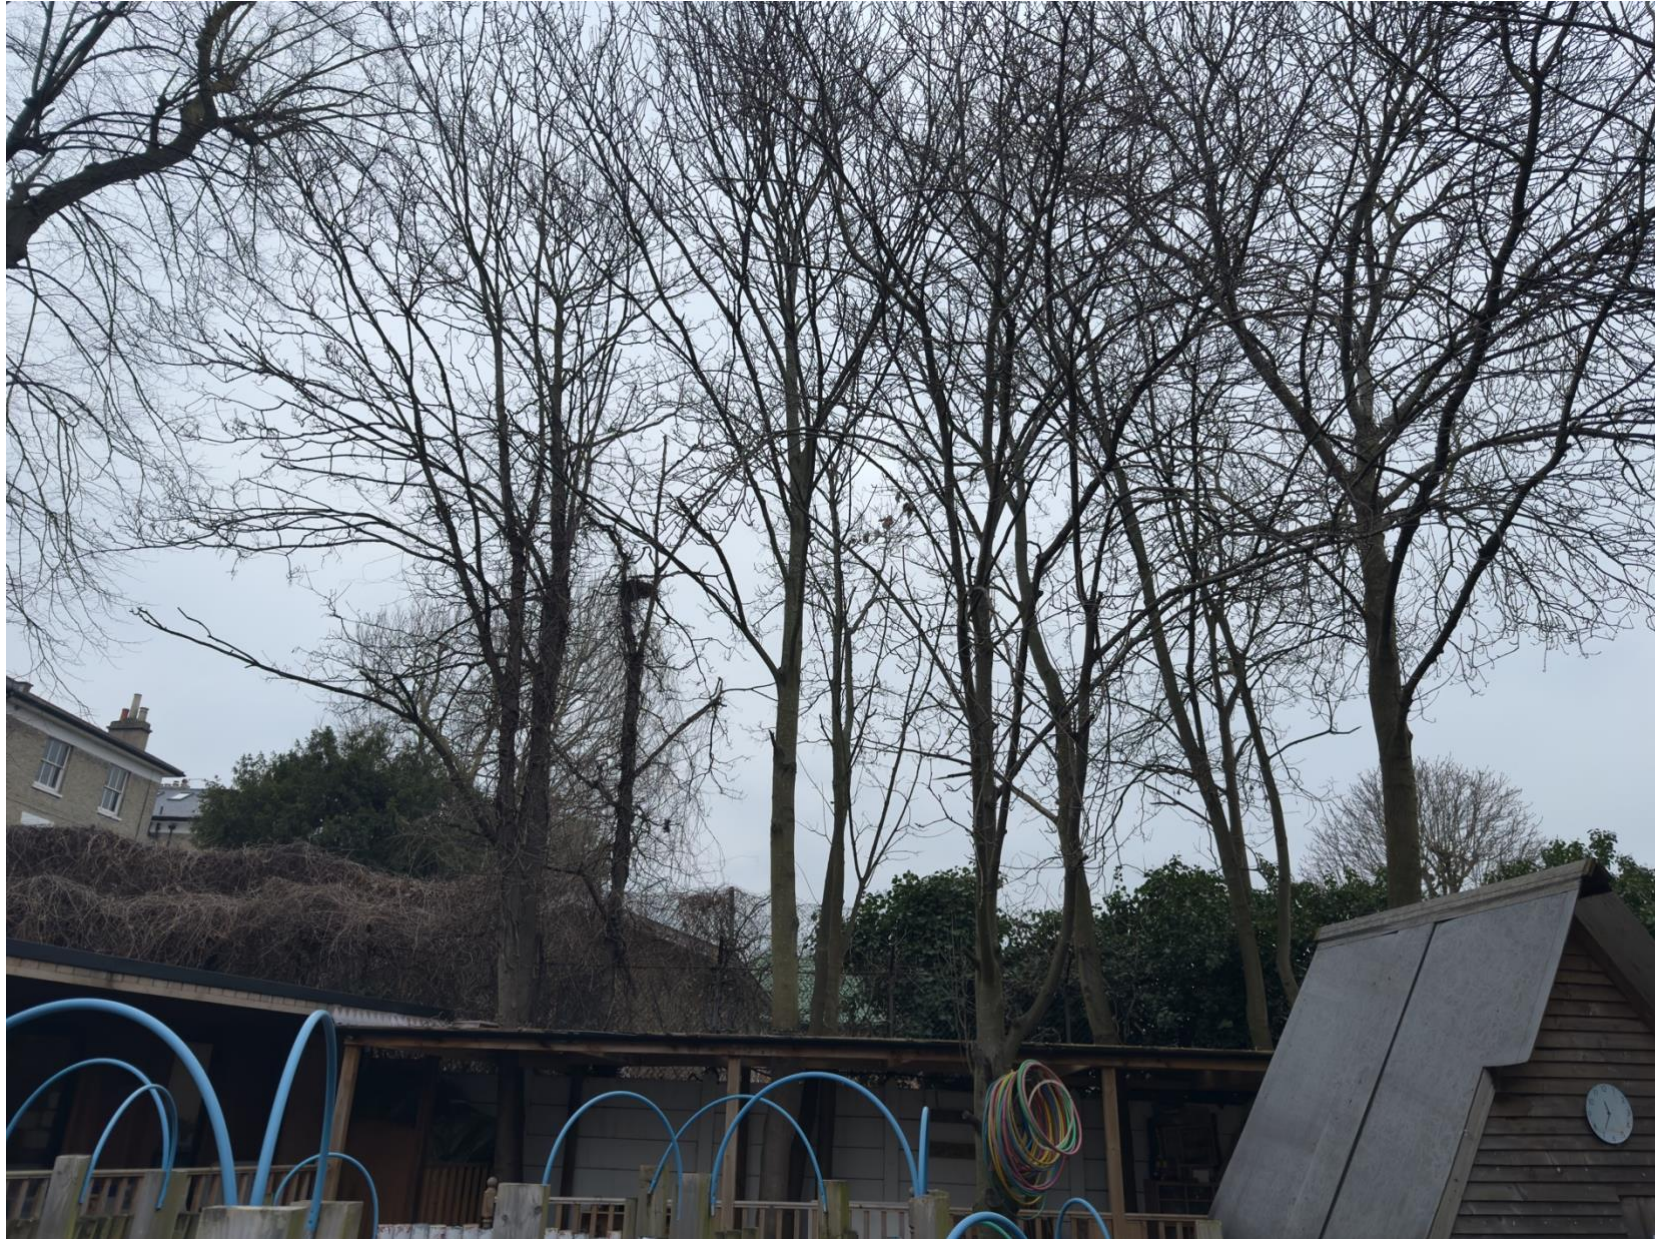
| T13 | Group of sycamores | N/A | Semi mature | 14m | 10m | good | Deadwood | |

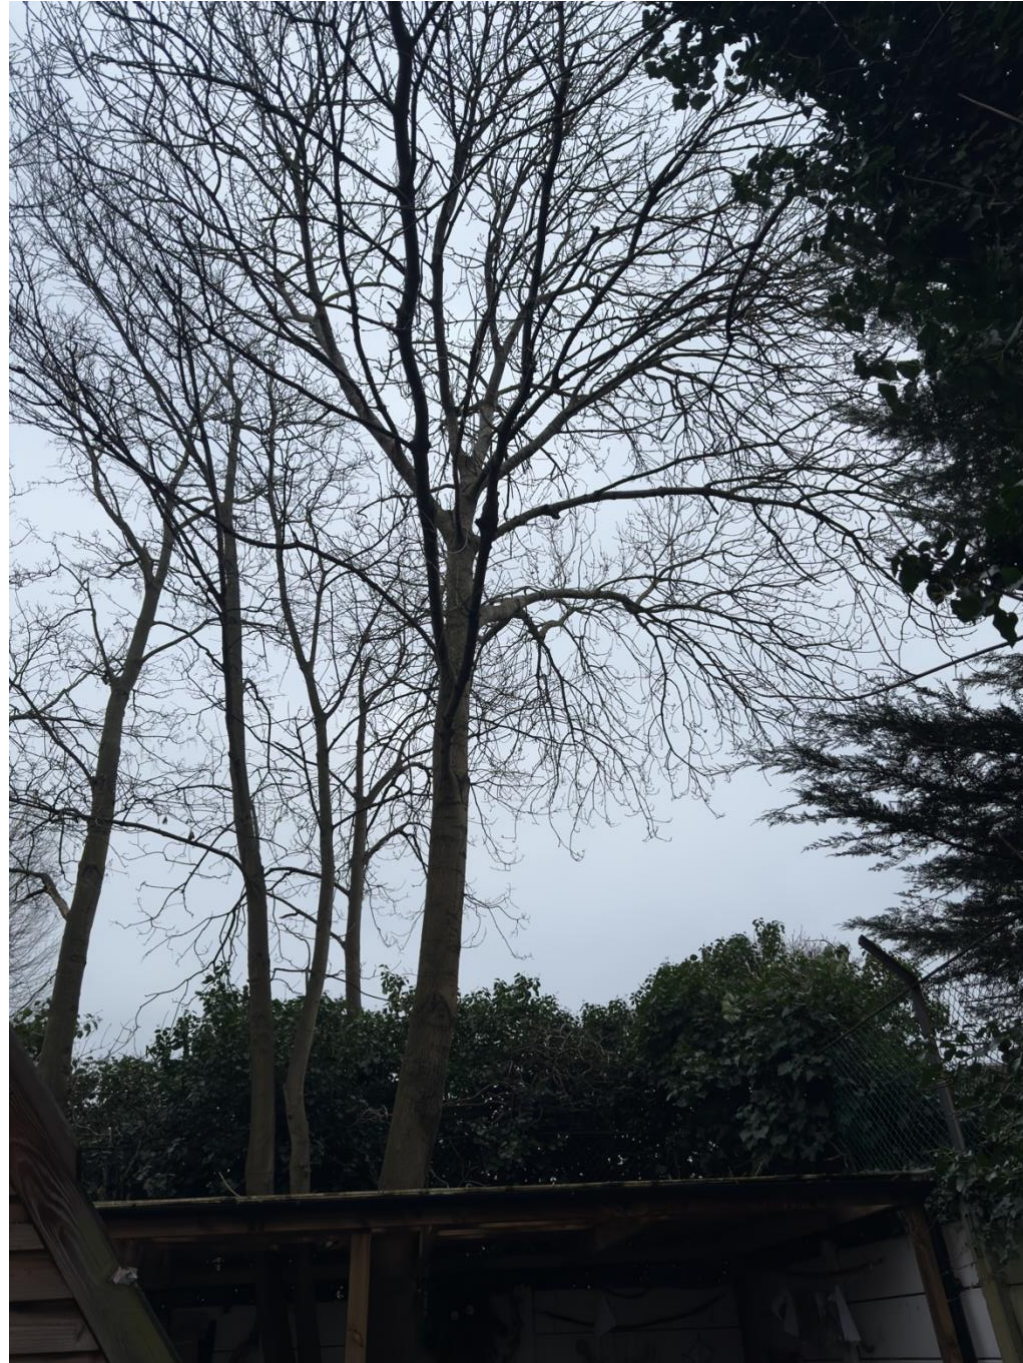
| T14 | Ash | N/A | Semi-mature | 15m | 4m | Good | Remove deadwood. | |

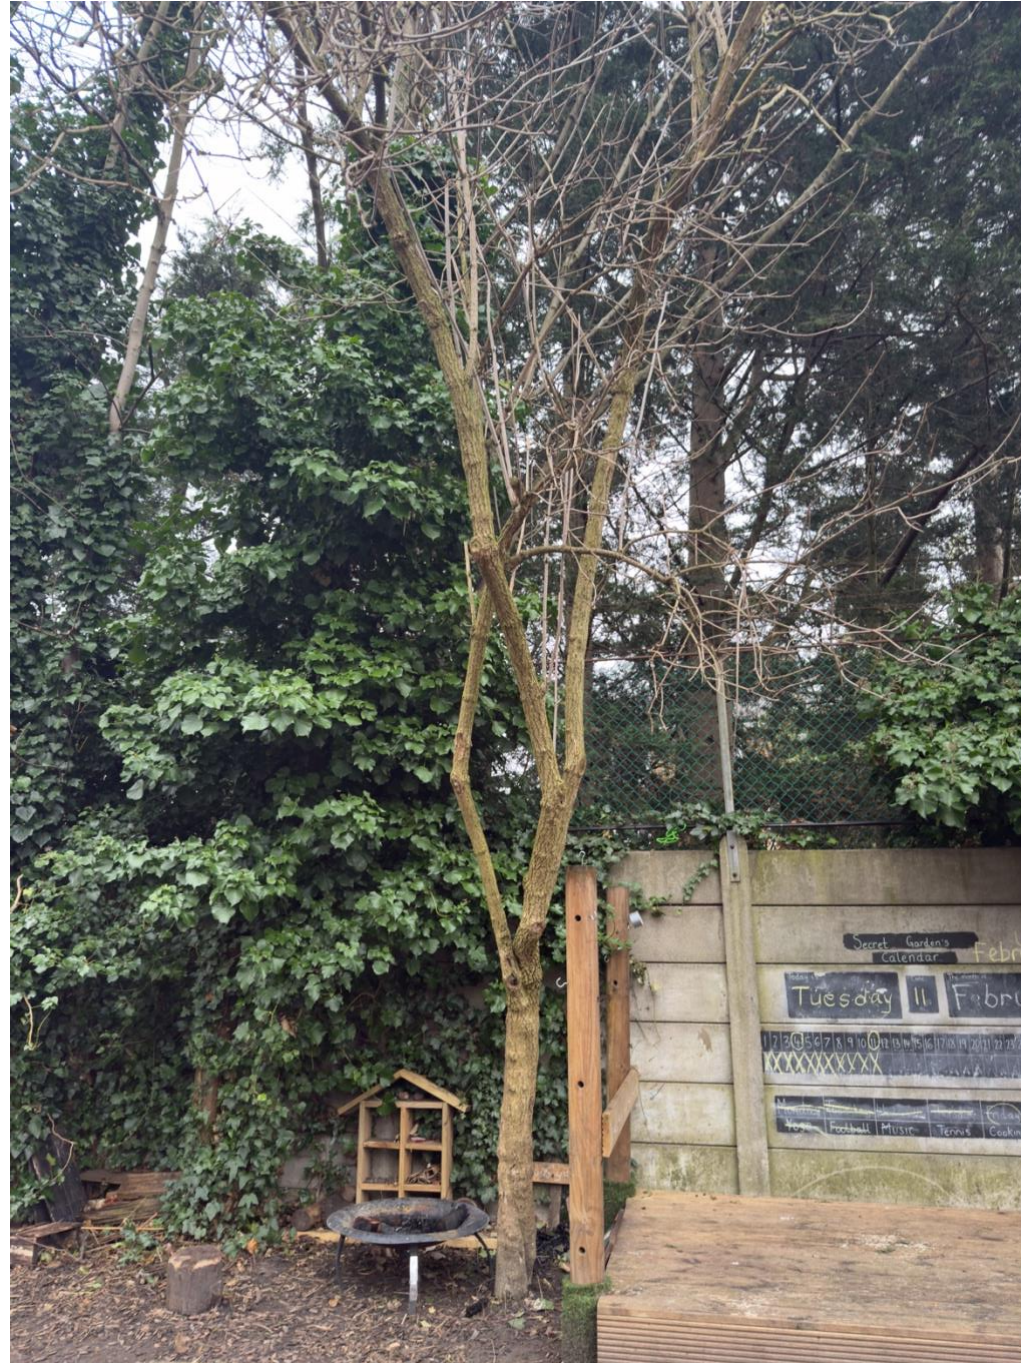
| T15 | Elder | N/A | young | 6m | 2m | good | Nothing at present | |
