Santos Timber

Arboricultural survey and management recommendations

Report reference TAP001 14/02/2025

This report has been compiled to record all trees within the ownership boundaries of Three Acres Pre School, NW3 2YH In order to minimize risk, compile works recommendations and apply the recommendations to a regime, creating a short term management plan for the site.

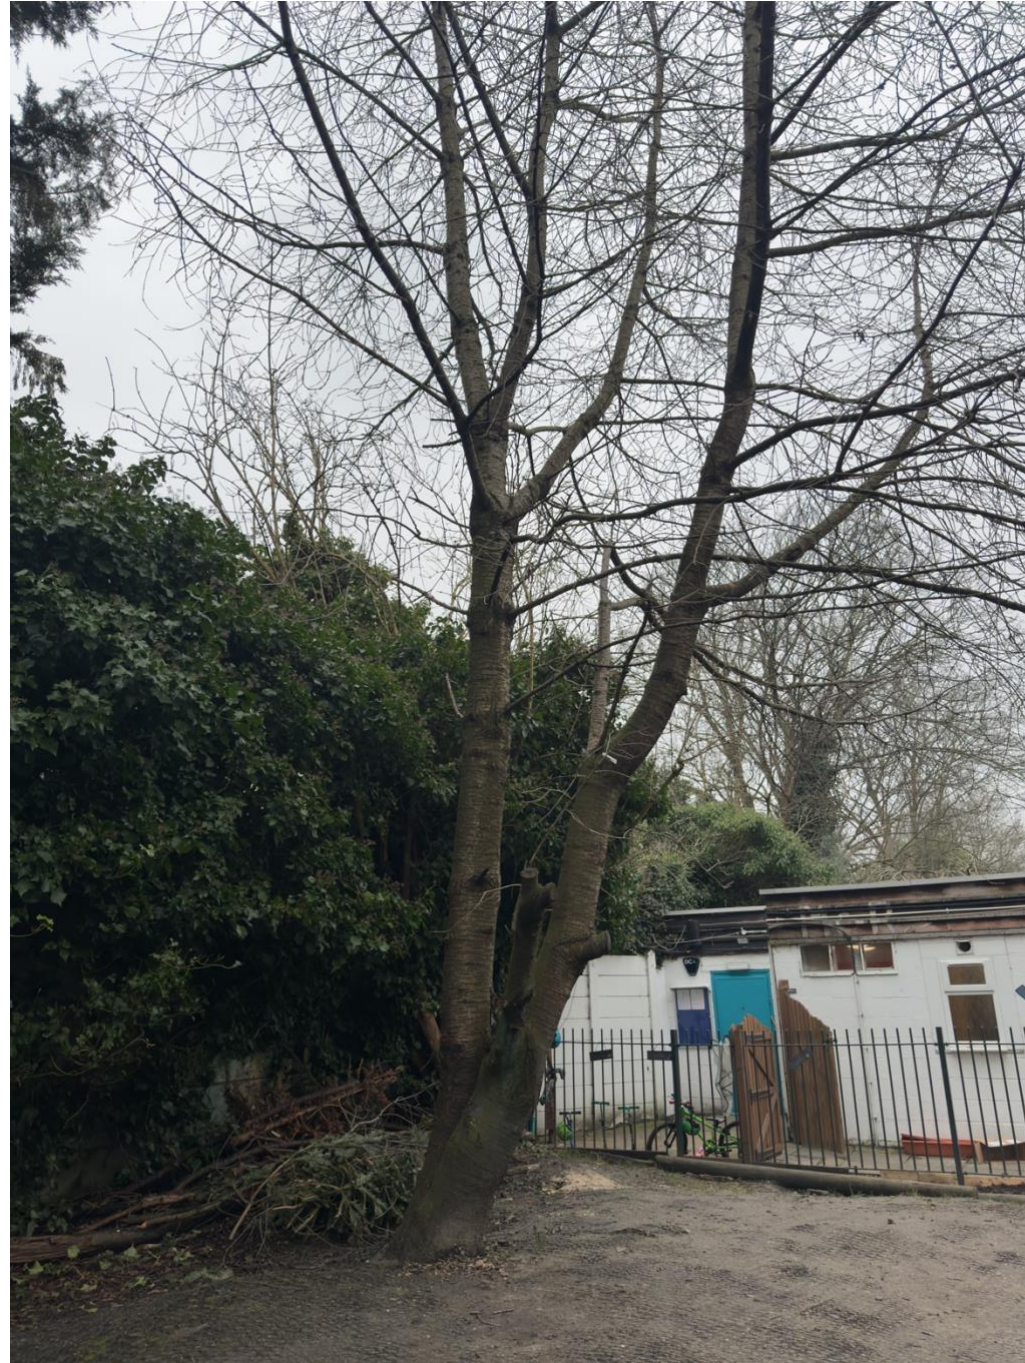
| T16 | Cherry | N/A | Young | 12m | 5m | Good | Remove deadwood | |

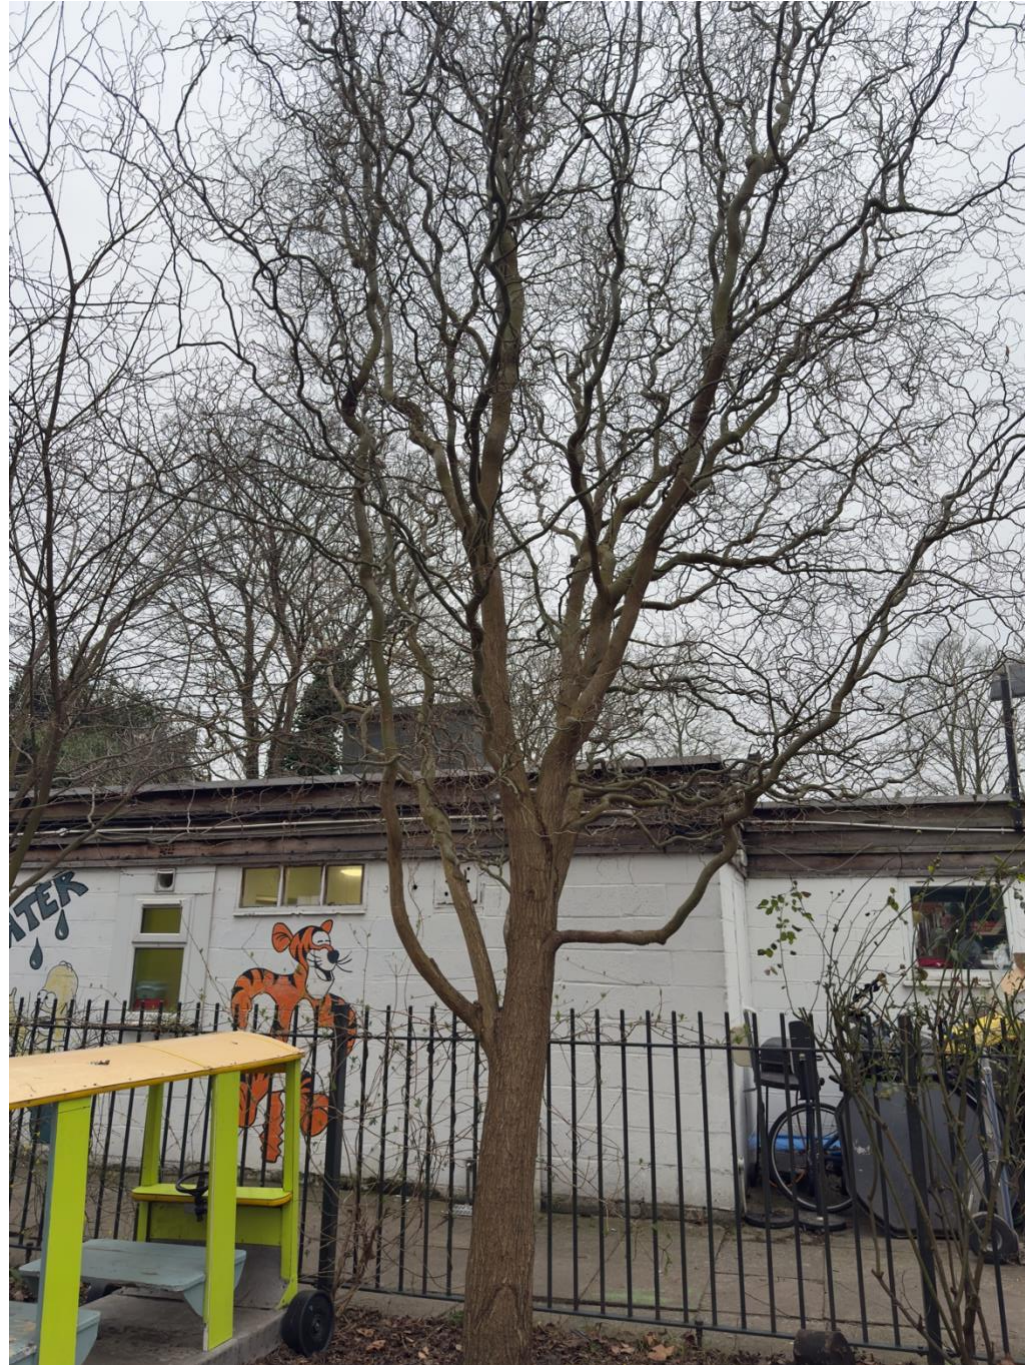
| T17 | Corkscrew willow | N/A | young | 7m | 2m | Good | Remove deadwood | |

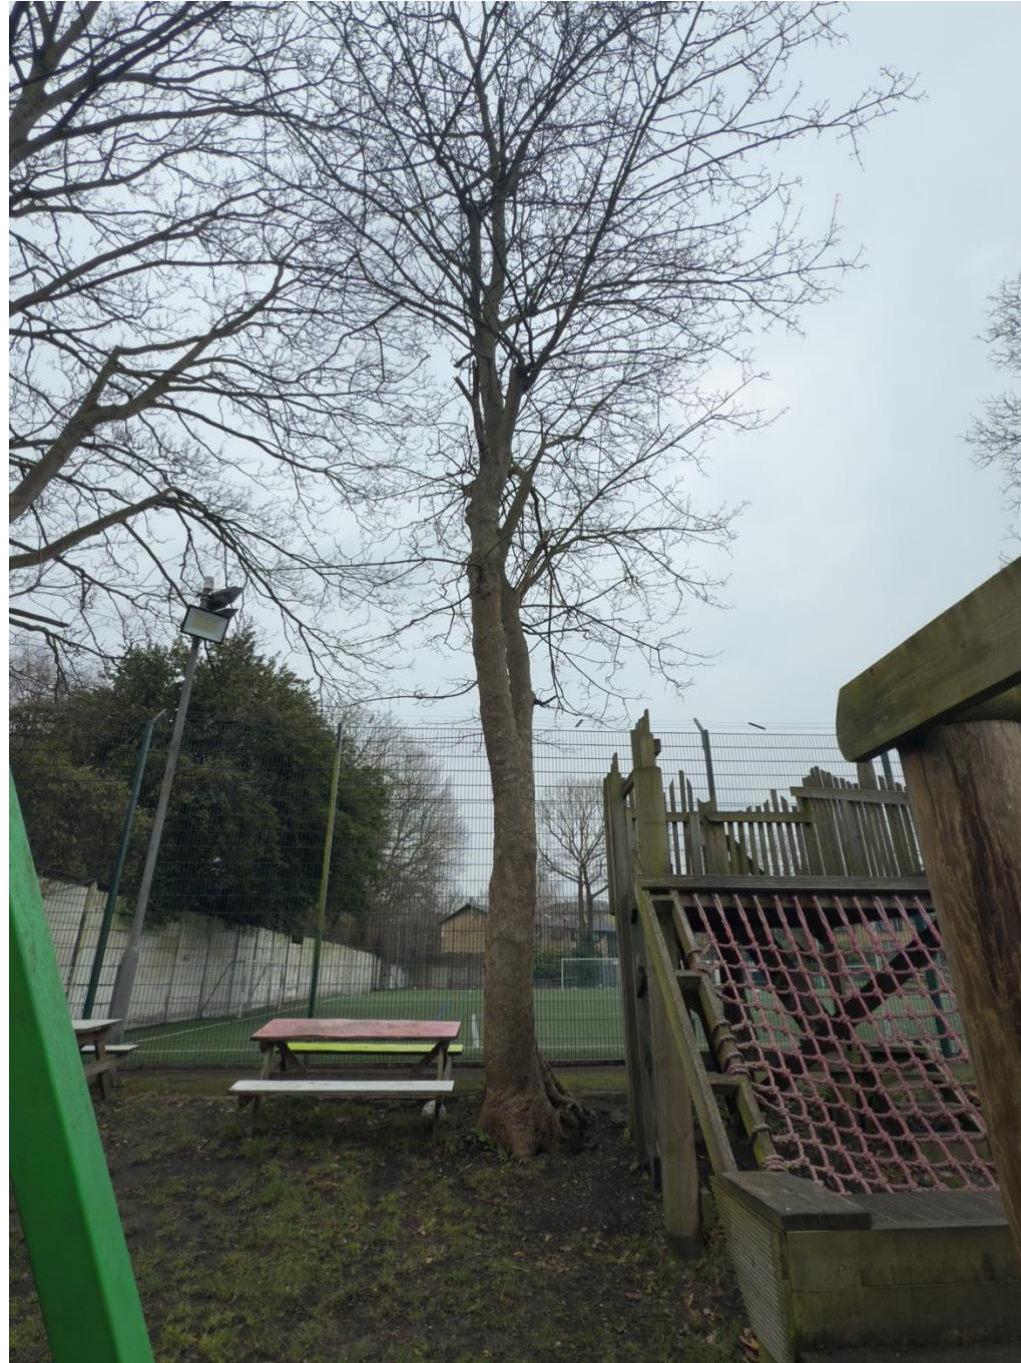
| T18 | Sycamore | N/A | mature | 14m | 4m | Good | Crown reduce and deadwood | Over a play structure |

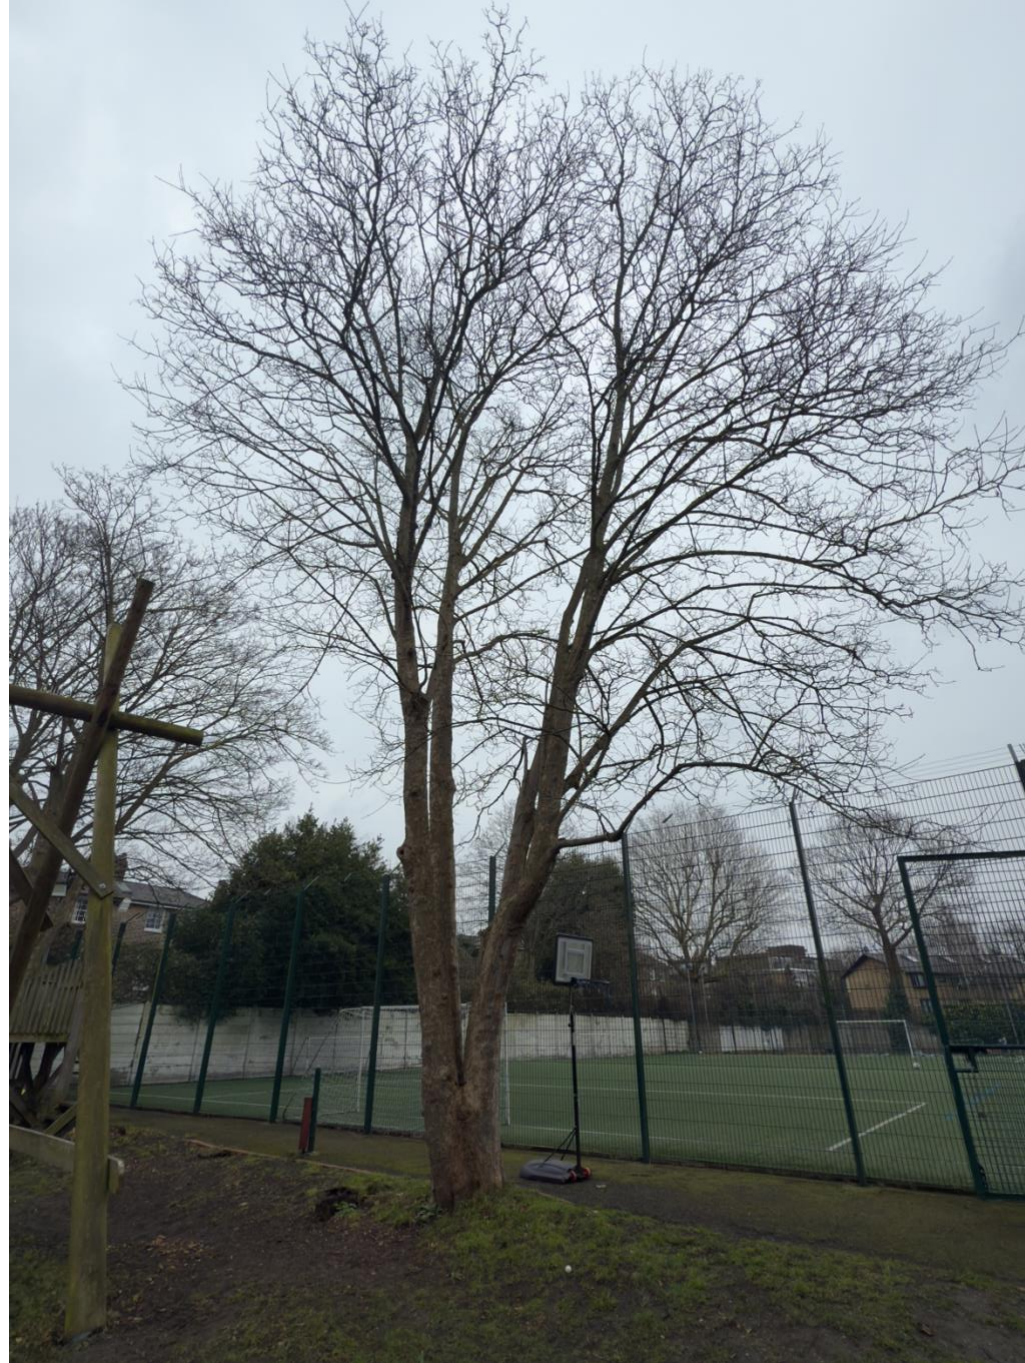
| T19 | Sycamore | N/A | mature | 15m | 8m | Good | Remove deadwood and crown reduce. | Next to play structure |

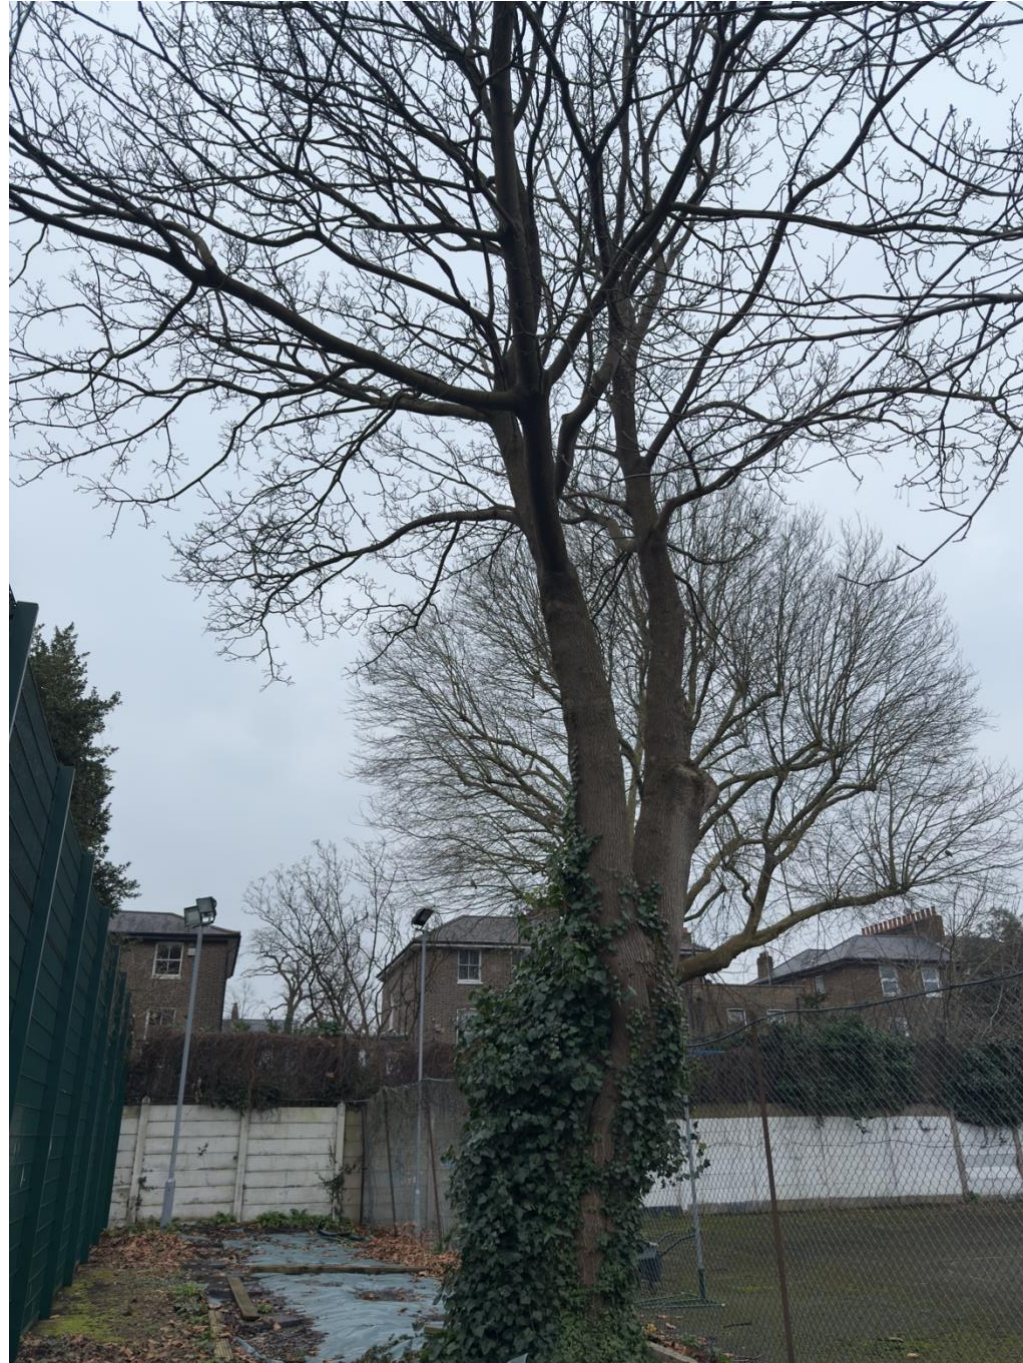
| T20 | Ash | N/A | mature | 15m | 8m | Good | Remove deadwood. | |

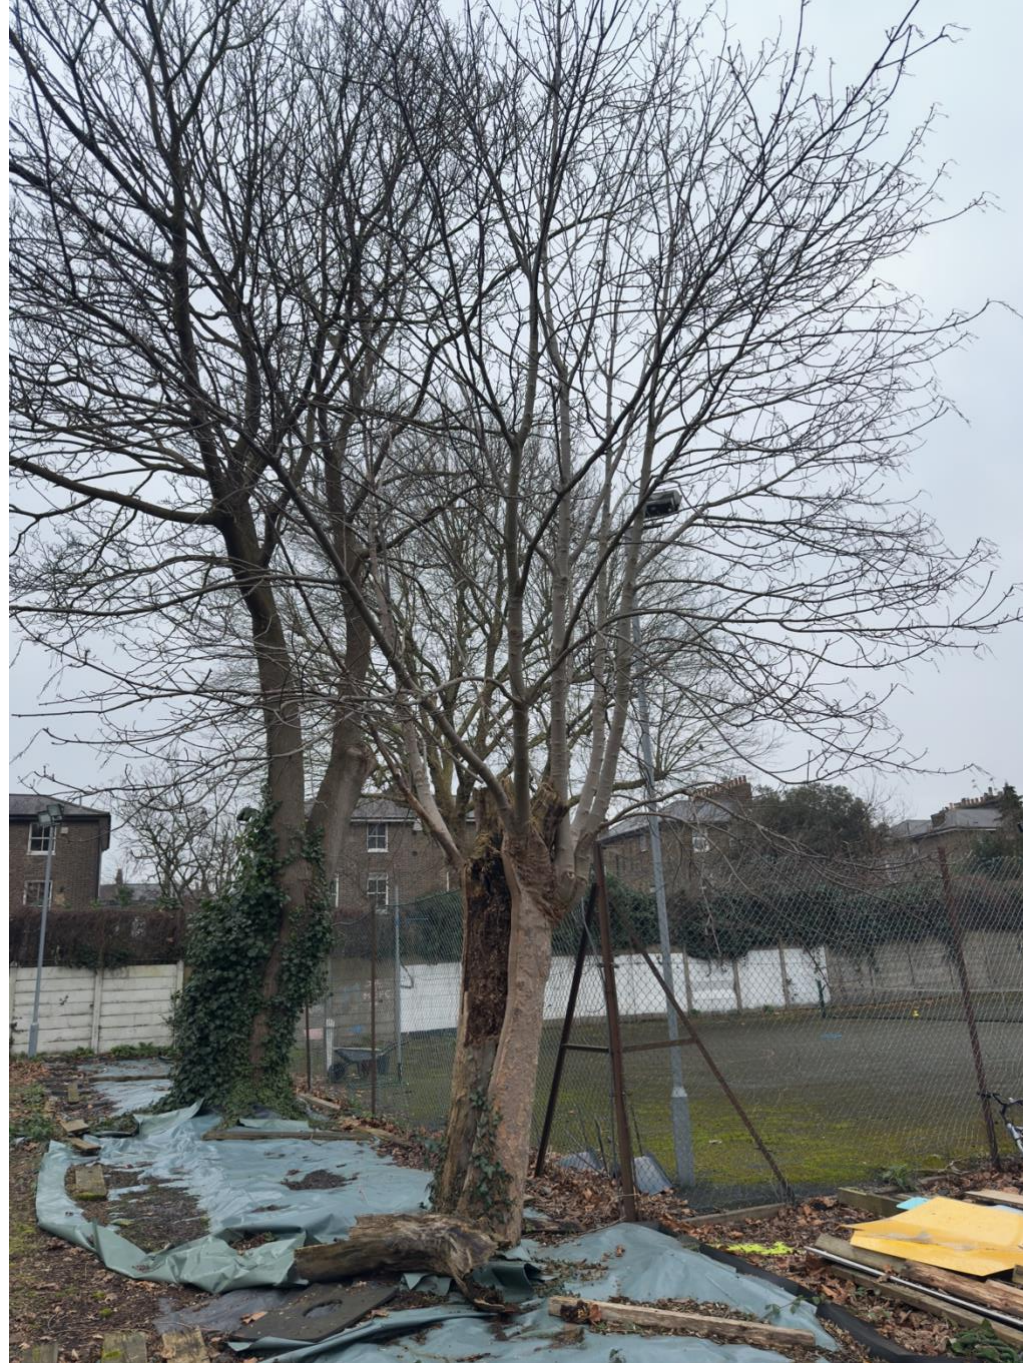
| T21 | Sycamore | N/A | young | 6m | 4m | Very rotten | Fell to ground level. | Next to pathway |
