**Tree condition report**  
**Southbank International**  
16 Netherhall Gardens  
London NW3 5TH

Report date: 01 11 2024  
Revised: 25 11 24  
Report reference: TCR 7784  
© The Tree Bureau 2024

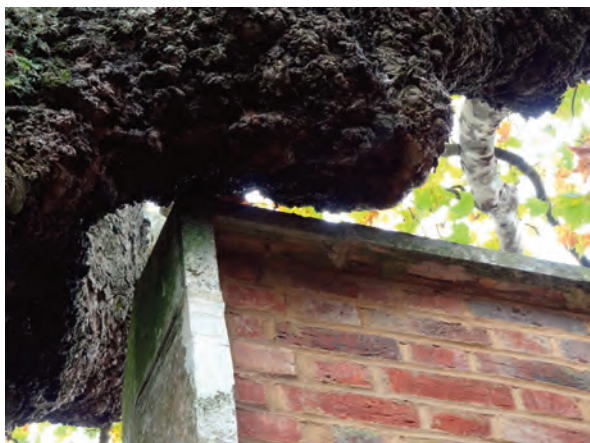
### Branch of London plane T4 and pedestrian gateway

- 2.1 Previous discussion and reports have raised the issue of the relationship between a large branch of the London plane T4 and the brick and concrete top of the pedestrian gateway from Nutley Terrace.

- 2.2 As previously explained, the large 'scaffold' branch of the London plane T4 gets slightly fatter each year and it is now almost touching the top of the gateway. If nothing is done, the branch will soon exert pressure on the gateway structure with a risk of damage and falling masonry.

- 2.3 My report of 2023 included specific concern and advised the school/landlords to start work towards a (conservation area) planning application to reduce the height of the gateway.

- 2.4 Action must now be taken to gain permission to reduce the height of the gateway and for suitable precautionary, preventive and protective measures to be taken during construction work to avoid damage to the tree. These measures need to be drawn up by an arboriculturist, and I recommend that an arboricultural method statement be submitted as part of the planning application.

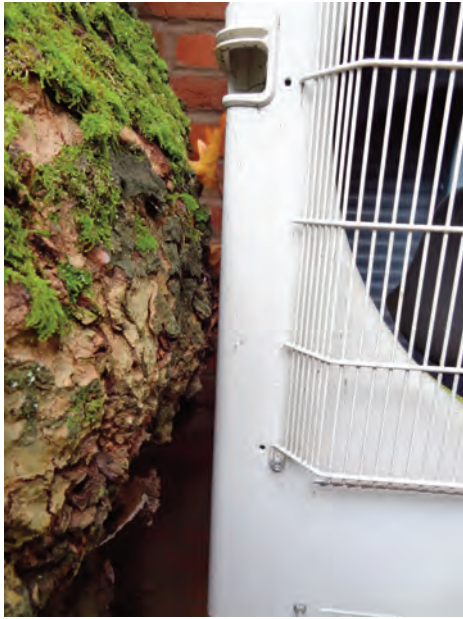
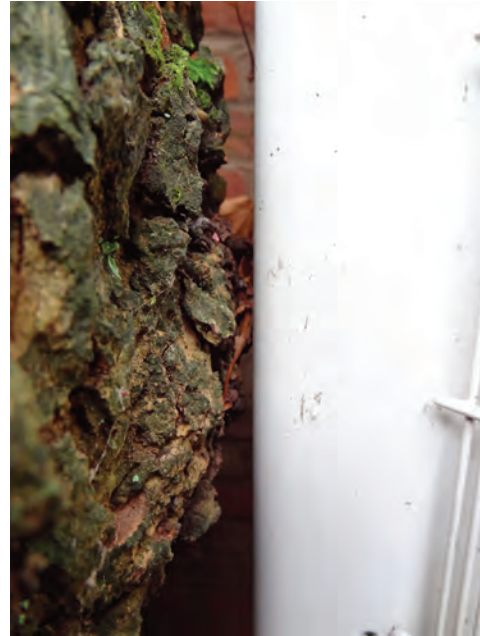
### Air-pump adjacent to the London plane T4

- 2.5 The trunk of the air-pump, or other metal installation, on the wall adjacent to the London plane T4 is growing increasingly close to the metal structure. It would be prudent to find an alternative location for the pump before the trunk gets any closer.

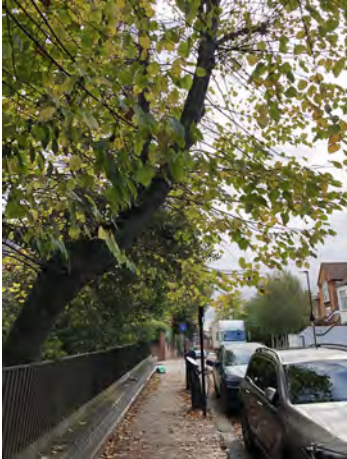
Tree ident on plan	Species and dimensions where needed	Condition and observations	Preliminary management recommendations	Reason	Priority/timescale
T12	<i>Tilia x europaea</i> common lime	<p>Crown satisfactory but tree starting to grow low over the footway and growing into the boundary fence.</p>

<p>Lift over the footway and highway to provide about 2.4m vertical clearance from ground level.</p> <p>Adapt the adjacent fence so that the tree does not 'engulf' it, leading to tree structural problems.</p>

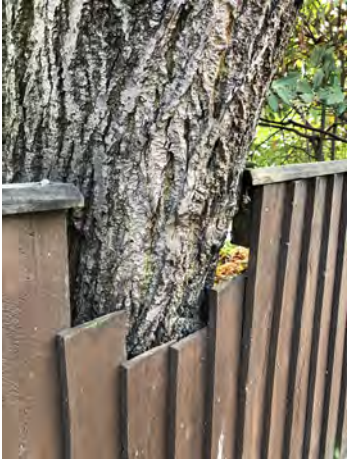
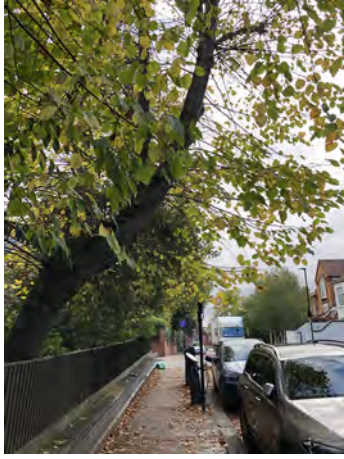
<p>To prevent injury, damage and nuisance.</p> <p>To prevent long-term structural problems.</p>	<p>Winter 2024-25.</p> <p>As soon as possible.</p>
T13	<i>Tilia x europaea</i> common lime	<p>Lowest S and SE branches starting to suppress the beech T14a.</p> <p>Tree touching part of the boundary fence.</p>

<p>Cut back lowest the lowest S and SE branches by about 1.5m from branch tips.</p> <p>Cut back the adjacent fence so that the tree does not 'engulf' it.</p>

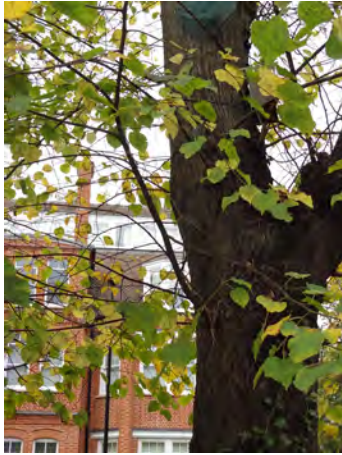
Tree ident on plan	Species and dimensions where needed	Condition and observations	Preliminary management recommendations	Reason	Priority/ timescale
T14	<i>Tilia x europaea</i> common lime	Satisfactory but helping to suppress the beech T14a.	Remove lowest SSW front branch. to prevent suppression of the beech.

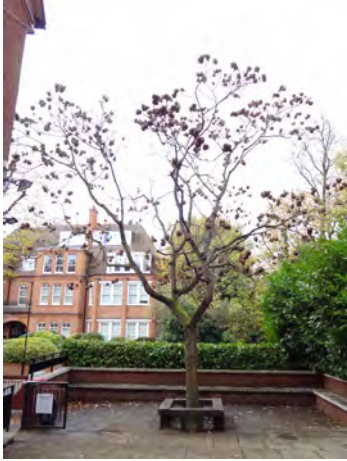
To reduce beech tree suppression.	Winter 2024-25.
T15	<i>Ailanthus altissima</i> tree of heaven	Sparse crown. Some branches becoming vulnerable to wind/ precipitation damage.

Selectively reduce the crown by about 1-1.5m from branch tips. to reduce leverage on long branches (up to 5m long) and remove dead wood.	To reduce leverage on exposed or long branches (up to 5m long).	Winter 2024-25.
T16	<i>Aesculus hippocastanum</i> horse chestnut	No access to trunk base. Heavy growth of ivy into upper crown. See also Section 3 of this report.
