Arboricultural Impact Assessment BS5837:2012

16 Lyndhurst Gardens, London, NW3 5NR

Apex Environmental Ltd

Ref: AEL-18129-AIA

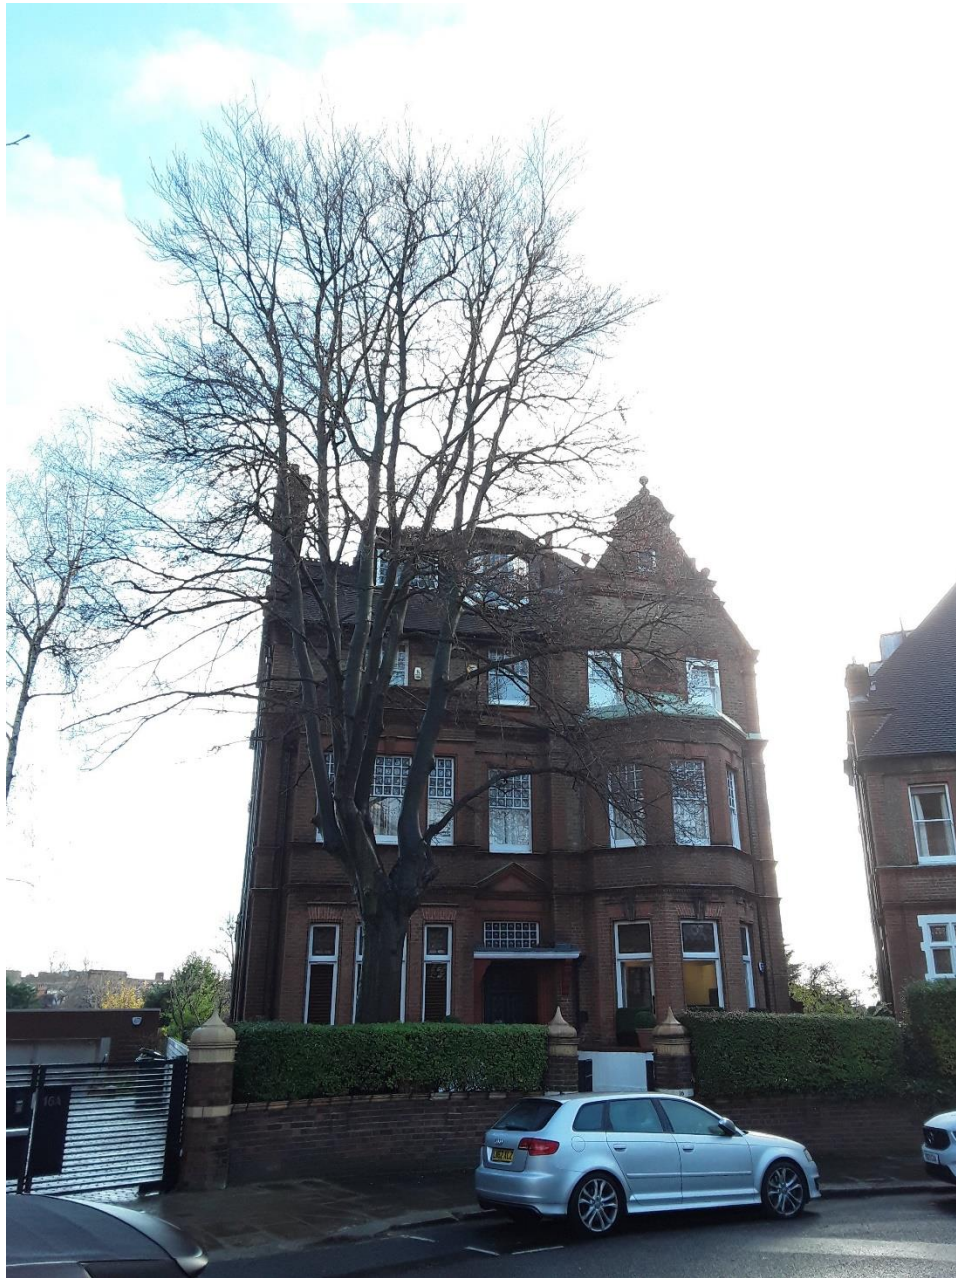
8.8 T.1 – Beech – This is a large mature tree in the front garden of 16. The tree is in good overall condition. The tree is growing within a raised planter which is showing signs of cracking. There are also some cracks to the front boundary wall in the same area. It is possible that this is due to pressure from tree roots. The nearby land is of hardstanding and there are some signs of cracking to the steps, which again could be from tree root damage (although no paving was lifted), and the hardstanding looked to established and it was seen that the tree had limited sources to moisture. The tree was free from fungus or defects in the lower stem. The tree looks to have been historically pollard at 4m. This has then been allowed to continue to grow to full height maturity. The has created a large dense canopy and there are signs of historical works to prune back the canopy (a separate search with London Borough of Camden, confirmed approval for the pruning back, thinning and crown lifting of this tree). This operation should be carried out again as the canopy is significantly shading the property (although this is not part of this application). This tree has been assessed as [Category B1](#)

AEL-18129-PIC1 – Showing T.1 in front garden

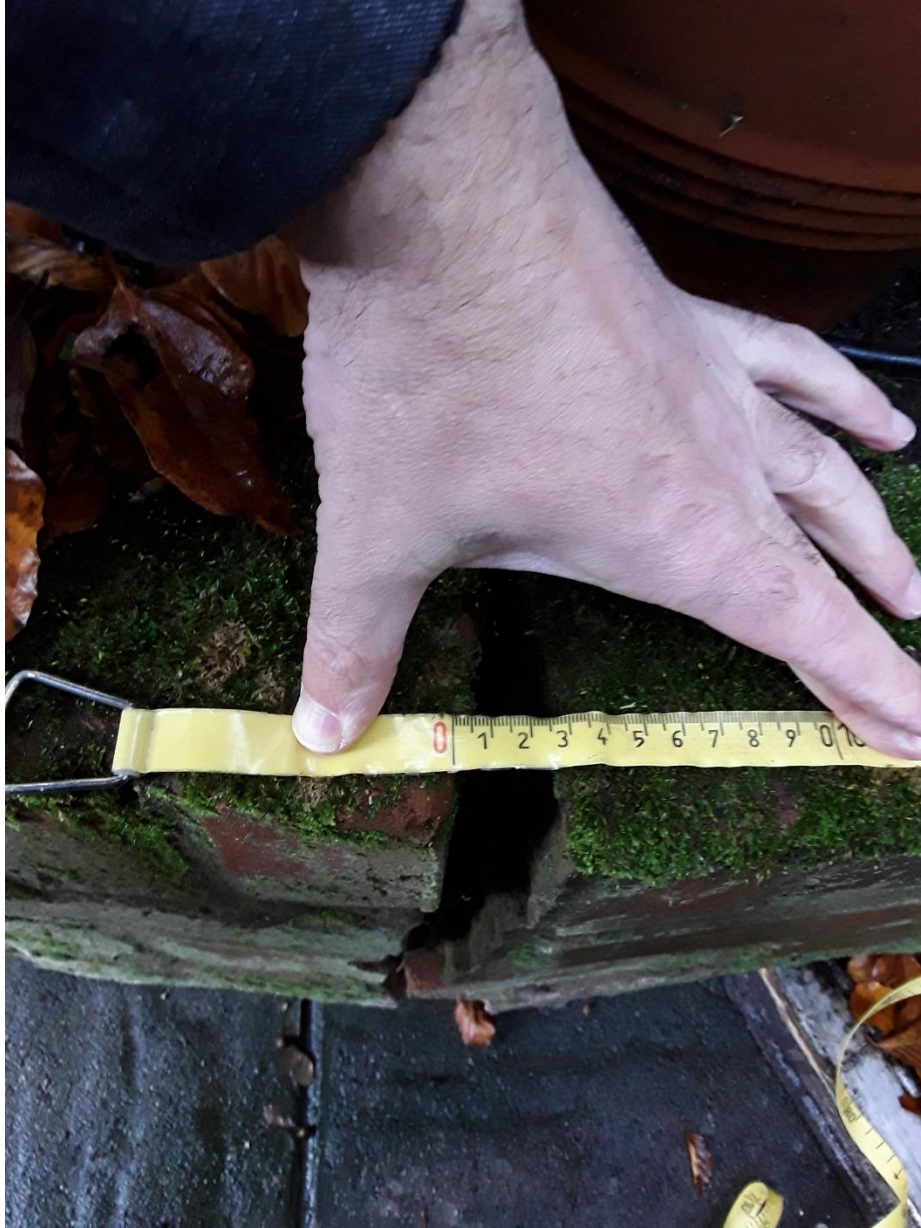
AEL-18129-PIC3 – Showing more significant crack in wall that will require repairing.

The brickwork is to be removed and replaced to remove any cracks to the concrete. The area will also include the removal of the existing storage building and the installation of a new bike storage area. The wall of the storage will be pulled back slightly from the current damaged wall. This will allow for a new reinforced wall to be installed outside of the current damaged wall. This will also allow for a new more substantial foundation and wall to be included to stop future damage from occurring.

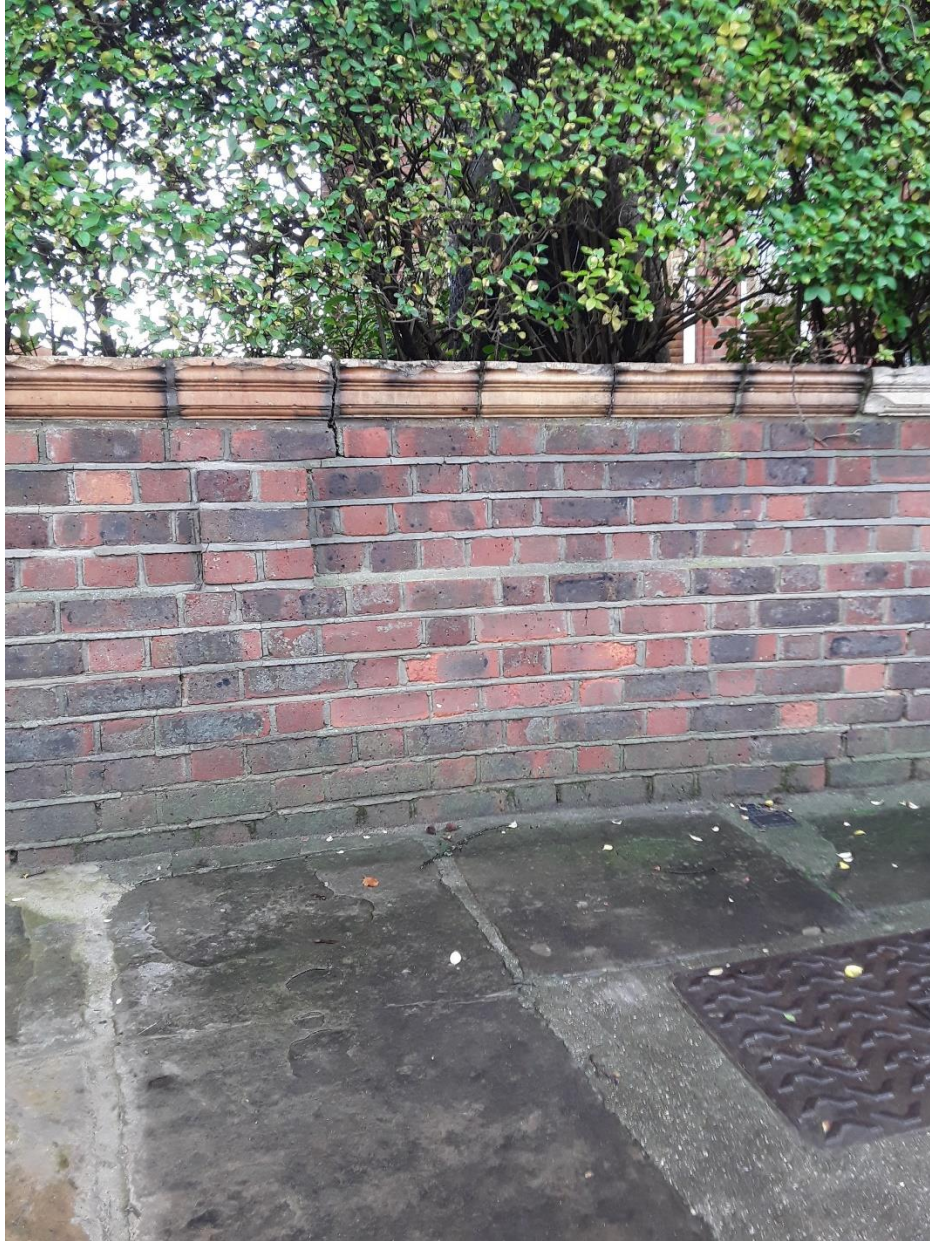
AEL-18129-PIC4 – Showing front boundary wall with crack that will require repair.
