six heritage

HERITAGE AND CONDITION INVESTIGATION

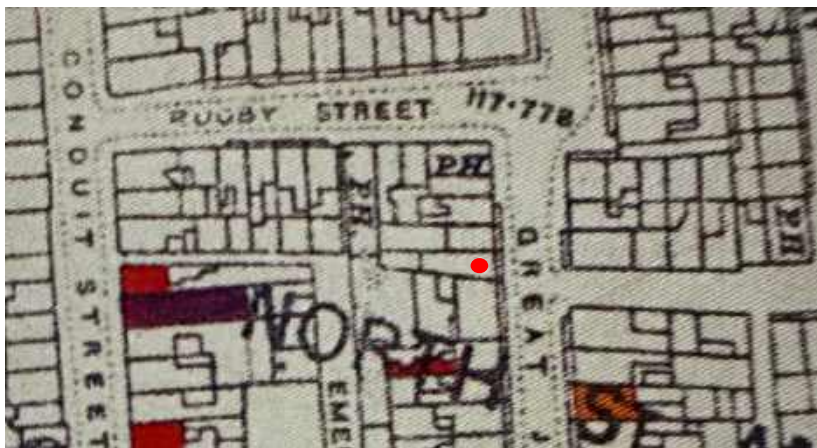
RPT-Figure-1: 22 Great James Street (red dot) was not reported to have suffered any damage during the Second World War.

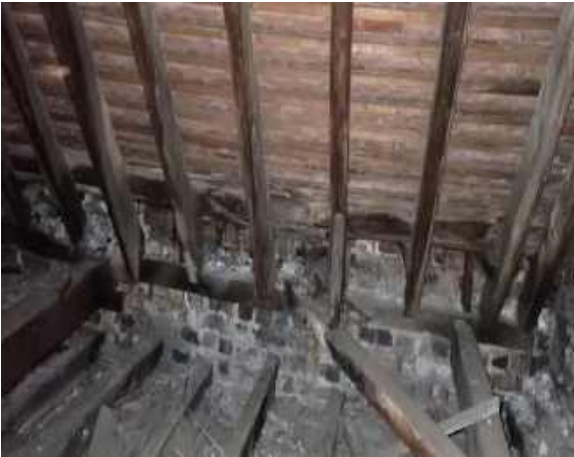
RPT-Figure-6: View of western parapet wall

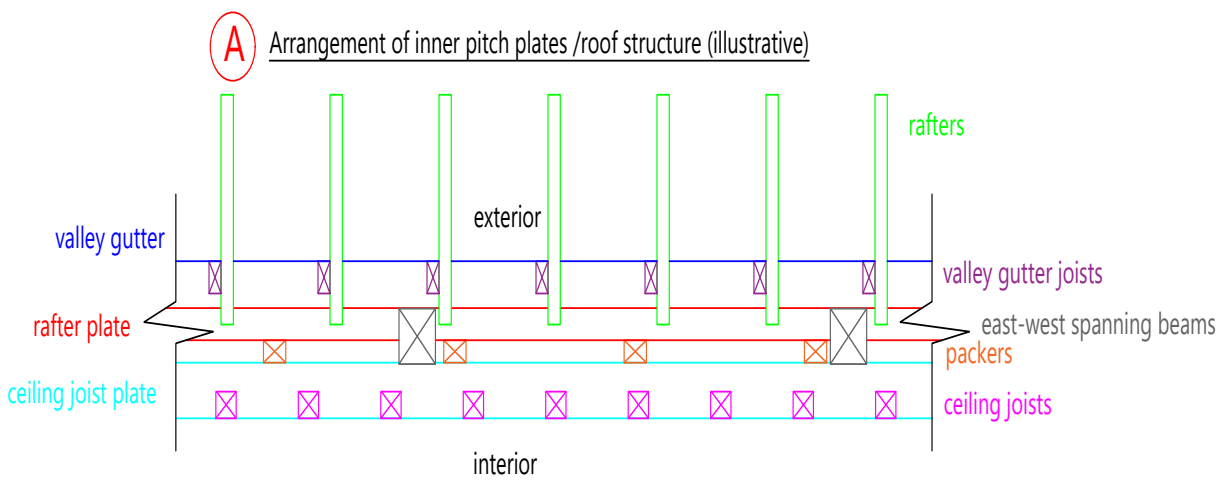
RPT-Figure-11: Illustration of structural arrangement to central pitches. See Drawings in Appendix II for more detail

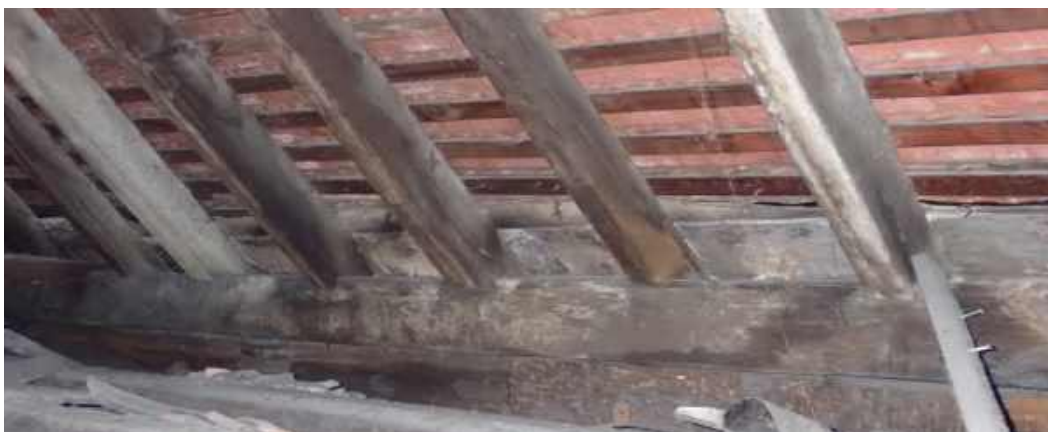
RPT-Figure-12: View of structural arrangement at southern, hipped pitches

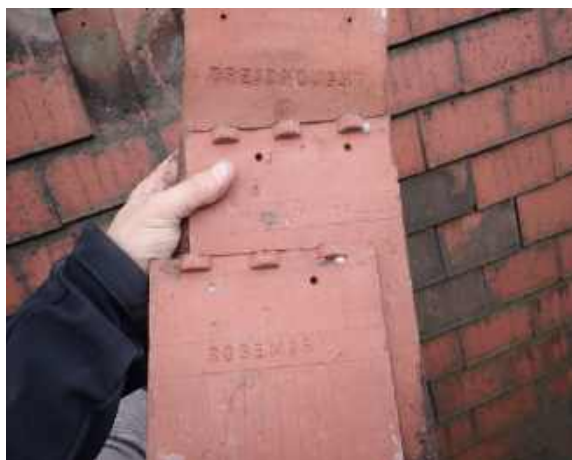
RPT-Figure-15: Several makers stamps/tile types were noted to be used over roof structure

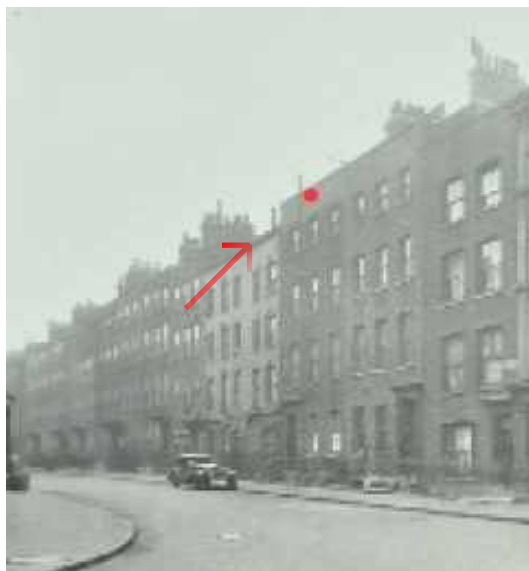
RPT-Figure-21: 1946 photograph extracted from Historic Context report supplied to SH showing 22 originally higher than 23-24 to the south

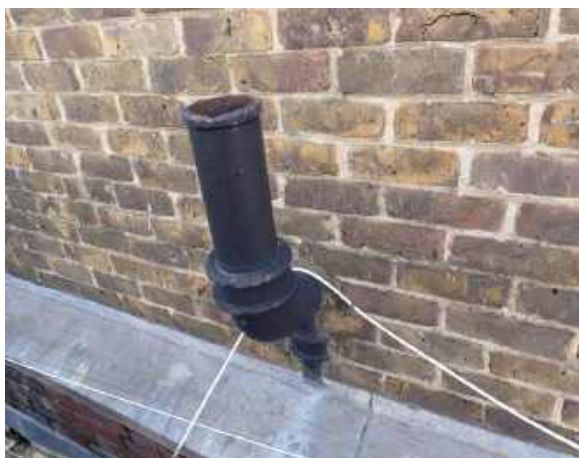
RPT-Figure-22: Soil pipe to the south had been encapsulated in masonry

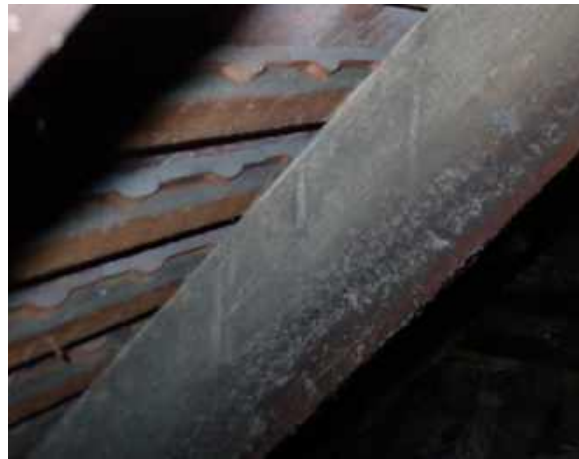
RPT-Figure-25: Bracker's marks were worn in some areas though still visible

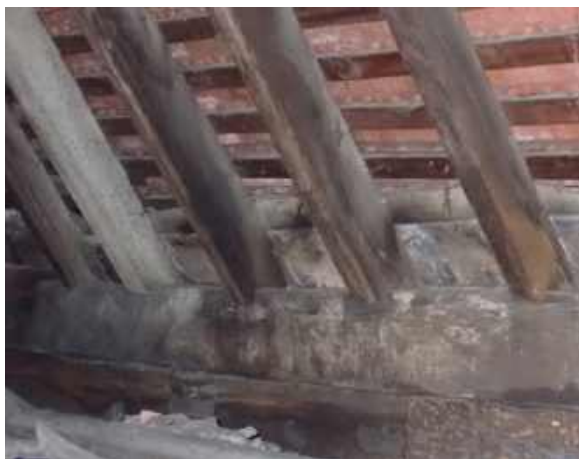
RPT-Figure-26: Birds mouth jointing noted to majority of rafter feet

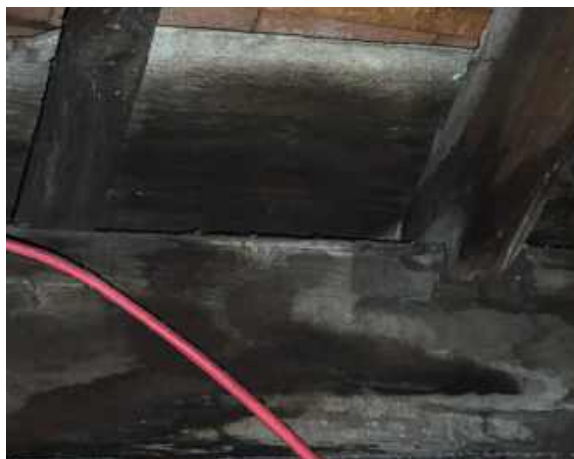
RPT-Figure-27: Differing jointing methods noted in localised instances

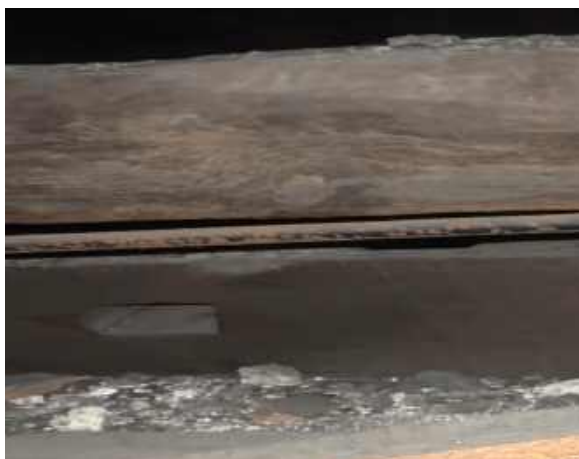
RPT-Figure-28: Different generations of timber were noted within roof voids

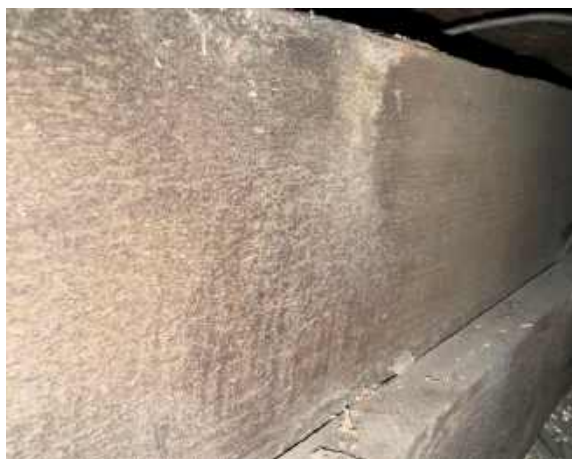
RPT-Figure-29: Saw marks were visible to accessible timber elements at time of survey

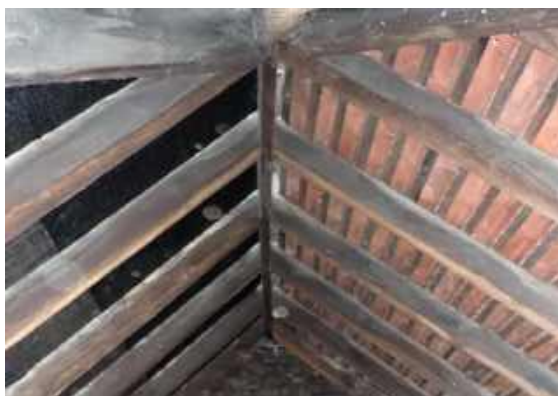
RPT-Figure-30: Timber elements comprising rafters and ridge beam had a fairly uniform colour/hue

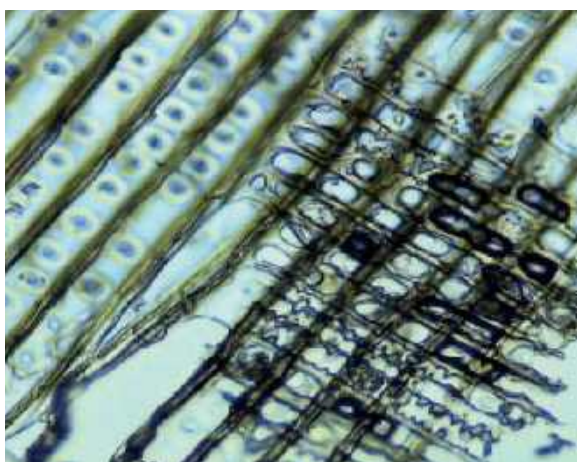
RPT-Figure-31: Samples were identified as *Pinus sylvestris* upon microscopical examination

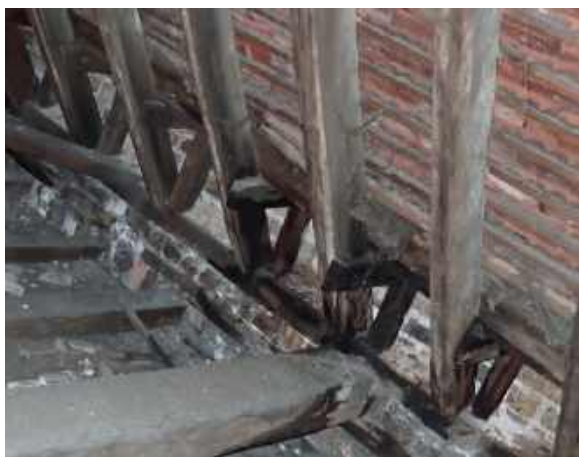
RPT-Figure-33: Clear damp staining was visible to timber elements to the east

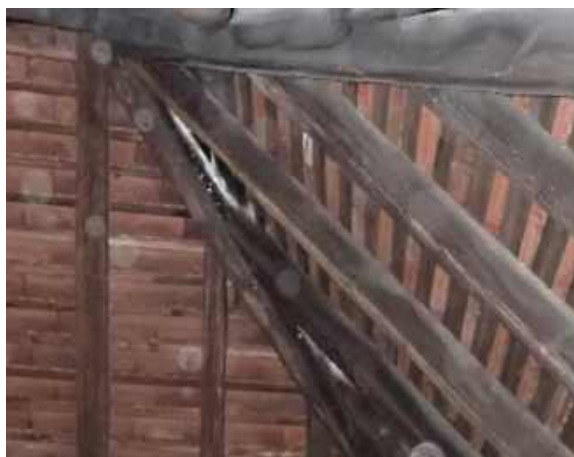
RPT-Figure-34: Wet rot was noted at high level to the east due to external defect

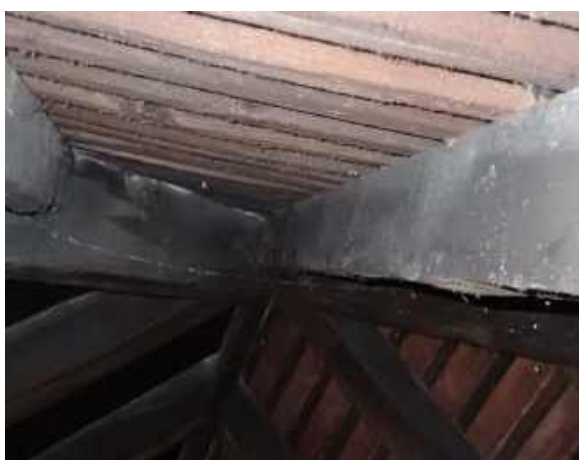
RPT-Figure-35: Interstitial condensation was noted to several timber elements comprising the roof structures in both voids

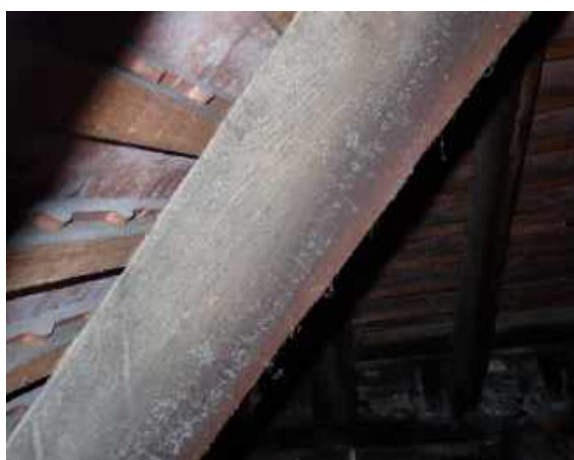
RPT-Figure-36: Interstitial condensation was noted to several timber elements comprising the roof structures in both voids

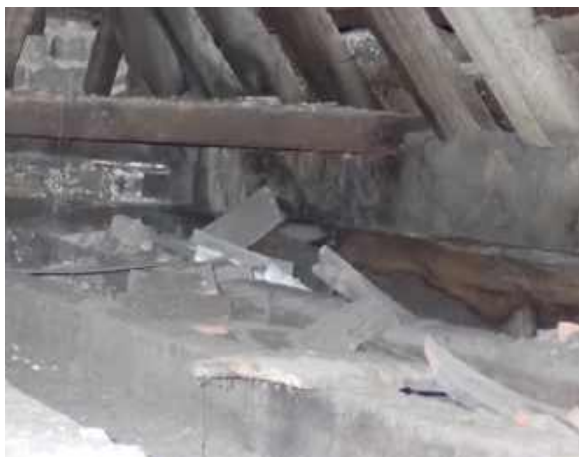
RPT-Figure-37: Debris was noted to the topside of ceiling finishes in both voids

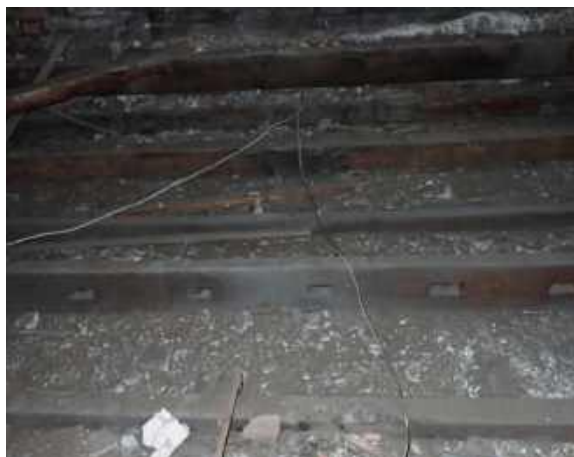
RPT-Figure-38: Debris was noted to the topside of ceiling finishes in both voids

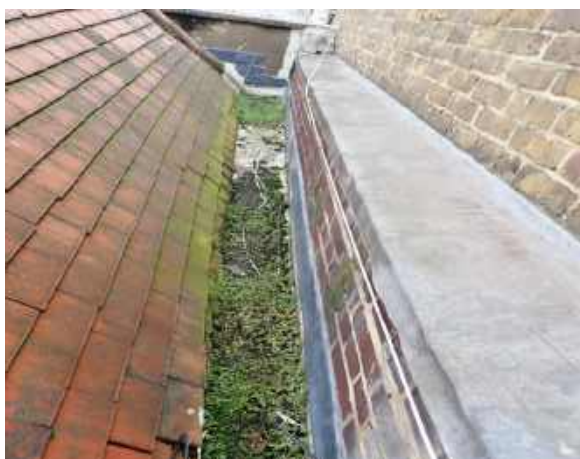
RPT-Figure-39: Rainwater drainage channels were blocked by debris in several areas

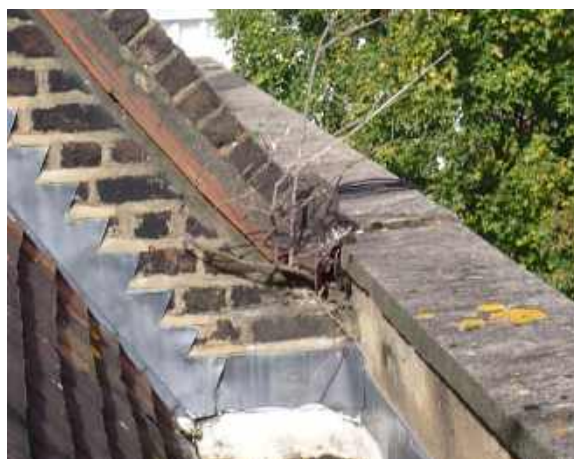
RPT-Figure-40: Rooted plant growth was noted within masonry and through gutter linings

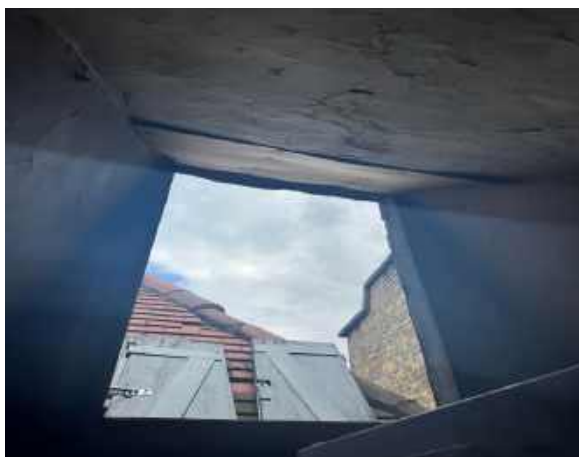
RPT-Figure-41: Failure of the roof access hatch doors left interiors vulnerable to water penetration

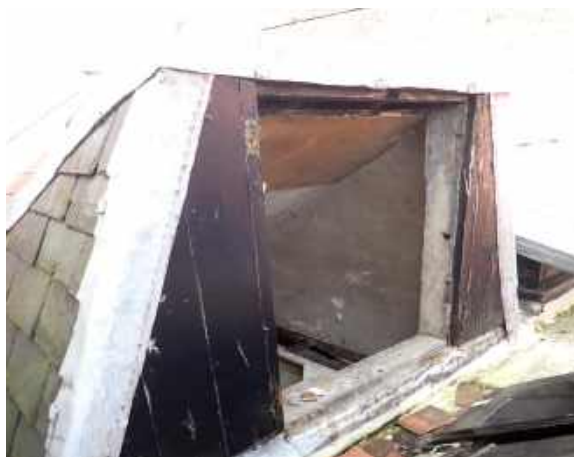
RPT-Figure-42: Roof access hatch doors had completely detached by the time of survey

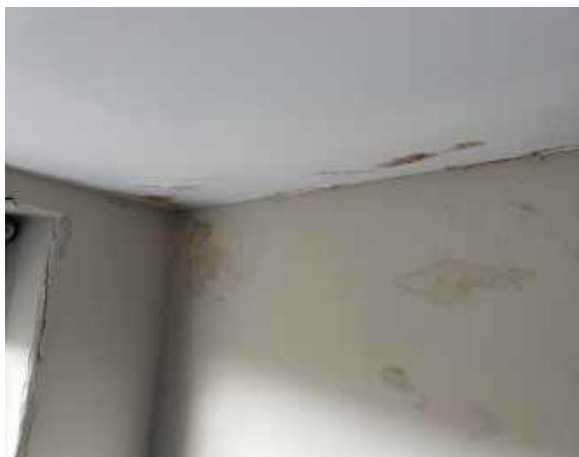
RPT-Figure-43: Damp affected ceiling finishes were noted beneath both roof voids

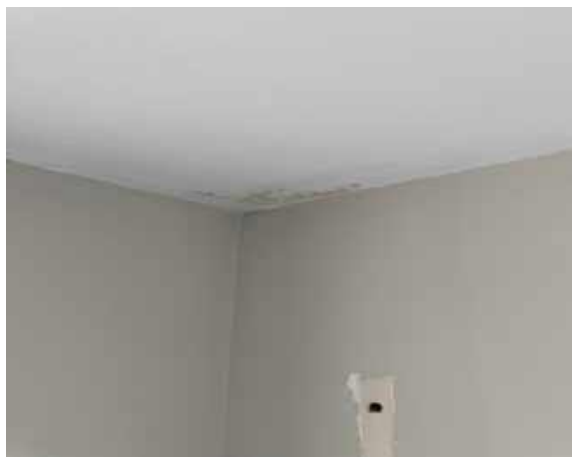
RPT-Figure-44: Damp affected ceiling finishes were noted beneath both roof voids

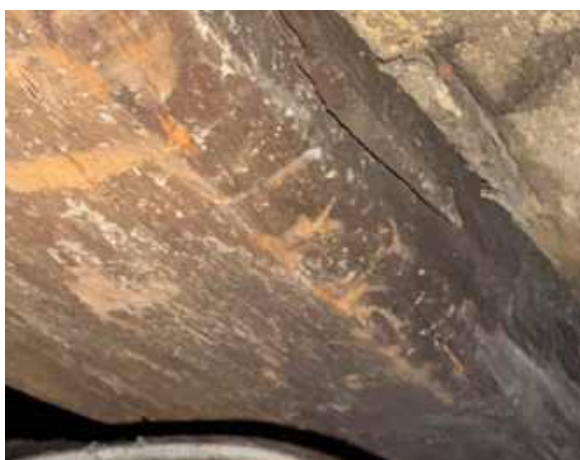
RPT-Figure-45: Evidence of historical and potentially active wood boring beetle was noted

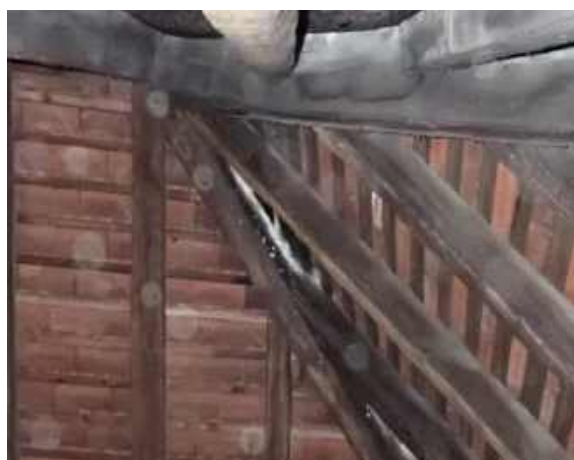
RPT-Figure-46: Wet rot was affecting timber elements in localised instances

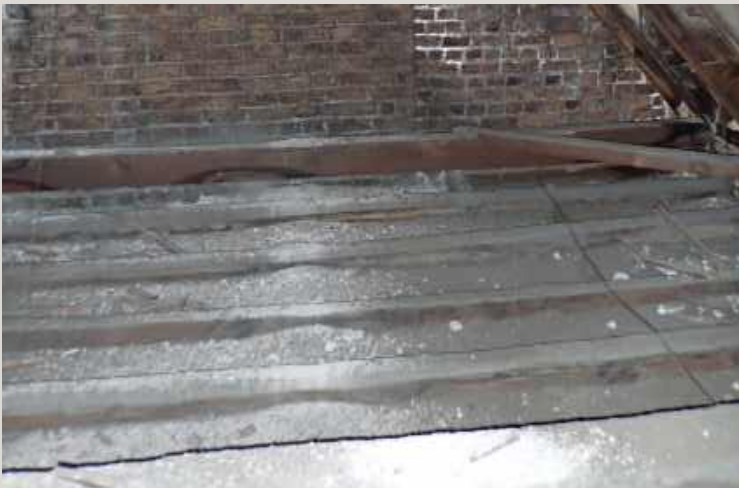
14 / Showing a series of ceiling joists within the east roof void that displayed surface conditions such as areas of cleaving and possibly hewing that suggested they were likely from an earlier phase of construction than other structural elements, such as some of the common rafters

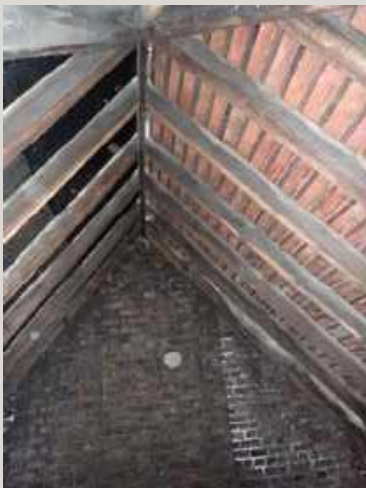
15 / Showing a general view of the structural arrangement of timbers forming the apex of the east roof structure

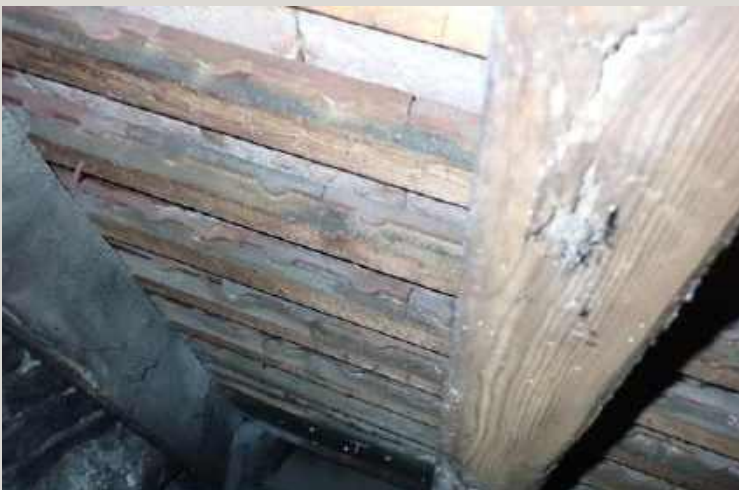
20 / Showing the underside of a common rafter. Note that this was untreated and the surface condition suggested that it was possibly from a later phase of construction/ refurbishment

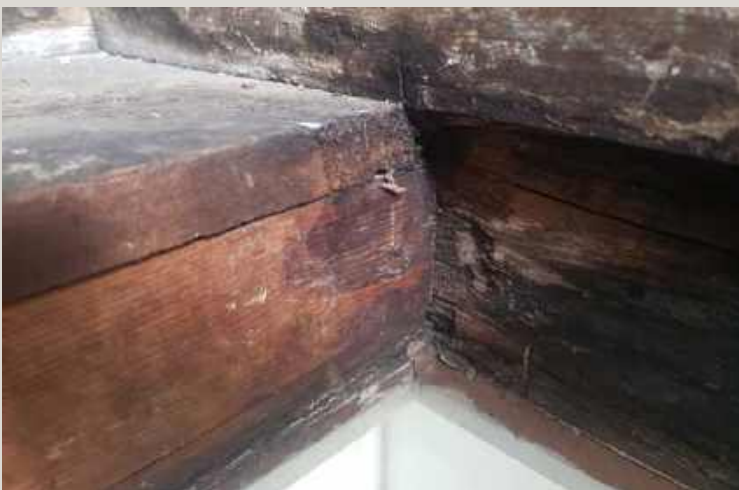
21 / Showing a bearing end of a trimmer joist forming the access hatch to the external roof area. Note the trimmer joist had been secured using wire nails, which were not developed until approximately the mid to late 19th century

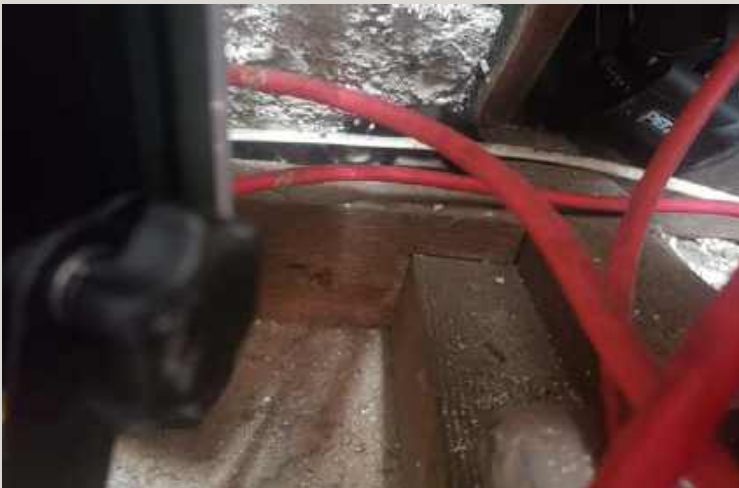
23 / Showing the lap-jointed bearing end of a joist within the roof hatch area. This joint had been secured using wire nails and the surface condition of the timber suggested a later provenance. These had likely been installed at a later date to support the water tank

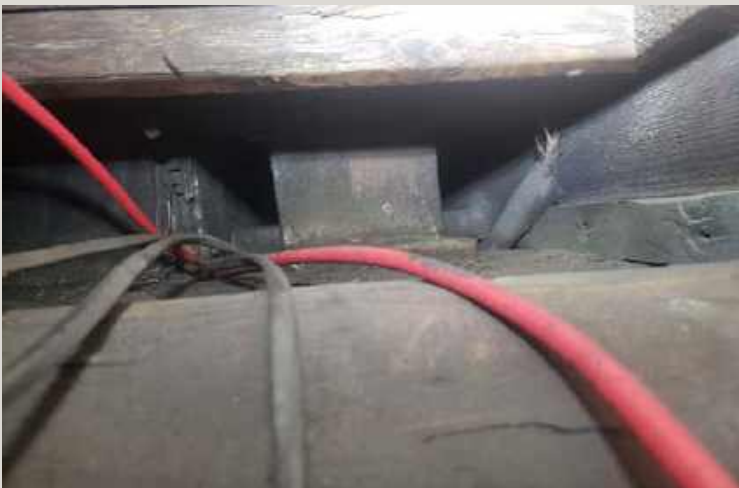
24 / Showing a general view within the void between roof structures, looking north. Note the presence of a later beam (visible on the right) that featured mechanical conversion marks suggesting significant works were undertaken after initial construction, likely to install the lantern

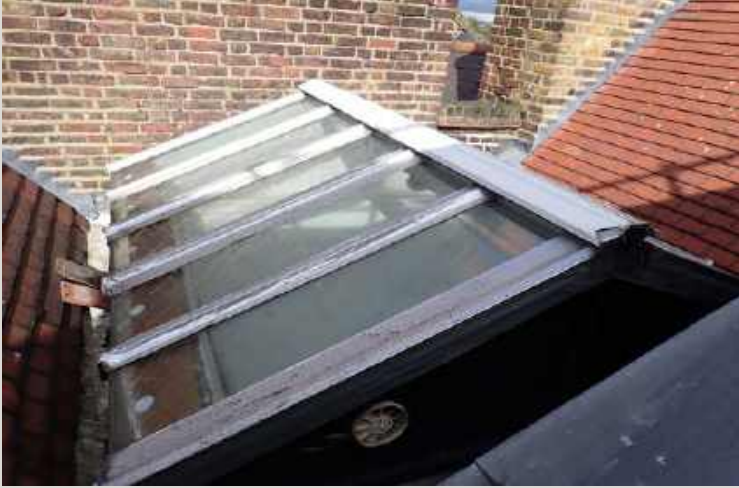
CONDITION SURVEY - LOCATION (EXT)

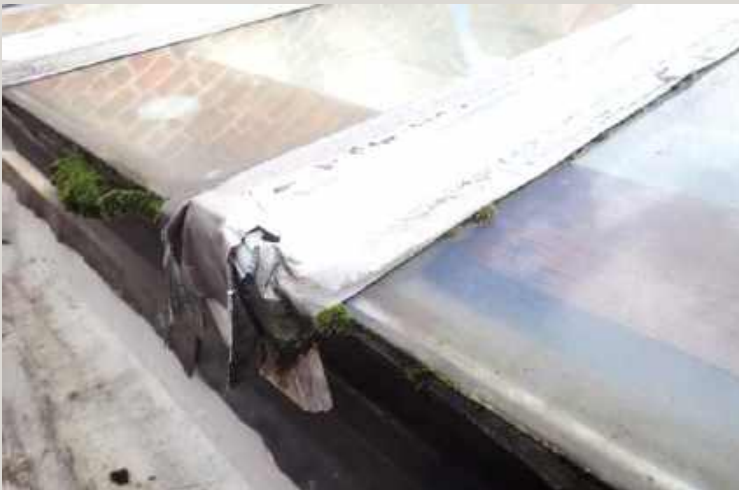
29 / Showing inadequate repair to lantern structure leaving it vulnerable to water penetration. Note localised biological growth to topside of lantern, indicative of chronic damp conditions

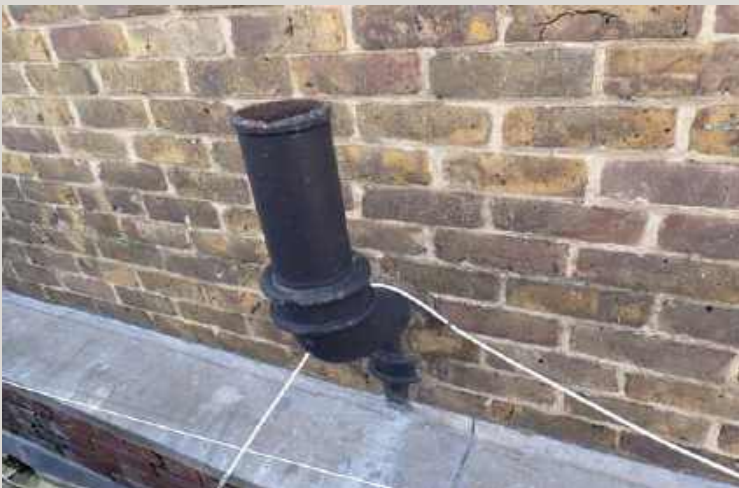
30 / Showing soil pipe to the south entirely embedded in party wall. Note, this may have compromised effectiveness of pipe and prevented access for inspection

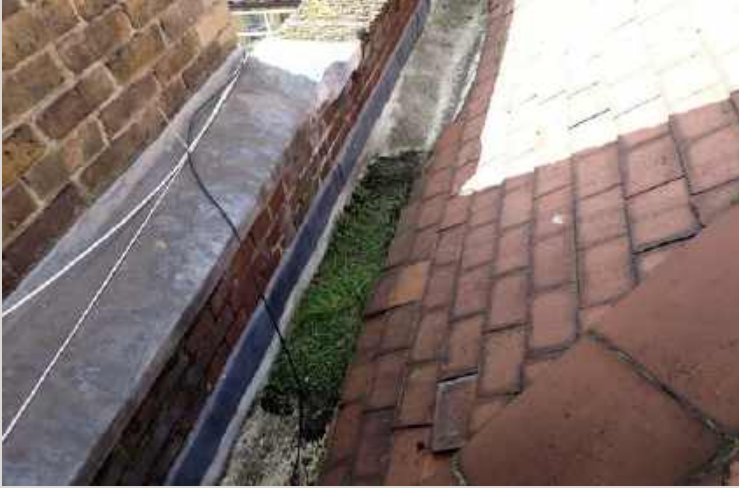
CONDITION SURVEY - LOCATION (EXT)

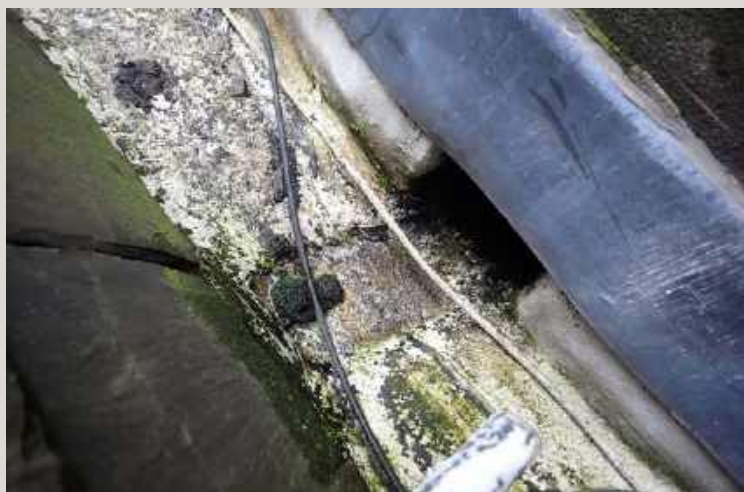
CONDITION SURVEY - LOCATION (EXT)

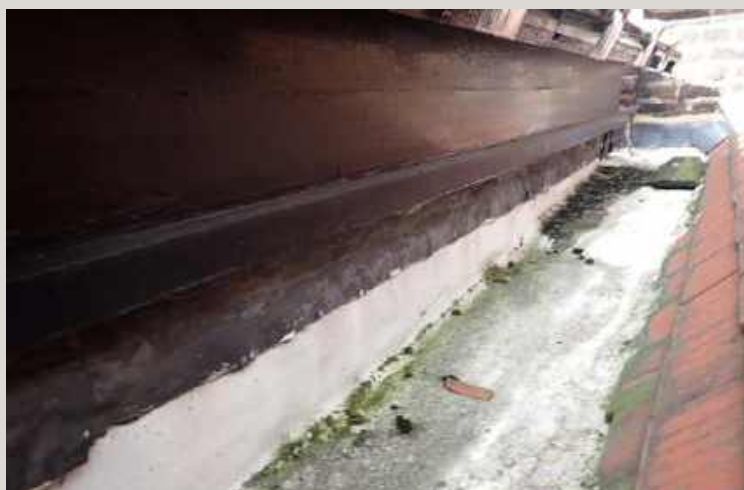
36 / Showing localised biological growth to valley gutter, indicative of chronic damp conditions

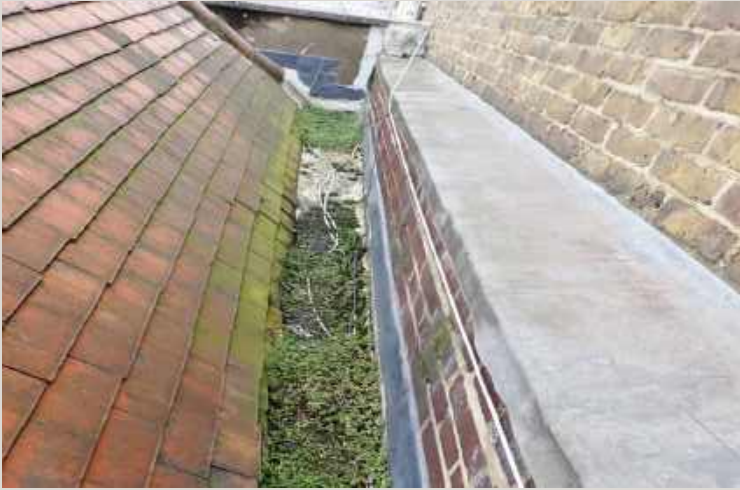
CONDITION SURVEY - LOCATION (EXT)

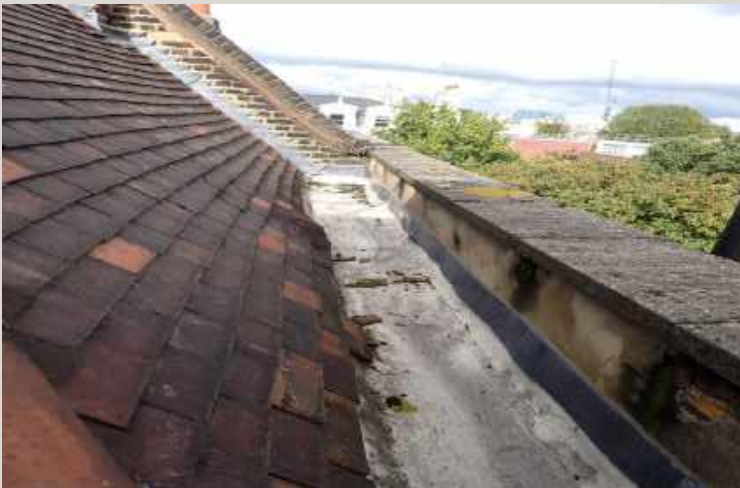
38 / Showing generally clear parapet gutter to the east, though localised cracks/ failure in gutter lining were noted

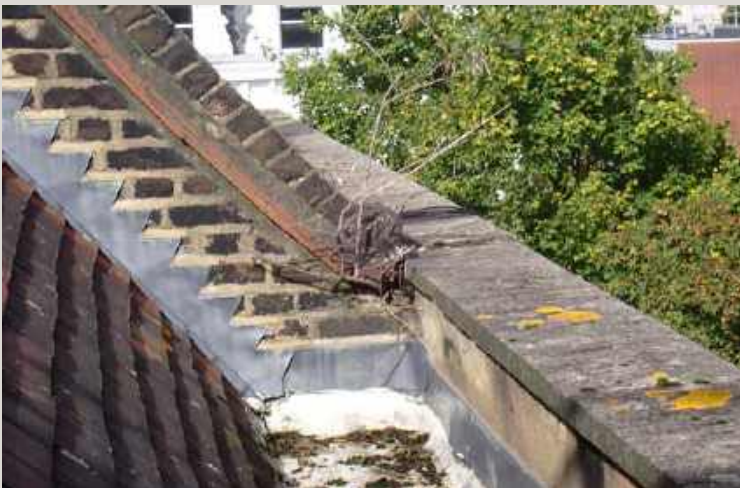
39 / Showing rooted plant growth to the north-east of the roof-scape, indicative of chronic damp conditions

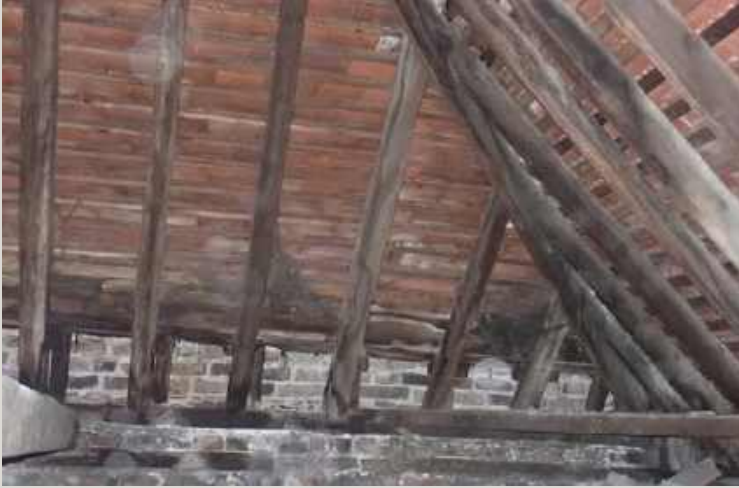
CONDITION SURVEY - EAST PITCH

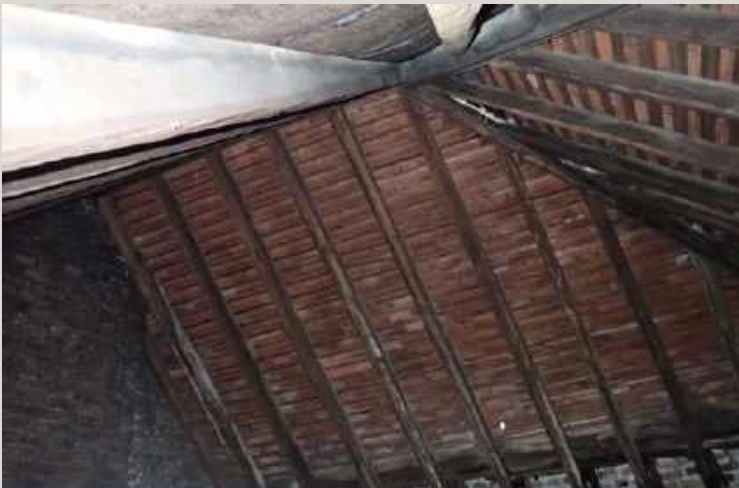
41 / Showing localised wet rot decay to high level rafter to the southern pitch

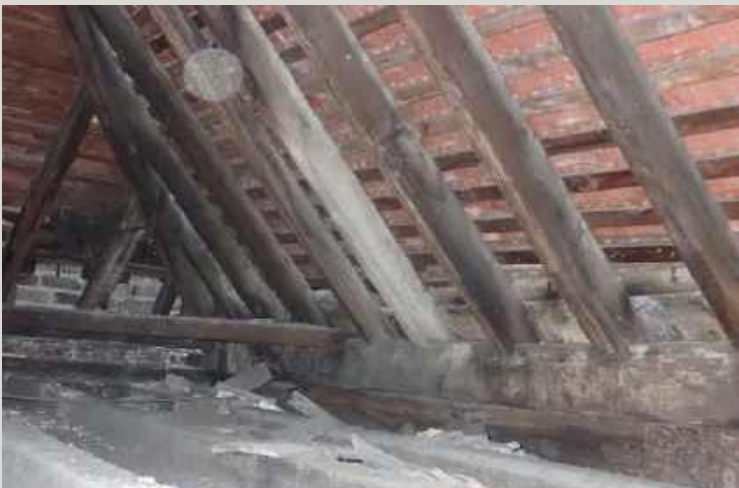
42 / Showing debris present within roof void to the topside of the ceiling finish

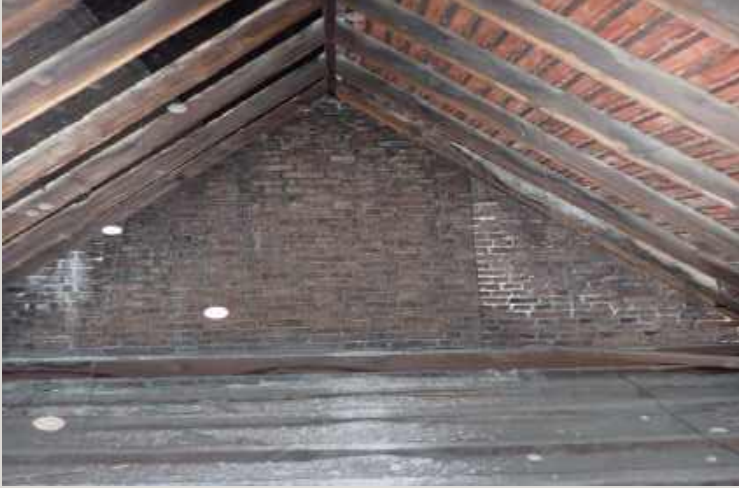
CONDITION SURVEY - EAST PITCH

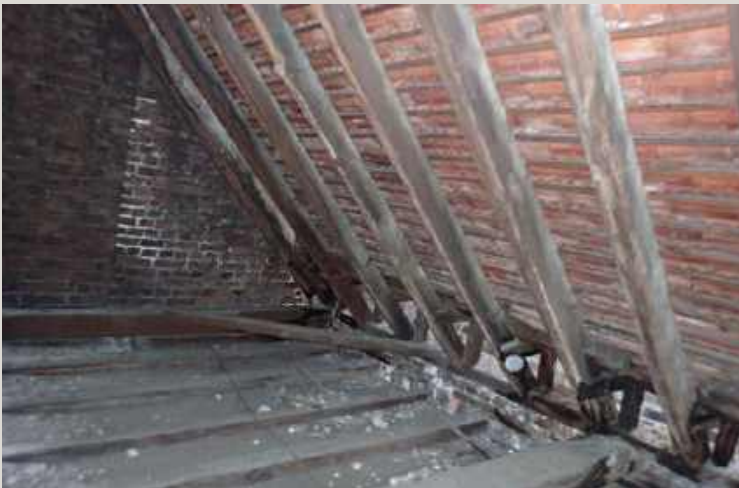
44 / Showing widespread damp staining to rafter feet, rafter plate and parapet gutter joists to the east

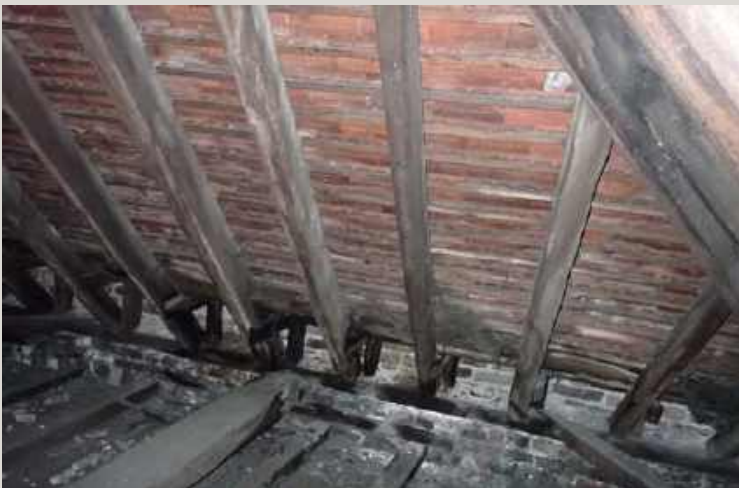
45 / Showing widespread damp staining to rafter feet, rafter plate and parapet gutter joists to the east

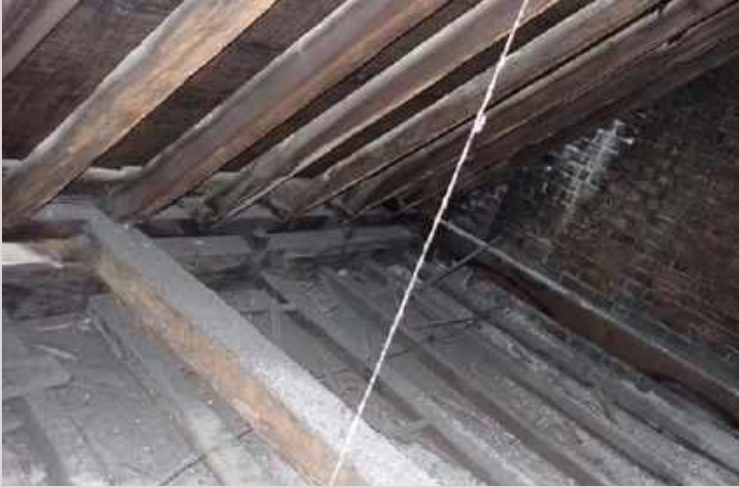
CONDITION SURVEY - EAST PITCH

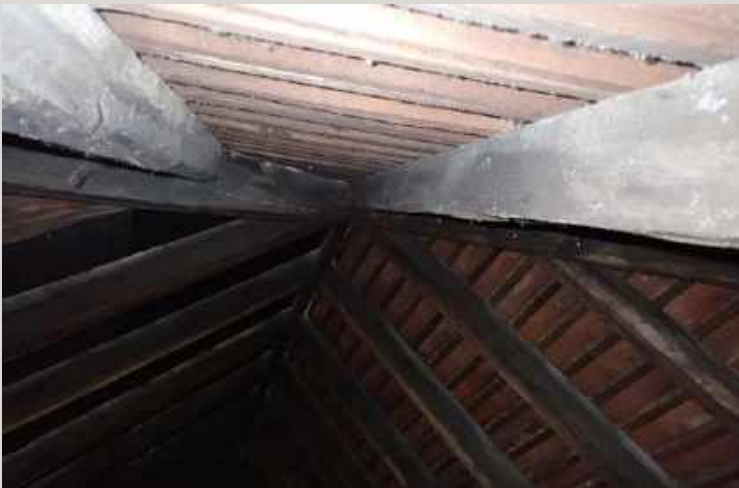
47 / Showing general view looking up at rafters, note underlay only present to west pitch of eastern roof structure

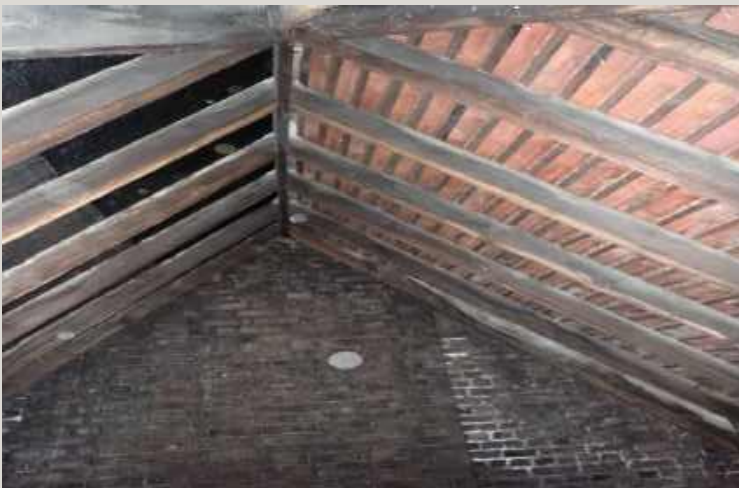
48 / Showing general view towards ridge, note rafters in reasonable condition upon visual inspection

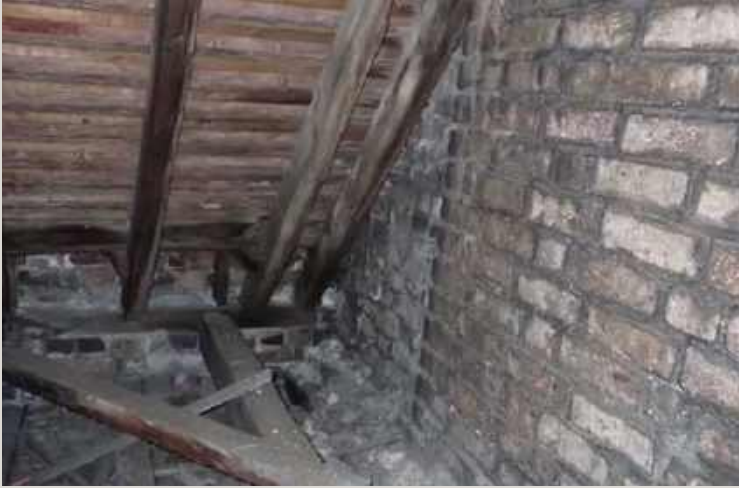
CONDITION SURVEY - WEST PITCH

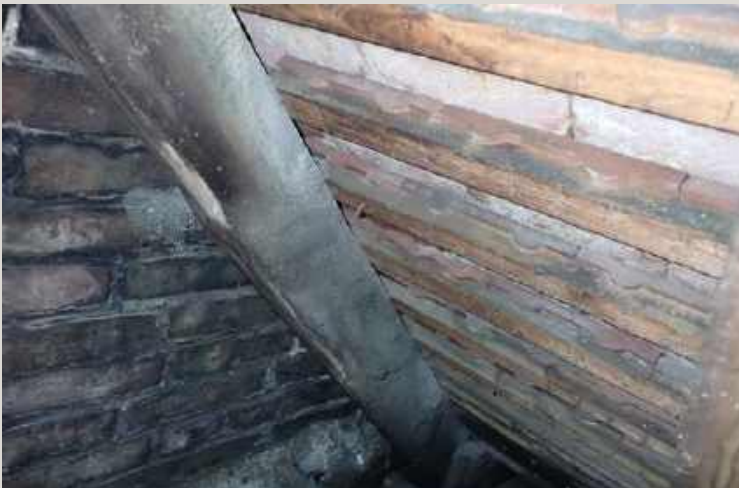
50 / Showing no underlay present to inner pitch of roof void as was the case to the east

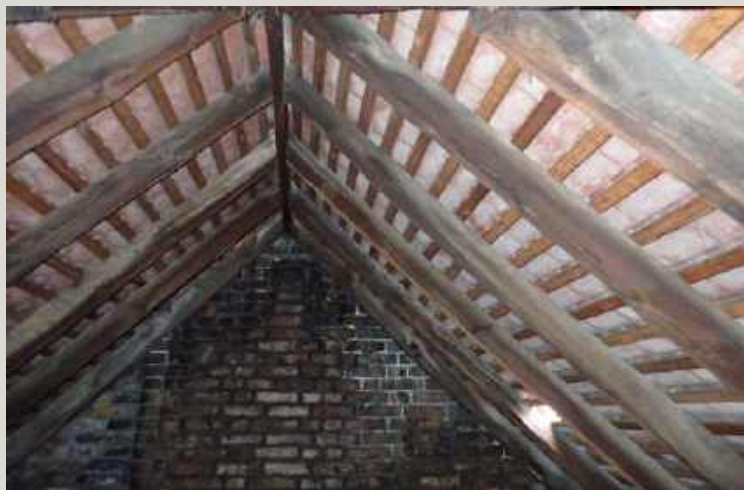
CONDITION SURVEY - WEST PITCH

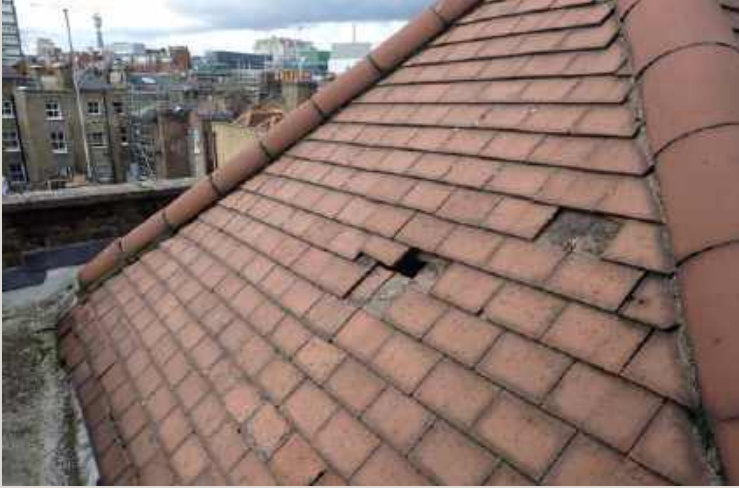
CONDITION SURVEY - TILE ACCESS

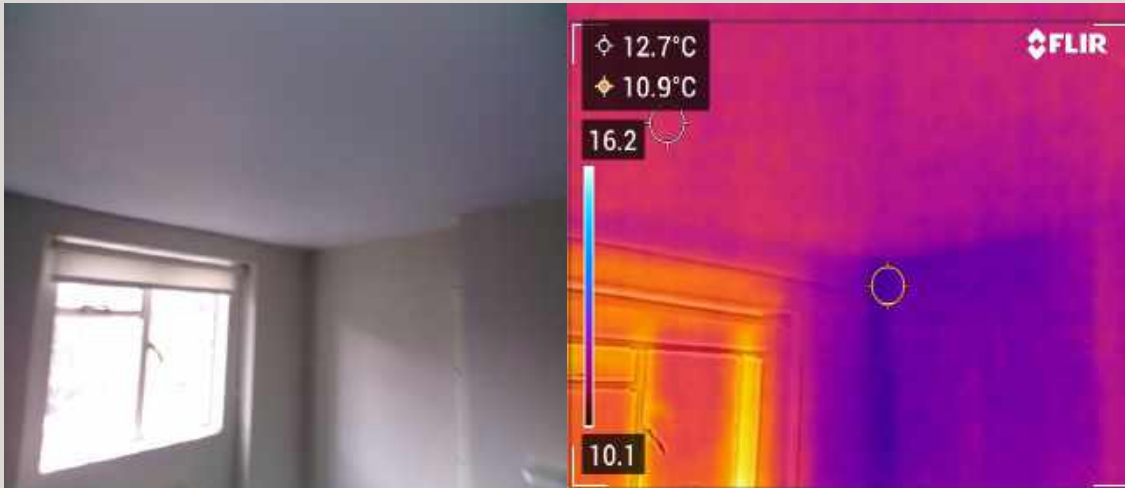
FIG: 57 / Showing both real-light and thermographic image taken from the south-east top-floor for comparative/contextual purposes. Note colder surface temperature was detected towards to high level masonry/interior finishes, indicative of damp conditions

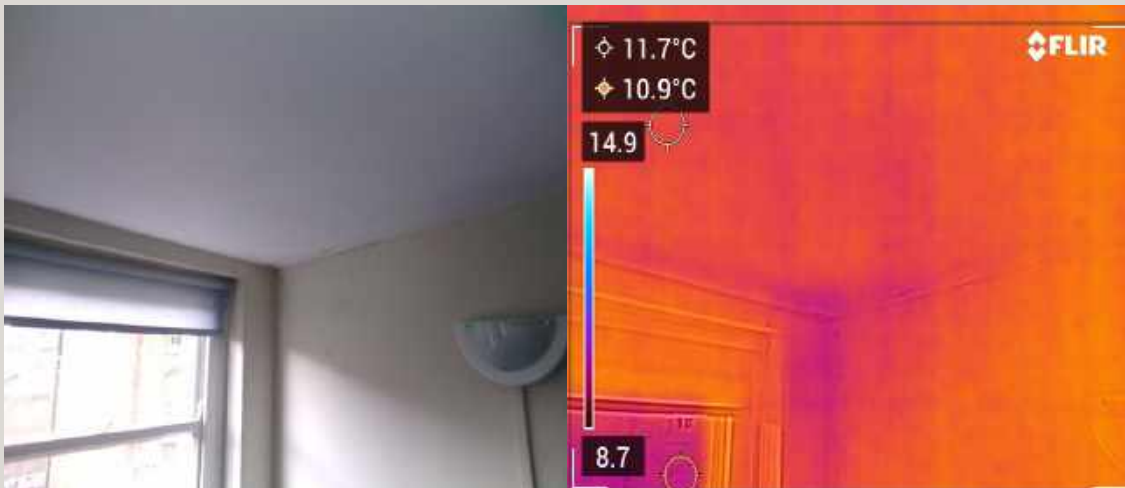
FIG: 58 / Showing both real-light and thermographic image taken from the south-west top-floor for comparative/contextual purposes. Note colder surface temperature was detected towards to high level masonry/interior finishes, indicative of damp conditions
