Arboricultural Report

2 West Cottages
West End Lane
London
NW6 1RJ

Ref: 36330
LIV-SN-22-004954

Site Visit Date:
28th October 2022
Report Date:
2nd June 2023

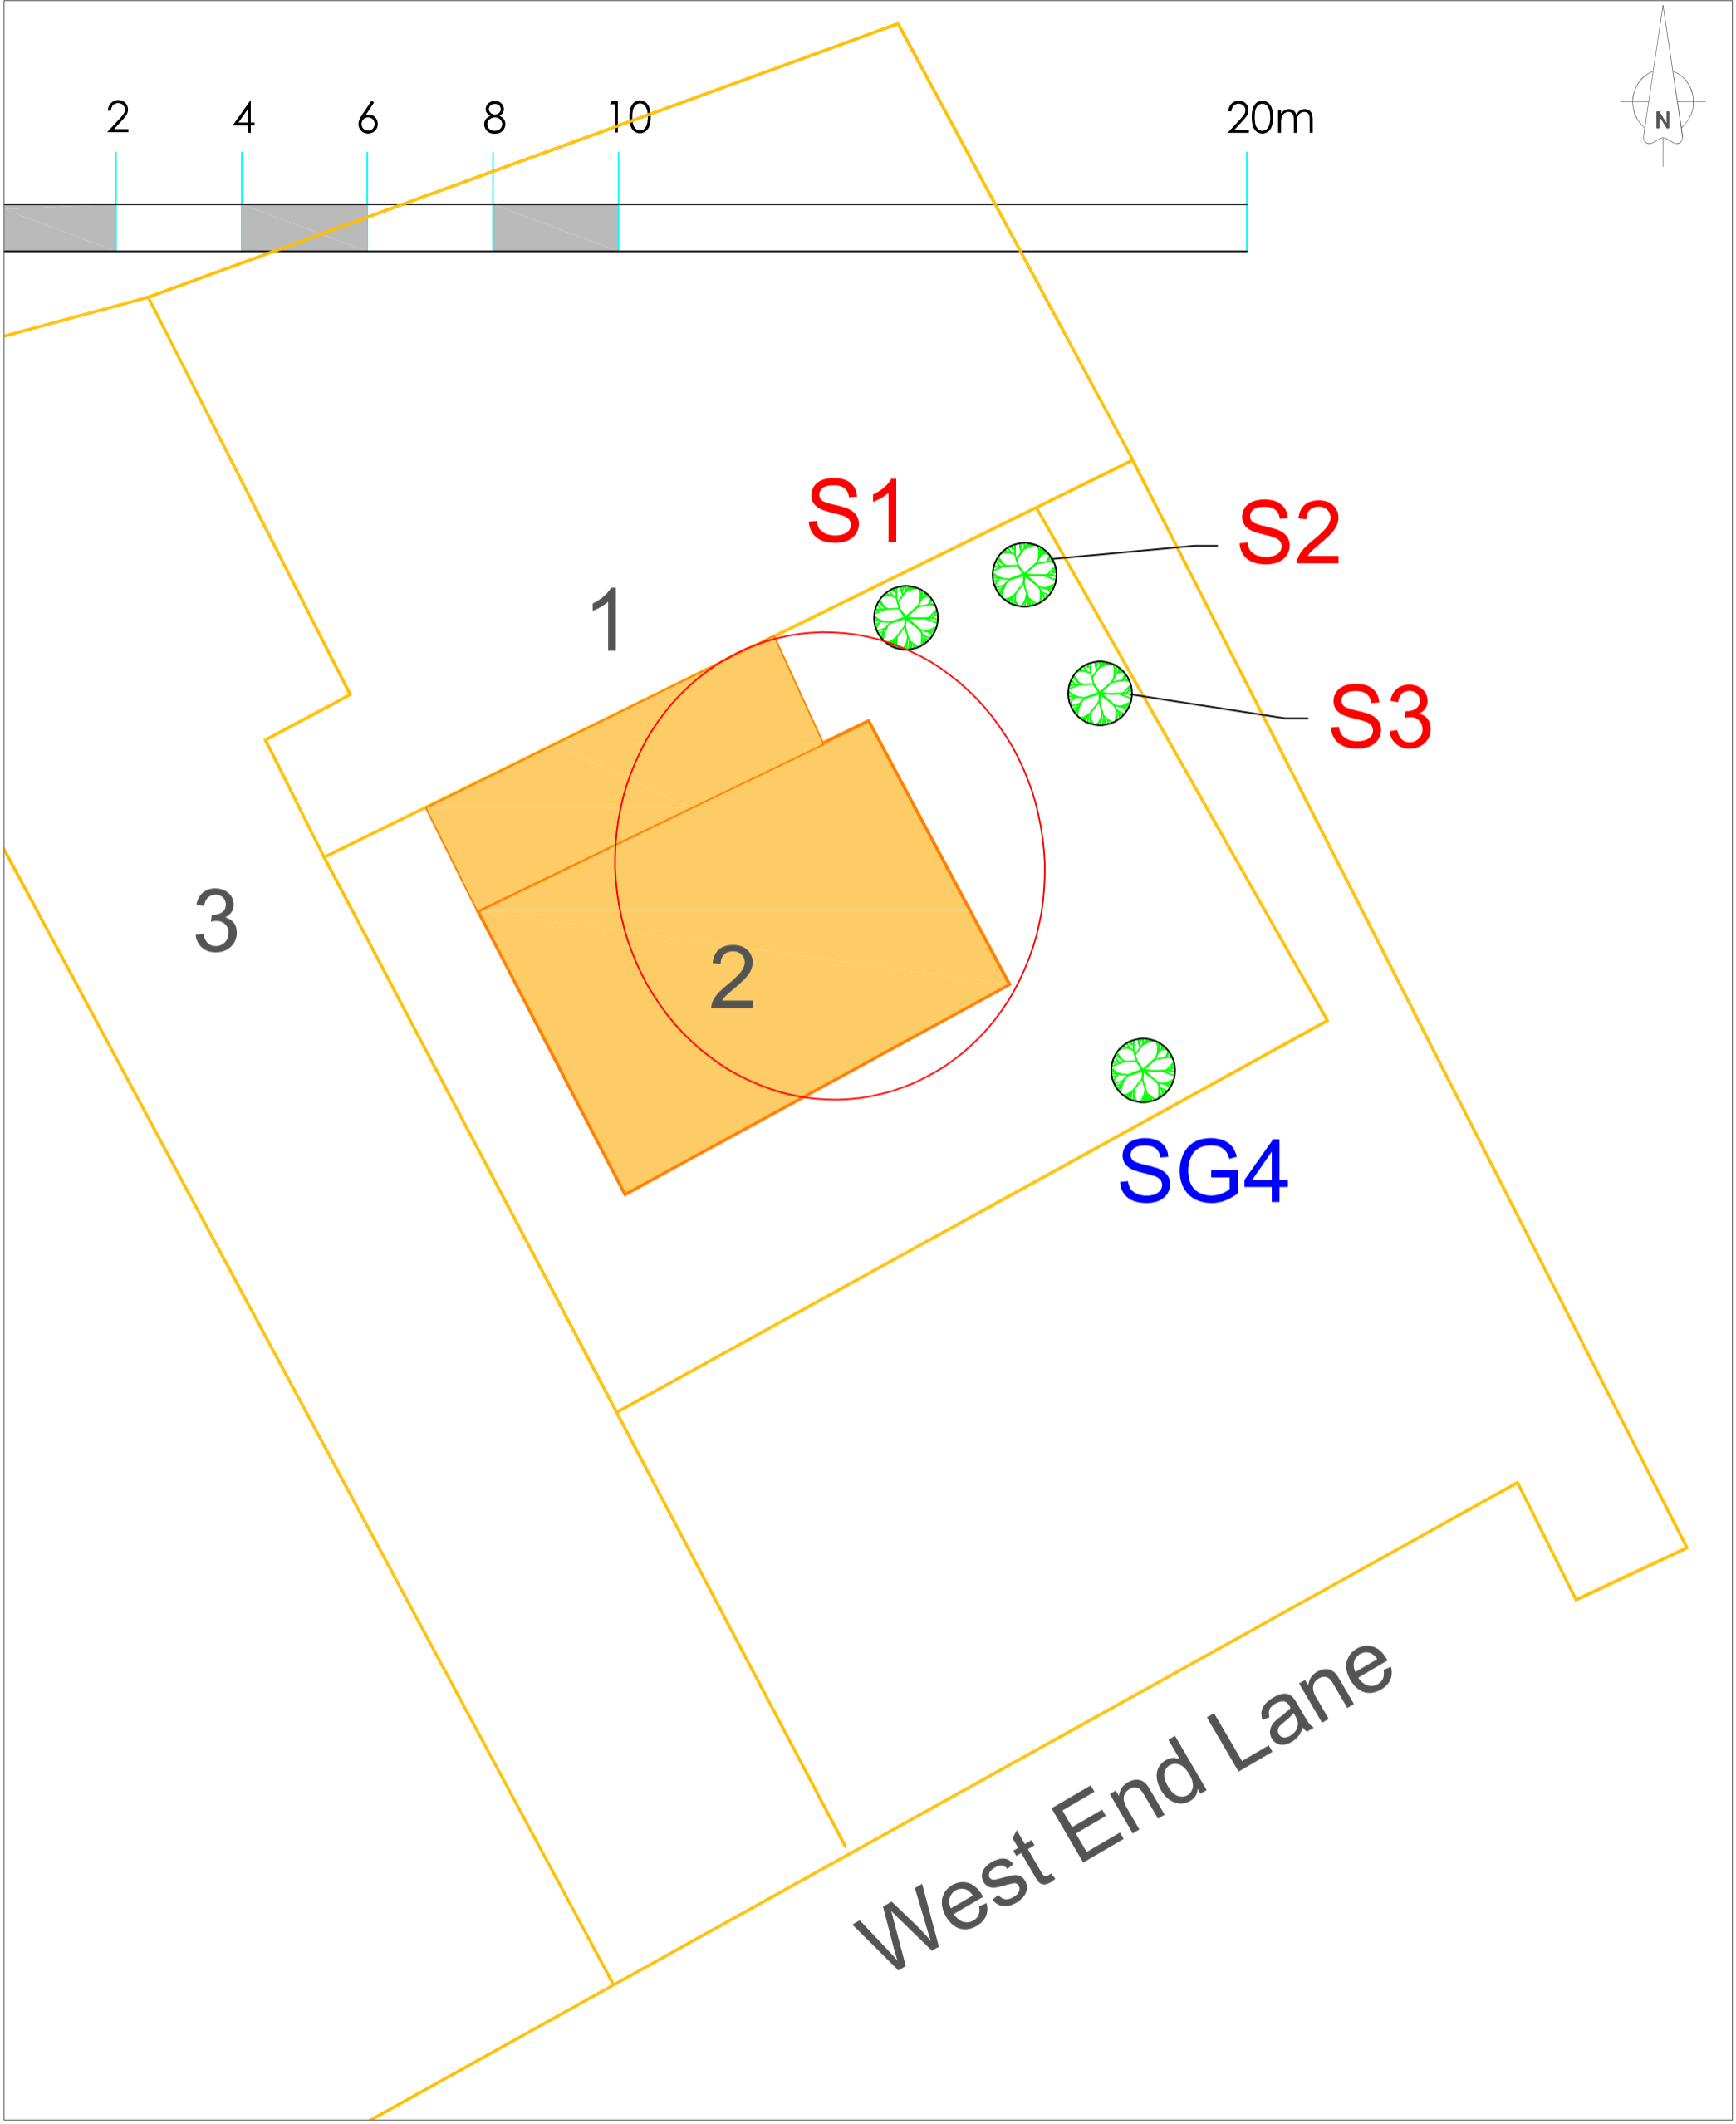
| Figure Number: | 1 |

- 5.2 In this case, with no roots found it is a matter of judgment as to which items of vegetation has caused the clay soil to shrink excessively. The pyracantha S1 is close but the elder S2 is larger but further away. The lilac S3 is also well developed but slightly further away than S2.

- 5.4 On the basis that the damage is on the right hand and rear sides of the property the nearest vegetation is S1, S2 & S3. These are therefore recommended for removal. Monitoring of cracks – informal or formal - at least should be undertaken post vegetation removal to ensure stability is reached.

- 6.1 Removal of the pyracantha S1, elder S2 and lilac S3 is recommended. Their stumps should be treated to prevent regrowth.

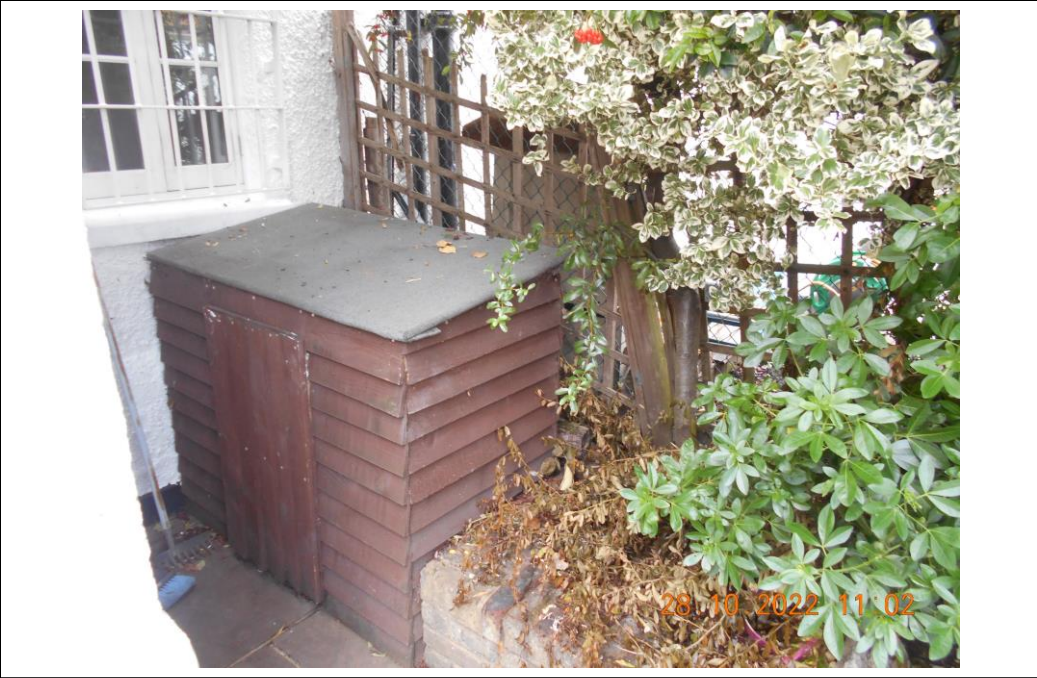
Figure 2: Between S1 and the property.

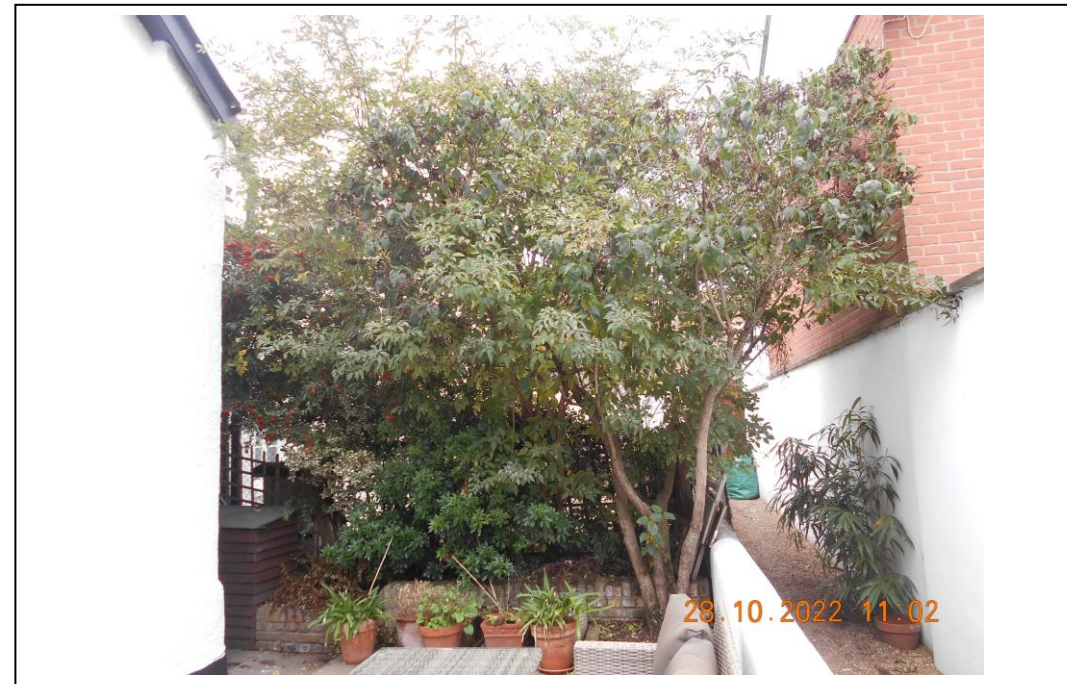
Figure 3: S3 on right with S2 and S1 behind.

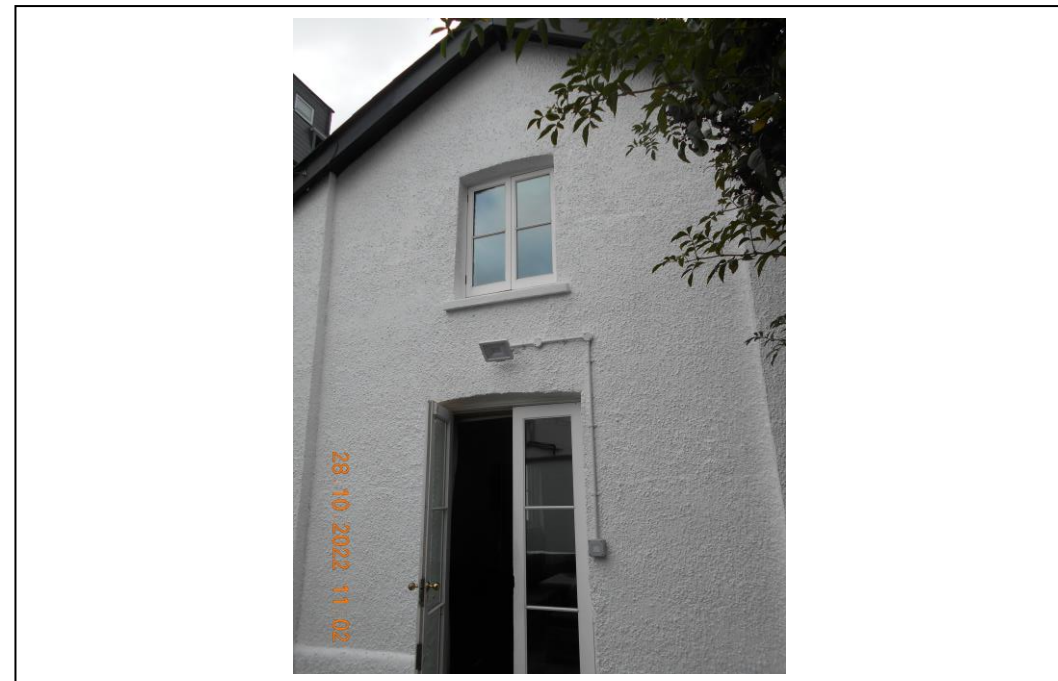
Figure 5: The RH entrance to garden.
