Landmark Trees

Our ref: GDST/5NTH/Ltr/01

**Re: Trees at 5 Netherhall Gardens NW3**

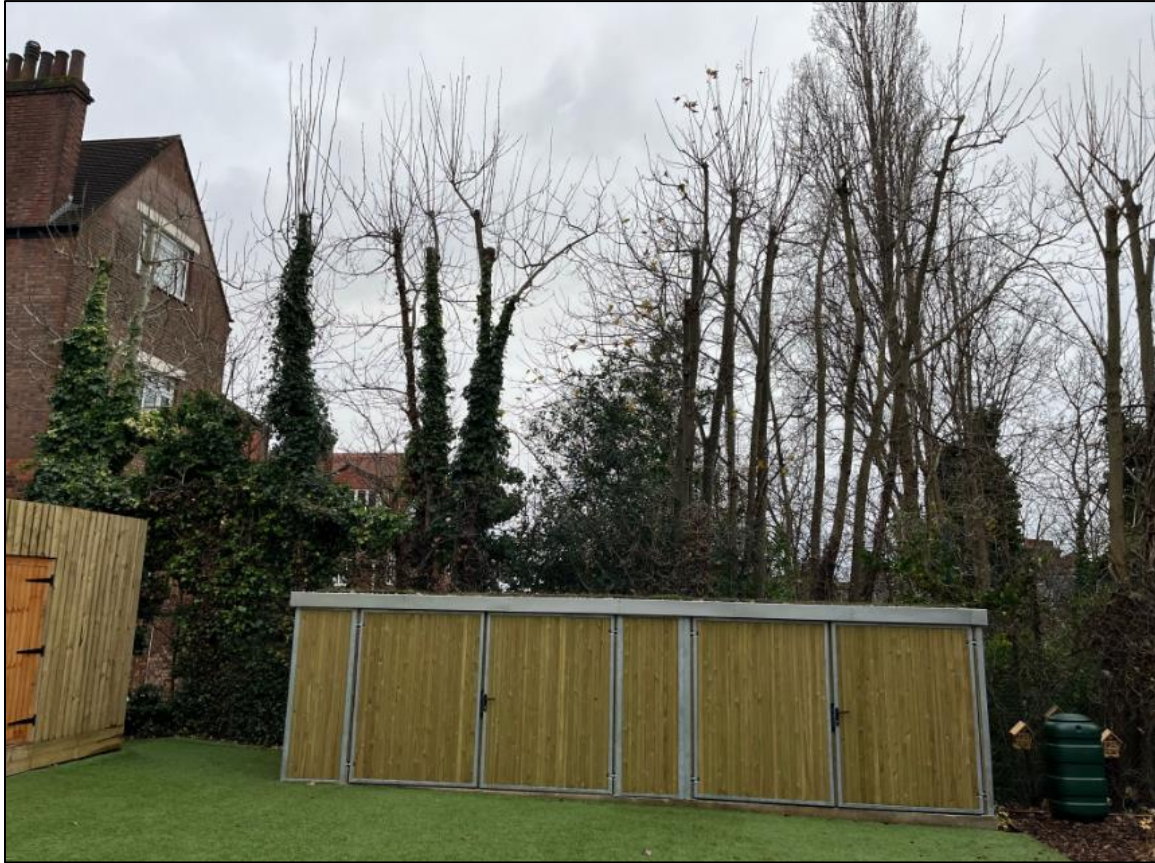
Photograph 1: Subject trees (ash stems on left)

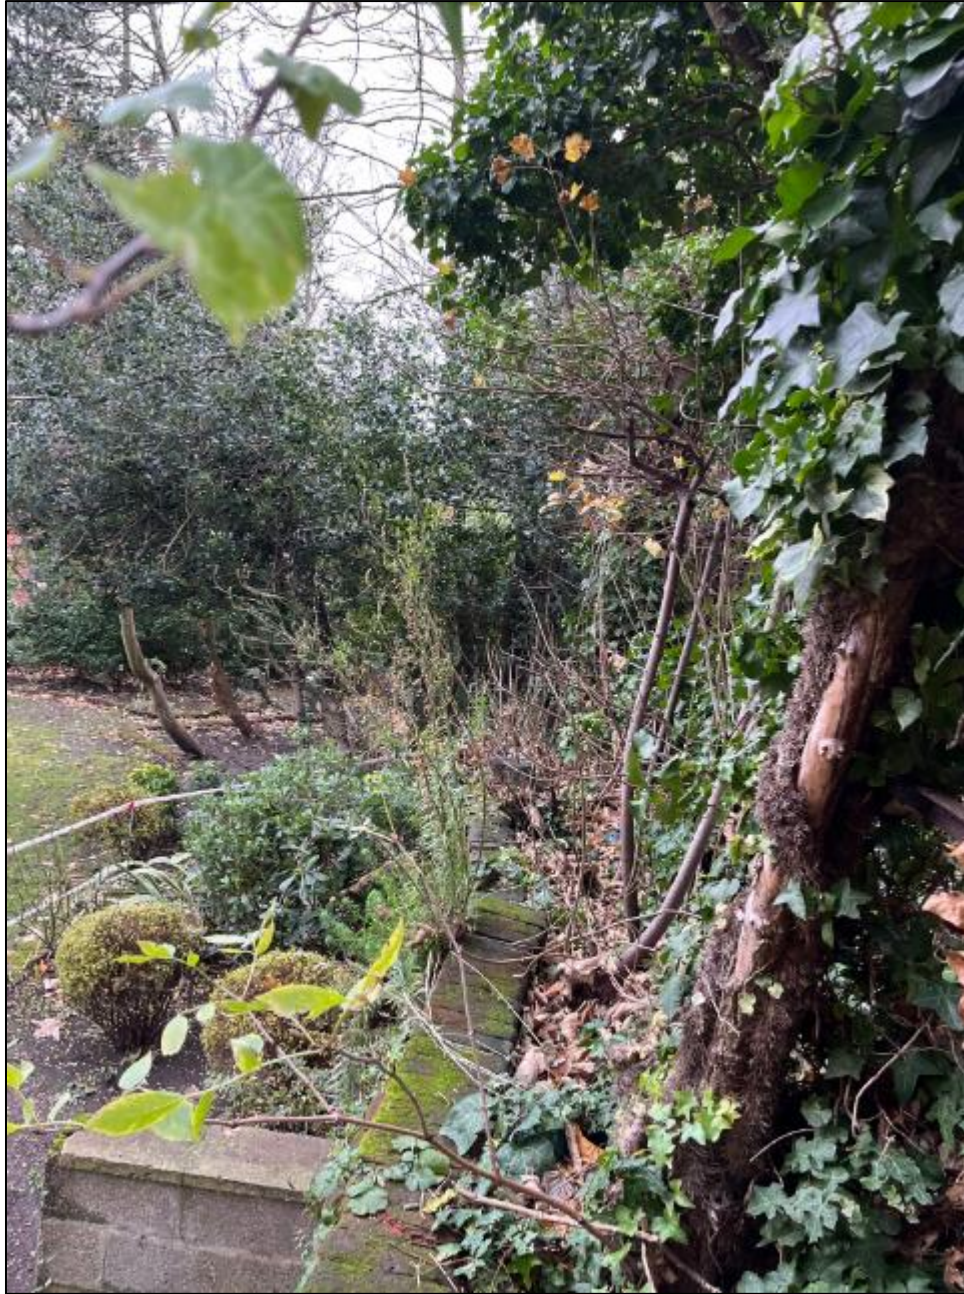
I have enclosed a survey of the condition of the subject trees but to summarise this, they are a line of semi-mature ash and sycamore that have previously been topped. They are growing within 0.5m of the retaining wall forming the boundary here. This wall is buckling outwards and I would consider it highly likely that the trees are causing this buckling via direct pressure from their roots.

Photograph 2: Approximately 0.5m between tree stems and wall

I understand that you would prefer to retain the trees but would recommend they be removed, the wall be repaired / reinforced and a native hedge replanted. This recommendation is principally based on the difficulty of repairing and reinforcing the wall without causing significant damage to the trees but this would also provide a more sustainable and attractive resource. The table overleaf is reproduced from British Standard 5837: 2012 Trees in Relation to Design, Demolition and Construction and details recommended distances from trees to structures to avoid damage. Both the ash and sycamore can, in theory, reach diameters >600mm.

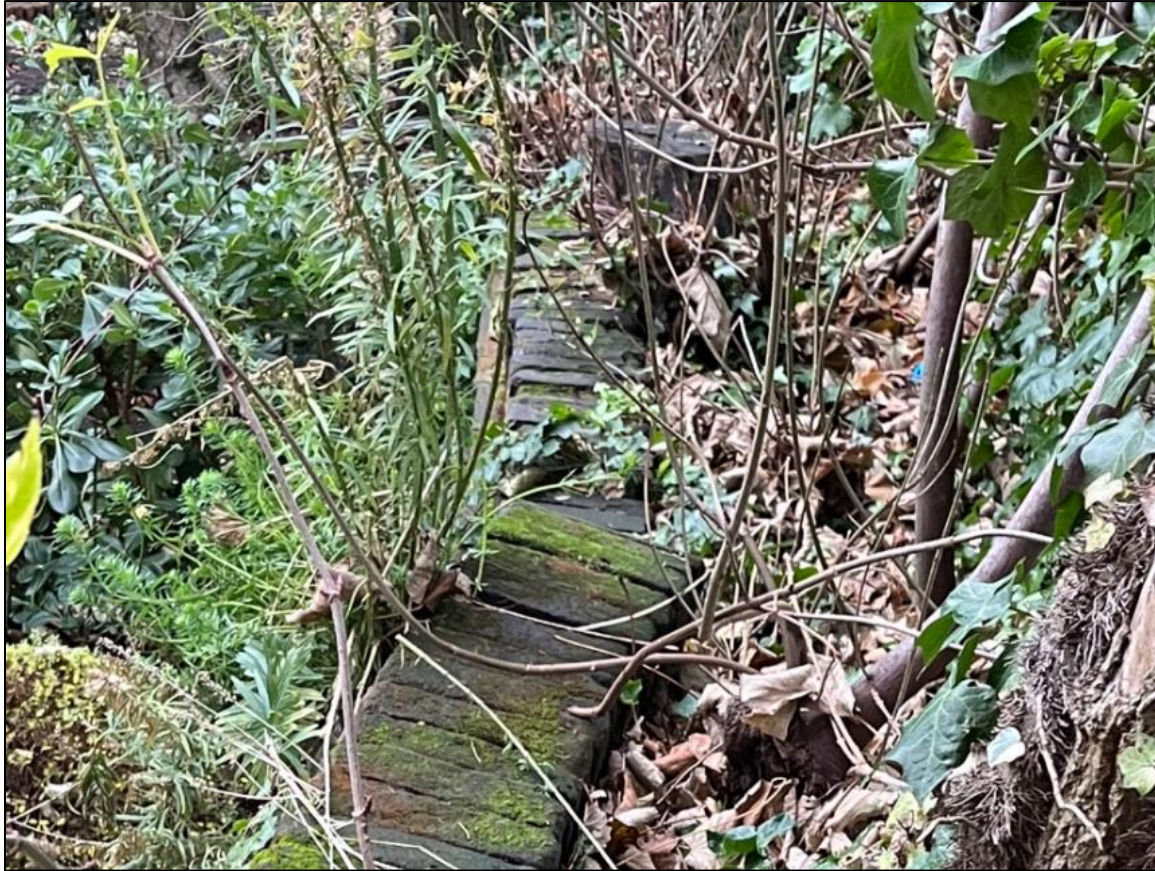
Photograph 3: Buckling of retaining wall evident

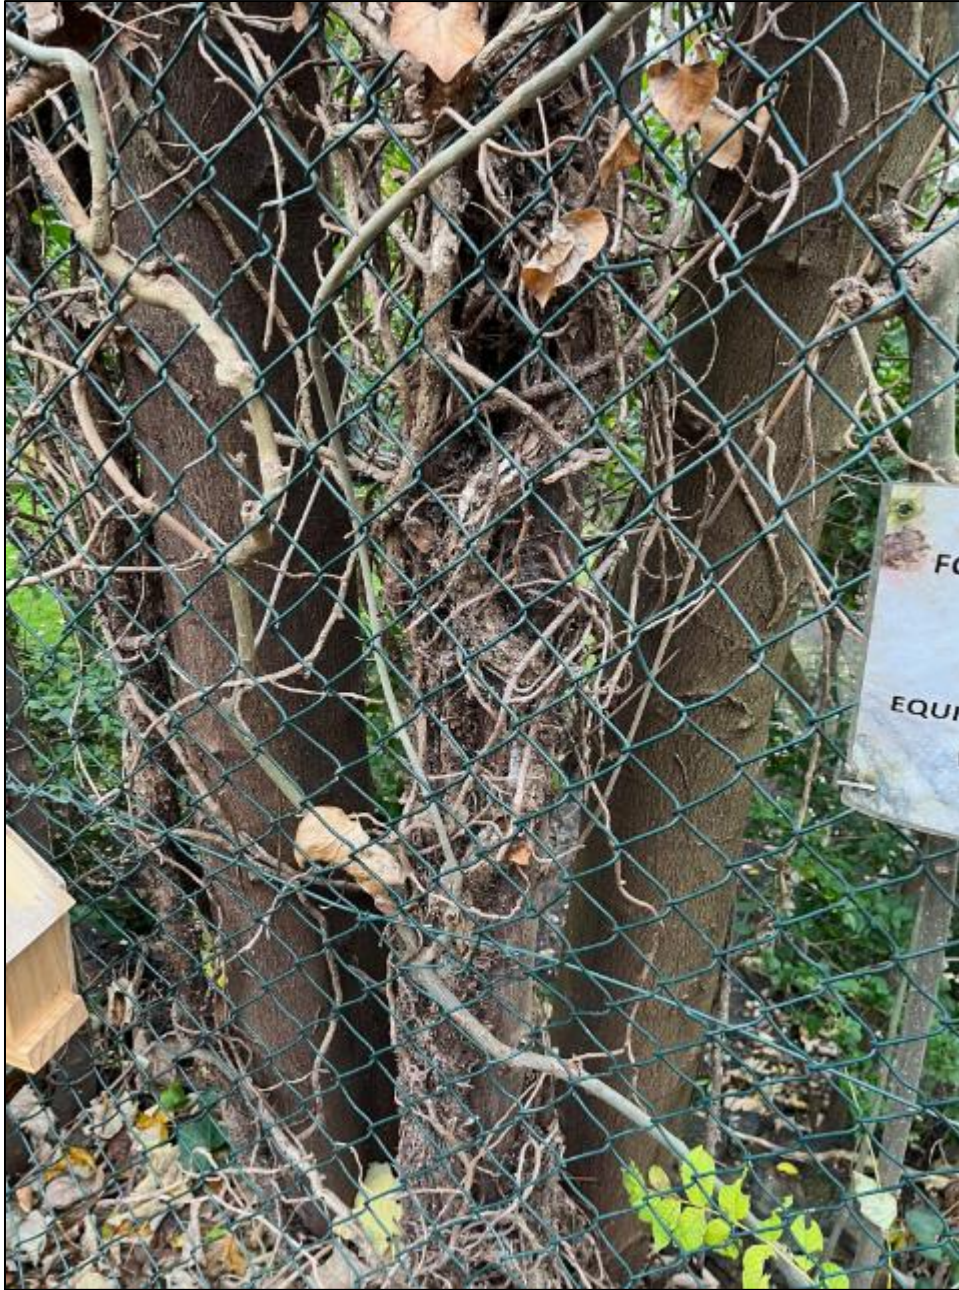
Photograph 4: Typical stem size of trees growing adjacent to wall
