Tree works plan

GREENMANTLE	
Woodfield Nurseries Cool Oak Lane London, NW9 7NB, tel. 02082009559 Greenmantle Ltd email: admin@greenmantle.co.uk	
Client:	Benjamin Khalili
Site address:	14 Templewood Ave, London NW3 7XA
Title:	Tree works plan
Scale:	1:250 Paper size A3
Date:	12.02.2025 Doc/Num 14TA/ 004
Rev:	3

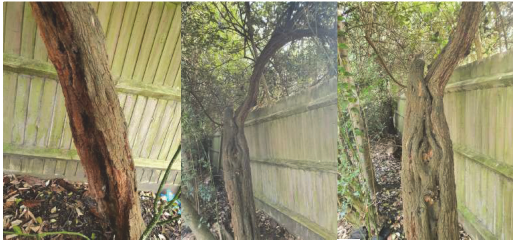
Tree ID	Species	Life stage	Condition Notes	Survey date	RPA (m ²)	RR (m)	Life expectancy (yrs)	BS Category	Works Description	Replacement Planting	Image
T5	Crataegus sp. (Hawthorn sp.)	Mature	Structural condition Poor. Physiological condition Dead. Dead tree / trees.	09.08.2024	26,1	2,9	0-10	U	Fell to ground level and grind out stump to prepare for replanting	Crataegus standard 12-14cmg

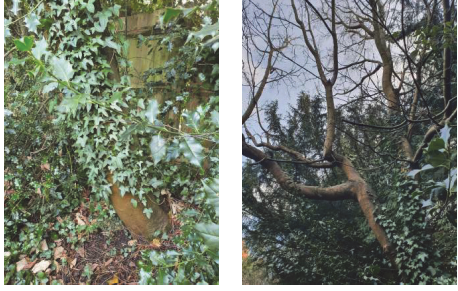
Tree ID	Species	Life stage	Condition Notes	Survey date	RPA (m ²)	RPR (m)	Life expectancy (yrs)	BS Category	Works Description	Replacement Planting	Image
T10	Acer pseudoplatanus (Sycamore)	Early Mature	Structural condition Fair. Physiological condition Fair. Arboricultural work - Historic. Base / stems obscured - Vegetation. Competition - Adjacent trees. Decay / structural defect in crown limb / limbs - Localised. Deadwood - Minor. Ivy or climbing plant. Leaning trunk - Minor.	09.08.2024	43,5	3,7	20-40	C2	Fell to ground level and grind out stump to prepare for replanting	Acer Campestris 12-14cmg

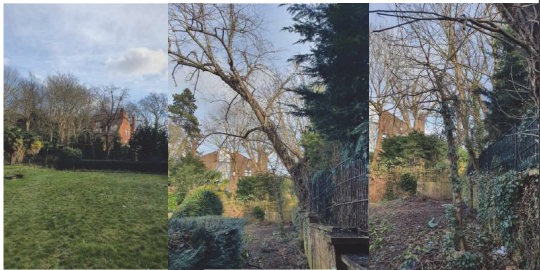
Tree ID	Species	Life stage	Condition Notes	Survey date	RPA (m2)	RP R (m)	Life expectancy (yrs)	BS Category	Works Description	Replacement Planting	Image
T21	Taxus baccata (Yew)	Early Mature	Structural condition Fair. Physiological condition Fair. Competition - Adjacent trees.	09.08.2024	21,9	2,6	20-40	C2	No work		
T31	Tilia x vulgaris (Common Lime) in neighbours property	Mature	Structural condition Poor. Physiological condition Fair. Access to inspect base - Restricted / obscured. Arboricultural work - Historic. Base / stems obscured - Structure. Base / stems obscured - Vegetation. Deadwood - Major. Deadwood - Minor. Decay / structural defect - Base. Form - Poor crown structure. Leaning trunk - Major. Off-Site. Growing upon the brick retaining wall; the wall has failed and is leaning away from the tree (i.e., towards the Site).	09.08.2024	162,9	7,2	10-20	5,5	Fell to ground level and grind out stump to prepare for replanting	Carpinus betulus 18-20cmg - planted within 14 Templewood Ave
