Site Visit Record

Project: 11 Cannon Lane
Date: 30th September 2024
Main Contractor: Enbuild Construction
Architect: Serena Mignnatti and Darling Associates
Weather: Sunny
Photos Taken: Yes, refer to the report below

THIS DRAWING IS TO BE READ IN CONJUNCTION WITH ALL RELEVANT ARCHITECTS, ENGINEERS AND SPECIALISTS DRAWINGS AND SPECIFICATIONS.					Drawing title Garden Wall Inspection				Project 11 Cannon Lane			
DO NOT SCALE FROM THIS DRAWING.					Scale 1:50 @ A3				ElliottWood			
C1 39/09/24 ET SB Construction					EWP Project 2230325				Fitzrovia • Wimbledon • Nottingham			
Rev Date By Chk Description					Date September 2024				•info@elliottwood.co.uk •+44 (0) 20-7499-5888			
					Drawn ET				Design Phase Construction			
									Status S4			
									Revision C1			
									[Project]-[Origin]-[Function]-[Spatial]-[Form]-[Discipline]-[No.]			
									2230325 - EWP - ZZ - 00 - SK - S - 0003

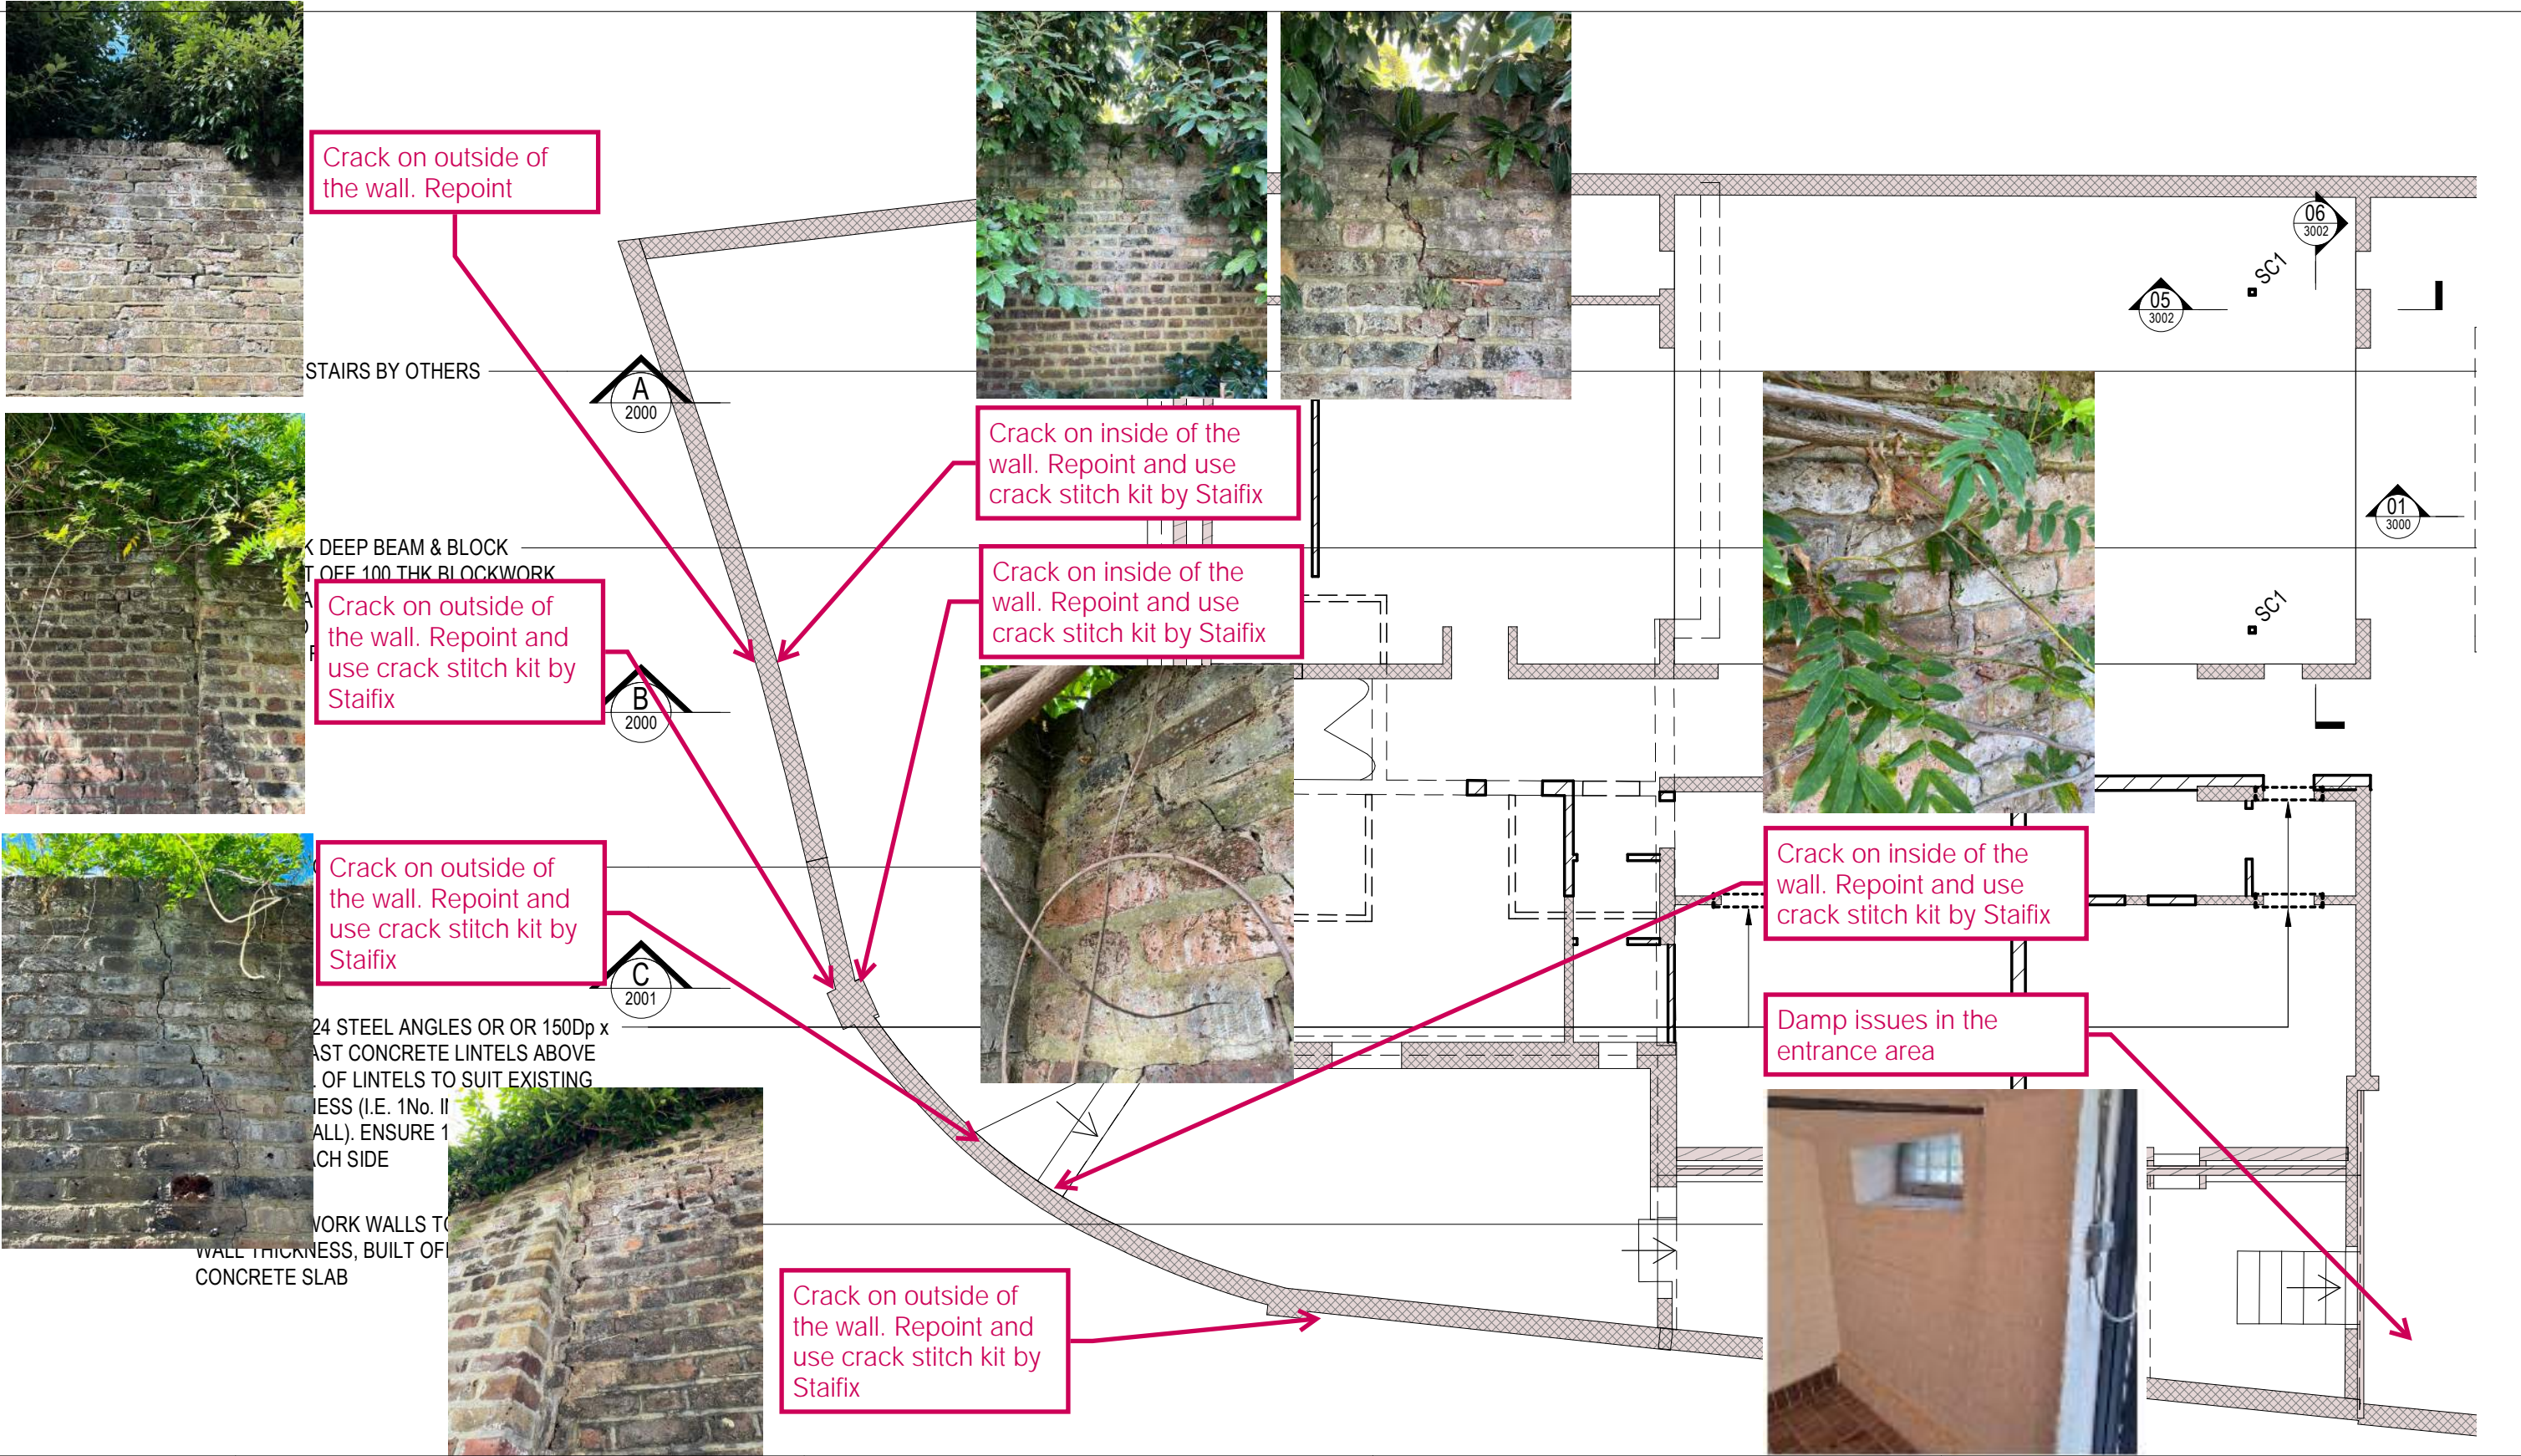
Masonry Repair Specification

Re-point Masonry and Re-render

Re-point masonry to BS 8221-2. Mortar mix to be non-hydraulic lime mortar to be compatible with existing masonry units and match the existing mortar characteristics and colour, Class B1 or better, to specialists specification to BS 890. Joints to be raked out, removing any loose mortar to between 38mm and 50mm, with non-mechanical tools. Joints to be cleaned and wetted before placement of new mortar. Clean surfaces as noted in Type 1.

Repair minor cracks in mortar and masonry

A crack in masonry is considered minor if it has a thickness of less than 5.0mm **and** an extent of less than 500mm. Remove finishes around cracking to determine thickness and extent. Any masonry units that are cracked are to be replaced, replacement brickwork should match the originals in material, size, colour, texture, density, hardness and porosity according to Section 9.2 and 9.3 of BS 8221-2. Cracks in mortar limited in extent to 500mm in both directions on the face of the masonry to be repaired by raking out and making good, as noted in Type 2. If existing mortar has disintegrated, or the crack penetrates, to a large depth, all loose mortar to be removed, replacement mortar should be deep tamped in layers according to 7.3.4 of BS 8221-2.

Stitch major cracks with non-ferrous ties

A crack in masonry is considered major if either the thickness is greater than 5.0mm **or** its extent is greater than 500mm. Remove finishes around cracking to determine thickness and extent. Insert non-ferrous or austenitic stainless steel ties as shown in detail 1 and according to manufacturers instructions. Mortar repair to match existing but in accordance with tie manufacturers instructions. Carry out general repairs elsewhere as Type 1, 2 and 3 as appropriate.
