Tree Condition Survey 2024

University of London

Gavin Jones Ref: MSURV/JV/UOL/2024

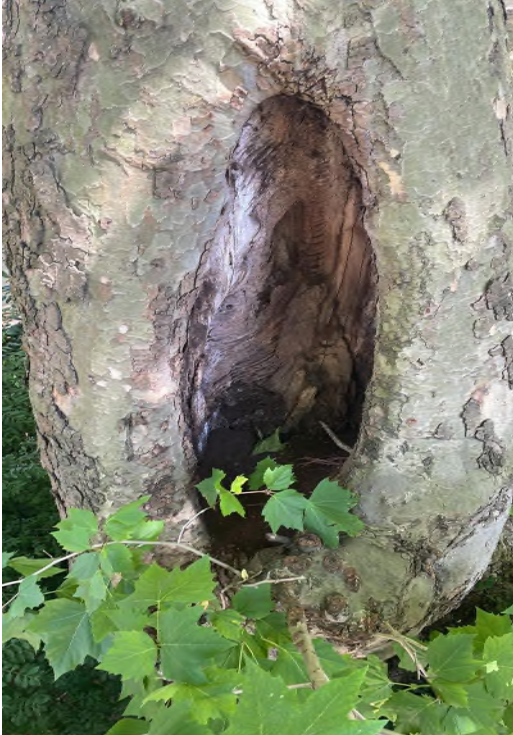
Unless carried out following the previous survey, it is strongly recommended to carry out an internal decay evaluation on the stem of T103, a large, mature London plane. The large cavity on the stem was highlighted during the aerial *Massaria* inspections two years ago and although the tree is producing well-formed wound wood, given the size of the tree and its location, it would be prudent to have the stem assessed to understand the extent and severity of any internal decay. The results will enable the surveyor to determine the structural integrity of the residual wood which will allow an informed evaluation of the level of risk of potential failure and any subsequent remedial works, if required (see figure 1).

<p>Figure 1: Showing the cavity on T103, a large London plane. Although the cavity seems stable it will be prudent to check the condition of the residual wood by conducting a decay evaluation.</p>

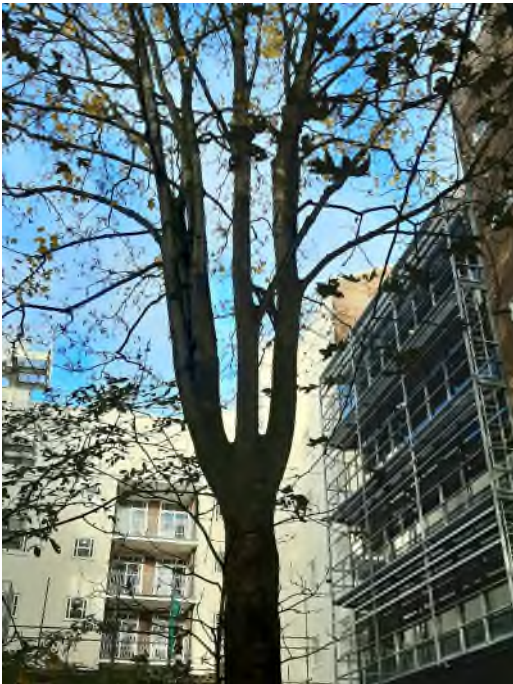
There is one tree which has been recommended for re-pollarding – T281, a sycamore classed as a lapsed pollard (see figure 2). This tree was heavily pollarded at least 20 years ago and has substantial growth above the old pollard points. Due to the extent/height of regrowth and the tree's close proximity to surrounding buildings, these works are recommended as a precautionary measure but are strongly advised.

<p>Figure 2: Showing T281, a 'lapsed pollard' sycamore. This will require pollarding to significantly reduce the risk of stem failure.</p>
