# Subsidence Risk Assessment Report

12 Clorane Gardens  
London  
NW3 7PR

Tuesday 13<sup>th</sup> August 2024

GD/240532/Ra

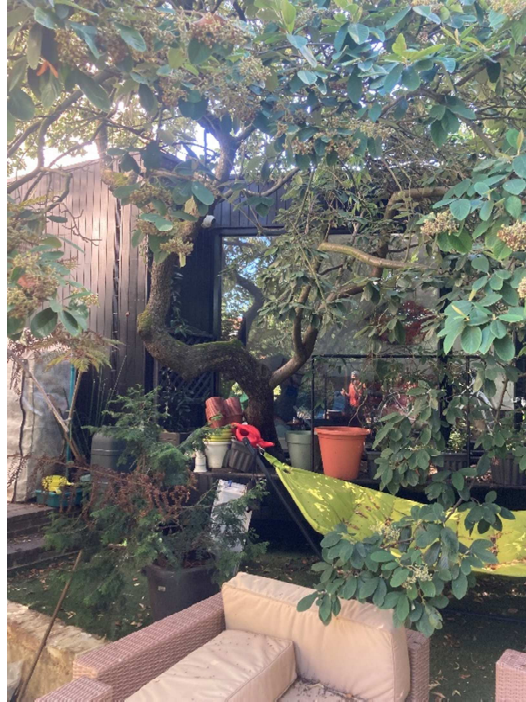
*Figure 2: Image of surveyed tree T1 growing adjacent to the separate office space.*

- 3.2.1 The property of 12 Clorane Gardens is believed to be of an Edwardian style constructed around the early part of 1900. Its construction is typical of the period consisting of a solid brick walls and clay tiled roof.
- 3.2.2 The premises has had undergone a number of works throughout its life including most recently a large renovation in 2007 prior to the current owners moving in.
- 3.2.3 There is also a detached office room to the southern boundary which I have been informed was completed in 2020 and constructed upon a deep pile foundation and designed to accommodate the retention of the adjacent mature Cotoneaster tree (T1) shown in figure 2 above.

- 7.3.1 The survey identified that the decking associated with the detached office building has been built around the main stem of the Cotoneaster (T1) and due to incremental growth of the tree is now in direct contact with the decking area. In the near future, the tree is likely to cause damage to the decking.

- 7.3.2 As such I would recommend that the existing clearance should be extended allowing for future unimpeded growth of the main stem.
- 7.3.3 During the survey it was noted that the crown of the Cotoneaster (T1) was in direct contact with the eaves and roof of the detached office building. The lower crown of the Common Ash (T2) was also overhanging and in in proximity to the roof of the detached office building.

- 7.3.4 In both instances, to prevent damage occurring, I would recommend that pruning works are carried out to ensure clearance between the trees and the building.

- 8.0.3 With regards to direct damage, this report has highlighted the need to carry out pro-active works to ensure suitable clearance between the decking of the detached office building and the cotoneaster (T1).

- 8.0.4 I have recommended selective pruning of T1 and crown lift of T2 in order to maintain a suitable clearance preventing direct contact and the potential for damage to occur.

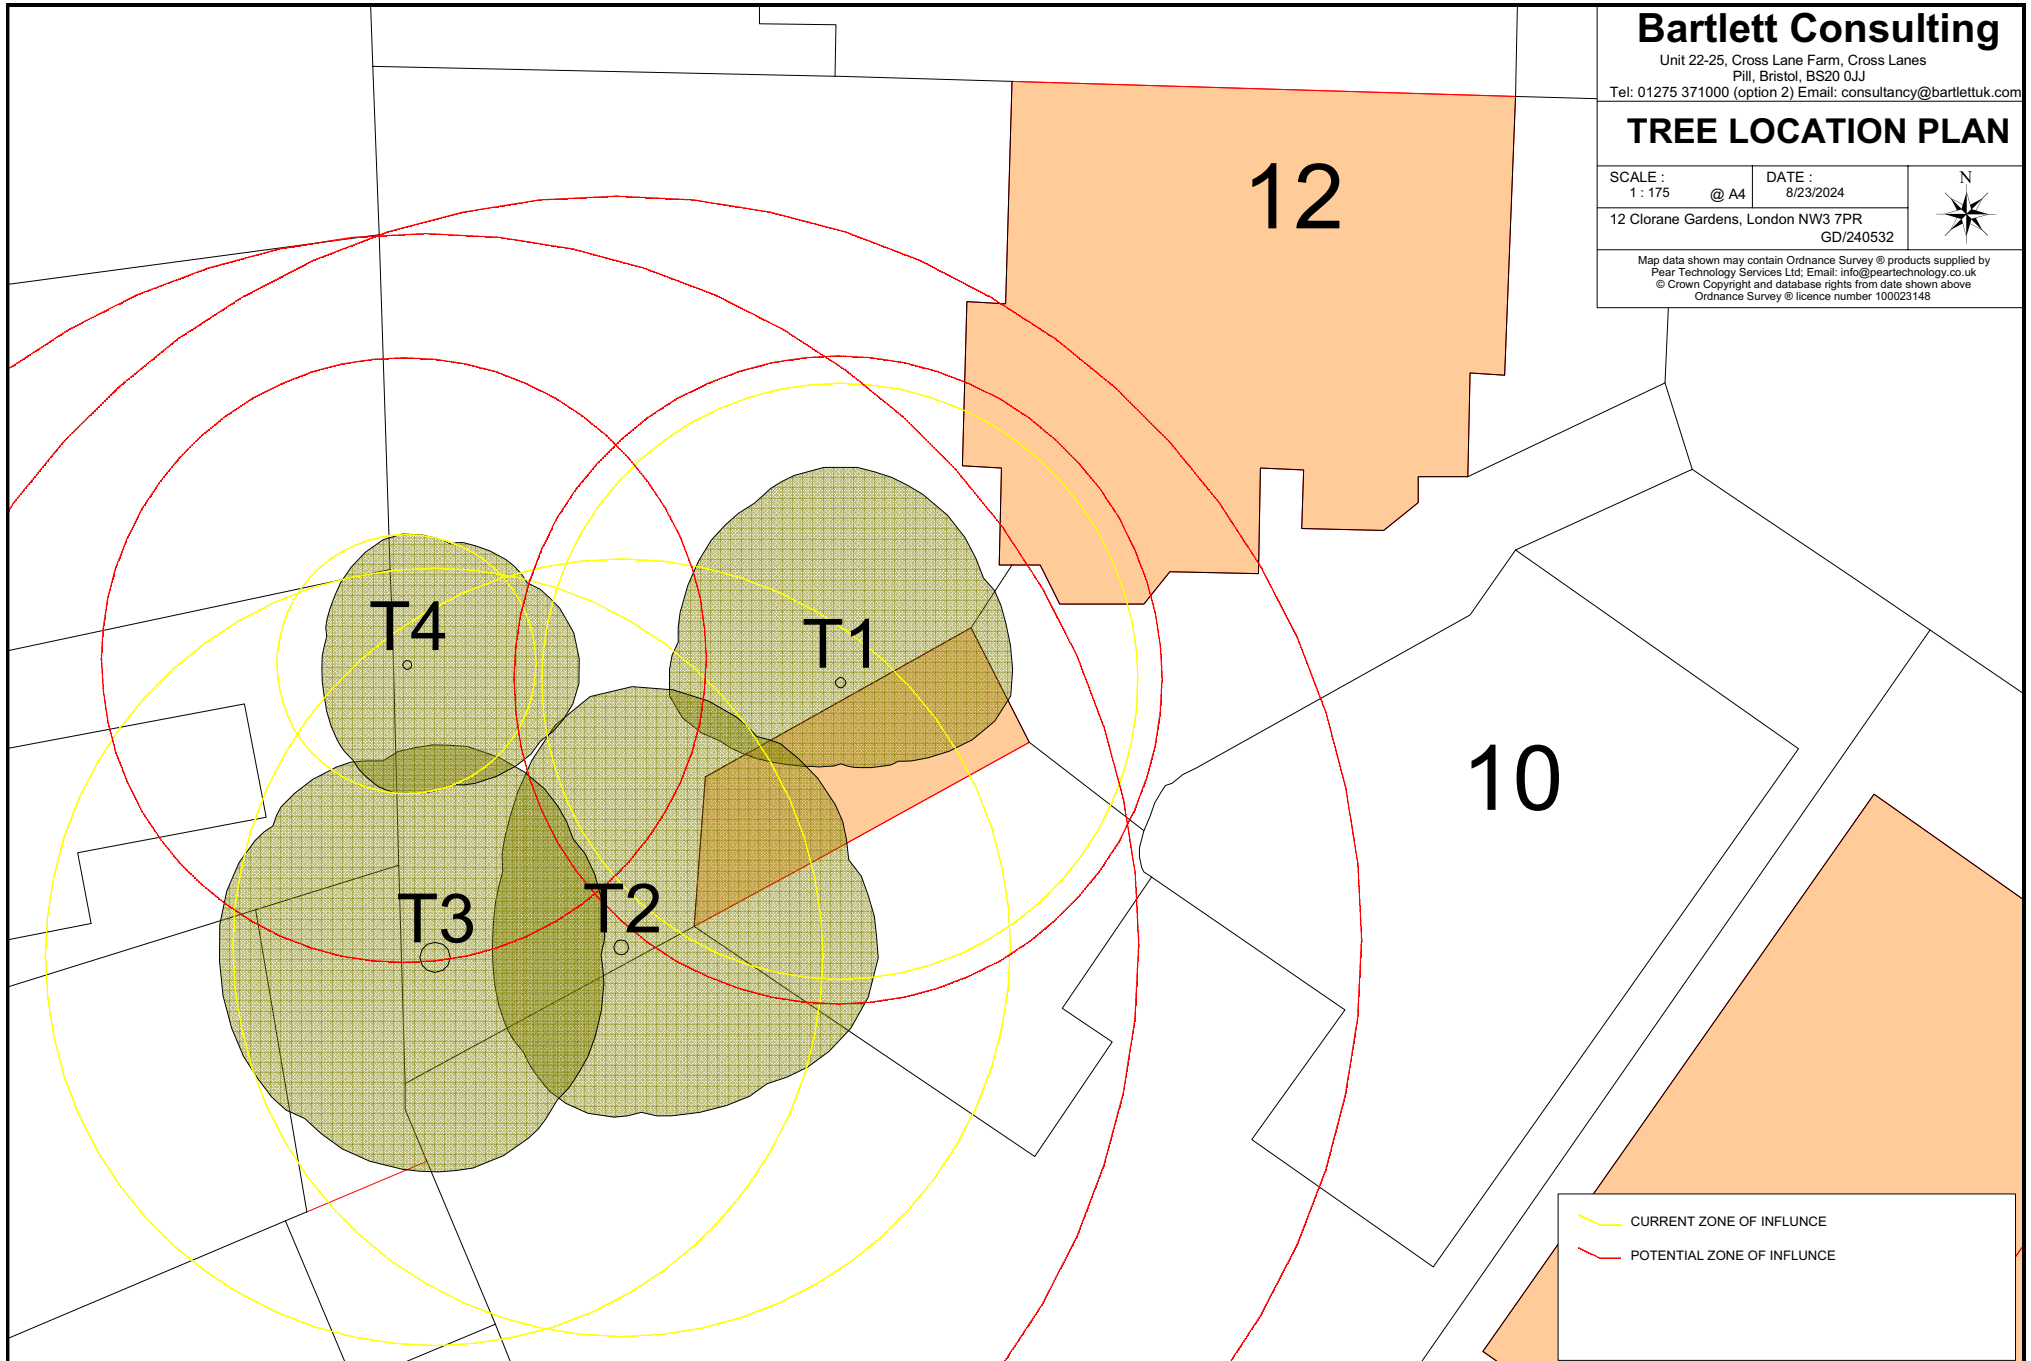
## TREE LOCATION PLAN

- 7.2.2 The water demand / uptake of the Cotoneaster (T1) is not stated within the table and subsequently a high-water demand must be assumed.
- 7.2.3 The Zone of influence is an area from the tree in which it can influence the local soils, this is based on a calculation derived from water demand and current tree height. Based on its ZOI, only the Cotoneaster (T1) falls within the footprint of the main house.

- 7.2.4 Based on the same calculation, the Common Ash (T2) and European Lime (T3) both fall within the footprint of the detached office room.
- 7.2.5 The Honey Locust (T4) currently has a ZOI that falls short of the footprint of either the main house or detached office room. Furthermore, even if this tree reached its anticipated ultimate height of 14.0m its ZOI would still fall short of the main house and outbuilding.

- 7.2.6 This information is as detailed within table 2 of this report and represented within the Zone of Influence map attached to the end of this report.
