ARBORICULTURAL SUPERVISION RECORD

<i>Client:</i>	Mr and Mrs Cremer
<i>Site:</i>	26A Ferncroft Avenue, Camden

Date. Friday 8th February 2024

Purpose: Supervision of trial excavations to ascertain the extent of the impact the roots of plane tree (no. 1) are having on the foundations and superstructure of this dwelling; in response to comments from the Council that there is insufficient evidence to conclude that the tree is the cause of the damage and alternative options have not been explored.

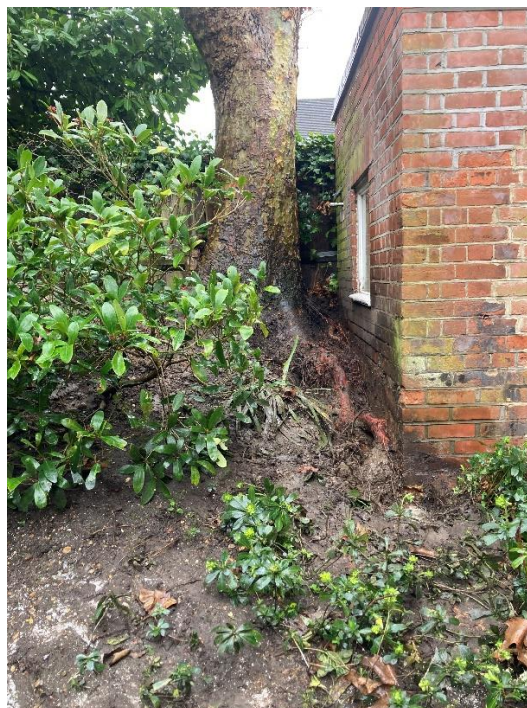
Photograph 1: location of tree no. 1 in relation to the rear of the listed building.

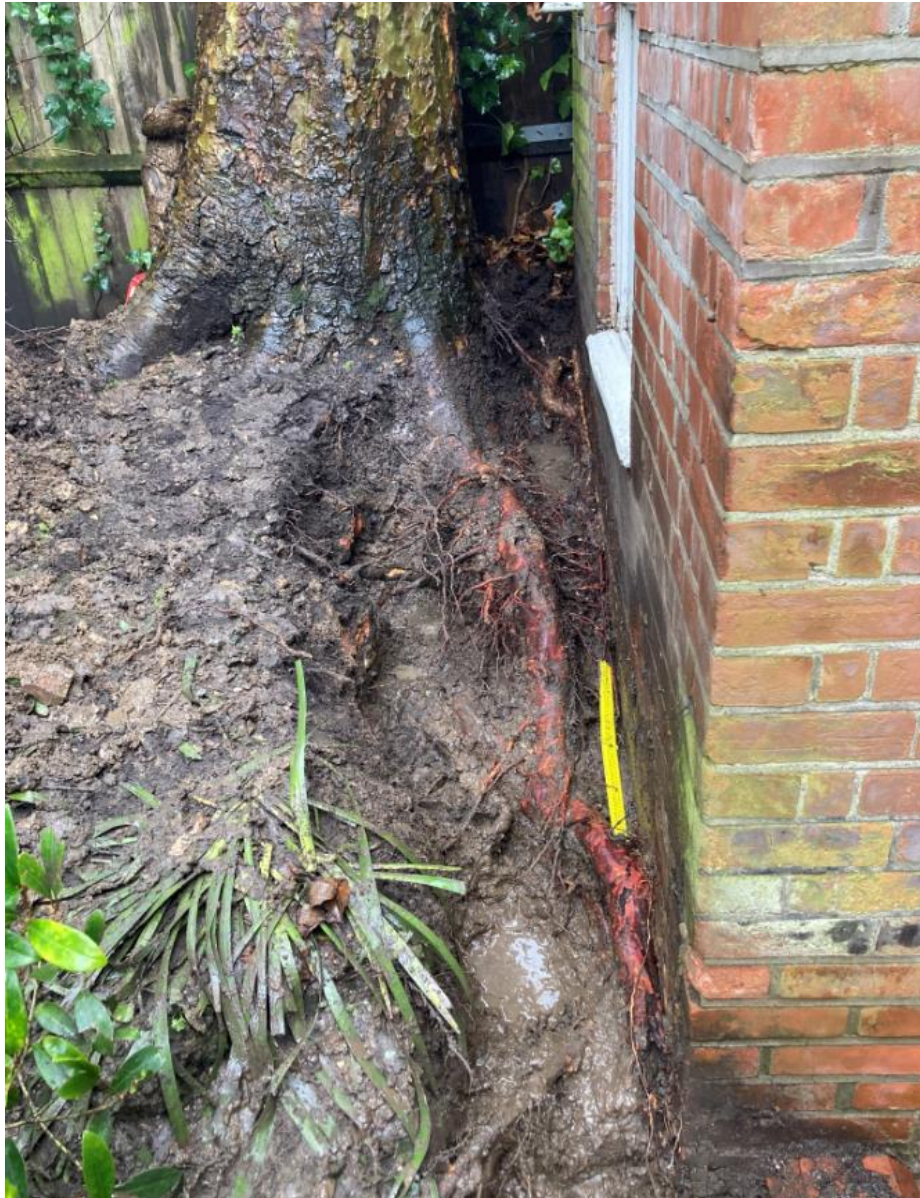
4. The structural root grows alongside and significantly close to the extension wall, extending to the wall's full length before terminating at the west-most corner where the root appears to have been historically severed.

Photograph 2: showing the significant proximity between structural root of tree no. 1 and the rear extension wall of the listed building.

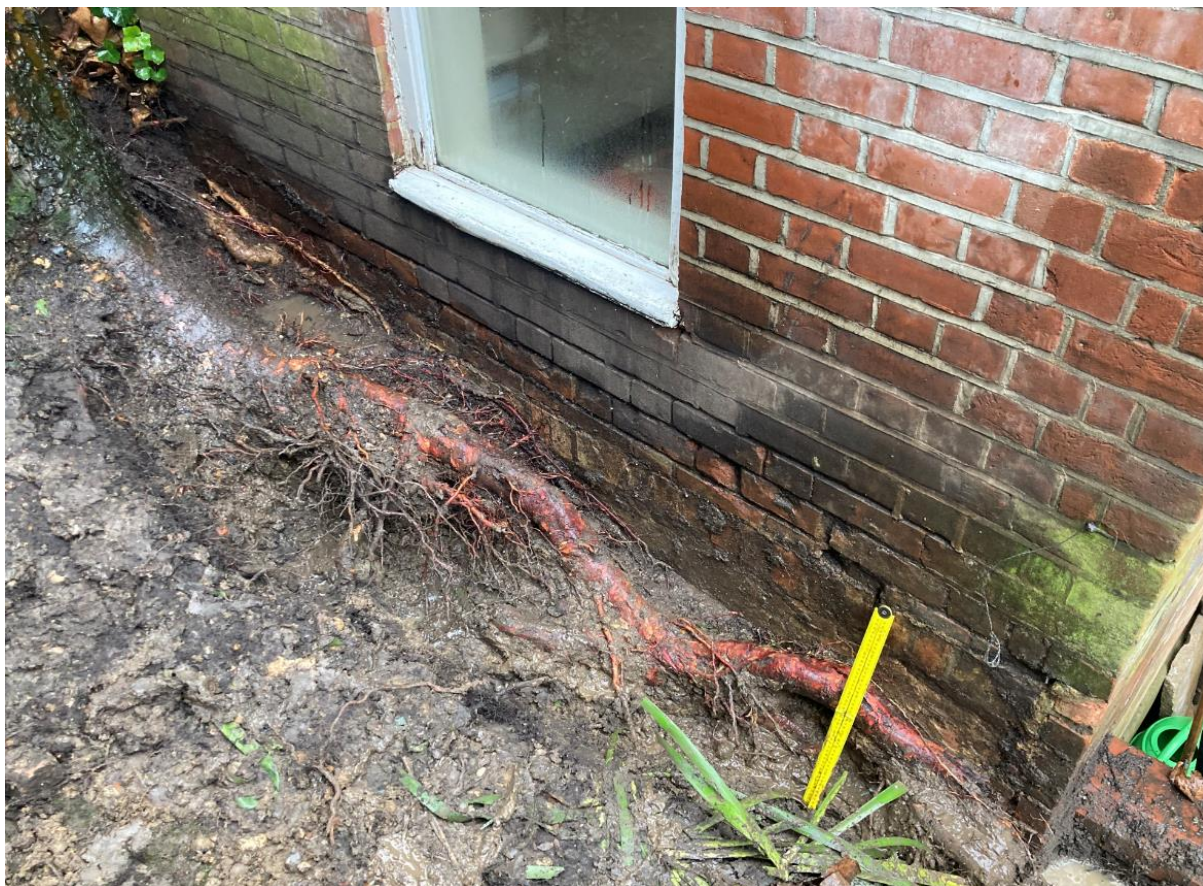
Photograph 3: showing the significant proximity between structural root of tree no. 1 and the rear extension wall of the listed building.

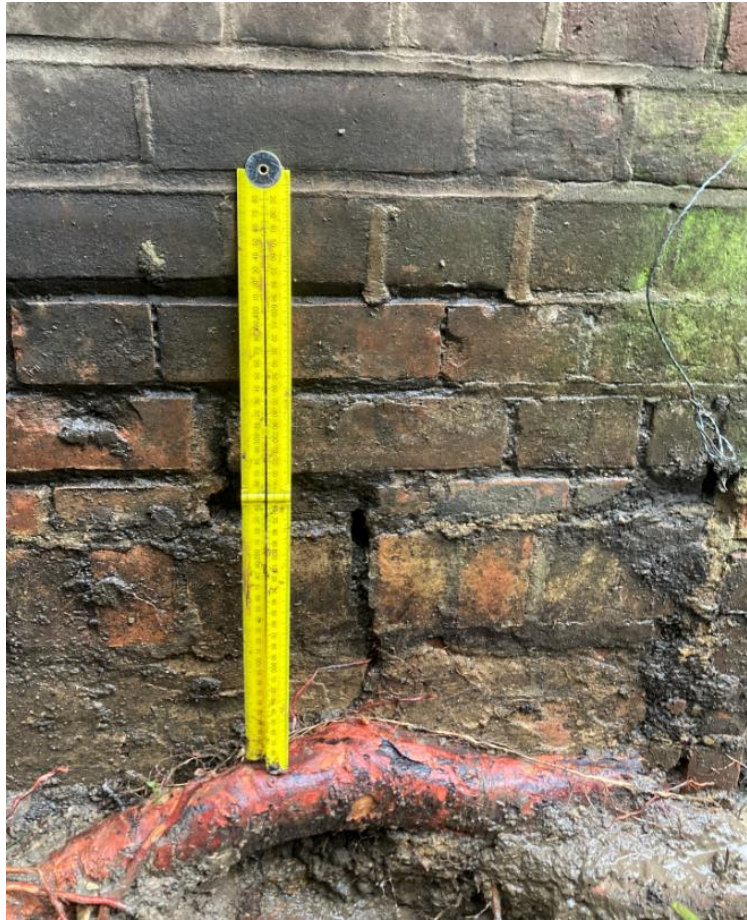
5. At its point of origin immediately beneath the soil, the structural root measures 280mm diameter and gradually tapers to 80mm diameter.
6. At its furthest distance, the structural root is located at 400mm from the building wall, and at its closest, presses into the part of the wall adjacent to the extension's west corner resulting in a crack measuring 20mm width x 250mm height within the brickwork directly above.

Photograph 4: showing the point at which the structural root grows directly against the rear extension wall; note the crack within the brickwork directly above.

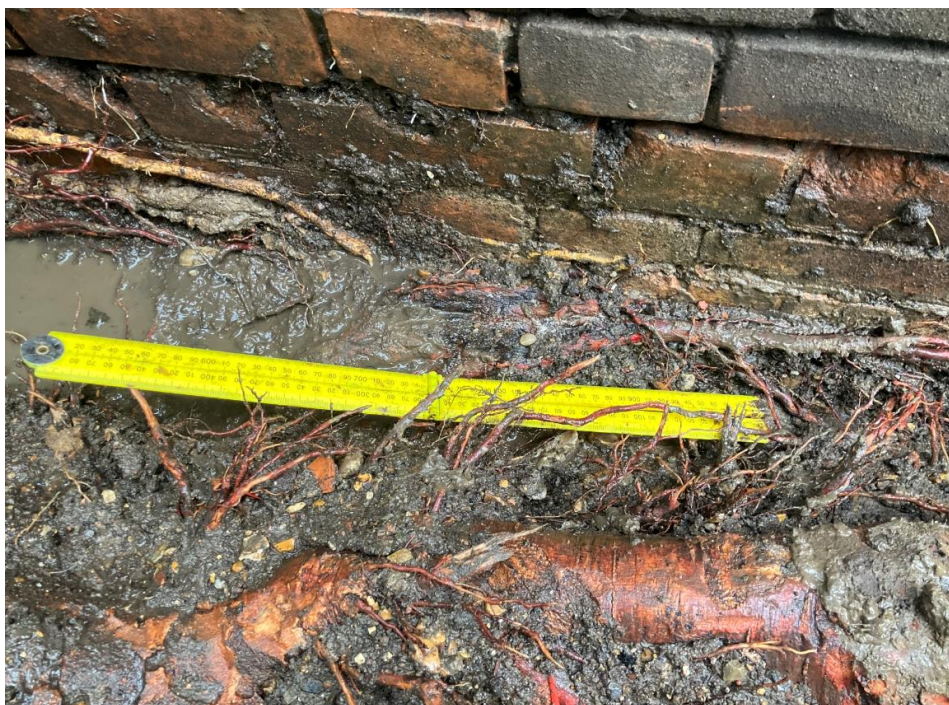
7. We were also able to partially uncover a seemingly separate root (110mm diameter) located at 1m from the east corner of the extension that was also growing tight against the building wall, but which did not appear to result in any clear evidence of associated damage to the adjacent brickwork directly above.

8. However, it should be noted that due to the density of rooting we were limited in how far we could excavate without the need to sever or damage significant roots (or without using specialist tools such as air lances and a soil vacuum). As such, I would not be surprised if there were additional deeper roots pressing against the building wall and causing further associated damage to the brickwork.

Photograph 5: showing the upper surface of an additional structural root that we were unable to fully excavate due to the density of roots, growing directly against the rear extension wall.
