14 December 2023

26A FERNCROFT AVENUE – STRUCTURAL REPORT ON IMPACT OF TREE

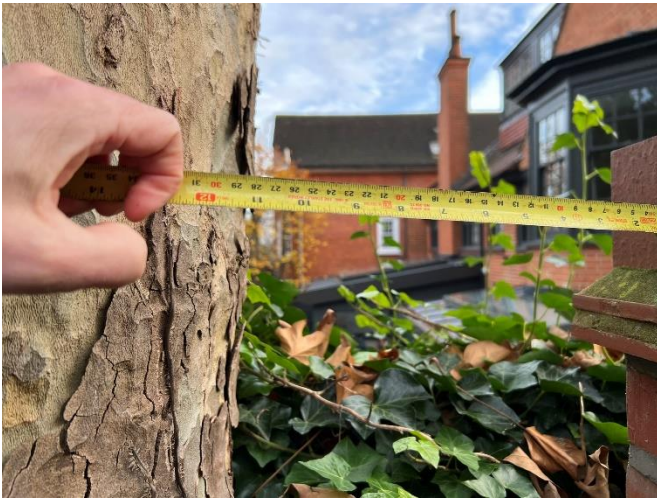
To the rear of the property there is a substantial London Plane tree in very close proximity to the rear elevation. Refer photographs 1,2 & 3 attached. The tree is in within an elevated bed approximately 1m above the ground level generally at the rear of the building. The distance from the trunk to the rear elevation is circa 300mm.

Photograph 3 – Trunk less than 300mm from rear wall of building

On the basis of the above, we would strongly recommend that the tree should be removed, subject to the necessary approvals, to prevent further damage to the Listed building and to the retaining structures within the garden.

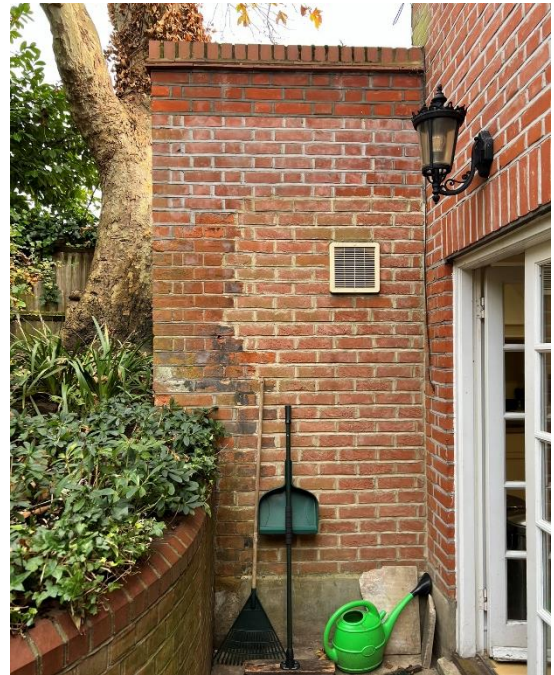
- There is evidence that the rear part of the building has been subjected to repeated repairs and partial rebuilding – refer photographs 4 and 5. It appears that one area has been reconstructed and tied into the existing, another area has been repointed, and the parapet looks to have been reconstructed.

The primary evidence of historic damage is the repairs carried out previously to the rear part of the building; these also look to have occurred at different times suggesting multiple incidences of damage rather than a single event.

Photograph 4 – Side elevation of rear part of building

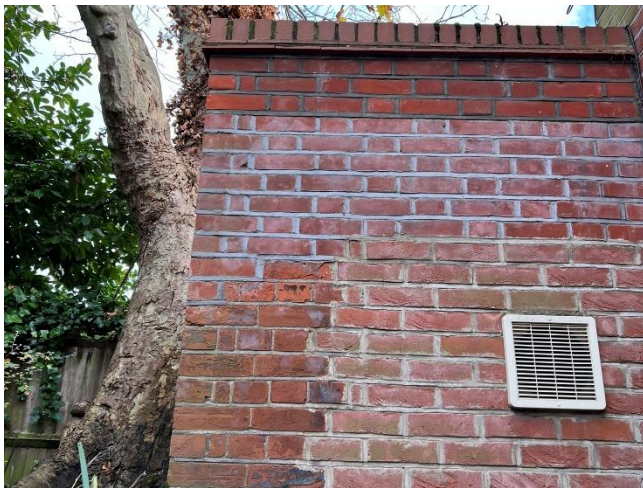
Photograph 5 – Detail of side elevation

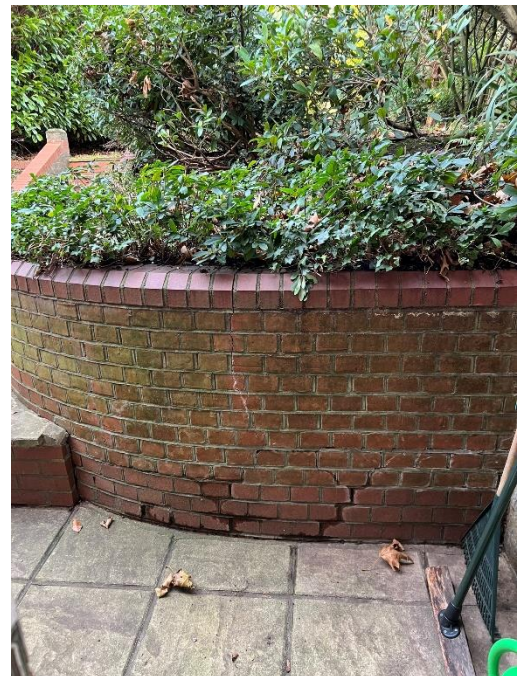
- There is a brickwork retaining wall surrounding the bed where the London Plane tree is located. There is significant cracking in several locations to this wall – refer photographs 6 & 7.
- At first floor there is evidence that the rear elevation has been reconstructed as the coursing of the rear elevation does not align with coursing of the side elevation – refer photograph 8.
- In the kitchen there is opening up of the joints in the flooring – refer photograph 9.
- To the first floor bathroom there is cracking in the tiling to the rear elevation - refer photograph 10.
- Internally at ground floor there are several cracks to the walls and ceilings to the rear part of the building. We understand that these have become apparent since a redecoration in 2022. Refer photographs 11-14.

Also of concern is the cracking to the rear garden retaining wall. If the cracking worsens it could lead to collapse of the retaining wall, which could in turn destabilise the tree. The same forces acting on this retaining wall will be also be acting on the retaining wall to the rear wall of the house; the concern would be that any damage would be concealed as the wall is hidden by kitchen units internally and is below ground level externally.

Photograph 6 – Cracking to retaining wall

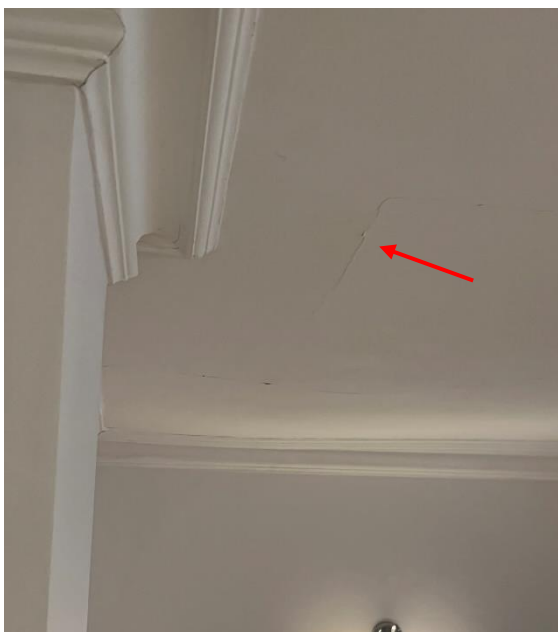
The large number of defects internally to the rear part of the building – in contrast to the low number of defects to the front of the property – again points to the tree being the cause. It is particularly of concern that many of these defects have only become apparent since a recent redecoration suggesting an ongoing issue.

Photograph 13 – Cracking to ceiling

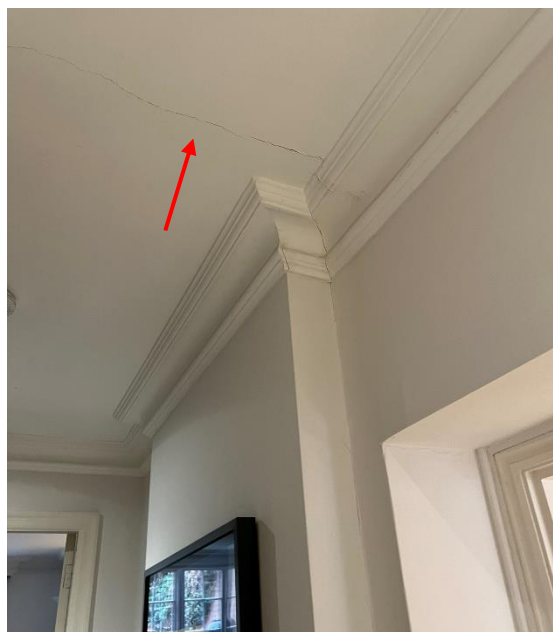
Photograph 14 – Cracking to ceiling
