**BUILDING SURVEY
REPORT**

**47 Shirlock Road
London
NW3 2HR**

**Mr Chrisopher Kelly
128 St Paul's Road
London
N1 2LP**

22nd August 2024

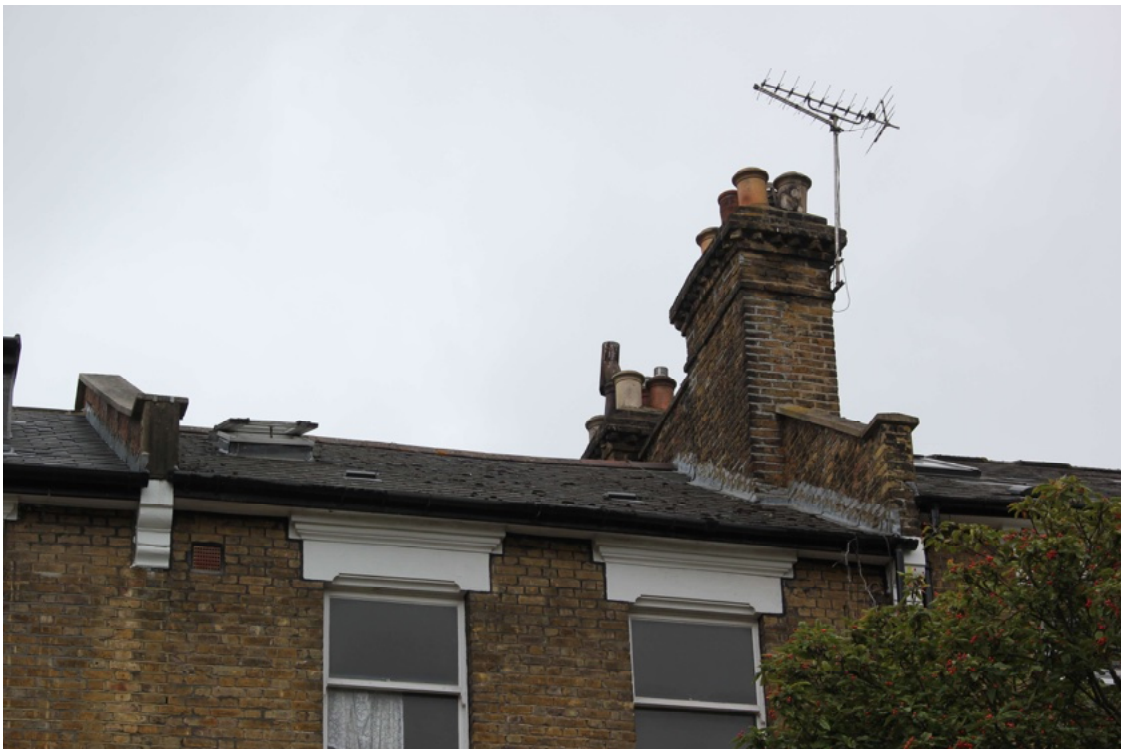
The front and rear main roof slopes are timber framed and covered with synthetic slates. The slates are discoloured as a result of the bleaching action of direct sunlight and will continue to fade to a pale cement-grey colour. There is also a light covering of moss. The deterioration is not entirely satisfactory for aesthetic purposes, but is superficial and no major remedial works are required. No slate slippage or other significant defects are apparent and no signs of leakage were noted when the corresponding ceilings and upper walls internally were inspected and tested with an electronic moisture meter, at least no dampness due to slate defects.

Photo 3 – View to the front main roof slope

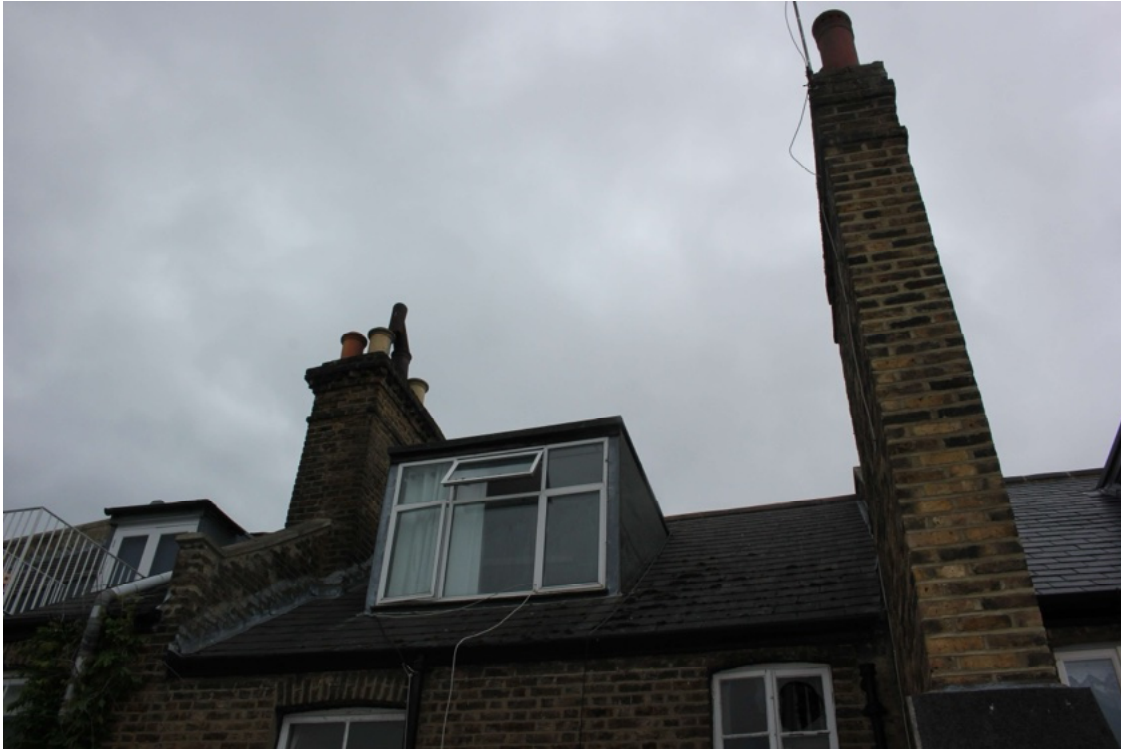
The front and rear roof slopes are generally uneven/undulating. This is due to deflection of the timber joists under loading over the years. The distortions are not such as to cause any immediate concern, particularly given the lightweight nature of the artificial slates compared to the original natural slates. It would, nevertheless be prudent to have the roof timbers inspected as and when exposed to carry out refurbishment works. Some minor strengthening works may be required and works will be required to straighten the rafters to achieve a level surface for plastering the ceilings in the third-floor accommodation.

Photo 4 – View to the rear main roof slope and dormer

The rear dormer is not well detailed and the window is a relatively flimsy fixture that does nothing to enhance the character or value of the house. Also, the dormer structure and window will have poor thermal insulation characteristics.

ACTION: You should allow for the cost of replacing/upgrading the rear dormer. You may wish to enlarge the dormer and provide doors and a balcony similar to those to neighbouring properties.

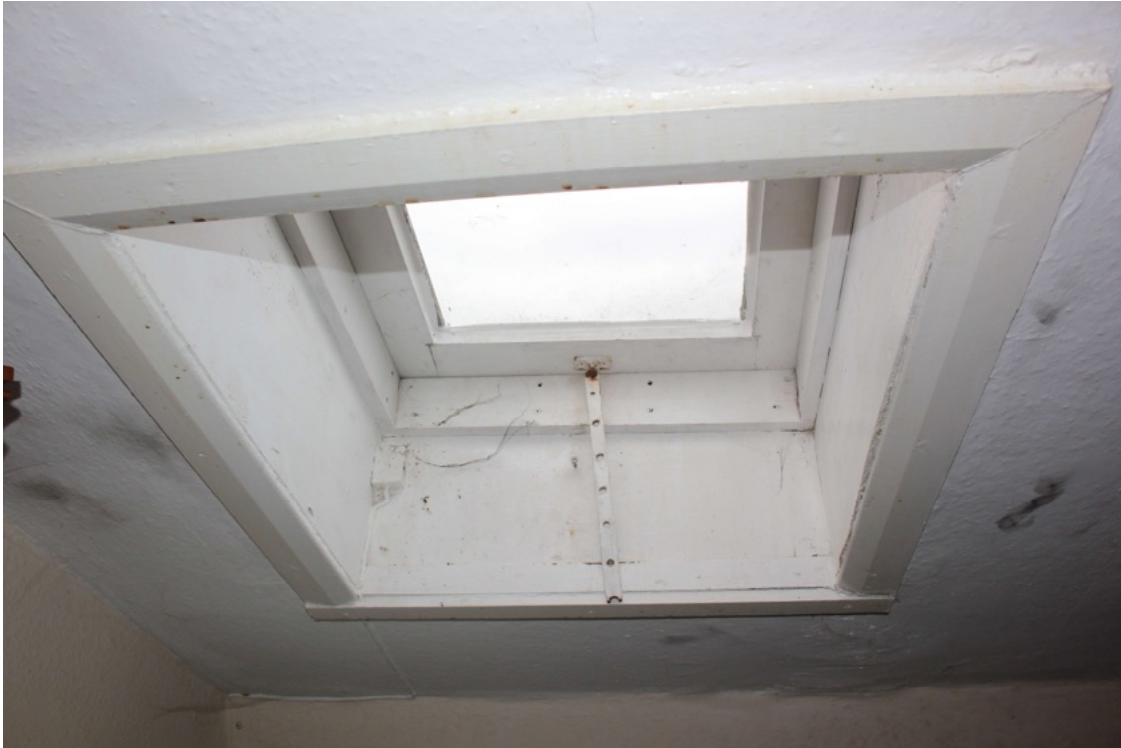
The roof light in the front roof slope is a poor-quality painted softwood fixture, which is not double-glazed and the opening casement is ill-fitting.

Photo 5 – View to the poor quality front rooflight

ACTION: You should allow for the cost of having the front rooflight replaced. You may wish to provide a larger unit and you may also wish to have a further rooflight inserted to allow more daylight into the third-floor bedroom.

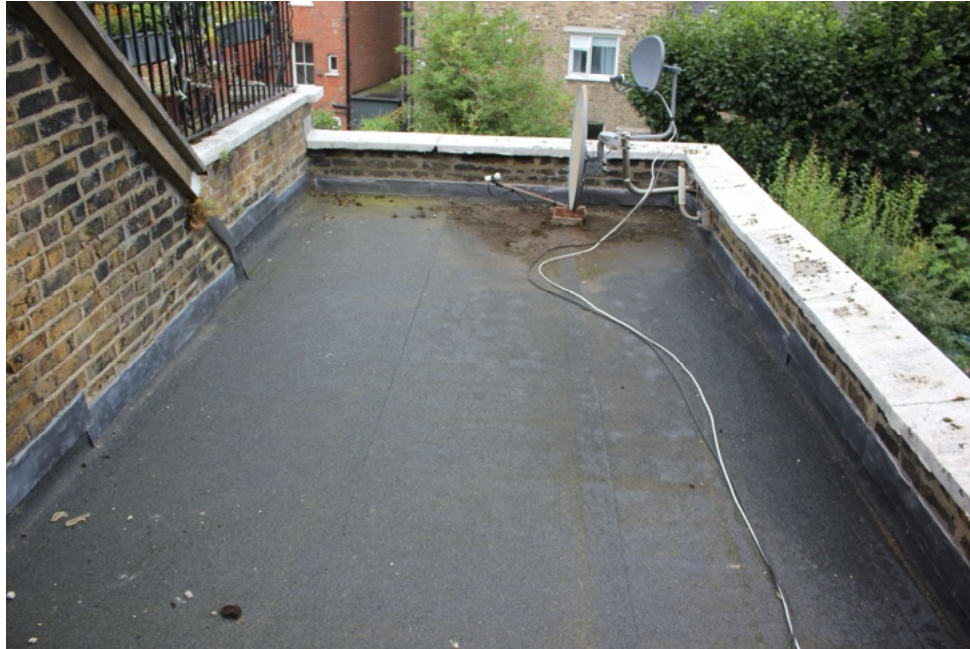
The roof over the two-storey, rear-projecting section of the house is flat, timber framed and covered with bituminous felt. Bituminous felt is not a particularly durable material, with a life in use of 25-30 years depending on detailing and exposure to direct sunlight. The existing felt appears to have been replaced within the last 10-15 years and is in fair condition. There is extensive damage and staining to the ceilings in the first-floor rear bedroom and bathroom. However, this is likely to have occurred prior to the provision of the existing felt, and the staining was found to be dry. The two-storey section of the house should, in any event be demolished because of structural movement noted in Section 5.4 below, at which time, of course, the roof will have to be rebuilt and re-covered.

Photo 6 – View to the flat roof over the two-storey, rear-projecting section of the house

ACTION: You should allow for the cost of having the roof over the two-storey rear-projecting section of the house rebuilt, at which time it is assumed that you will wish to enlarge the window opening off the landing providing access to the flat roof so that you can insert doors, provide decking or other pedestrian covering and use the flat roof as a deck. You will need to provide handrails to the perimeter of any deck/terrace and works to provide a terrace will require planning and building control consents.

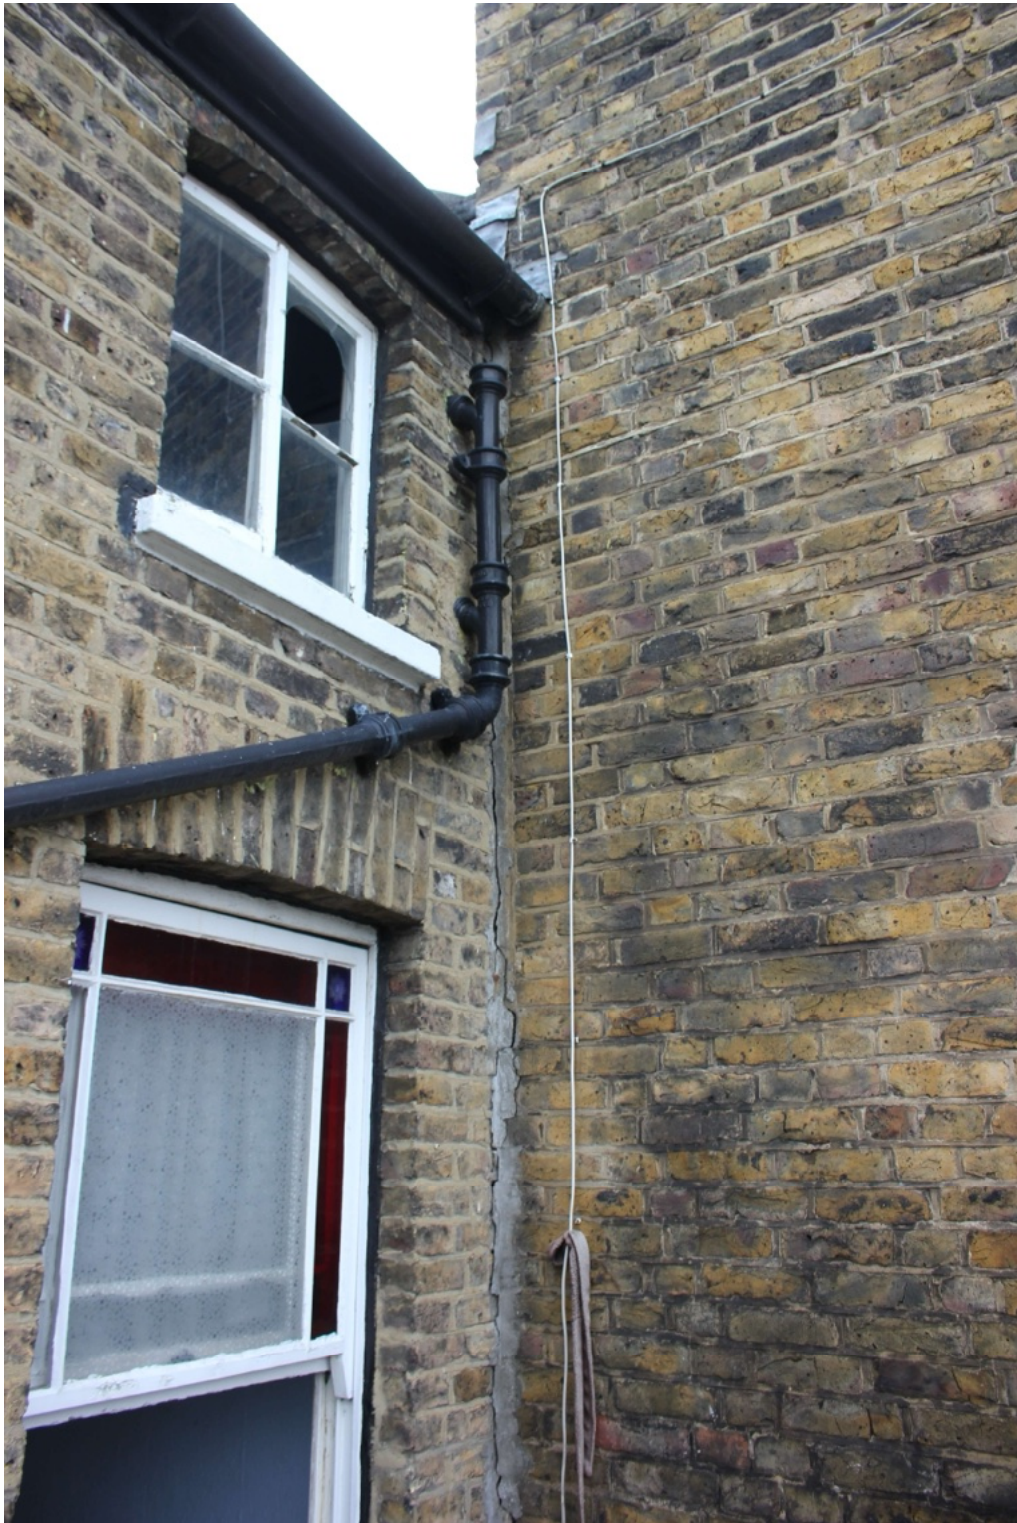
The walls to the two-storey, rear-projecting section of the house have been subject to significant settlement, hence the open joints between the tall chimney and rear main wall, see Photo 7 overleaf, the open joints internally between the ceiling and walls to the lower first-floor landing and the rear main section of the building, see Photo 8, and distortion to the floors in the first-floor rear bedroom and bathroom. This movement appears to be the result of an inherent design defect, i.e., the footings/foundations to the rear section of the house simply do not appear to be deep enough. Similar movement can be seen to neighbouring properties. In fact, the rear sections of the immediate neighbouring properties have been rebuilt. In addition, and more seriously, the right and rear walls to the two-storey section of the house, and particularly the right wall, are lacking lateral restraint at first-floor level and have bowed outward some 50mm-60mm. To exacerbate the issues with this part of the building, the brick-on-arch to the kitchen window has partially collapsed leading to deflection of the brickwork adjacent, see Photo 9.

Photo 7 – Previously filled and open joints between the rear main wall and tall chimney

Taking all issues into consideration, the only economically viable option in this instance is to demolish the right and rear walls and interior of the two-storey, rear projecting section of the building, leaving only the party wall, chimney and chimney-breasts, and to rebuild the external walls on new foundations. It would be preferable to rebuild the party wall as this is likely to be built on relatively shallow footings and may, therefore, be subject to 'seasonal movement' at least, (movement caused by seasonal fluctuations in the moisture content of the underlying subsoil), but this would, of course, be a very disruptive undertaking that would require the consent and cooperation of the neighbour. An alternative would be to underpin the party wall, but this too would be costly and complicated. The rebuilt walls should serve to stabilise the structure as a whole and rebuilding or underpinning of the party wall is not considered essential.

ACTION: You must allow for the cost of having the two-storey, rear-projecting section of the building rebuilt.

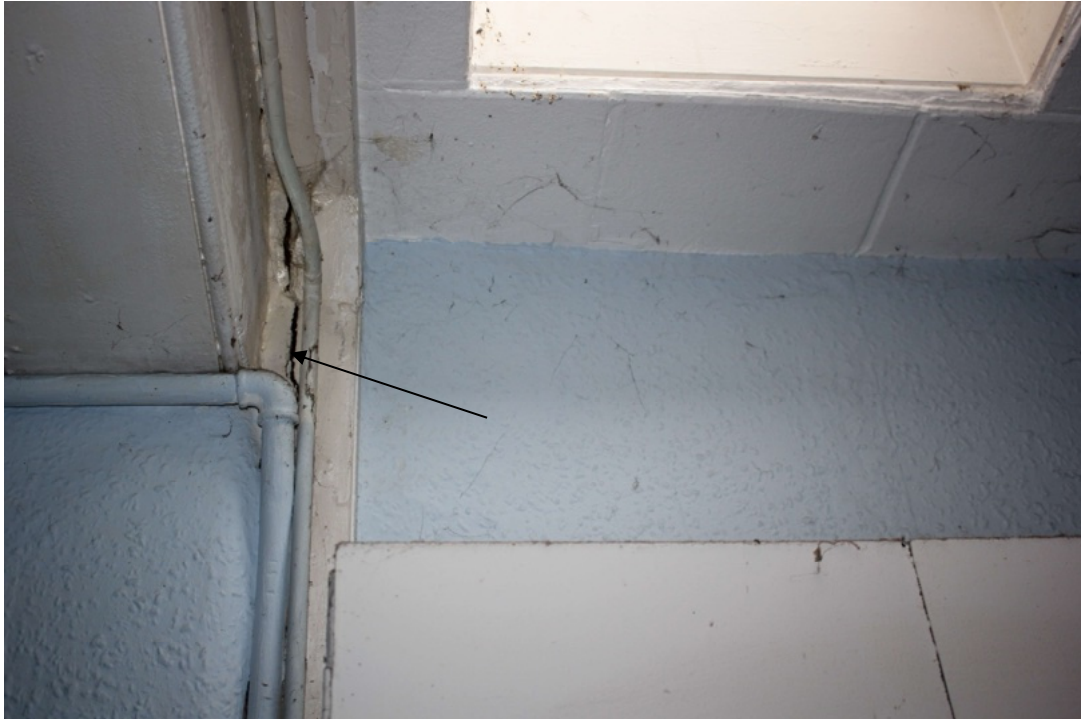
Photo 8 – Open joint at the ceiling and rear main wall in the lower hall

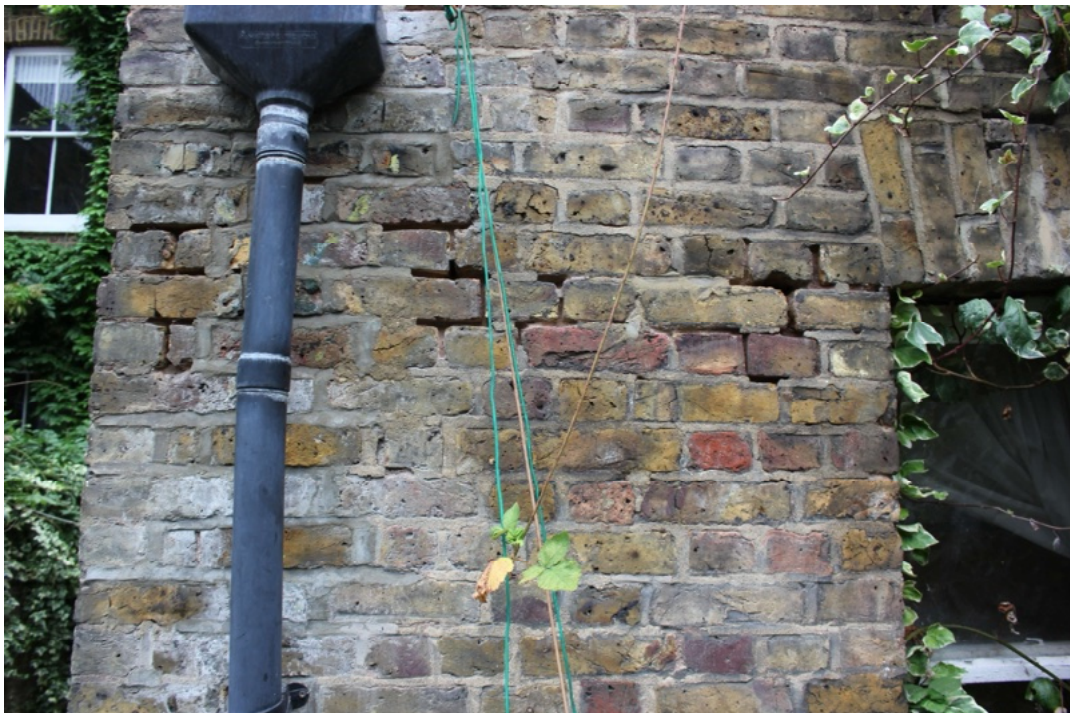
Photo 9 – Partially collapsed arch to the kitchen window with unstable brickwork adjacent

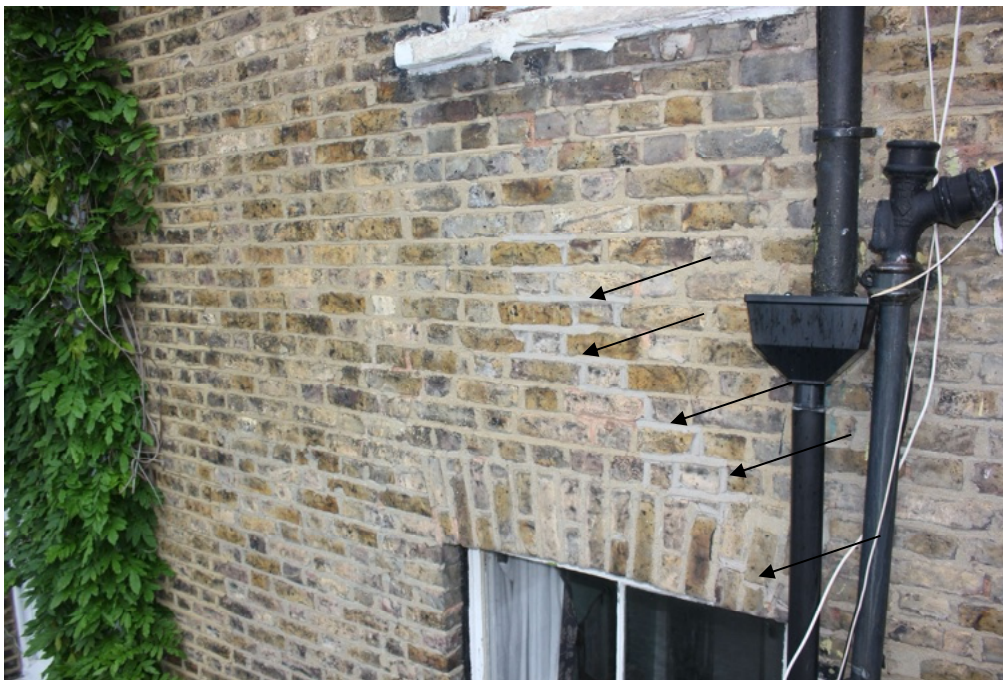
The rear main wall has been subject to some settlement, which has cracked the brickwork above the window opening above the first-floor mid-bedroom. The crack has been filled with cement-rich cement mortar, see Photo 10 below. The movement has also caused distortion of the rear window openings, deflection of the sills to these window openings, and distortion of the brick courses beneath the sills, see Photo 11 overleaf. The sills are misaligned from the horizontal by some 25mm-30mm across their width.

Photo 10 – Filled crack to the rear main wall above the first-floor mid-bedroom window opening

The settlement noted to the rear main wall is likely to be the result of uneven consolidation of underlying subsoil shortly after the house was built, although the drain runs from the rear of the building, underneath this wall, and out toward the front of the Property, and it is possible that leakage from this has caused or contributed to the movement. There is no sign of recent or ongoing movement and no major remedial works are essential. However, the drains should be checked and some works are required to the external masonry.

ACTION: You should have the drains inspected with the aid of a CCTV camera, ideally prior to exchanging contracts, so that you are able to assess the extent of any drain repairs required. A further allowance should be made for having the distorted and weathered window sills to the rear bedrooms re-formed.

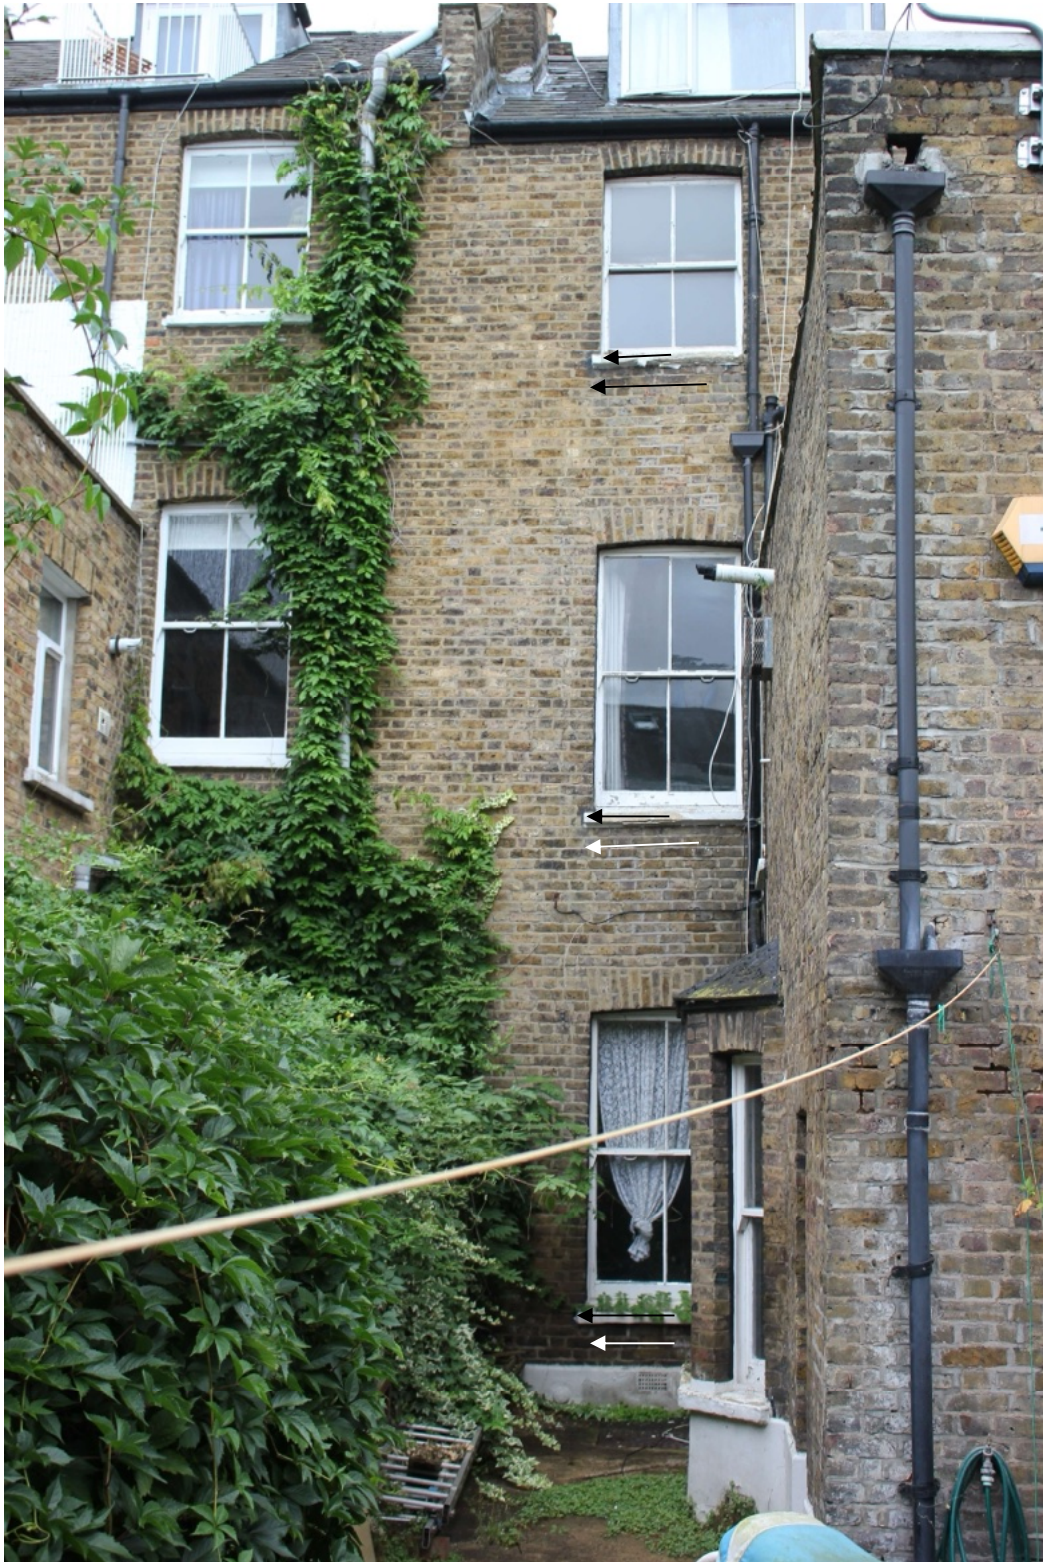
Photo 10 – Settlement of the rear main wall

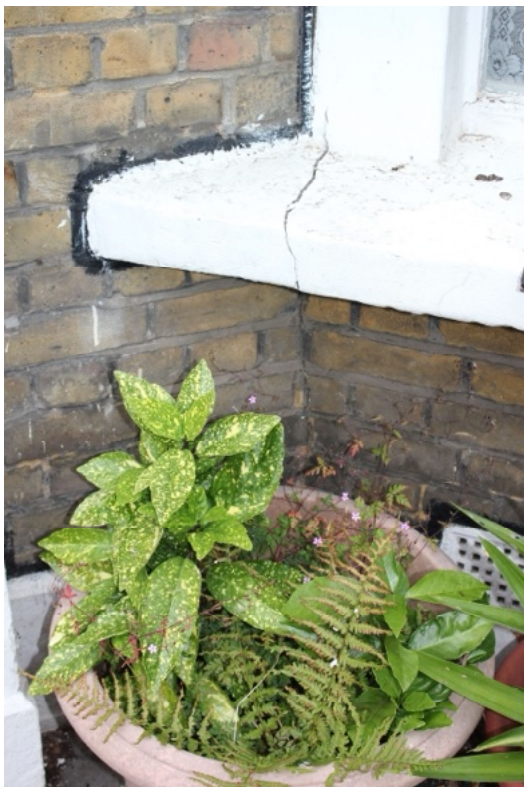
Further movement was noted to the two-storey, front bay structure. The bay walls have settled slightly and have pulled away from the adjoining front wall, see Photos 11 & 12 below. This is likely to be the result of seasonal fluctuations in the moisture content and, therefore, volume of the underlying subsoil, probably exacerbated by moisture uptake from a nearby street tree, which has recently been removed. The movement, whilst noticeable, is not likely to worsen to a significant degree in the future and no major remedial works, i.e., underpinning or rebuilding, are required. Some relatively inexpensive, wall tying would nevertheless be prudent.

Photo 11 – Cracked bay sill

ACTION: It would be prudent to insert Helibar wall ties into the joints between the front bay walls and the front main wall at ground and first-floor levels. These would be inserted into the brick joints and would be an invisible strengthening measure. The street tree, which would have exacerbated fluctuations in the moisture content of the underlying subsoil has, as mentioned, already been removed.

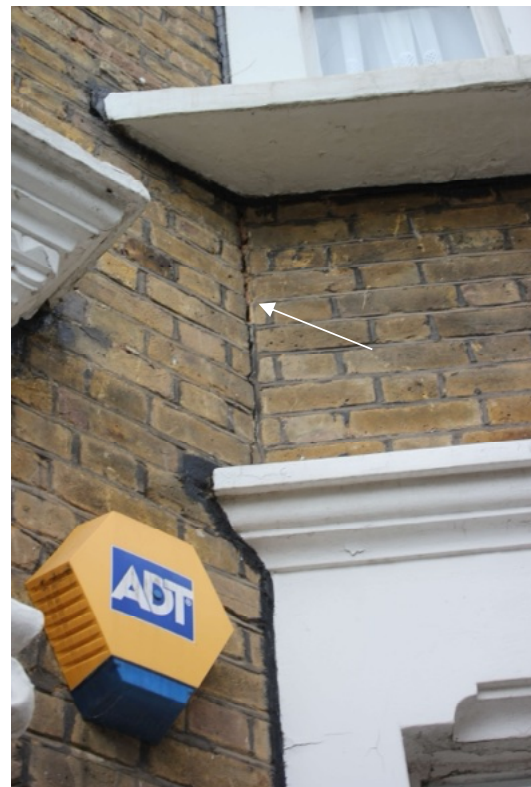
Photo 12 – Crack at bay wall junction

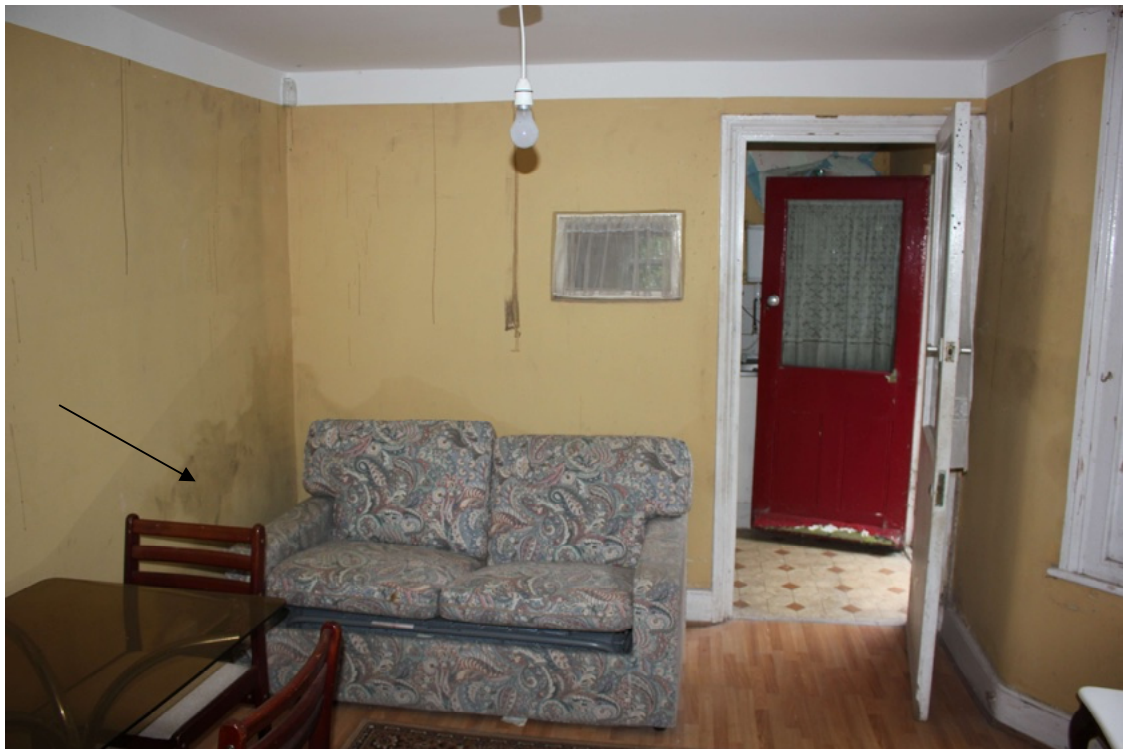
Dampness was noted to the lower chimney-breast and left wall in the rear living/dining room, see Photo 13 below. This chimney-breast and the left party wall will be retained while the adjoining walls are demolished. You should, therefore, allow for the cost of damp treatment, as set out in Section 5.5 above. The chimney flues should be opened up and swept to remove all damp soot and detritus prior to this damp proofing work.

Photo 13 – Dampness to the lower chimney-breast and left wall in the rear living/dining room.

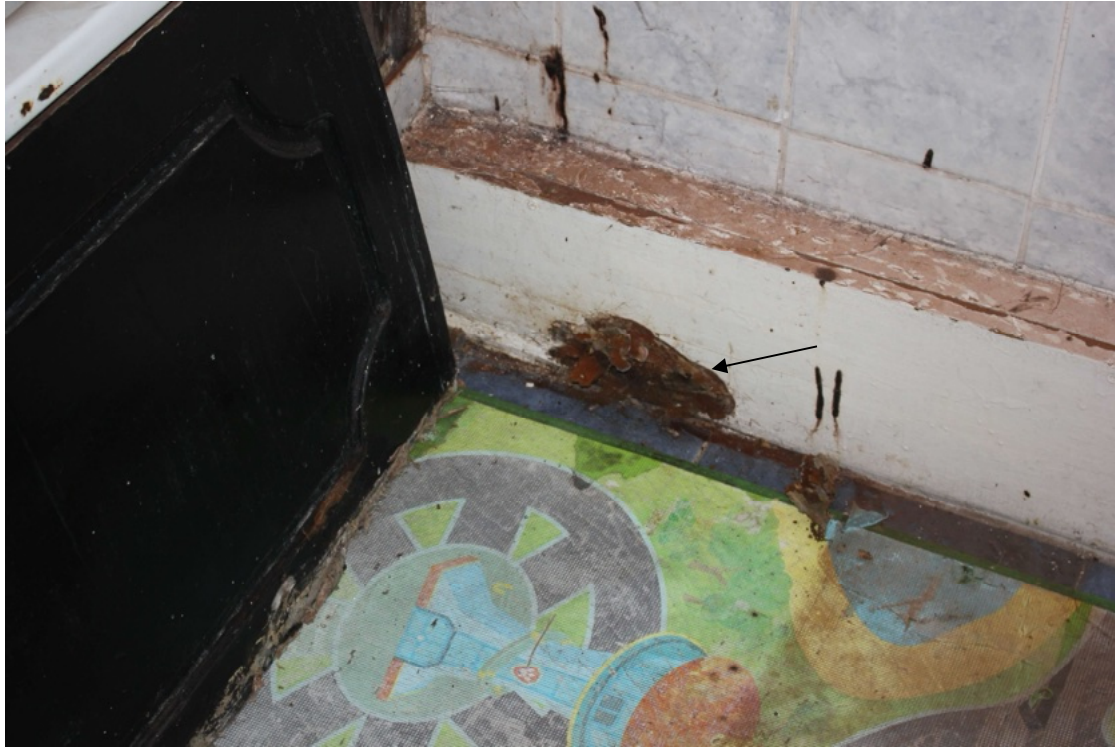
A dry-rot fruiting body was noted to the skirting board in the first-floor bathroom, see Photo 14 overleaf. Further dry rot was noted to the lower sash and frame to the window in the second-floor rear bedroom. The floor to the first-floor bathroom will, obviously, be removed as and when the walls to the two-storey, rear-projecting section of the house are demolished. The rot-affected timbers to the window in the second-floor rear bedroom should be cut out and replaced, or the window should simply be replaced as set out in Section 5.6 above.

Photo 14 – Dry rot in the skirting board to the first-floor bathroom.
