Arboricultural Impact Integration Assessment Report:

**West Hampstead Lawn Tennis Club, off Croft Way,
Ferncroft Ave, London NW3 7PQ**

Report Date: 16th November 2024

Ref: WCEL/PEW/AIAR/1116:24

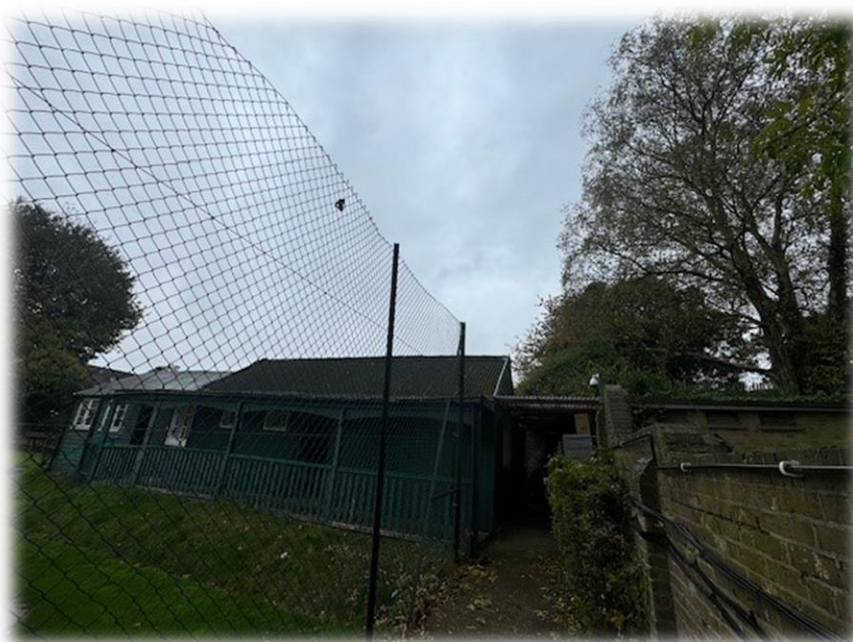
Silver Birch (T1) Right- In Neighbouring Garden Notable Distance from Clubhouse – No RPA Conflict

🌿 Silver Birch (T1) is a large mature specimen which has passed its active growing stages of its life cycle. The tree has a well-formed crown which is formed on a clean vertical trunk which is growing two gardens away behind a large brick and concrete building some distance from the proposed replacement club house. The tree is a good size and provides some amenity value to the broader conservation area. The tree is growing at a reasonable distance from the existing Clubhouse and the proposed replacement Clubhouse structure. The specimen is mature and the theoretical radial RPA of the tree does not conflict with the proposed building works and is sufficiently far enough away to be unaffected by where the Clubhouse is to be constructed. The crown of the tree is substantially far enough away to be unaffected by the proposed new structure. The tree has a modest crown spread and the distance to the new structure would have a similar relationship.

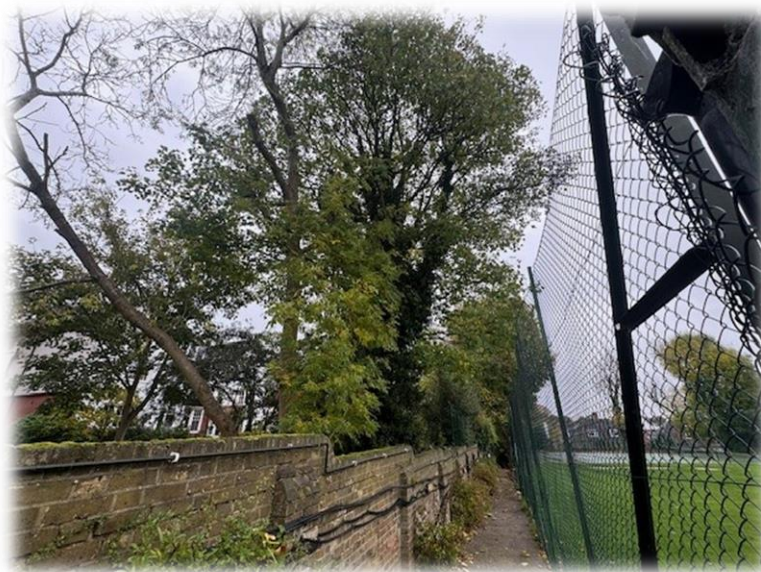
Trees (T2-T4) Trees Located Significant Distance from Proposed Replacement Clubhouse

- ☼ Ash (T2) is an over-mature specimen of slender form and limited vigour. The tree is very tall and slender and slightly sparse crown formed at a very high level. The tree is growing with a conjoined trunks with Ash (T3) both of which are growing on a relatively high mound of soil formed up against the boundary wall. The tree is slender but has some value to the broader amenity of the conservation area when combined with nearby trees. The tree is growing at a good distance from the Clubhouse and the proposed replacement Clubhouse. The specimen is over-mature with a large longitudinal cavity running down its trunk and the theoretical radial RPA of the tree does not conflict with the proposed building works and is sufficiently far enough away to be unaffected by the location of the proposed replacement Clubhouse to be constructed. The crown of the tree is suitably far enough away to be unaffected by the proposed extension. The tree has a relatively small high crown and the distance to the new structure would have a similar relationship to the existing one.

- ☼ Ash (T3) is a semi-mature specimen of very slender contorted form and limited vigour. The tree is very slender, growing at a significant angle with sparse crown formed at a high level. The tree is growing with a conjoined trunks with Ash (T2) both of which are growing on a relatively high mound of soil formed up against the boundary wall. The tree has a slender poor-quality form and has no significant amenity value to the broader conservation area. The tree is growing at a good distance from the Clubhouse and the proposed replacement Clubhouse. The specimen is semi-mature with a very substantial growth lean and the theoretical radial RPA of the tree does not conflict with the proposed building works and is sufficiently far enough away to be unaffected by the location of the proposed replacement Clubhouse to be constructed. The crown of the tree is suitably far enough away to be unaffected by the proposed extension. The tree has a relatively small high crown and the distance to the new structure would have a similar relationship to the existing one.

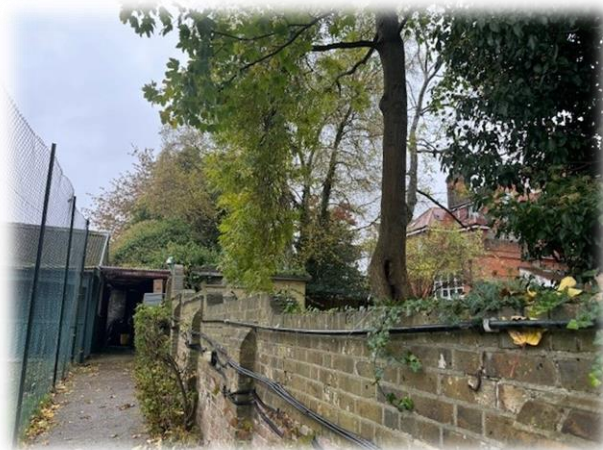
Access to and from Site Along Pedestrian Entrance Path

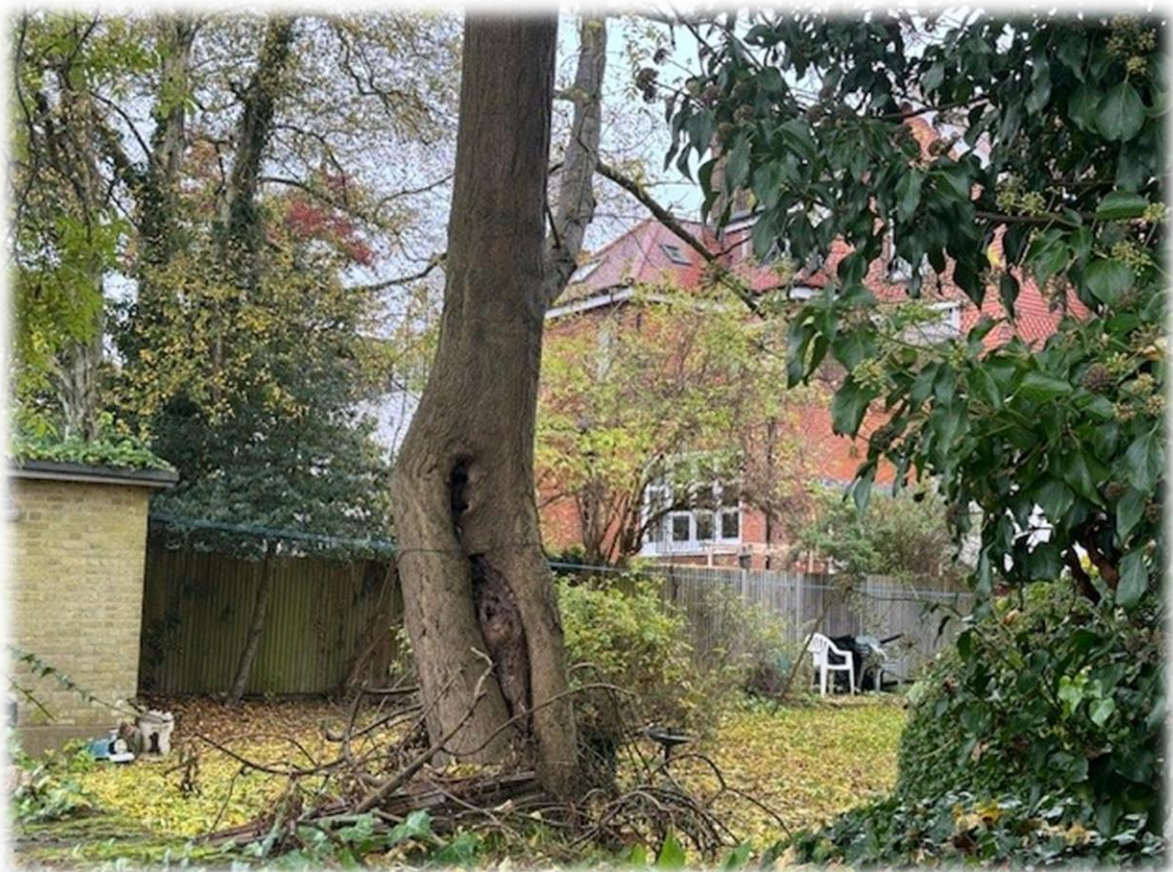
Significant Area of Decay on Trunk of Neighbours Tree (T4)- No RPA Conflict
