project	131_9 Wedderburn Road
client	Private Client

site address	9 Wedderburn Road, London, NW3 5QS
--------------	------------------------------------------

drawing title	<b>Fence Condition</b>
project number_drawing number_revision	<b>131_425_PL01</b>

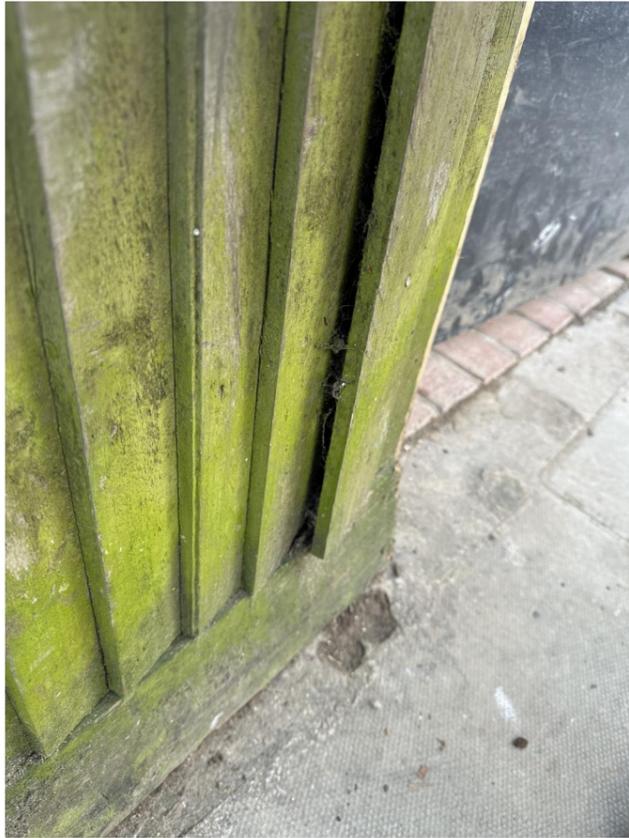
Loose feather edge boards

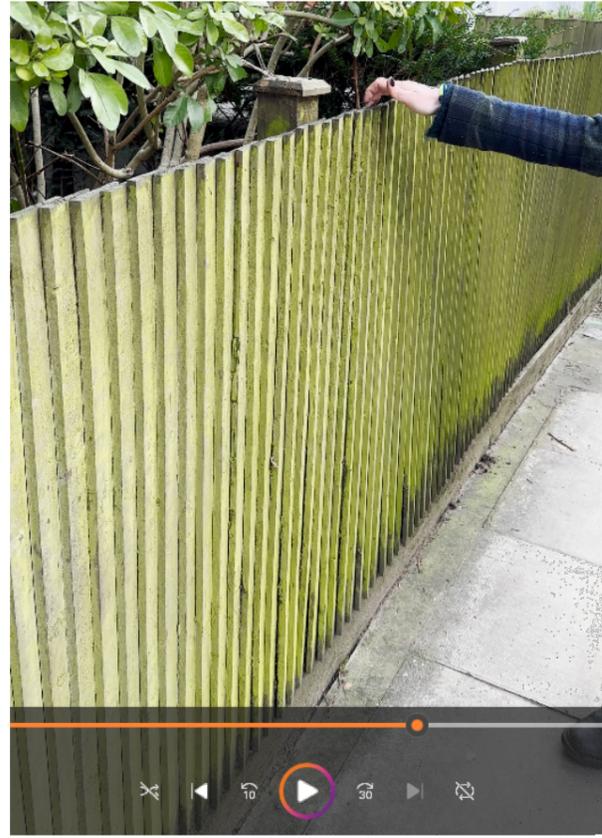
Video can be provided to demonstrate instability of the fence

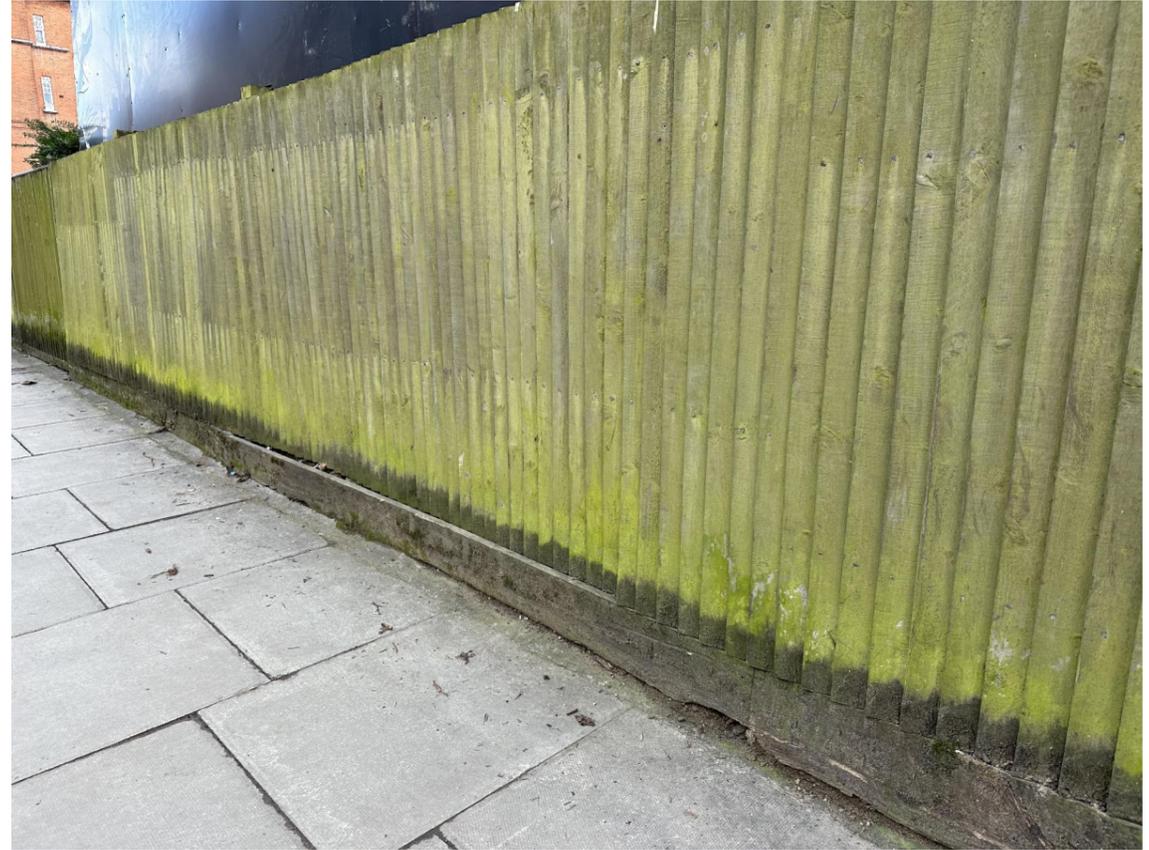
Rotten gravel board and lower part of the fence, indicating evidence of rising damp

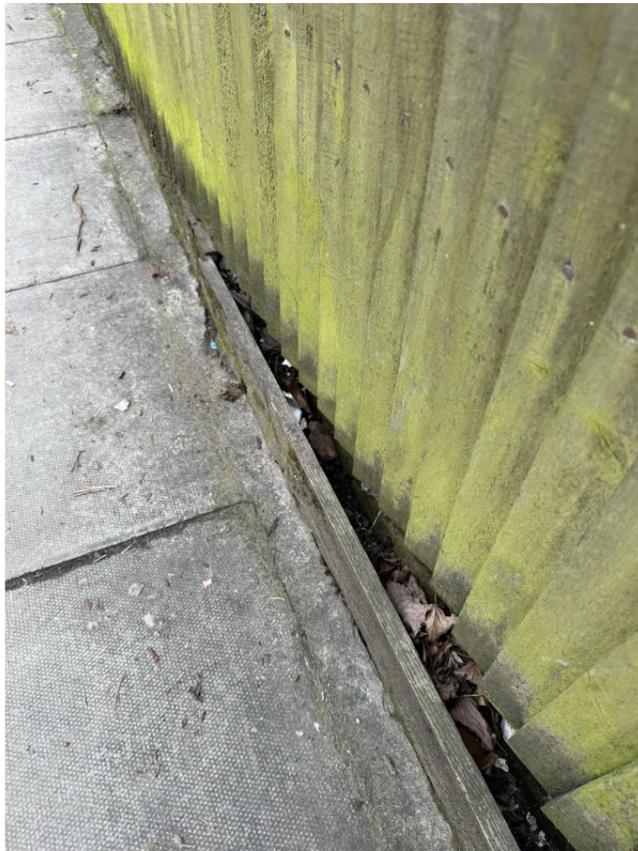
Fence is not aligned with the gravel board

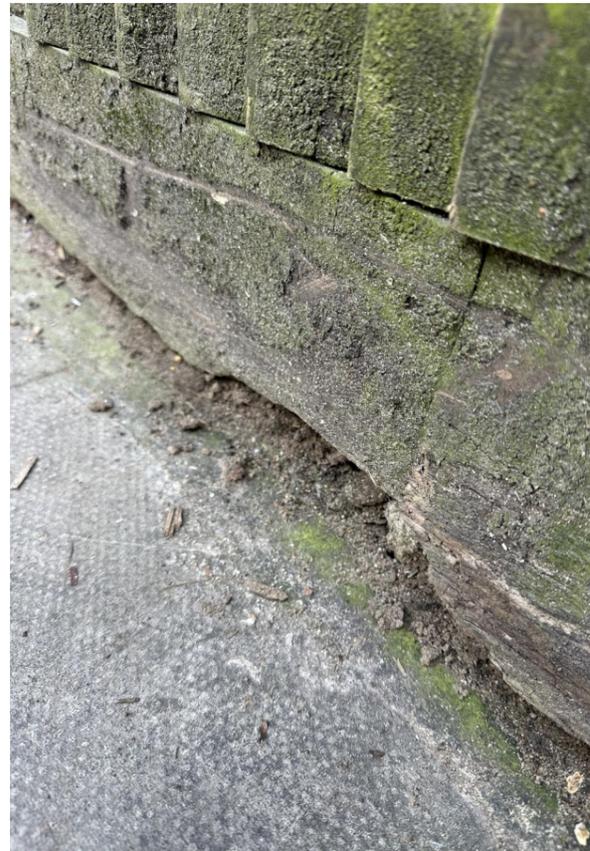
Rotten gravel board

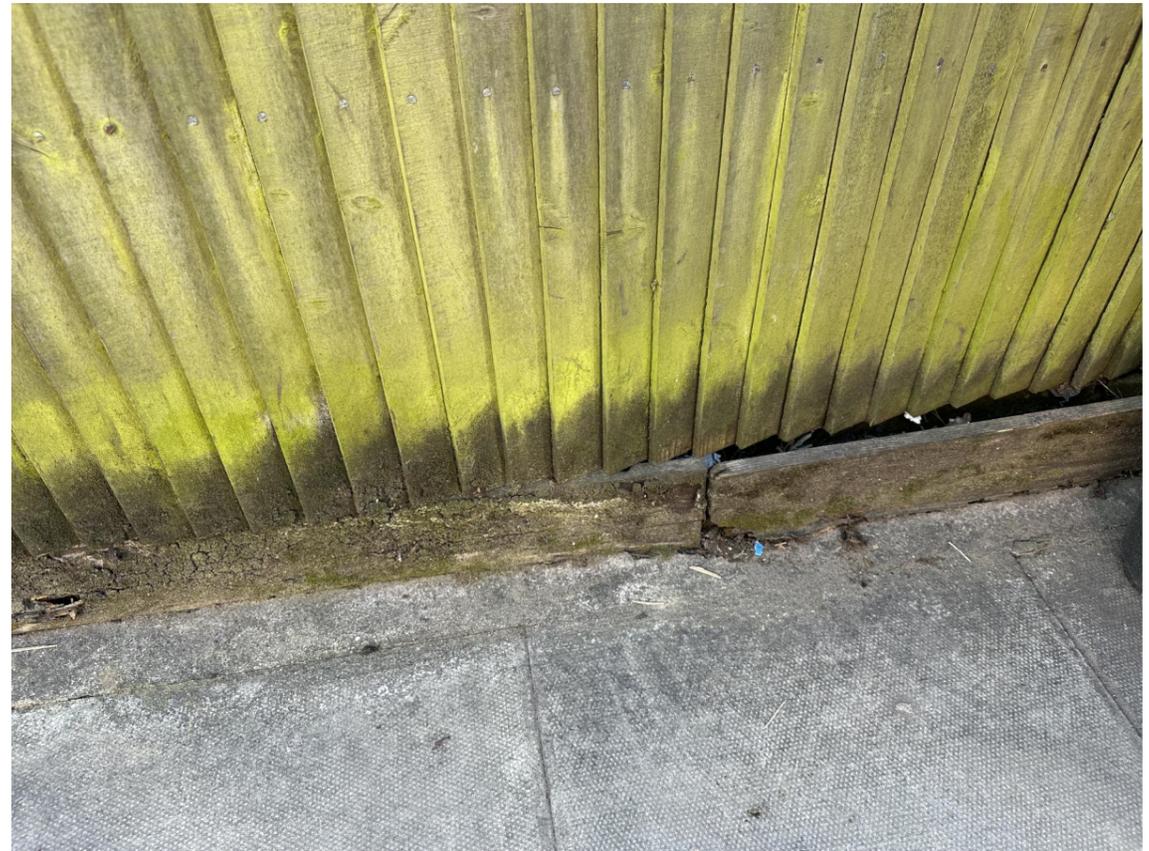
Rotten gravel board and lower part of the fence, indicating evidence of rising damp
