9 Wedderburn Road

project number\_drawing number\_revision

131 424 PL01

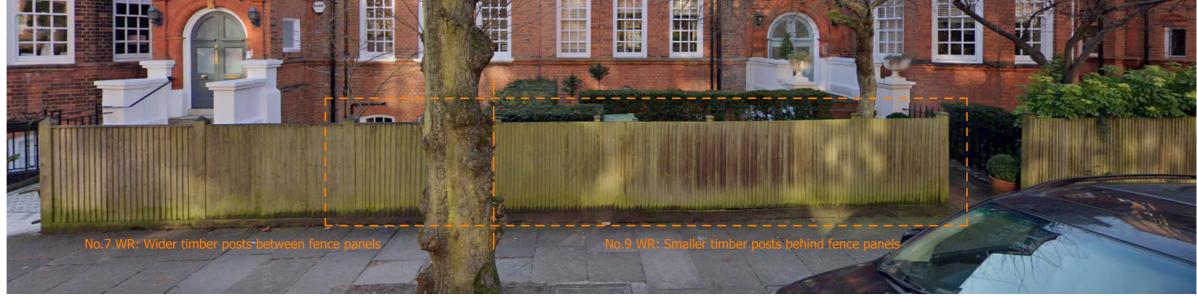
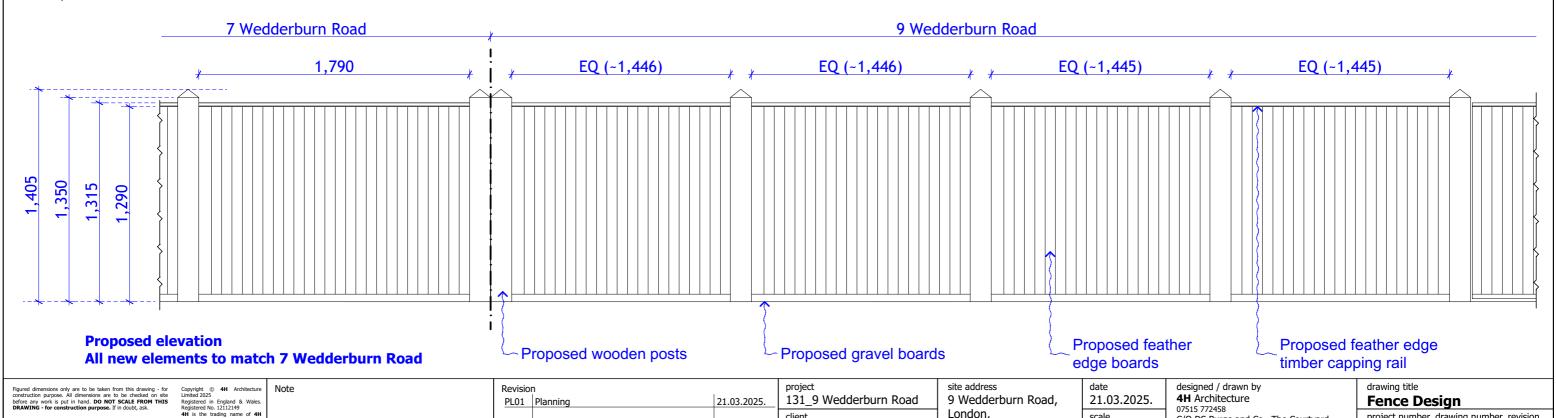
- 1. The design of the feather fences at the front of No. 7 and No. 9 Wedderburn Road currently differs. At No. 7, the feather fence is positioned between the wooden posts, whereas at No. 9, the fence is mounted in front of the posts. This difference in design creates an inconsistency in appearance between the two properties.

- 2. All of the wooden posts along the fence line need to be replaced, as they are severely rotten. The deterioration of the posts has compromised the overall structural integrity of the fence, making it unsafe and prone to collapse.

- 3. The gravel boards along the fence also require replacement due to the effects of rising damp. The moisture has caused significant damage to the boards, leading to rotting and weakening of the material, which could worsen if left unaddressed.

- 4. The fence panels themselves are loose and unstable, with significant gaps between them. These panels have been severely affected by rising damp, which has led to most of them becoming rotten and no longer providing adequate protection. The loose and damaged panels create both aesthetic and security concerns.

By replacing the damaged posts, gravel boards, and panels, we can introduce a new, unified fence design for both No. 7 and No. 9 Wedderburn Road, ensuring consistency in appearance and improving the overall stability and durability of the fence.
