**26 Rosslyn Hill
London – NW3**

**Structural Engineering Strategy
Stage 2 Report**

Date:	14/12/2022	Prepared by:	TS
Reference:	1031-rep-001	Checked by:	JD
Filename:	1031-rep-001-P1-Stage 2 Report.docx	Status:	Stage 2 - PRELIMINARY
Revision:	P1		
Revision Date:	14/12/2022		
Revision:	P2		
Revision Date:	10/03/2025		
Kiosque Ltd, 20-22 Wenlock Road, London, N1 7GU t. 020 3740 0745 – e: mail@kiosque.co.uk

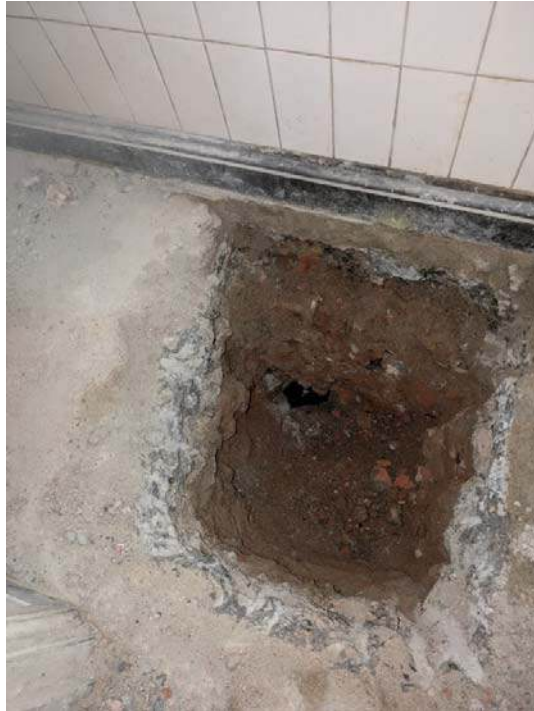
- A void under the foundations was noted in the rear lower ground floor toilets, with the brick wall bridging over the void with no lintel of reinforced concrete beam. This shall be investigated further. The void shall be filled with concrete and local underpinning of the foundation shall be carried out to ensure the wall above bear on sound ground.

Void under foundation

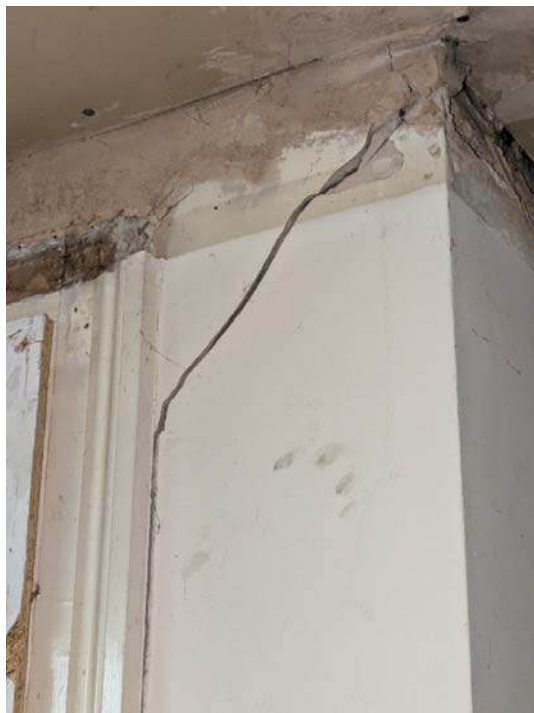
- Cracks and movement in walls were noted in some external walls (front wall and rear wall). These cracks would indicate that differential movement has occurred at foundation level. In addition to repairs and strengthening the walls (eg installation of Helifix bars in masonry joints to bond walls junction together) local underpinning of the foundation shall be considered.

Crack in wall adjacent to bay window

- Where structural cracks were observed, local stitching of the walls shall be carried out by inserting stainless steel reinforcement bars (eg Helifix bars) within the brick joints.

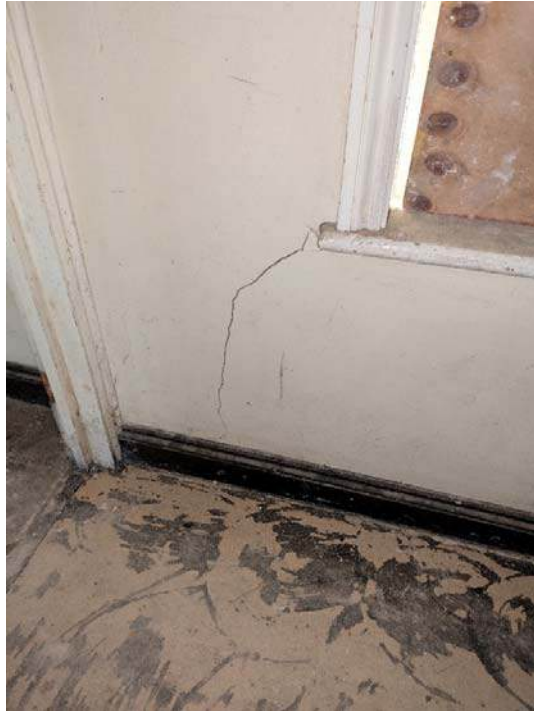
Crack adjacent to window in top landing

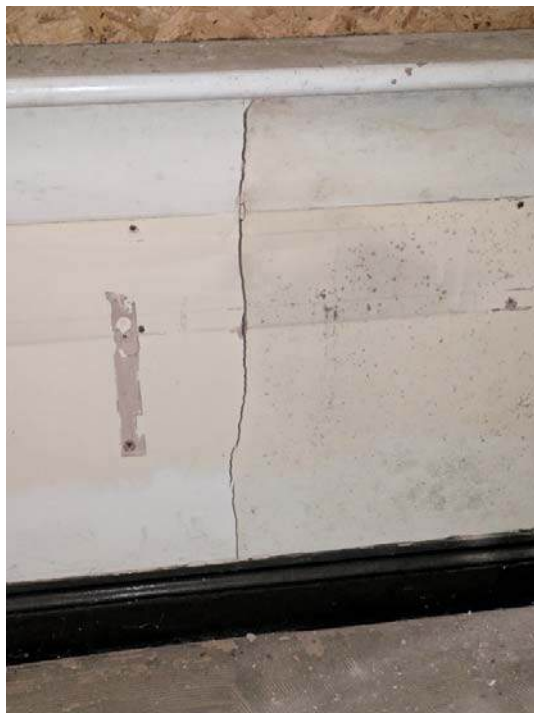
Crack under window in rear rooms

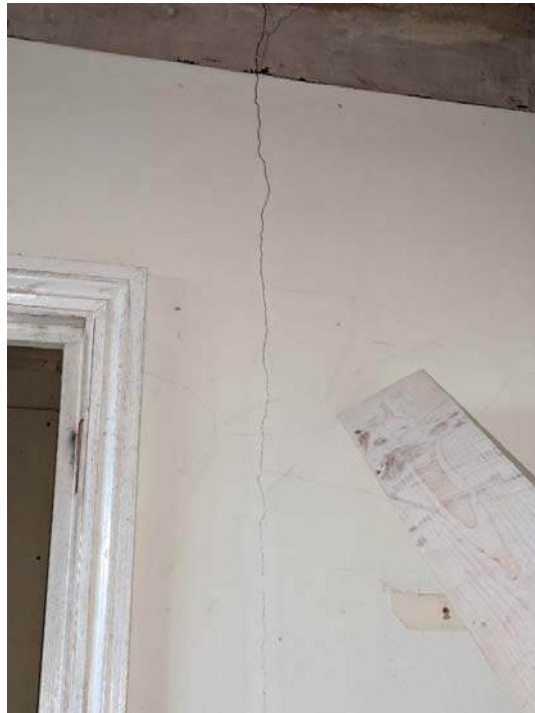
Crack in wall in rear room at first floor

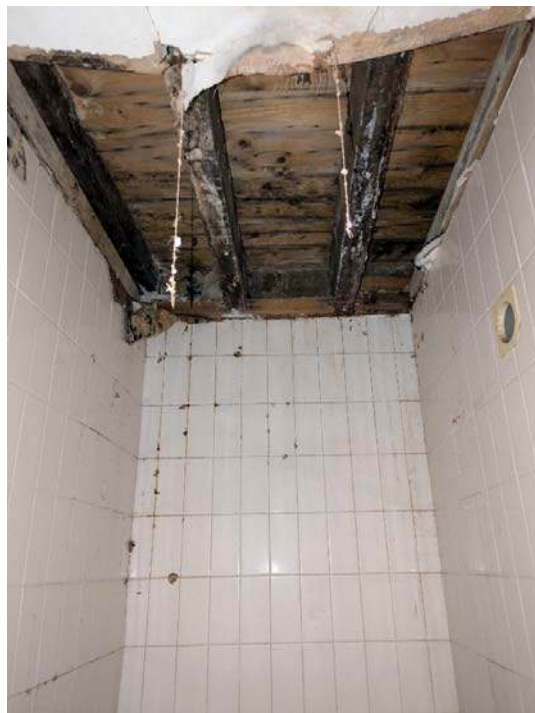
- A high level of dampness, fungal growth and local decay was noted. We suspect that once all ceilings and floor boards will be removed a more widespread problem of timber dampness and decay will be uncovered. Consequently, we will recommend that during the future development the timber joists are replaced throughout the floor.

Fungal growth in timber

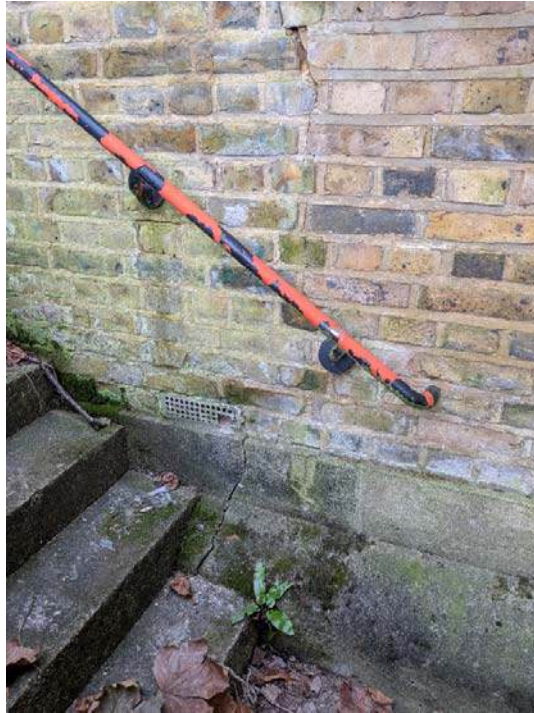
Crack in external wall

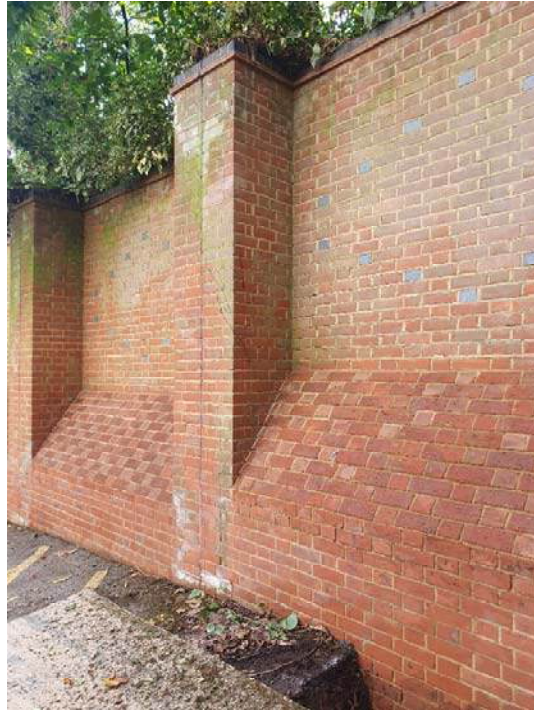
Photo 1: Brick Garden Wall

- The wall is a substantial brick construction given the required purposes.
- The wall appears to be in good condition with no sign of distress or structural damage.

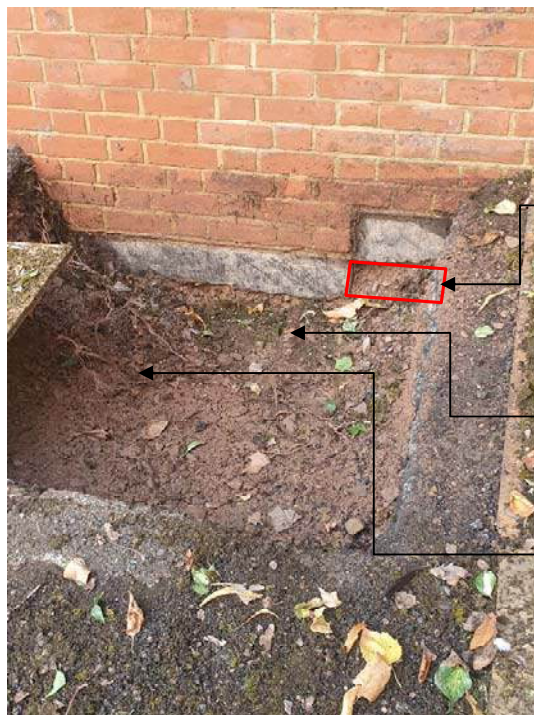
Photo 2: Trial Pit - Wall Foundations

- No overlap has been installed at the step between the higher and lower level concrete footing (see Photo 2).
- Roots, including a large approximately 60 mm diameter root, below the foundations were noted in the trial pit. These roots appear to be from the plane tree on the other side of the wall on No 24 garden.

- The stepped foundations have been installed with no overlap at the change in level of the footing (see Photo 2). Consequently, there is a weak point at the step location and should ground movement occur, cracks could develop from this point.

No footing overlap
At step

60 mm diameter root
under footing

roots
under footing

- A preventive measure to make the wall futureproof would be to increase the depth of the foundations and underpin the wall to such depths so that the bases of the underpins are outside the tree roots influence zone.

- In the view of high risk of potential structural damages, which could occur in the near future, we recommend that the wall is underpinned as described above at the earliest opportunity.

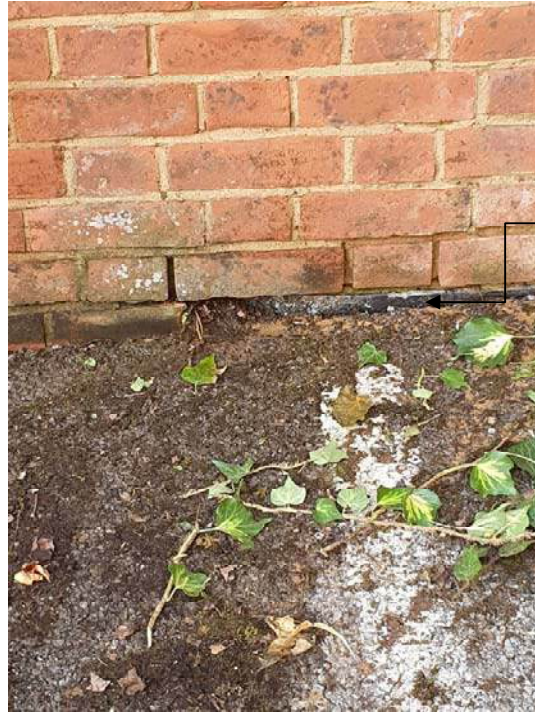
Photo 3: Wall Foundations at or Above Ground Level

- At one location the step has been installed slightly above ground level (see Photo 3) and consequently the foundations formation level at this location is only 150 mm below ground level.

Concrete footing
above ground
