TO BE READ IN CONJUNCTION WITH KTA  
STRUCTURAL SITE INSPECTION  
REPORT DATED 8TH JANUARY 2025.  
PHOTOGRAPH REFERENCE NUMBERS RELATE  
TO THE REPORT.

The Assembly House  
292-294 Kentish Town Road  
London, NW5 2TG

Proposed West Elevation

drawing number	revision
9312-06	-
checked SG	drawn LAC
scale 1:50 @ A1 (1:100@A3)	date Feb 2025

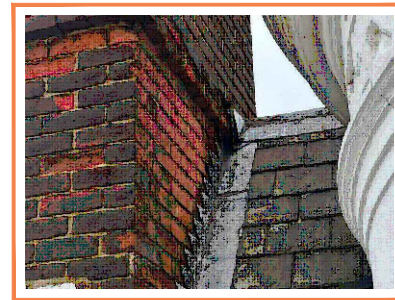
**Photo 12**  
Existing lead flashing is to be secured back to the existing brickwork using an appropriate lead sealant.

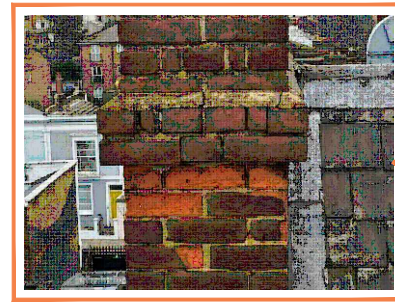
**Photo 11**  
Blown bricks are to be sufficiently repaired using a brick masonry repair filler.

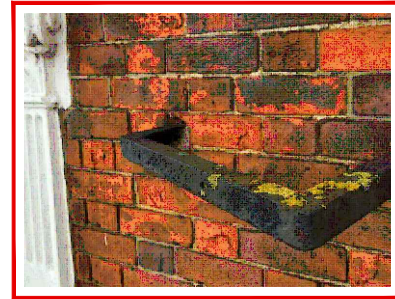
**Photo 21**  
Blown/damaged bricks are to be sufficiently repaired using a brick masonry repair filler.

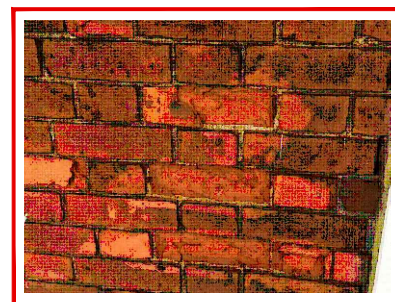
**Photo 22**  
Blown/damaged bricks are to be sufficiently repaired using a brick masonry repair filler.

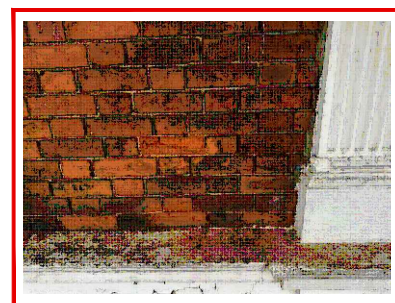
**Photo 23**  
Blown/damaged bricks are to be sufficiently repaired using a brick masonry repair filler.

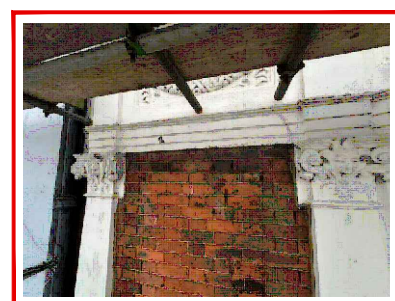
**Photo 29**  
Blown/damaged bricks are to be sufficiently repaired using a brick masonry repair filler.

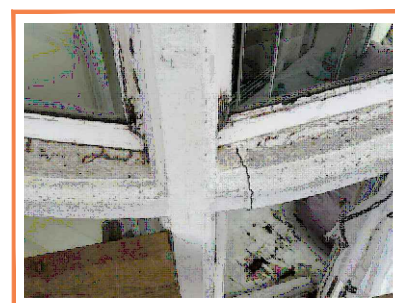
**Photo 20**  
The rotten timber windows are to be sufficiently repaired or replaced to prevent further water ingress and degradation to the stone supporting cills and corbels. The cracks to the stonework around the windows are to be raked out and filled using a lime based stone repair mortar.

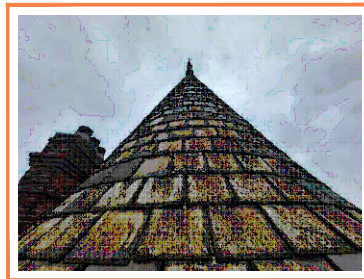
**Photo 4**  
Any damaged or cracked tiles are to be carefully removed and replaced on a like for like basis.

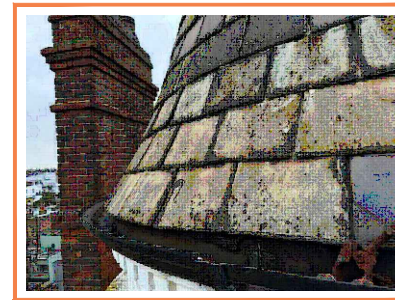
**Photo 5**  
Any damaged or cracked tiles are to be carefully removed and replaced on a like for like basis.

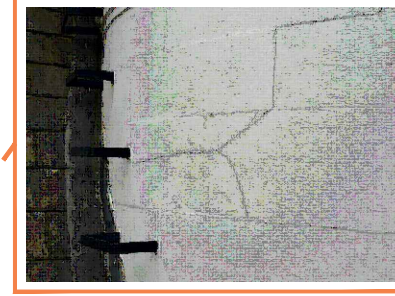
**Photo 13**  
The cracks to the upper stone walls are to be raked out and filled using a lime based stone repair mortar.

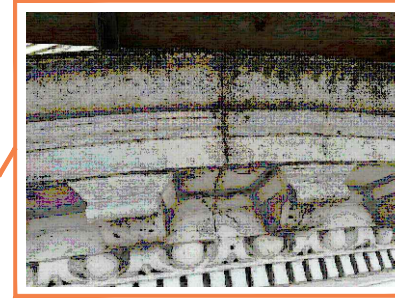
**Photo 15**  
The cracks to the upper stone corbel are to be raked out and filled using a lime based stone repair mortar.

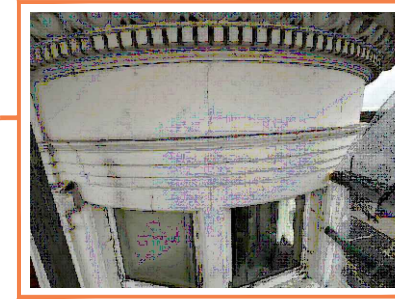
**Photo 16**  
The cracks to the upper stone corbel are to be raked out and filled using a lime based stone repair mortar.

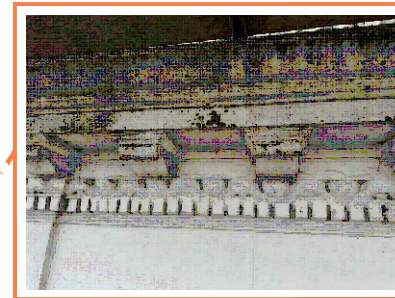
**Photo 14**  
The cracks to the upper stone corbel are to be raked out and filled using a lime based stone repair mortar.

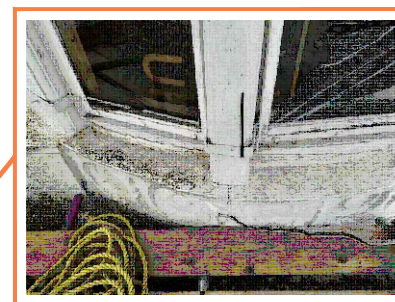
**Photo 17**  
The rotten timber windows are to be sufficiently repaired or replaced to prevent further water ingress and degradation to the stone supporting cills and corbels. The cracks to the stonework around the windows are to be raked out and filled using a lime based stone repair mortar.

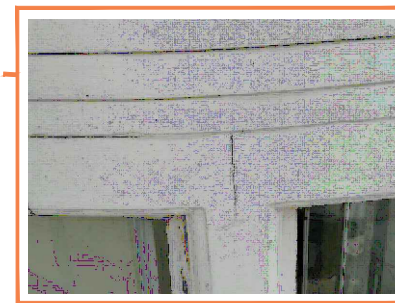
**Photo 19**  
The rotten timber windows are to be sufficiently repaired or replaced to prevent further water ingress and degradation to the stone supporting cills and corbels. The cracks to the stonework around the windows are to be raked out and filled using a lime based stone repair mortar.
