Richard Oxley, Oxley Conservation. April 2024

No. 114 Heath Street is one of a pair of surviving 18<sup>th</sup> century [list description] timber-framed buildings located within the Hampstead Conservation Area.

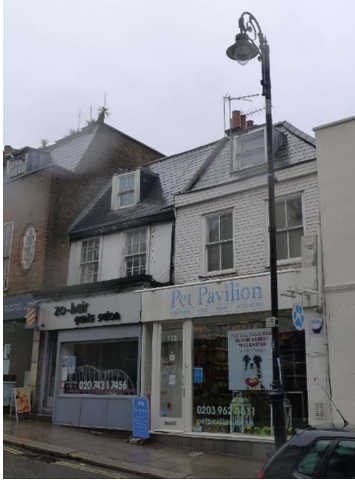
No. 114 on the left and No. 122 on the right

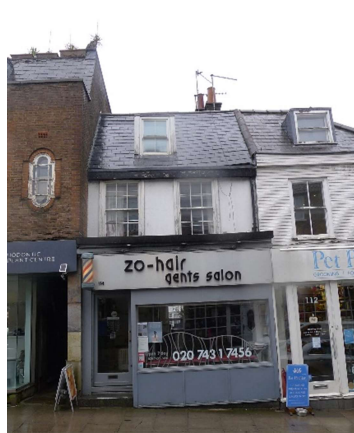
No. 114 front elevation

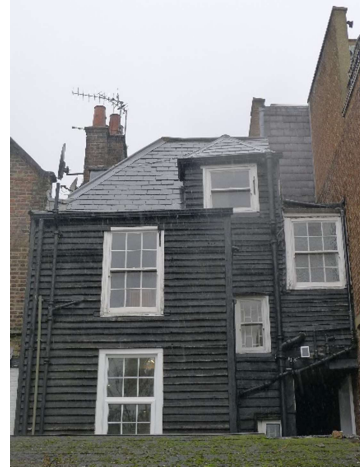
No. 114 rear elevation

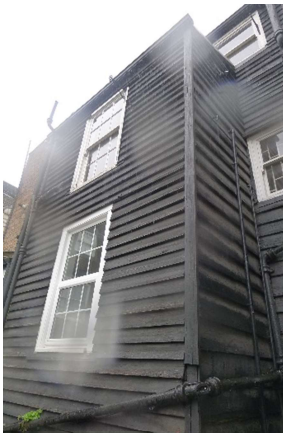
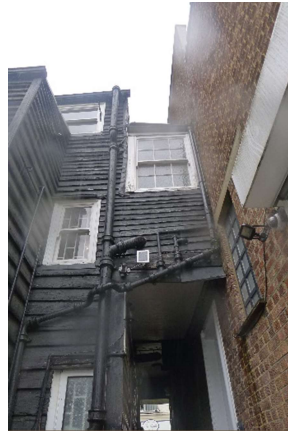
Rear elevation details
