Application for Planning and Listed Building Consent
114 Heath Street, London NW3 1DR

Photographic Survey

March 2025

EMILY
GREEVES
ARCHITECTS

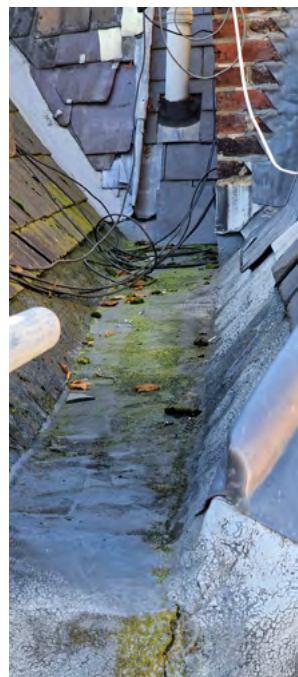
Valley gutter next to side dormer.

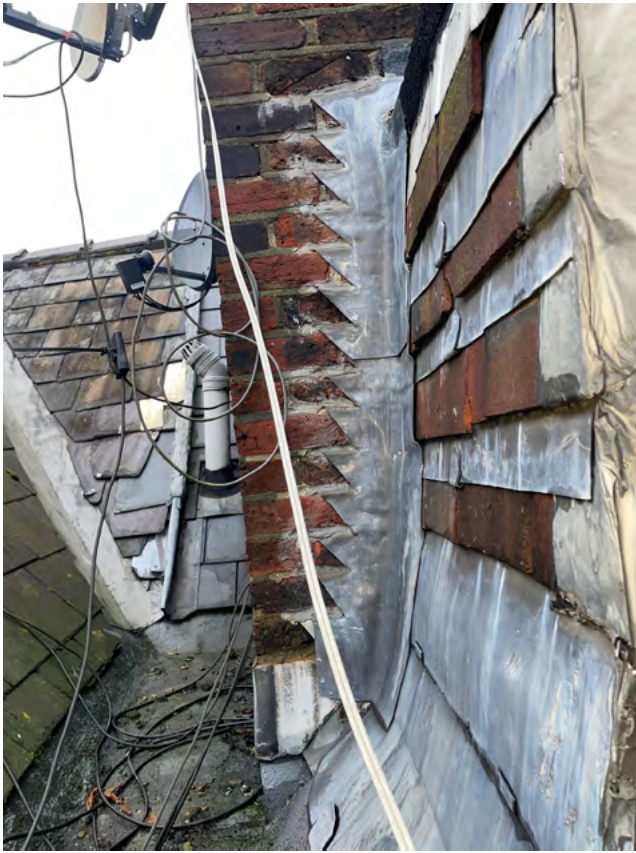
Junction of side dormer and chimney stack.

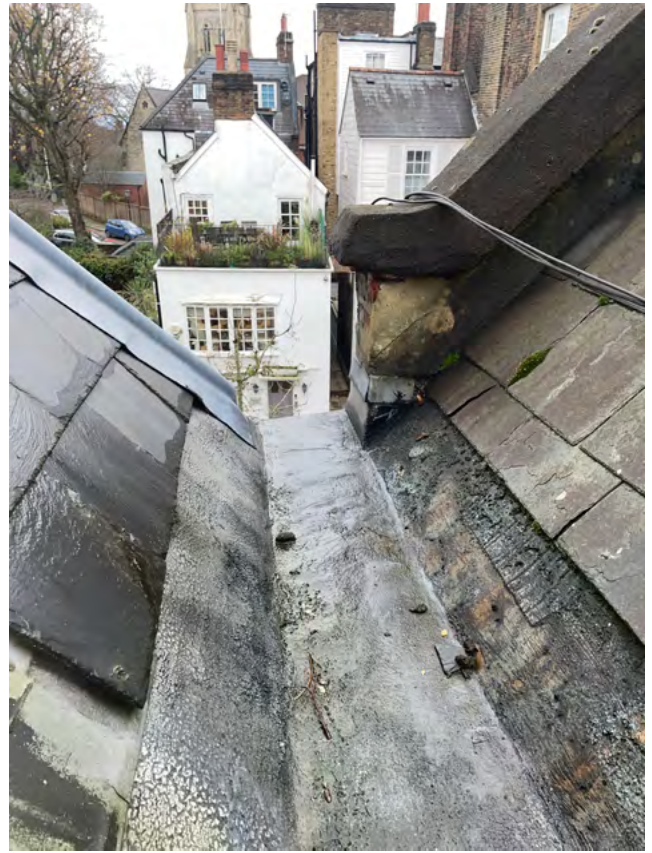
Valley gutter next to side dormer.

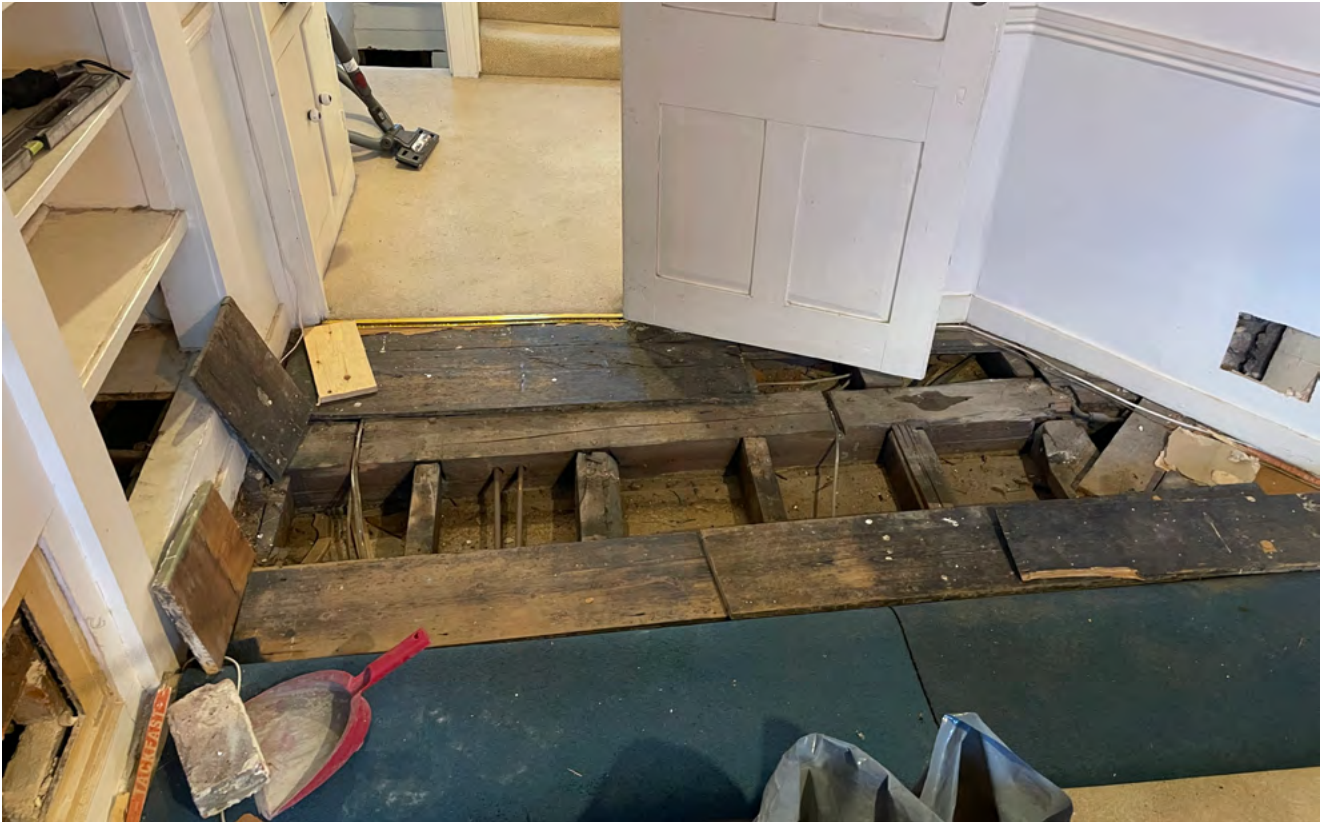
Living room floor construction: cross-beam between party wall and chimney stack, and joists between beam and front wall.

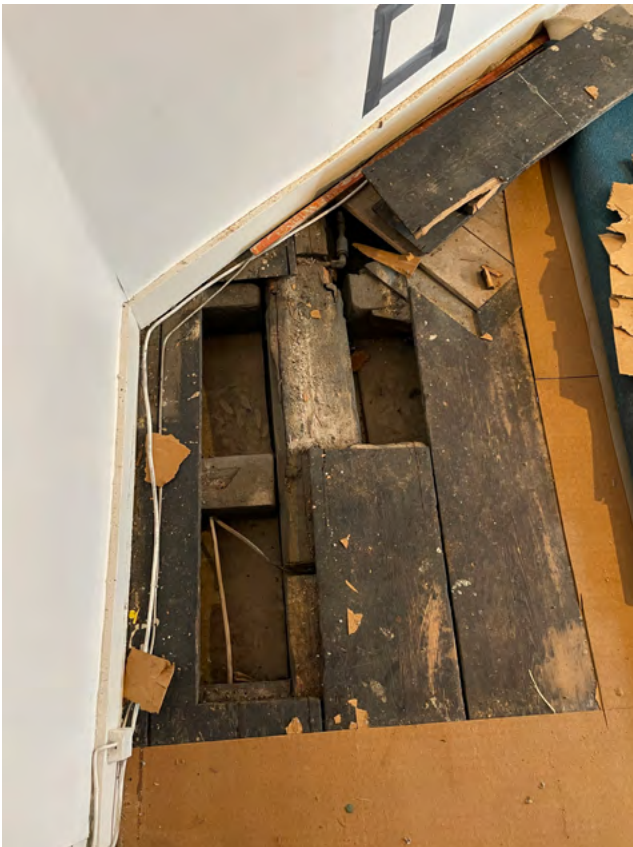
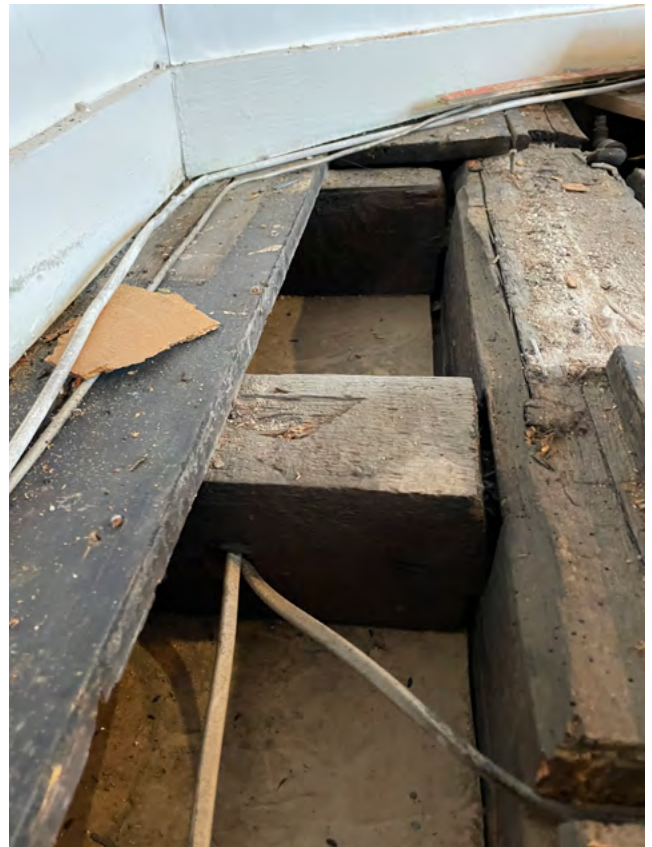
Close-up views of beam and joists showing condition and notching for services.

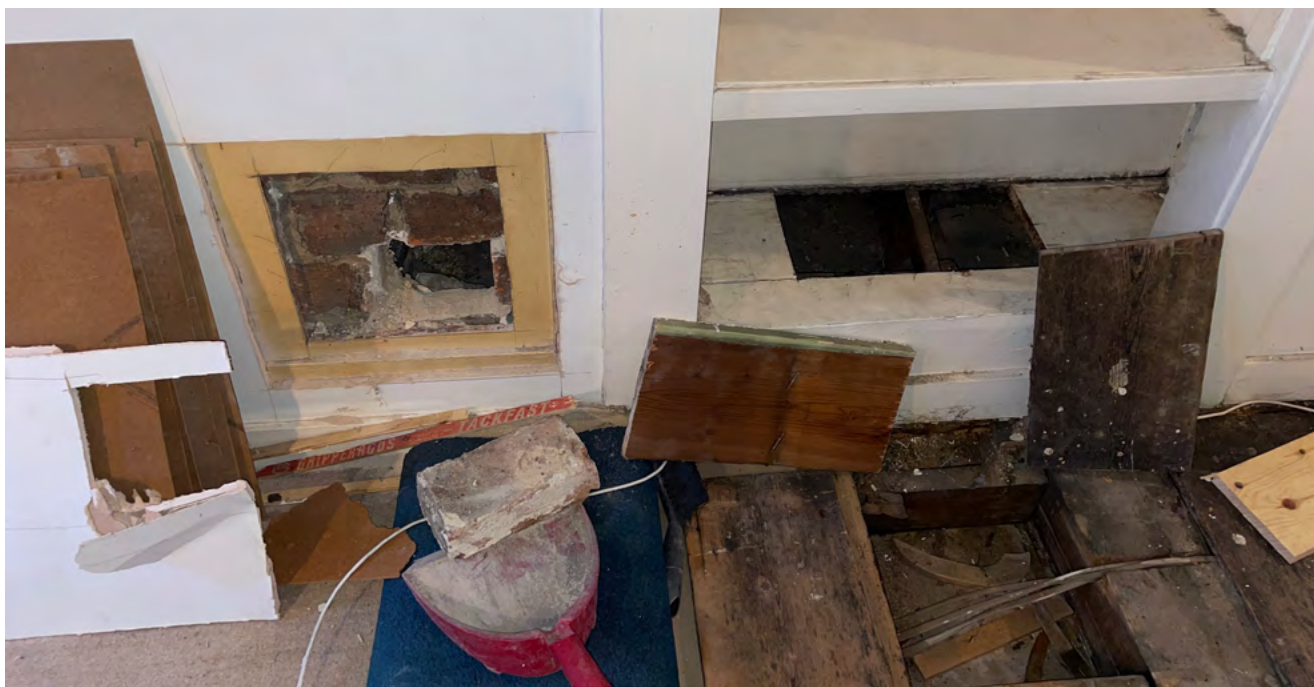
North wall of living room showing (left) timber stud wall with masonry infill and void behind, with cream coloured old timber panelling, and (right) floor joists extending below bookshelves to wall behind.

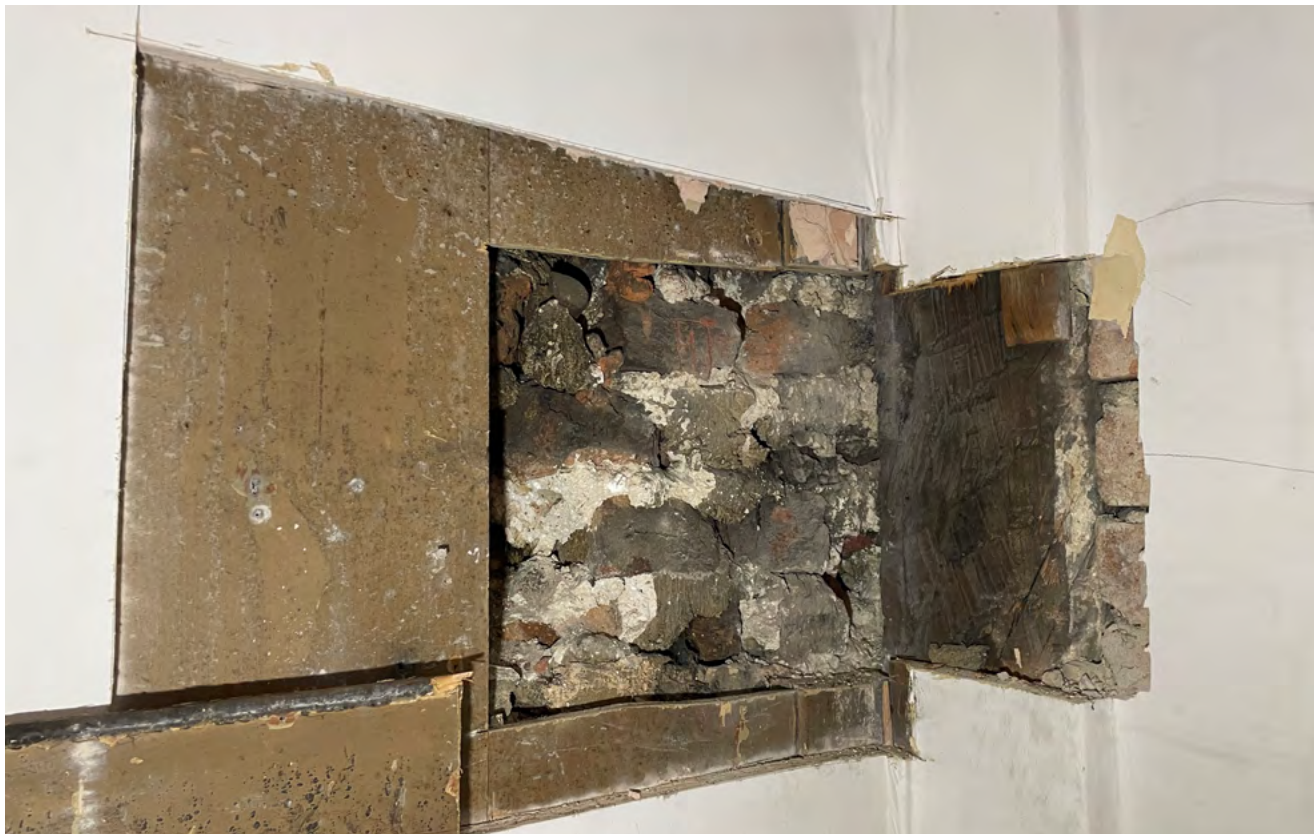
Junction of south wall (left) and west wall (right). Old panelling over stud wall with masonry infill. 120cm stud at corner.

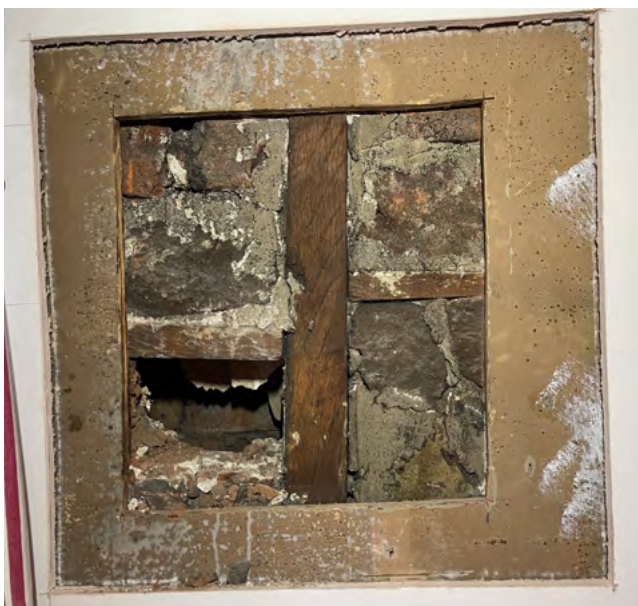
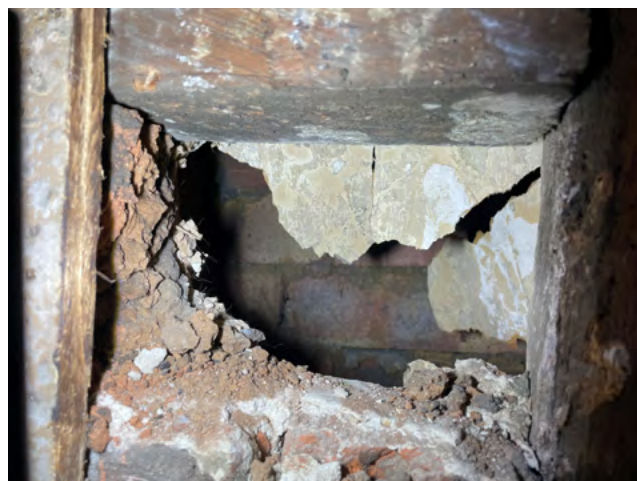
South wall of living room with panelling and stud wall exposed. Old wallpaper and void to no. 116 visible through hole.

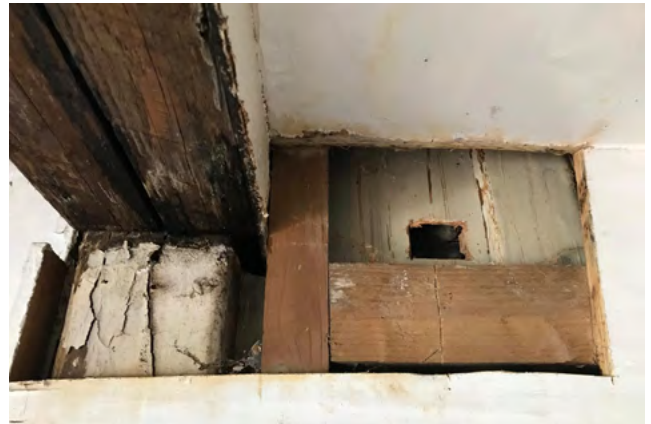
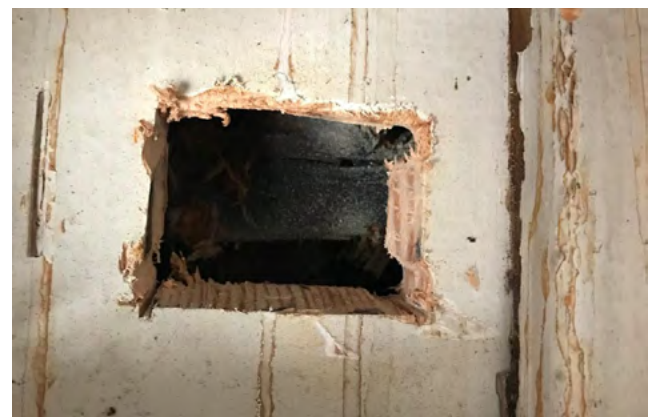
Plasterboard lining cut away to show old tongue and groove panelling behind. Hole in old panelling (below) reveals the party wall has a timber frame construction with timber panelling on either side. The frame is without brick infill.

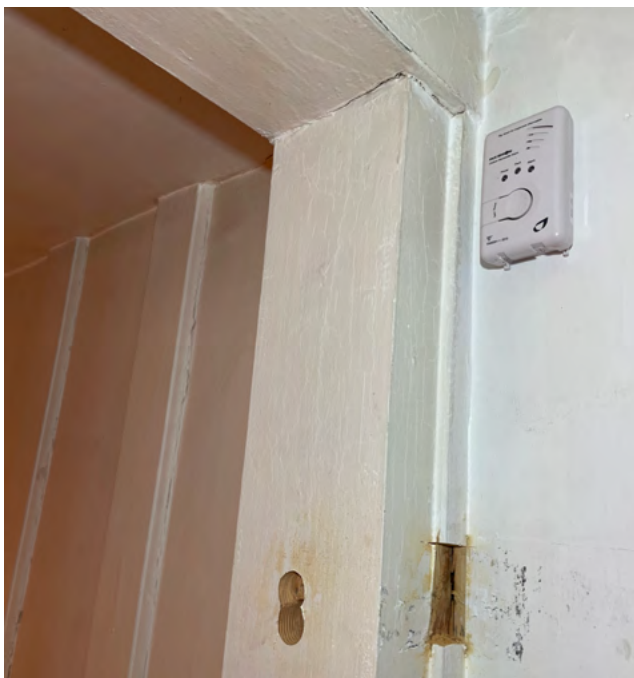
Cross-beam and post at north wall of kitchen. Timber post is a modern replacement.

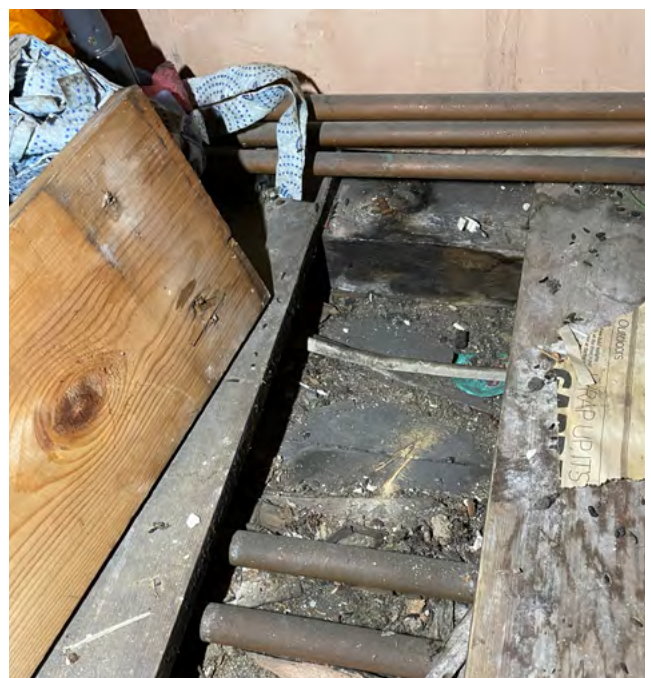
Kitchen floor within boiler cupboard, showing modern boards on bearers over service void with old boards below.

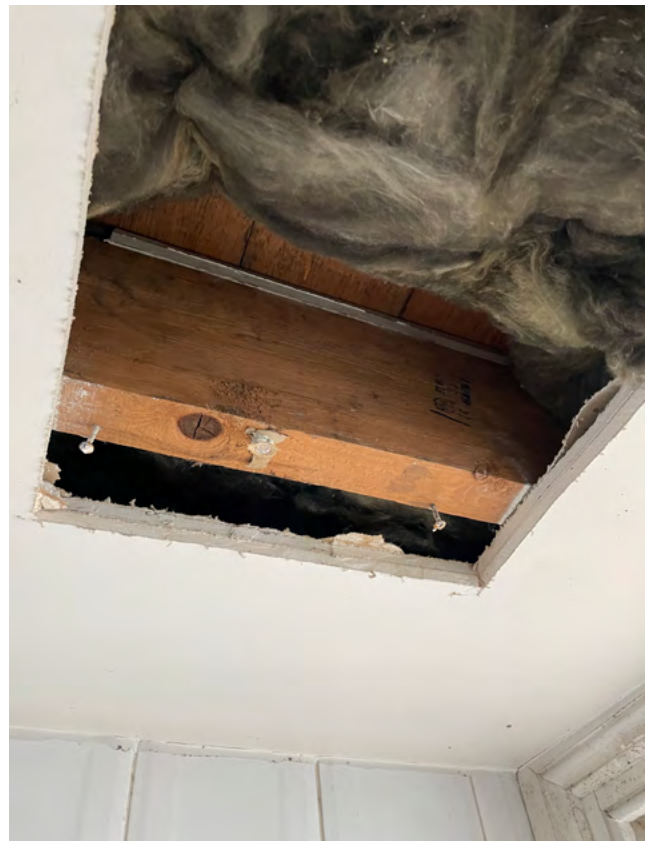
Bathroom flat roof joists, timber deck, loose insulation batts and plasterboard ceiling.

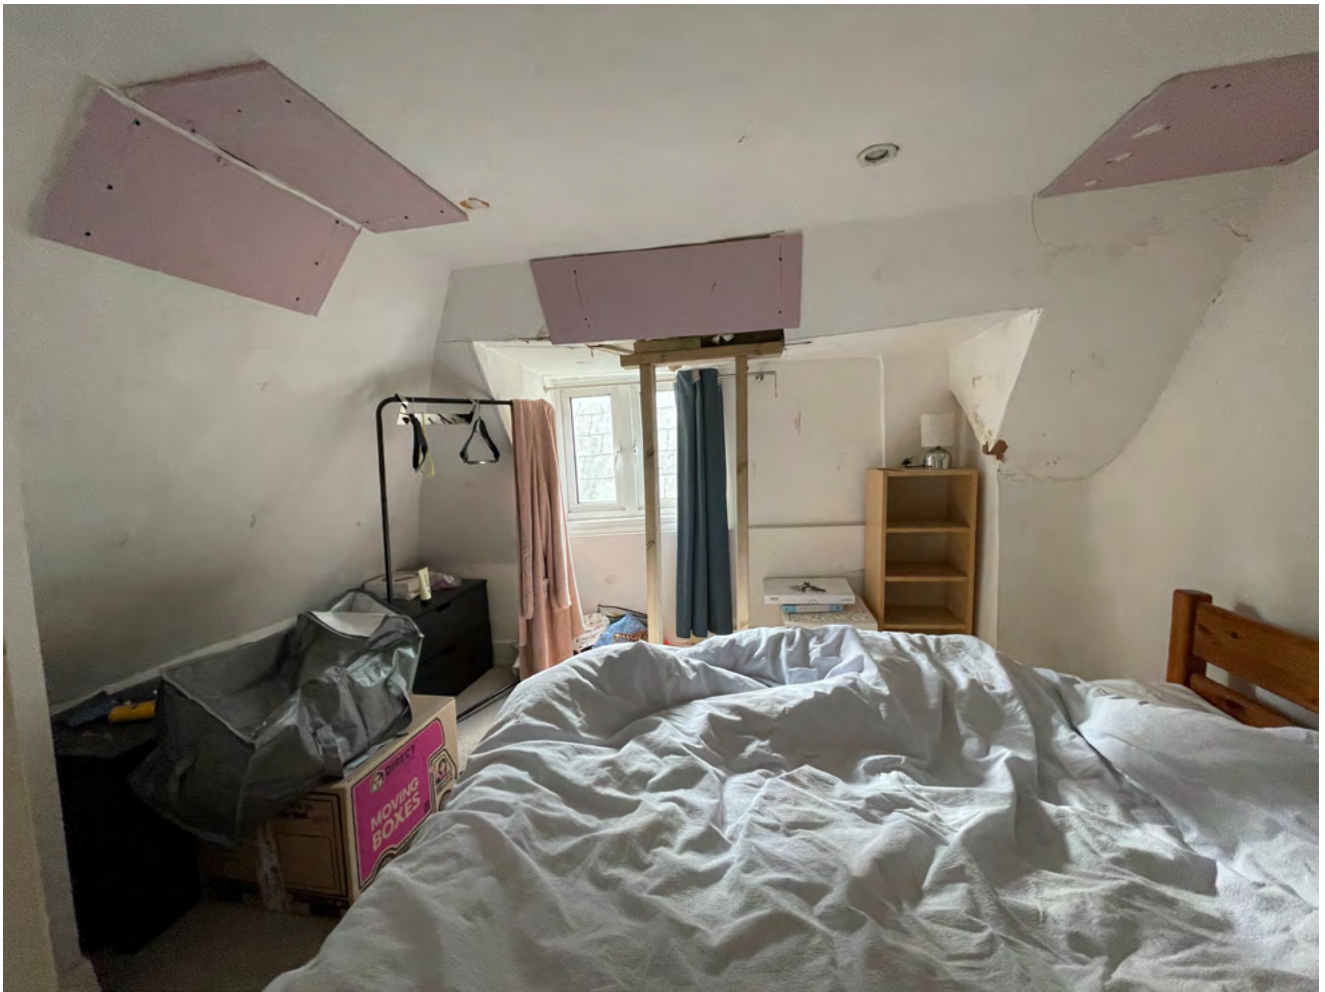
South wall showing interior of side dormer, propped due to structural failure.

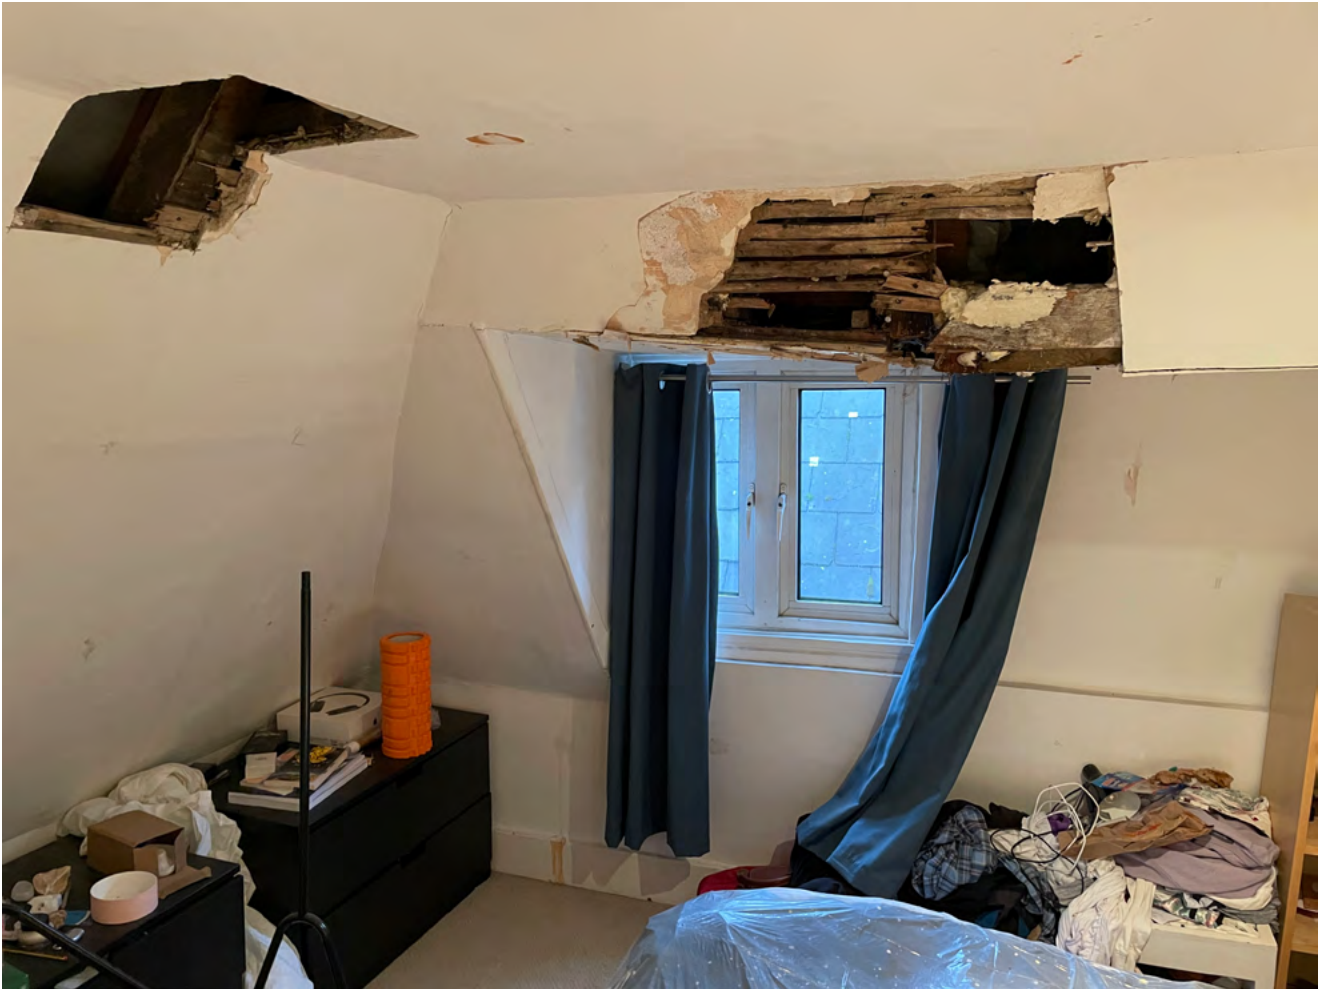
South and East walls opened, showing lath and plaster ceilings, and structural failure to south (side) dormer.
