CFBL WINDOW REPAIRS PHASE 2

87 Holmes Road, Kentish Town, London NW5 3AX

WINDOW REPAIRS PHASE 2 REPORT REV. 03
Report Existing windows at CFBL & proposals for their
repair in 2025.

Francis Birch
Architect Dipl.Arch. RIBA

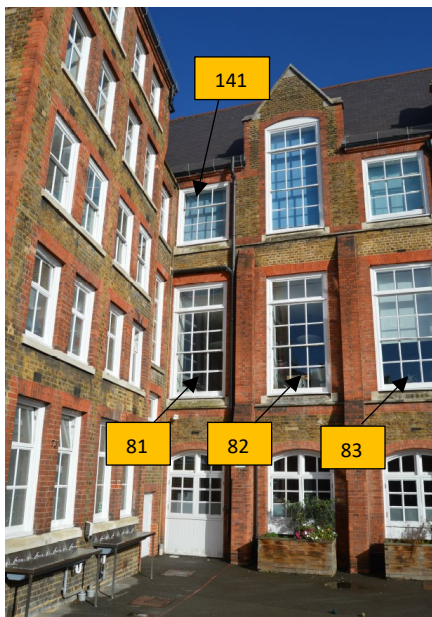
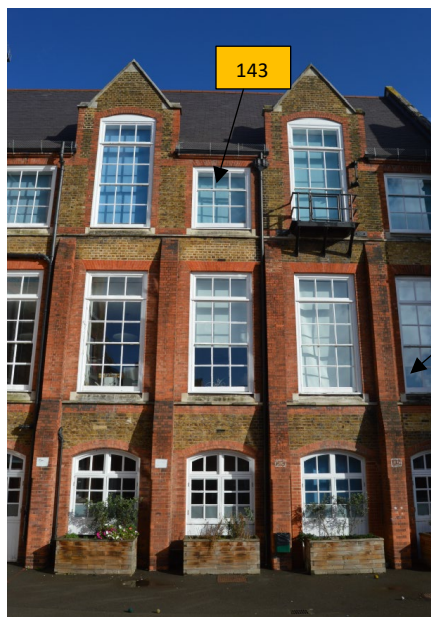
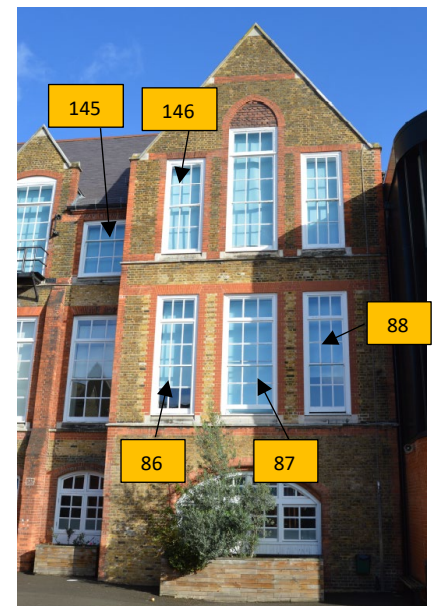
Type 2 sash windows to SW Elevation requiring urgent repairs

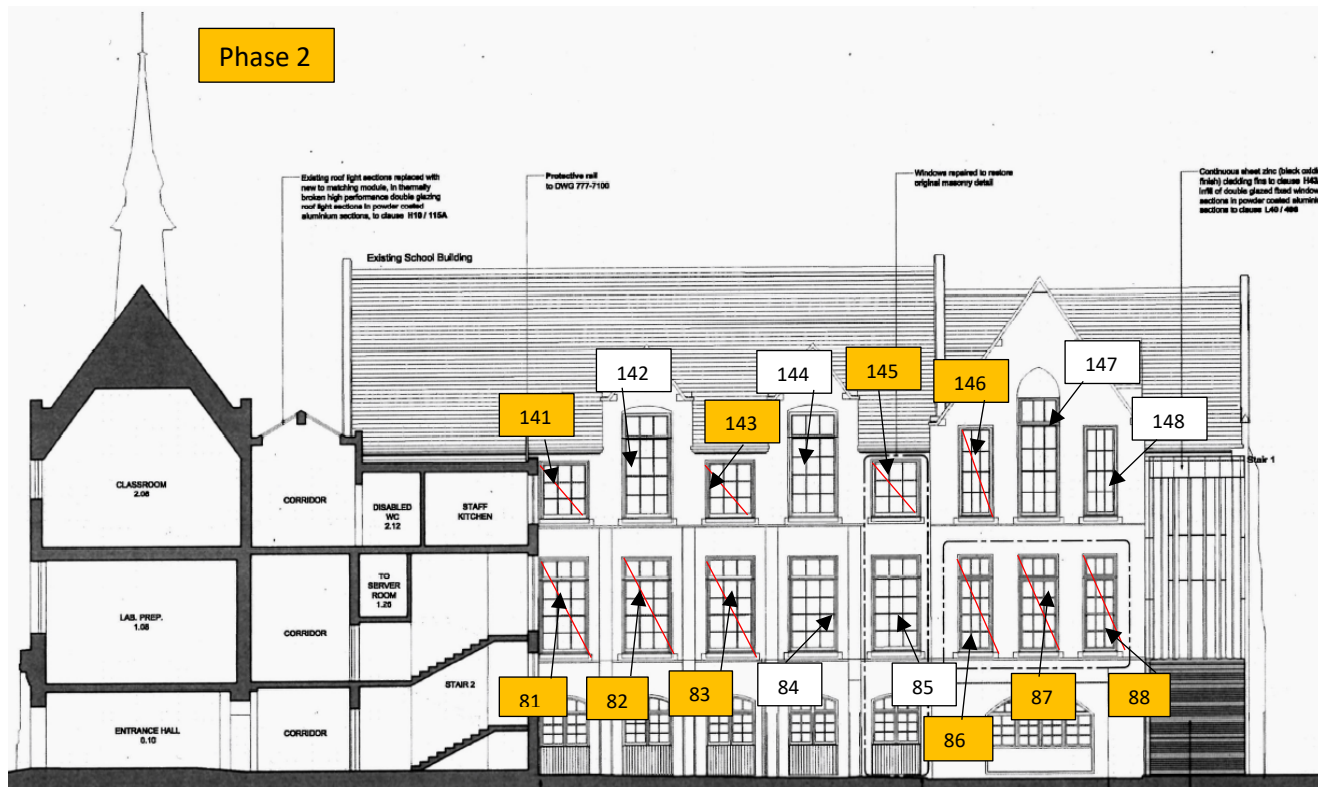
South West Elevation to playground

Type 2 sash windows to SW Elevation
requiring urgent repairs

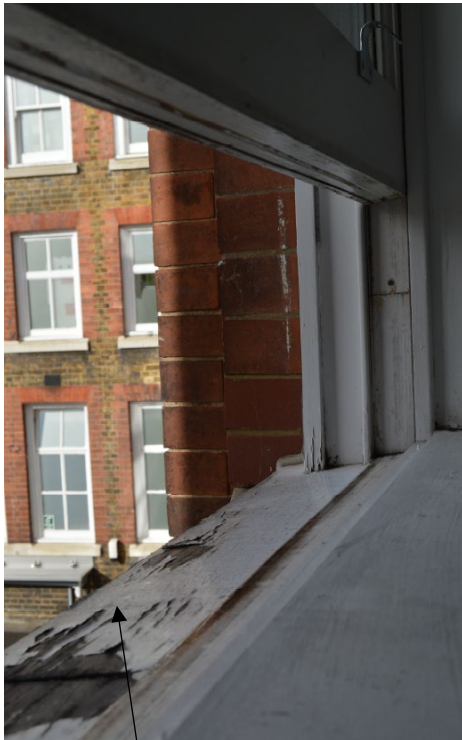
Cill failure to window when scarf repair has failed in South West Elevation

1. Remove existing damaged or rotten base window cill & replace it with new hardwood (oak) to match existing cill profile. It is assumed that the work will be carried out from within the building with the new cill to be fitted in situ without external scaffolding & primed & painted prior to the whole window being reinstated.
2. Repair/ scarf in any damaged or rotten sash boxes, rotten sash frames all to match the existing profiles.
3. Use 'Repair Care' CT1 or similar resin fillers where necessary.

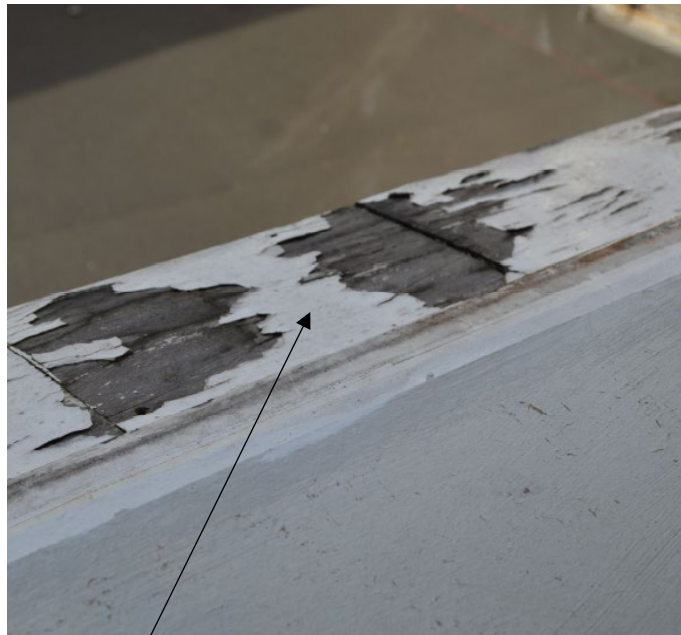
Detail of cill failure

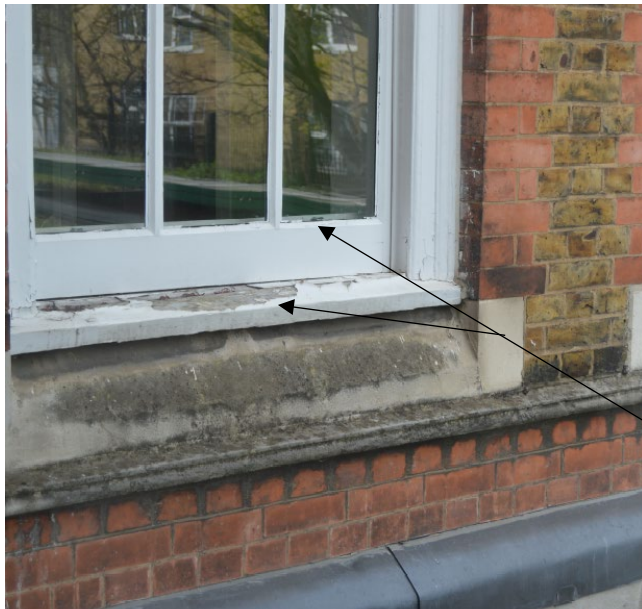
Peeling paint & damaged putties Window on South West Elevation

Redecoration - CFBL's Painting Contractor will carry out all the external & internal redecoration of the windows after the repairs are completed i.e removing all peeling paint & cracking putties. Filling all cracks with suitable external filler. Apply 1 coat external wood primer, plus 3 coats Dulux Weathershield or similar breathable external paint to all parts of the window.

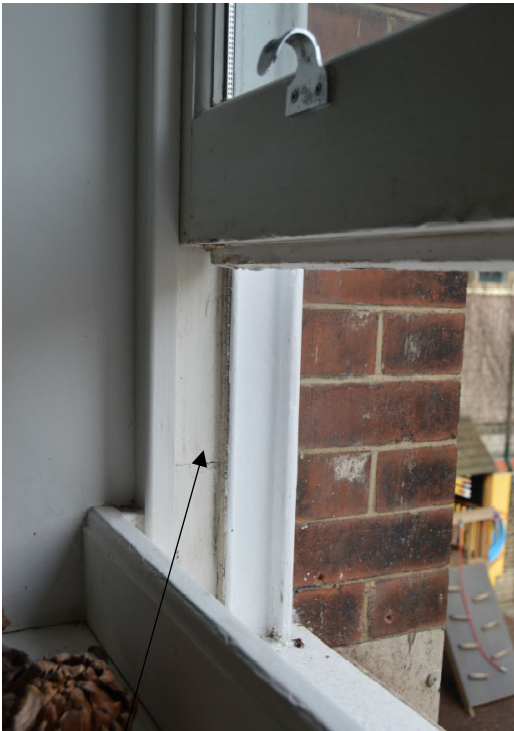
Draught seals to sashes to be replaced – all windows

1. Check all sash cords & re-cord where necessary. Replace damaged pulleys & ensure all opening sashes run smoothly & can be operated easily.
2. Replace any damaged or missing parting beads & stop beads.
3. Check & replace all damaged or missing draught seals.
4. Replace any damaged ironmongery with new fittings to match the existing.

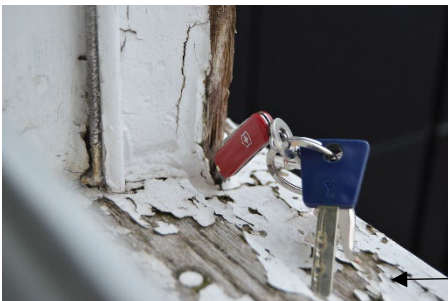
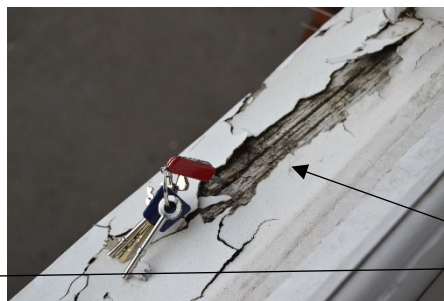
Rotten cills to be replaced in South West Elevation
