Date of Inspection	2024-09-18
Area of the Venue	Internal
Room Reference / Location	Stage right gallery
ID of Submission	01

Name and description of inspected element	Concrete filler joist sloping wall
Priority Category	Action required within the next 12-18 months
Priority	CAT 2

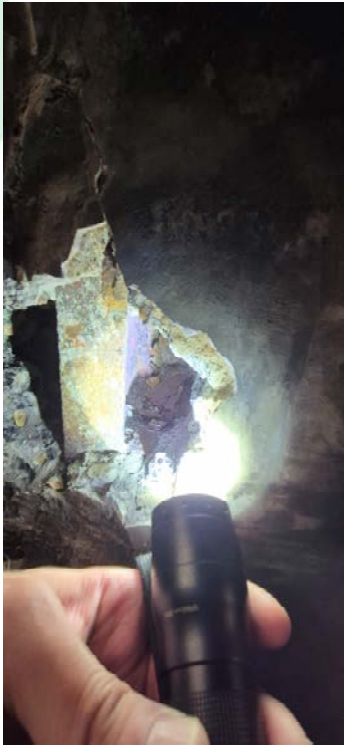
*Ref 1*

Description of Defect/Fault	<p>Steel filler joists have been exposed to reveal the condition of the steel. The top flanges of the beams are in varying degrees of disrepair ranging from completely corroded (ref 1), heavily corroded (ref 2) and lightly corroded (ref 3), which in turn has caused the render to crack along the steel positions. The corrosion will have reduced the lateral stability of the wall under wind loads.</p> <p>The corrosion of the top flanges indicates water has/is penetrating through the roof finishes (felt). Patch repairs have been carried out to the felt. The gutter line appears to be just above the worst affected areas internally (ref 4) which looks to be the more likely source of the water ingress.</p>
Proposed Action or Recommendation(s)	<p>The wall will need to be supported with additional steelwork to re-introduce the strength. A steel grillage will need to be formed which may have an impact of the grid operations. Currently a design is being carried out to determine the size of steel required to support the wall and what impact this may have on the gallery for access.</p> <p>The waterproofing externally should be reviewed with a view to renewing to prevent any further water ingress. The gutter should also be assessed to ensure it's watertight. A liquid plastic system should be considered.</p> <p>The second option would be to completely remove the concrete wall and replace with a new timber structure. In doing this the access on the gallery would be improved as the wall could be re-built vertically in timber.</p>

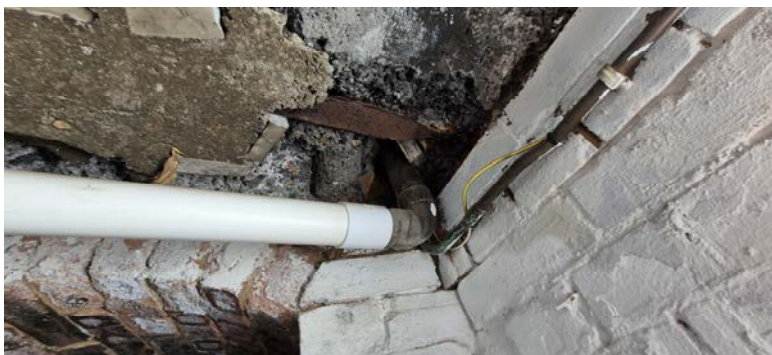
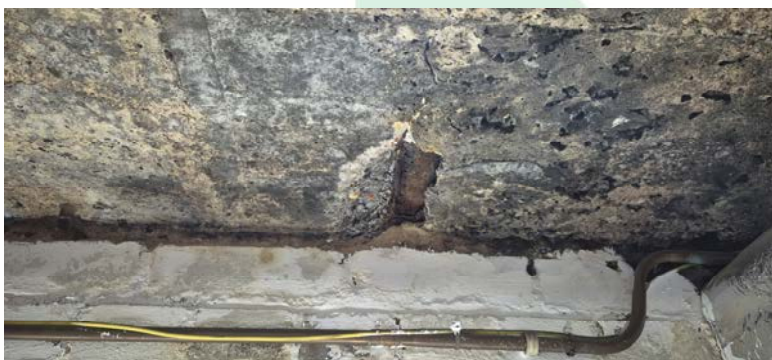
Description of Defect/Fault	Steel filler joists, where visible, exhibiting signs of corrosion, causing the concrete to crack. In the corner of the room the bottom flange of a filler joists has completely corroded away.
Proposed Action or Recommendation(s)	New steel beams to be installed below the existing concrete to support the filler joist floor. All steel to be galvanised.

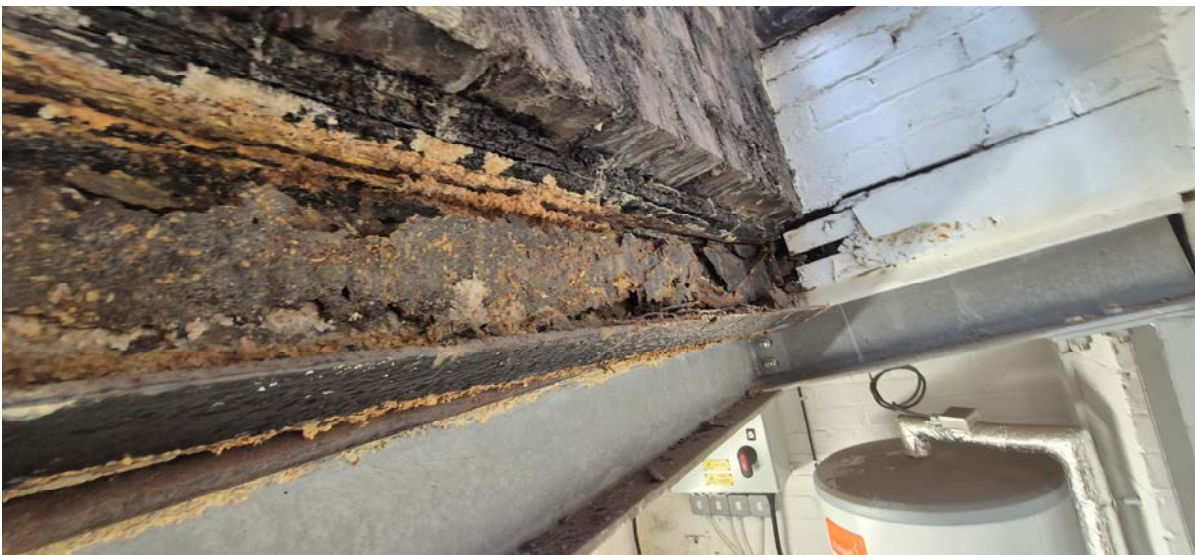
Description of Defect/Fault	Original steel beams around the pavement lights severely corroding. New steel has been installed to support the surrounding structure, so the original steelwork is redundant.
Proposed Action or Recommendation(s)	Remove corroded section of the beam to prevent it from falling.
Recommended timescale for Actions	We recommend that follow up repairs and/or inspections are undertaken within the next 12-18 months unless deterioration or other concerns are raised in the intervening times.

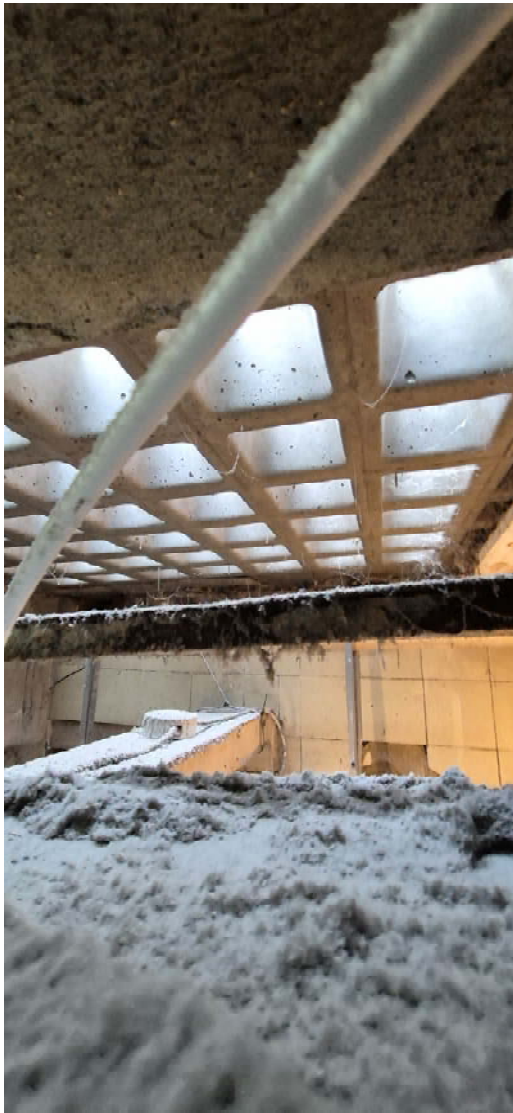
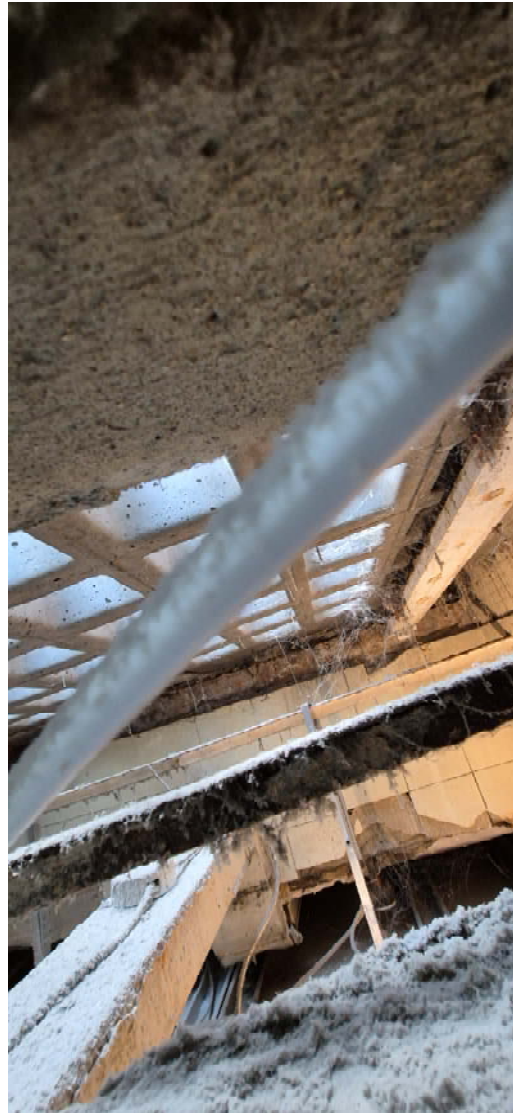
Description of Defect/Fault	Limited view of the steelwork due to the WC false ceilings. Only point of view was via the use of a camera taking blind shots of one area above the female WCs ceiling. No steelwork visible in its entirety to be able to comment on the overall condition, however, given there are multiple repairs to the original pavement lights supporting steelwork throughout the venue, there is a good chance the steelwork will be in a similar condition. One beam appears to be clad with ceramic tiles, with brickwork over. A small section of the bottom flange can be seen which does look to have begun to corrode. The tiles in this area have cracked/fallen off which would suggest there is some degree of corrosion occurring.
Proposed Action or Recommendation(s)	Scheme provided by Momentum to be costed to allow these works to be included in any future works. Further investigation required to determine the exact condition of the supporting steelwork. Once viewed and the steelwork assessed a decision can be made as to whether the full Momentum scheme is required or if the repairs can be scaled back to cleaning, treating and repainting.
