**BS5837:2012 TREE SURVEY AND
ARBORICULTURAL IMPACT ASSESSMENT:
Garth Hotel, 69 Gower Street, London, WC1E 6HJ**

Dated: 4th April 2025

Our reference: GHA/DS/888160:25

Location: Garth Hotel, 69 Gower Street, London, WC1E 6HJ
Our reference: GHA/DS/888160:25
Client: Garth Hotel
Dated: 4th April 2025
Prepared by: Glen Harding MICFor, MSc (Forestry), MArborA
Date of Inspection: 7th March 2024

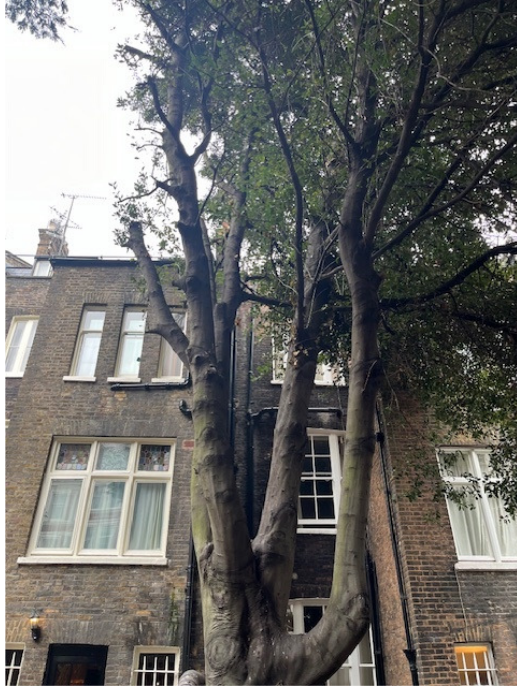
- The tree is 3.5m from the nearest part of the building and as such its crown is touching the hotel building.
- The crown has been pruned heavily to the north in the past as the crown has also caused issues for the property to the north.

Below: crown proximity to buildings

6.2 The removal of the bay tree has been consented in the past and would be required regardless of the proposal, given its proximity to the existing building and all of the associated issues as outlined below:

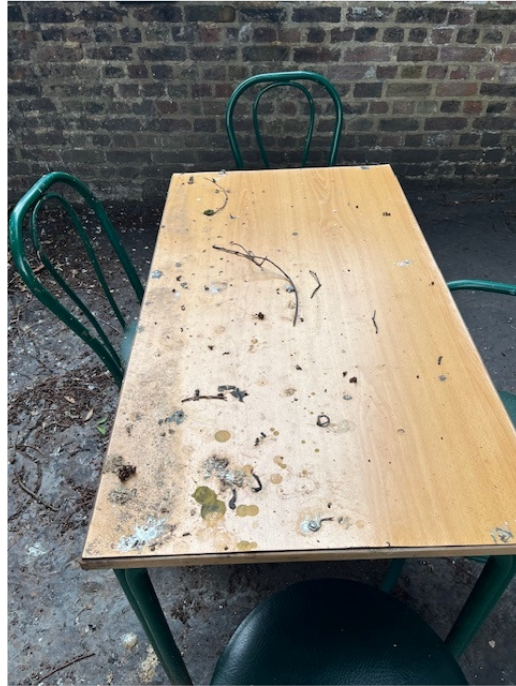
- The crown dominates both nearby properties making the gardens unusable due to shade as well as incessant bird droppings on the patio area.
- The roots are causing damage the patio area.
- The stem touches the boundary wall and will likely damage it, if left unmanaged.

Below: bird droppings on table on patio

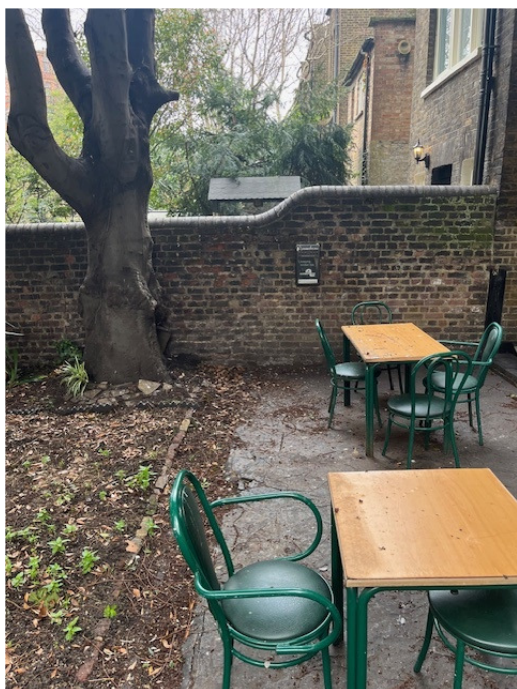
Below: damage to patio

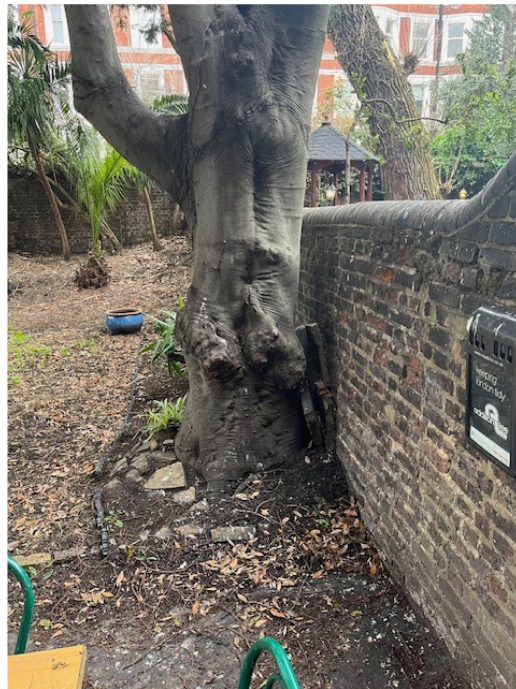
Below: stem in contact with wall
