## PHOTOGRAPHIC PLATES

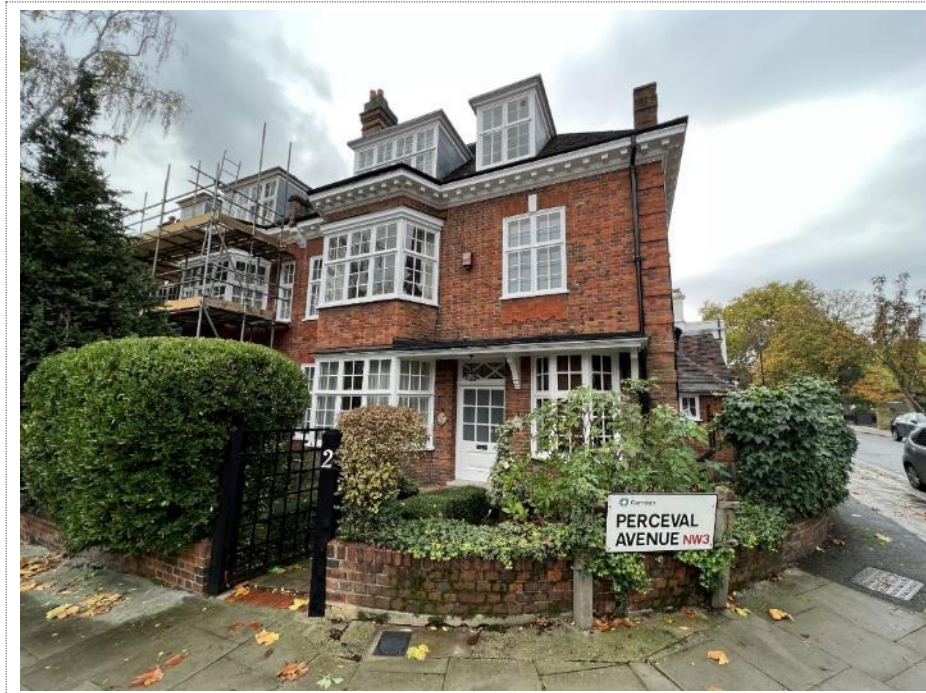
Plate 1. General view to front of property.

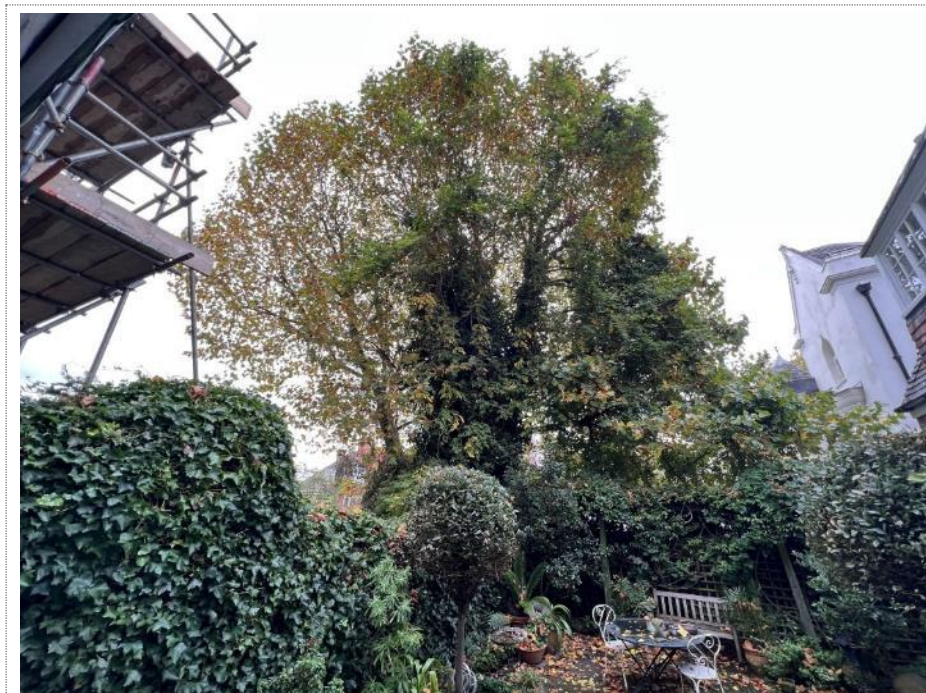
Plate 2. Large Plane tree to rear of property.

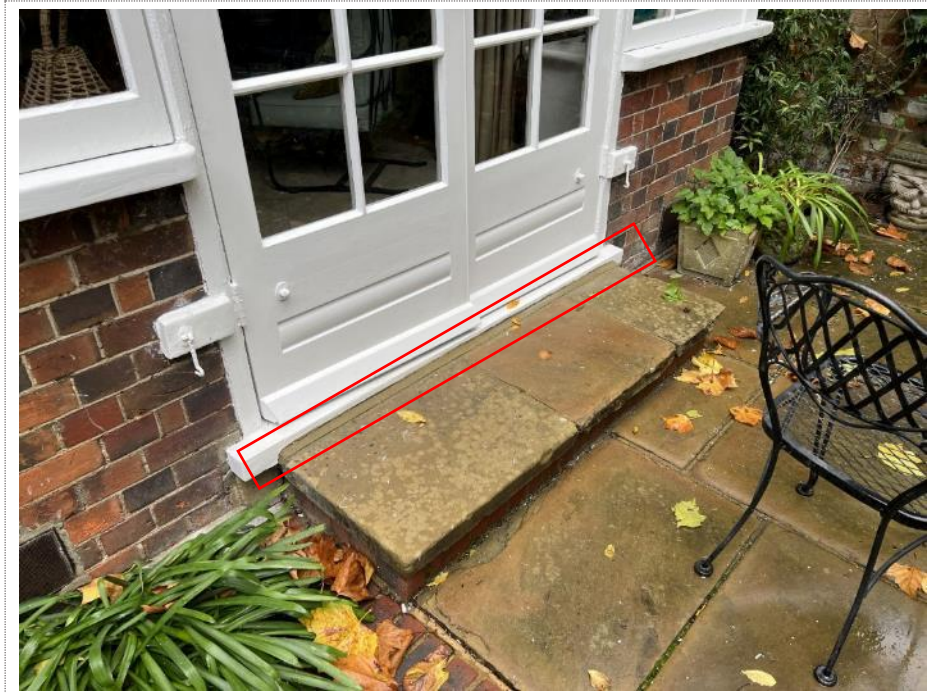
Plate 3. Displaced step now filled with grout.

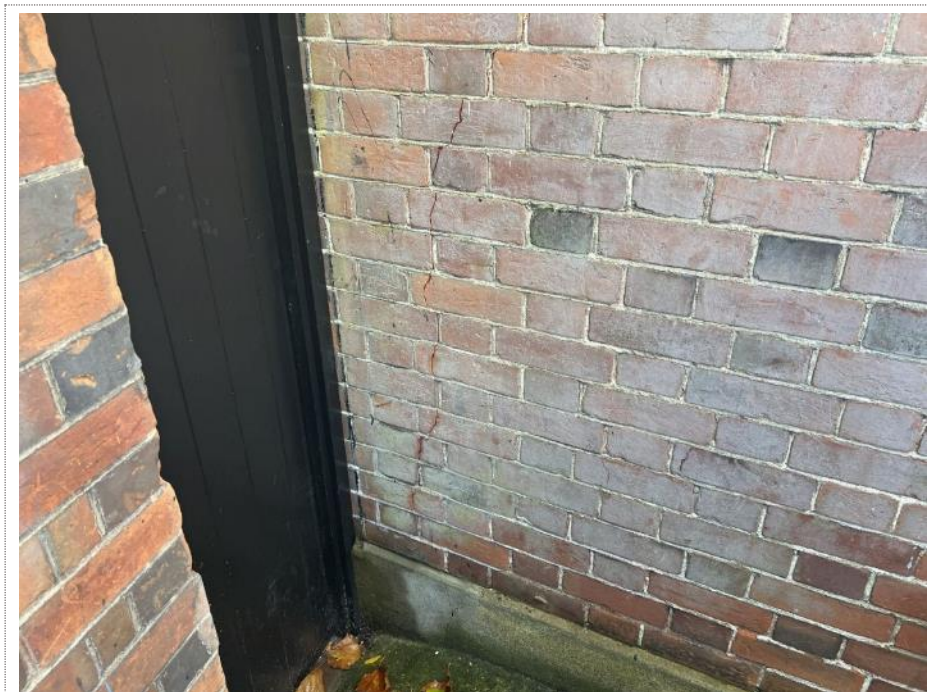
Plate 4. Vertical crack to garage wall.

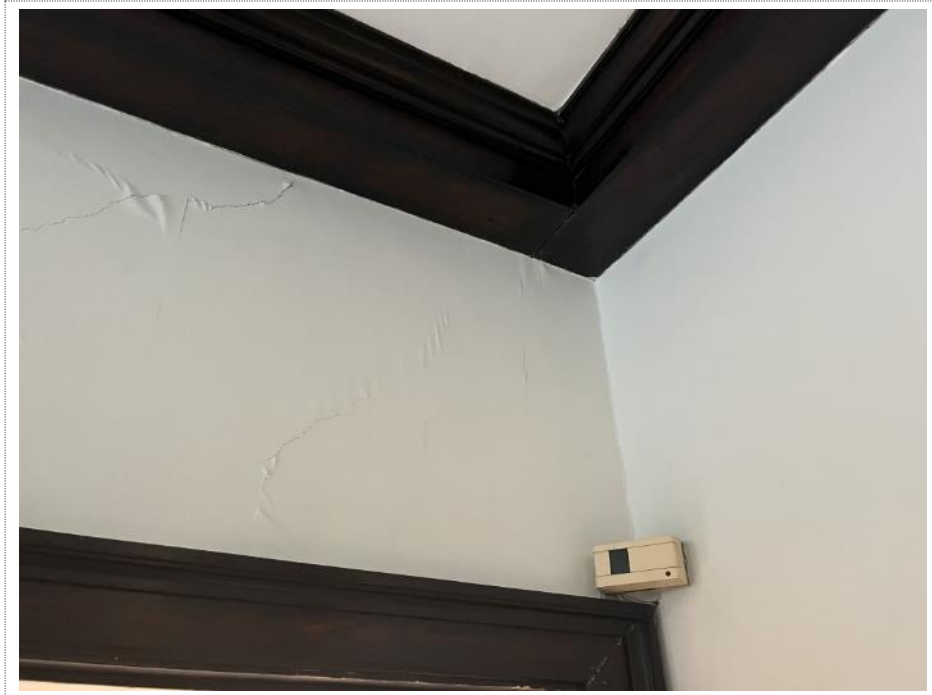
Plate 5. High level cracking to wall in living room.

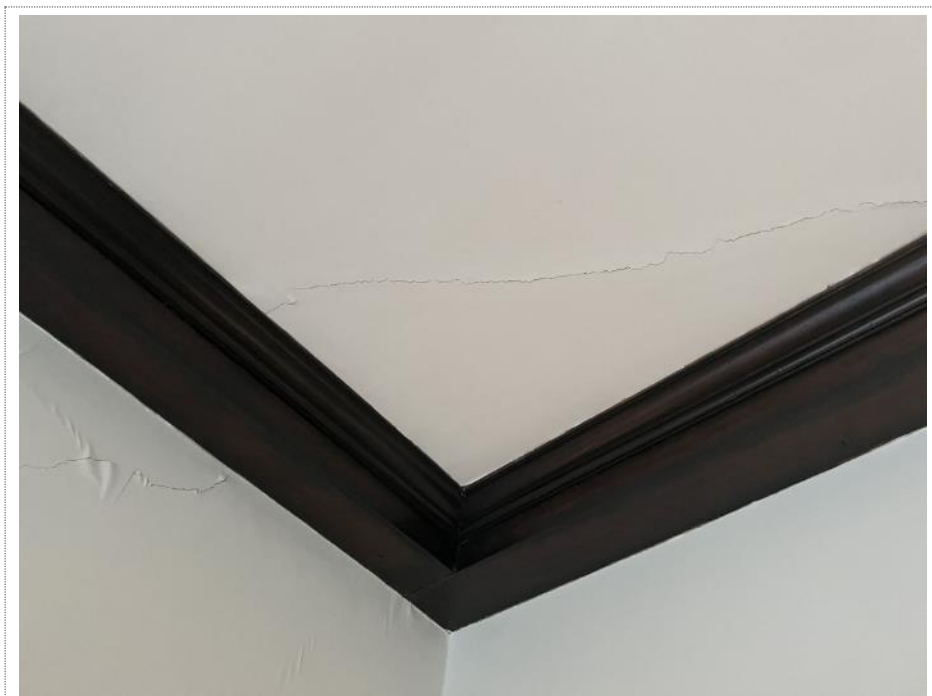
Plate 6. Cracking to ceiling in living room.

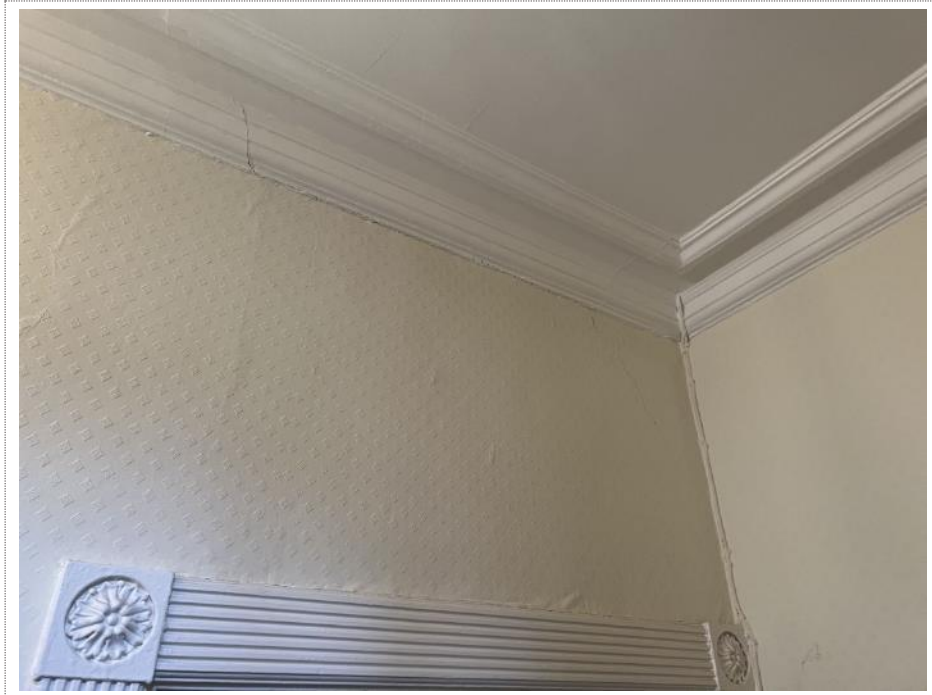
Plate 7. Cracking to wall in hallway.

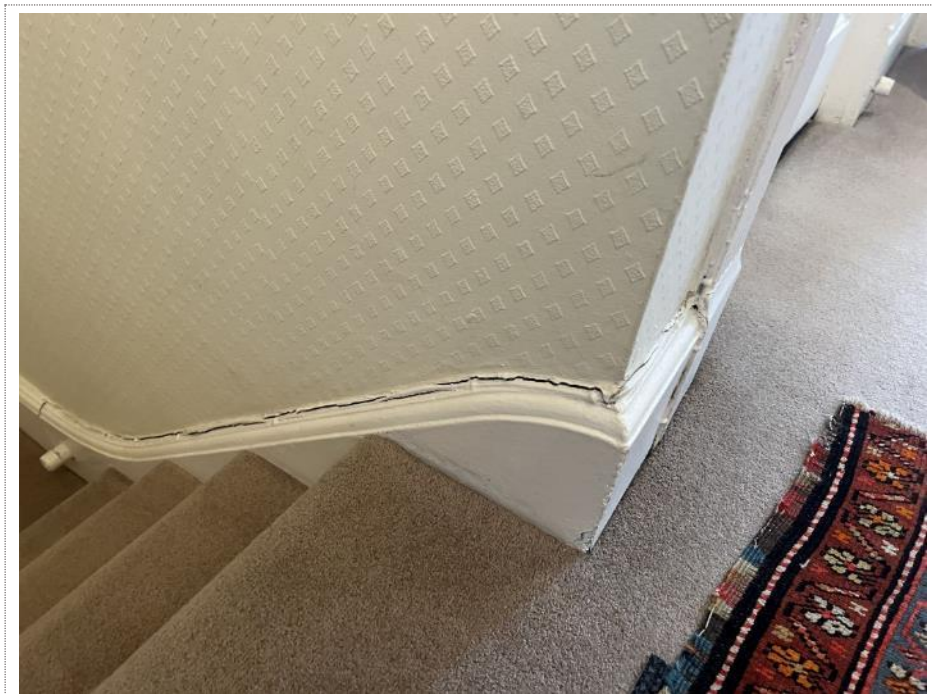
Plate 8. Skirting to GF WC.

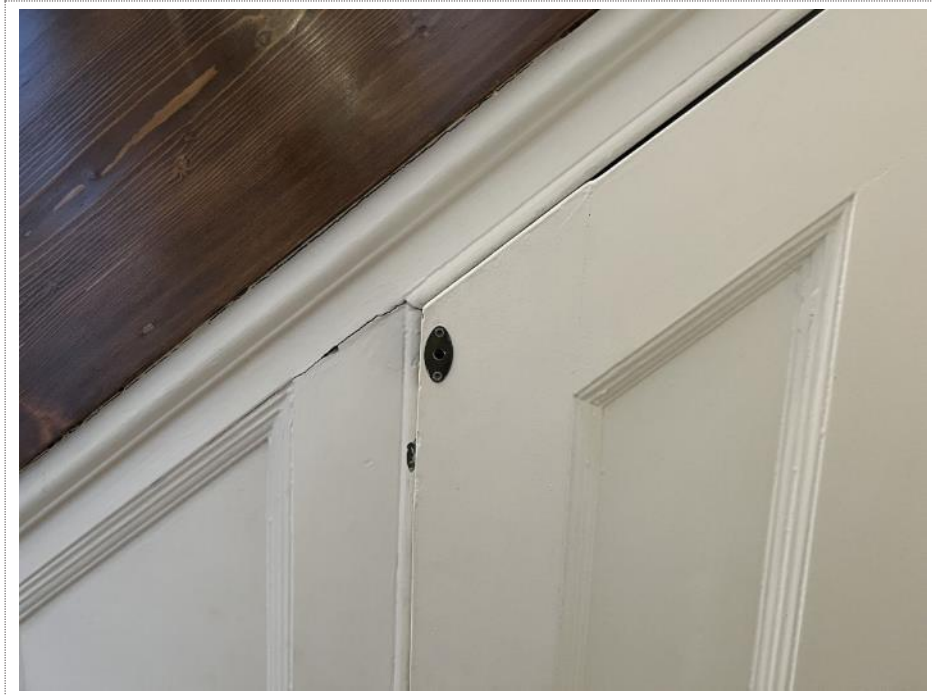
Plate 9. Misaligned door to understairs cupboard.

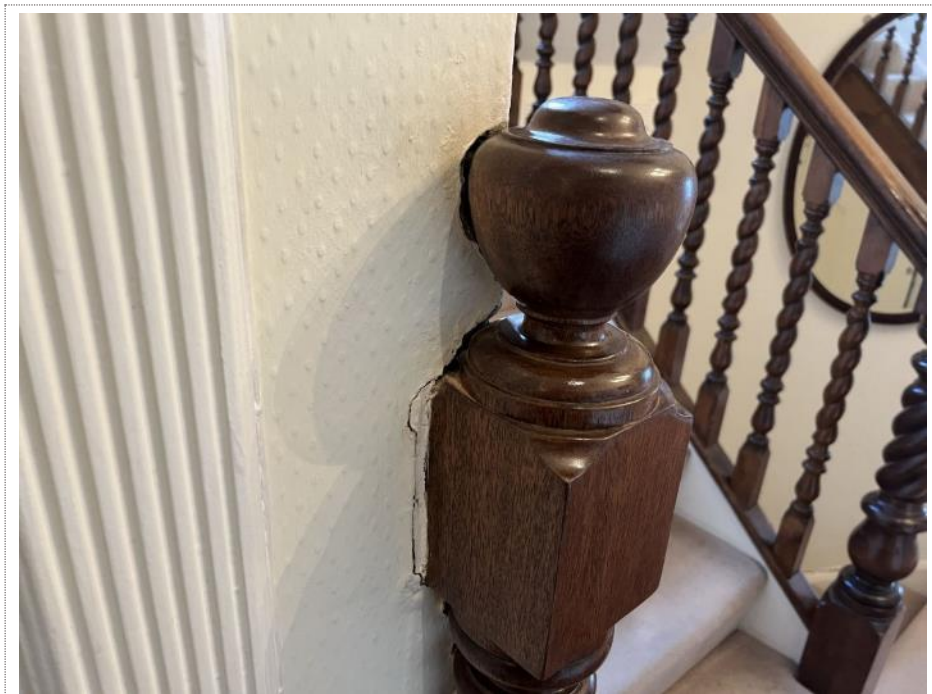
Plate 10. Displaced newel post.

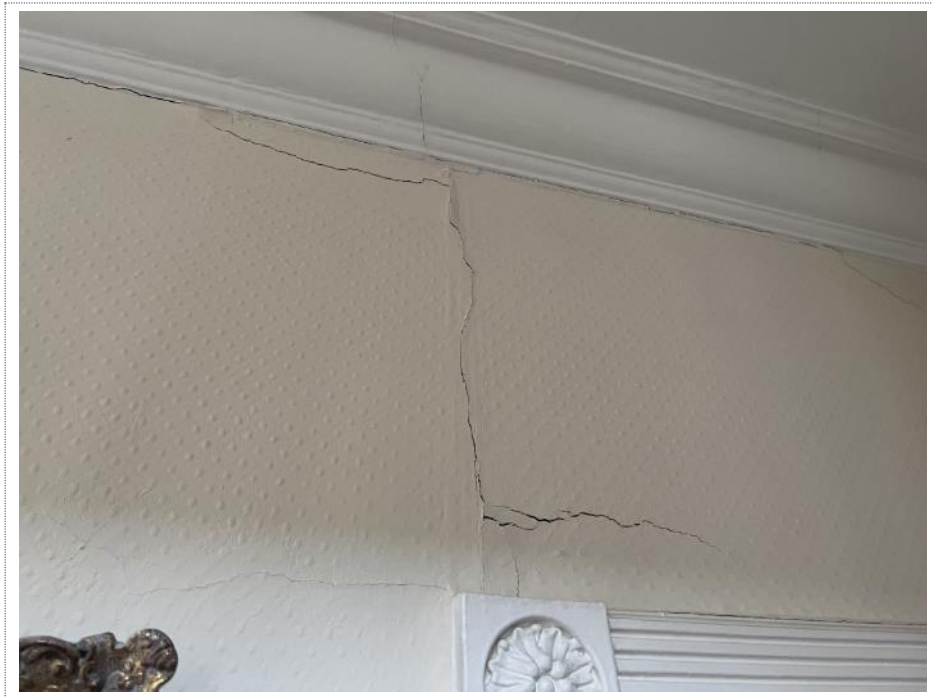
Plate 11. Cracking to landing at FF level.

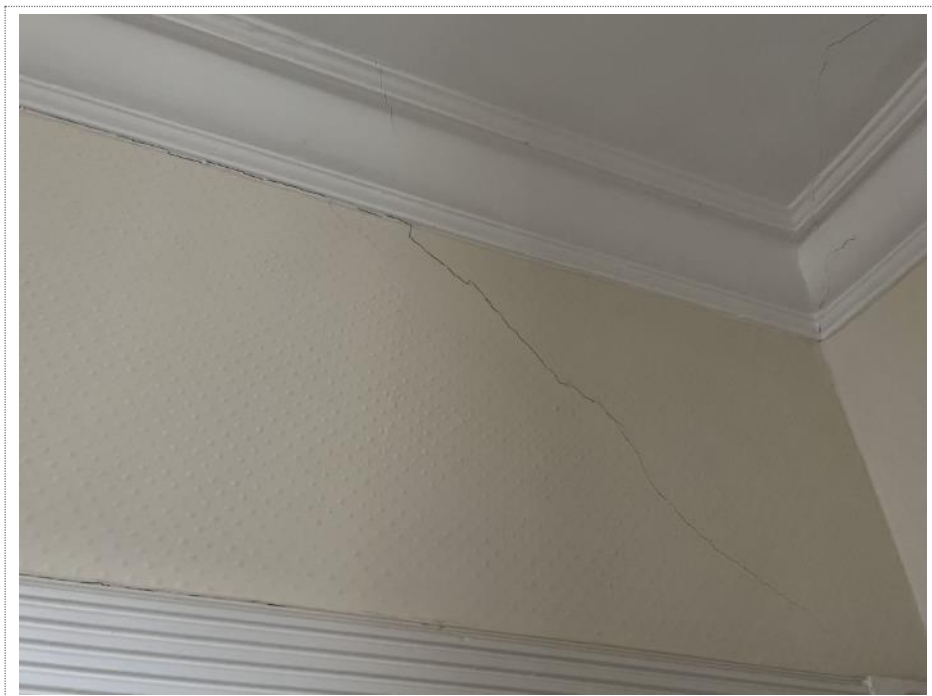
Plate 12. Further view of cracking.

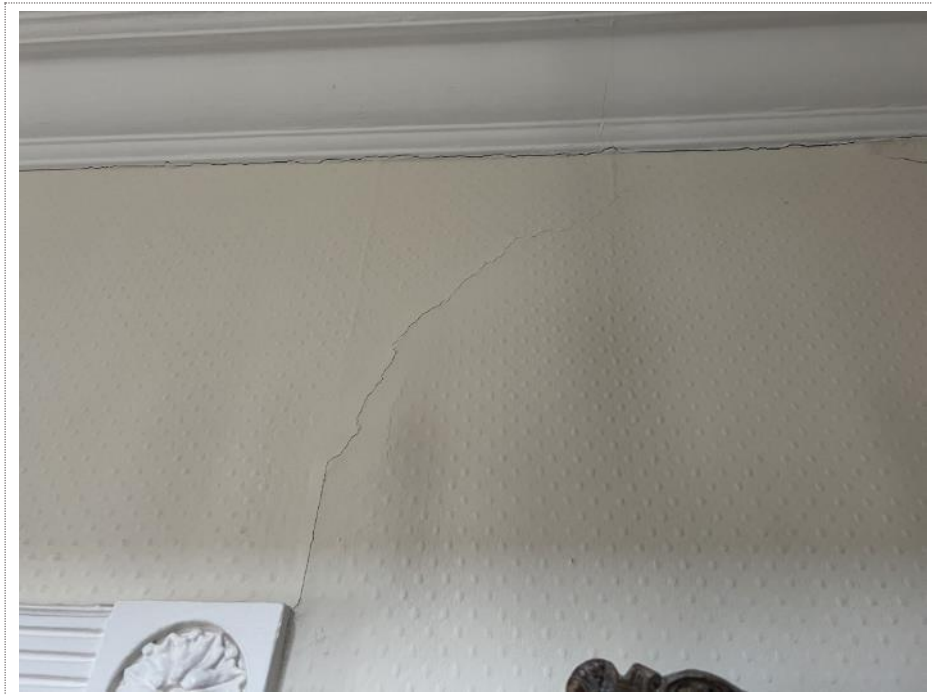
Plate 13. Cracking in hall above door to front bedroom.

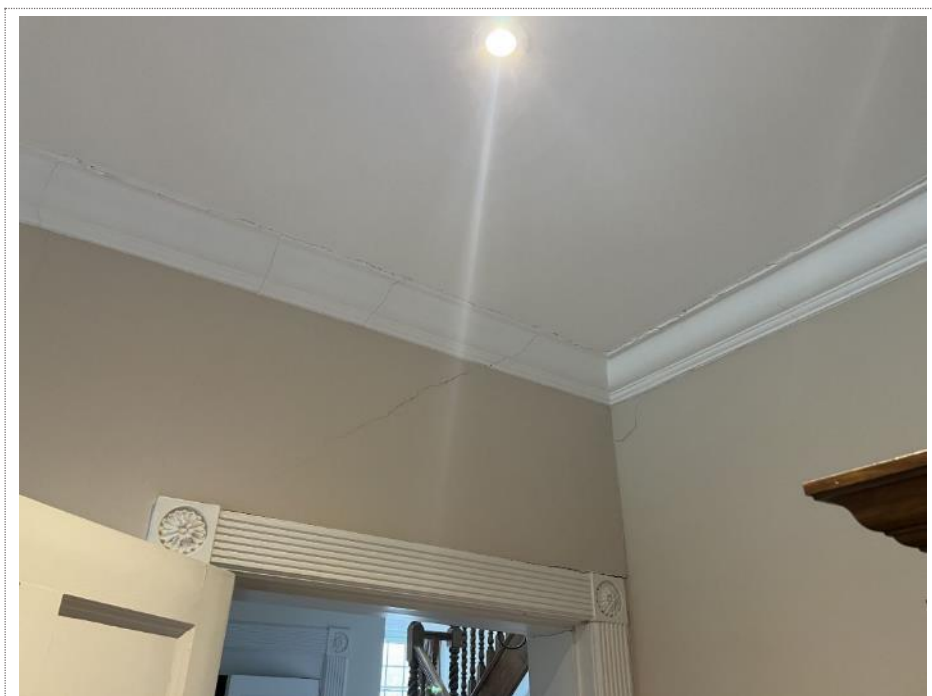
Plate 14. Cracking above door in master bedroom.

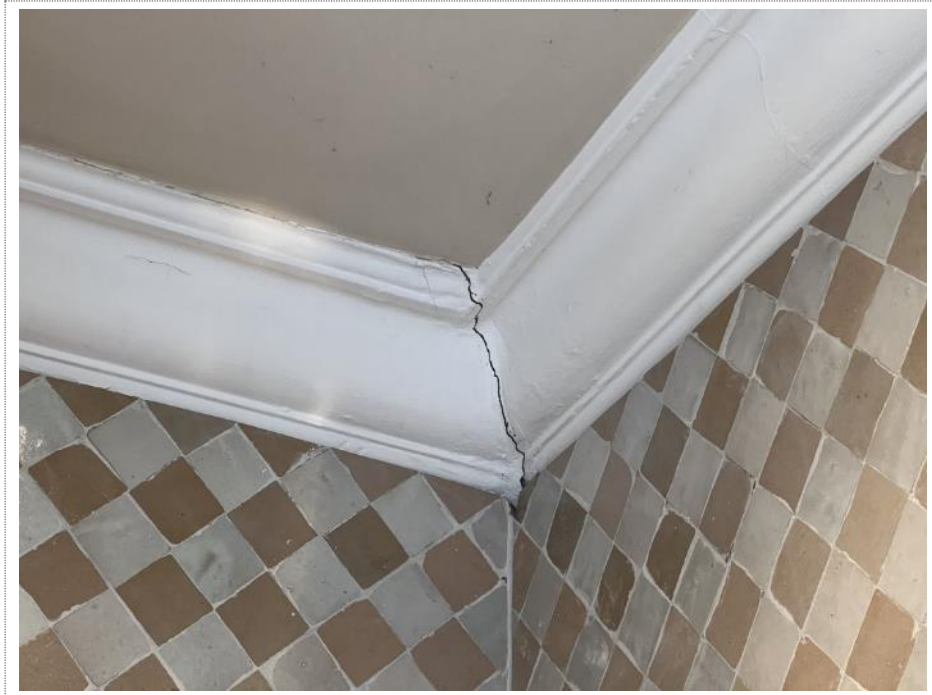
Plate 15. Corner cracking to ensuite.

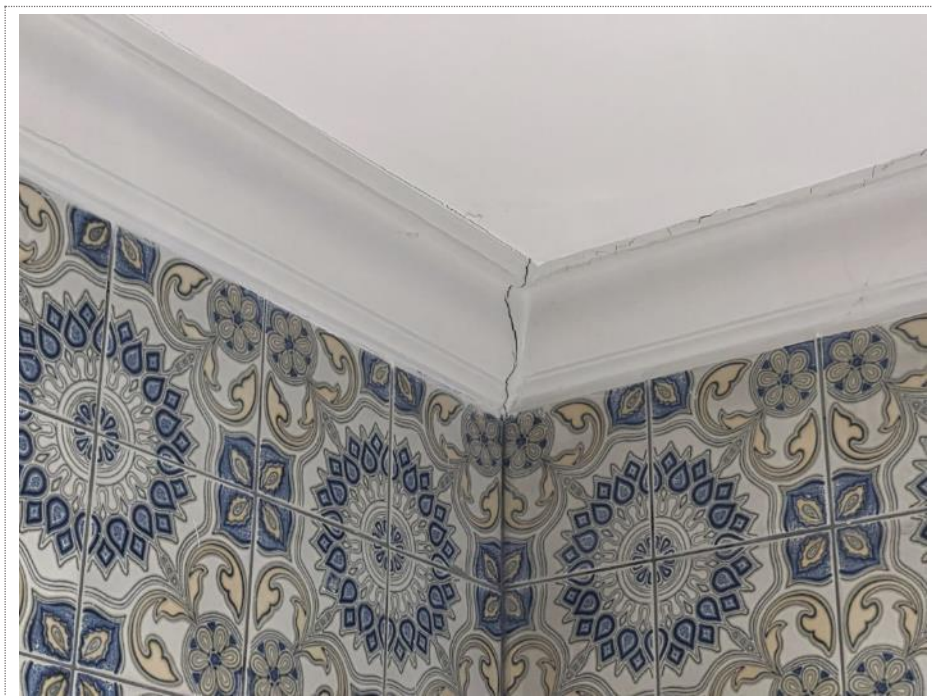
Plate 16. Corner cracking to main bathroom.

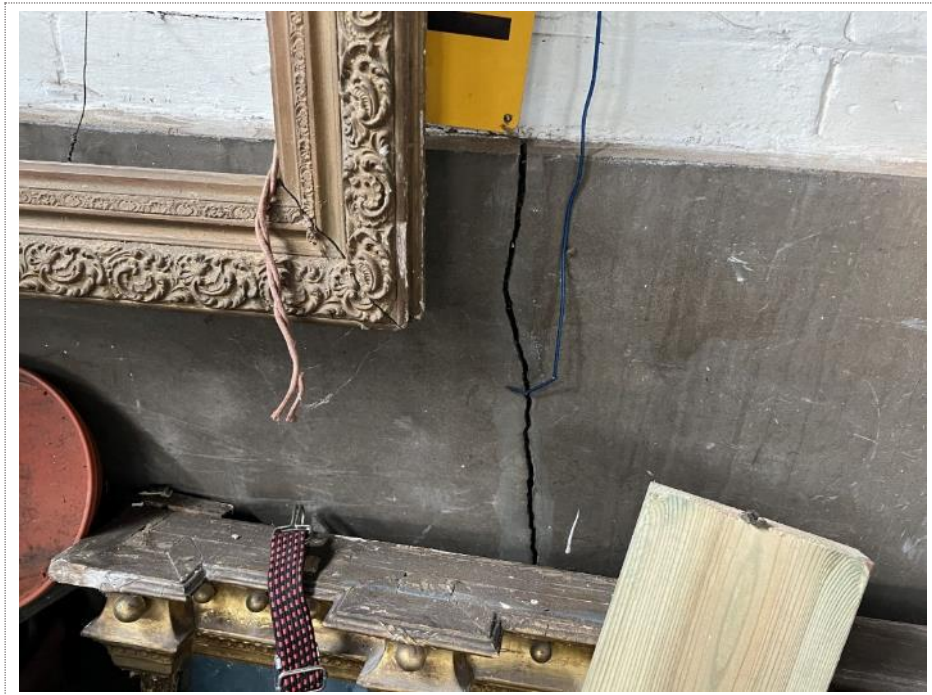
Plate 17. Vertical crack in garage.

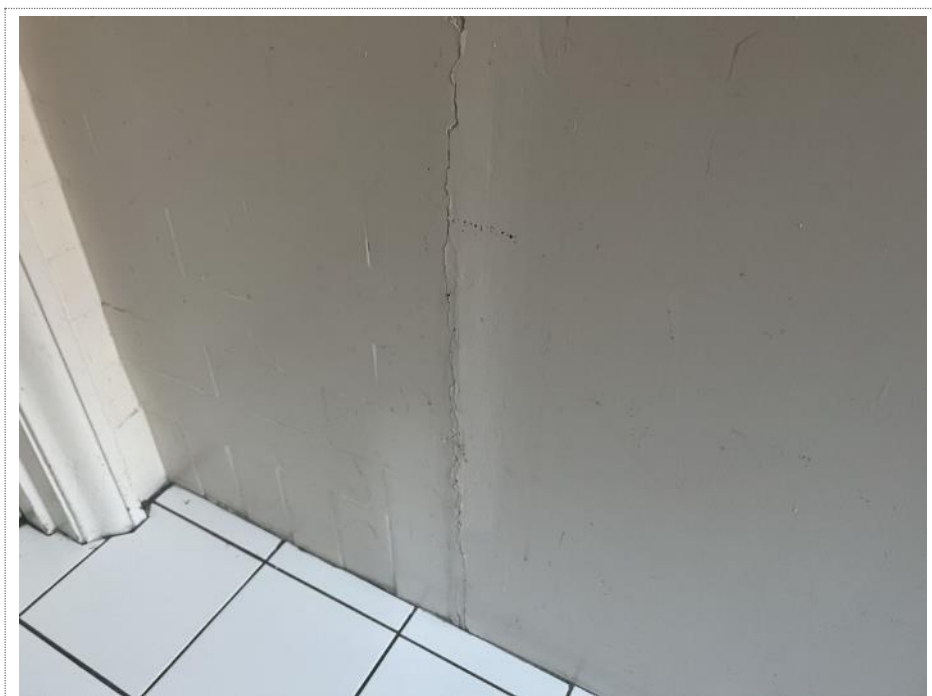
Plate 18. Cracking in pantry – change in medium.

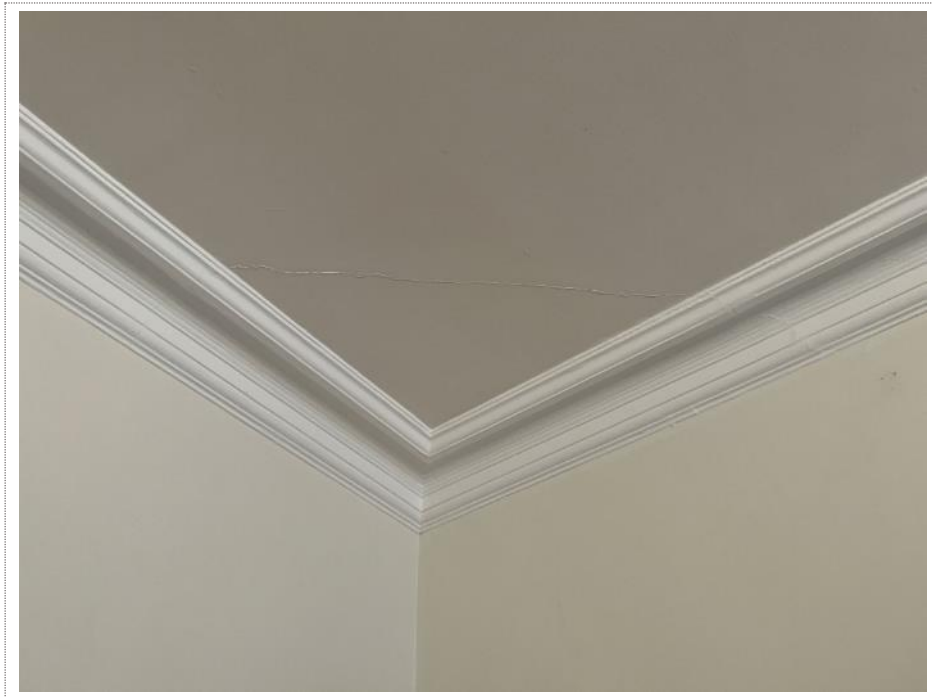
Plate 19. Evidence of existing cracking.

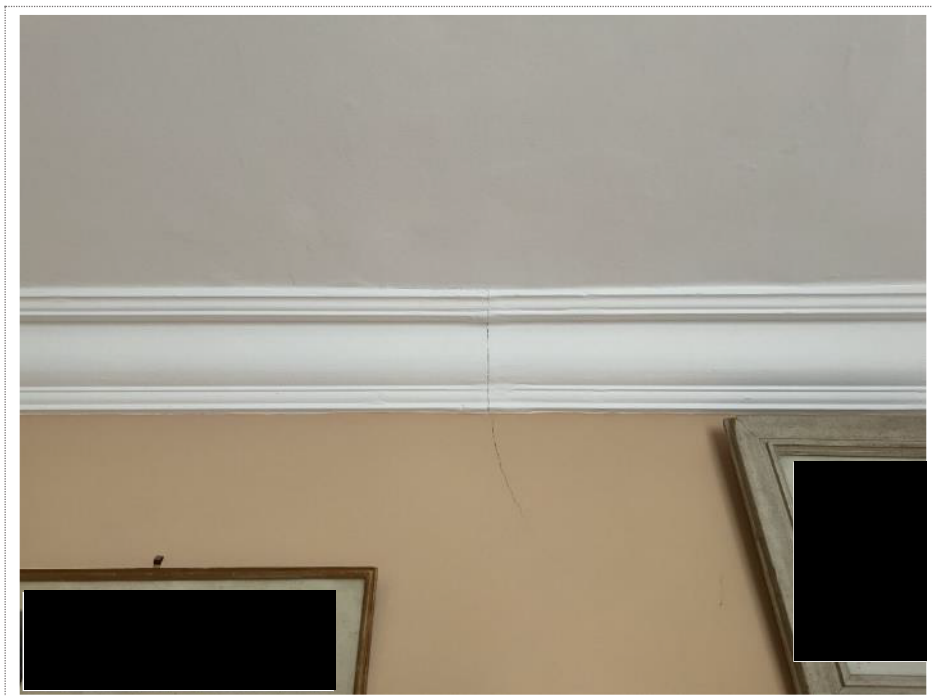
Plate 20. Hairline cracking to coving in office.

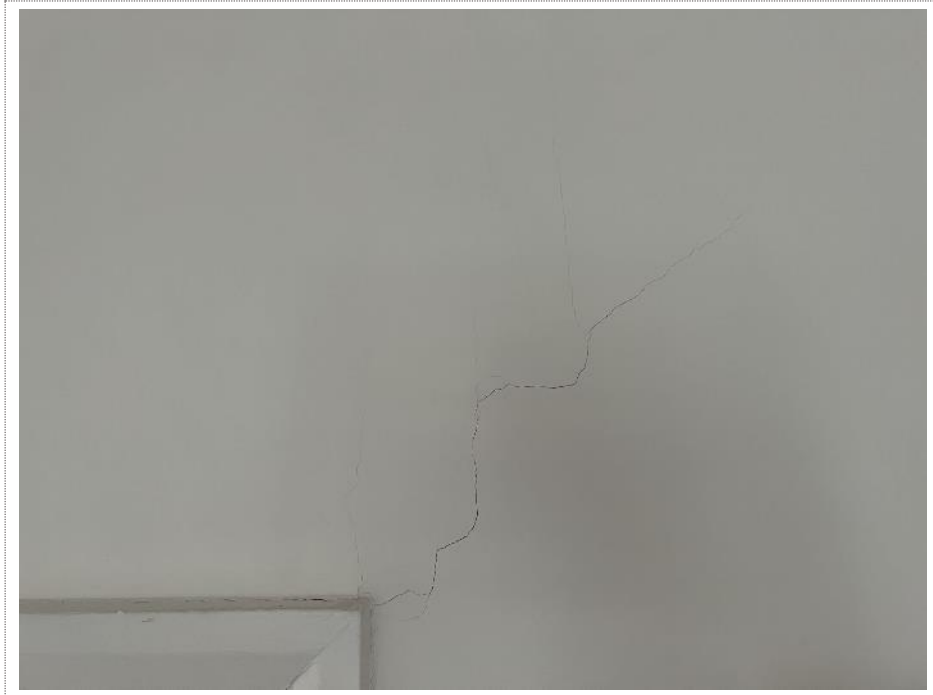
Plate 21. General condition of cracking at second floor level.
