Ref: BA3234rev

Date: 02/02/2012

RE-ASSESSMENT OF PLANE TREE IN REAR GARDEN.

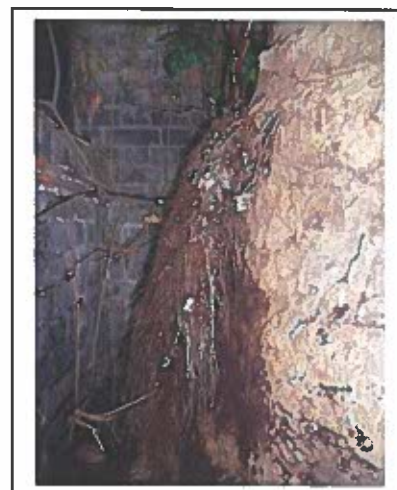
Comments: The tree is located in a narrow bed in the northwest corner of the garden close to the rear and side boundary walls. The area between the stem and the wall is filled with leaves which have accumulated over the recent seasons as shown in the photograph. Cracking can be seen in the nearby walls.

The northern and western tree buttress touches the wall at a low level, when measured at 600mm above the ground the face of the stem has a gap of approximately 200mm between the brick work and the tree.

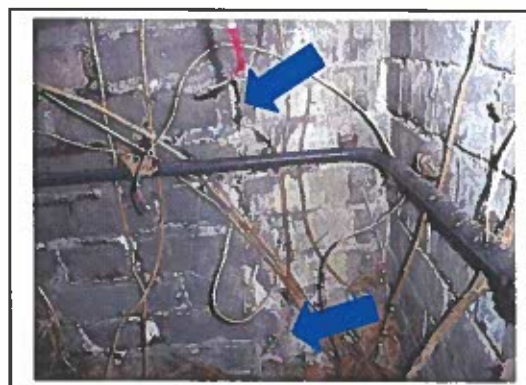
Closer assessment of the western wall shows a large step crack which extends vertically from a point close

to the stem as indicated by the blue arrow in the photograph opposite. Elsewhere the western boundary has a series of smaller step cracks which I assume is a result of direct damage.

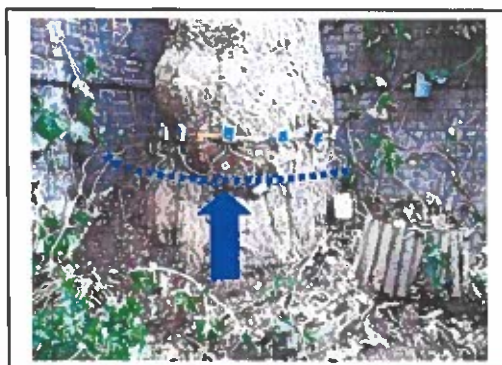
Closer assessment of the stem shows a distinct flaring of bottle but normally an indicator of internal decay, which prompted the internal assessment. Unfortunately, due to the presence of the wall I was unable to accurately measure the stem dimension as would normally be undertaken using the Picus equipment, to get around this the north-south axis of 1250mm and the east-west axis of 1300mm were used to create an ellipse and the sensor points were set at equal intervals.

The assessment height is approximately 800mm above ground level, at a point where the stem

circumference is 3800mm indicated by the blue dotted line on the photograph above. This is the same location as the assessment in 2011 to enable a comparison of the results. The blue arrow shows the position of Sensor 7.

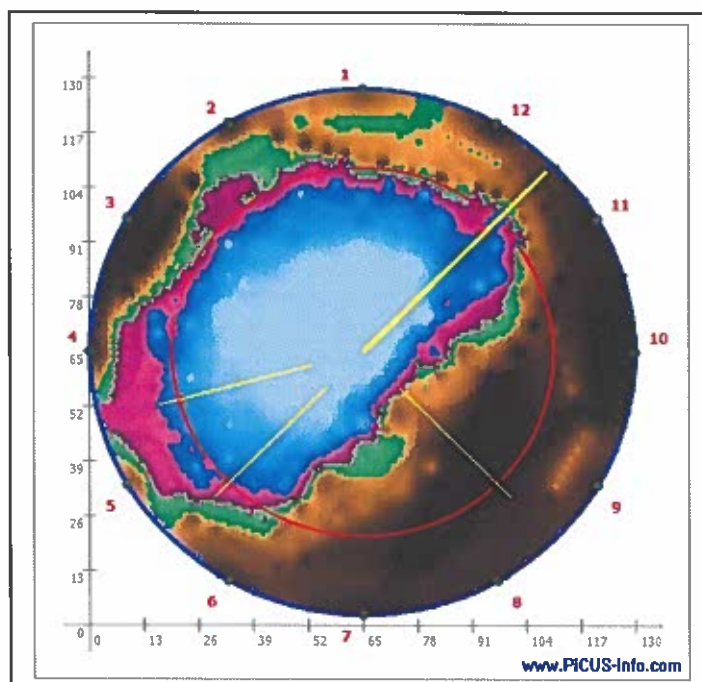
2011 Results

The Tomograph shows that the internal section of the stem has been affected by a section of stem decay indicated by the blue and magenta areas, which in a significant area goes beyond normal safe limits shown by the red line which shows the position of the 30% stem radius.

The yellow line on the tomography indicates the likely presence of internal cracks, which may have accelerated the spread of the decay fungi and may have adversely affected the tomography by increasing the time of flight for the sound signal.

A significant area of decay is present in the north western section of the stem indicated by the Blue section.

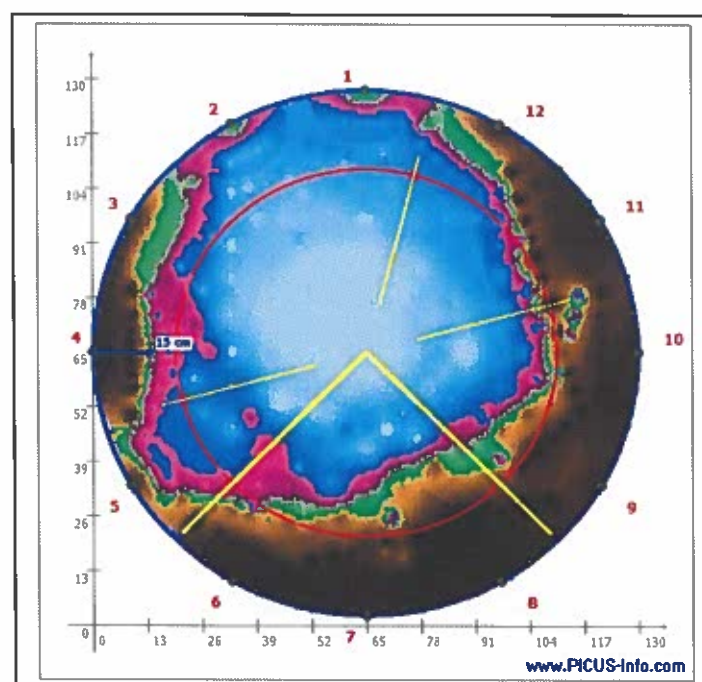
2012 Results

The yellow line on the tomography indicates the likely presence of internal cracks which are more defined than previously.

The extent of internal decay is significantly increased in volume and breached the Red minimum safety line in several places.

Recommendations: On this basis of the above findings I find the tree retention is unsustainable and offers an unreasonable risk to both site users and neighbours alike, for this reason I recommend that the tree should be removed and replaced.

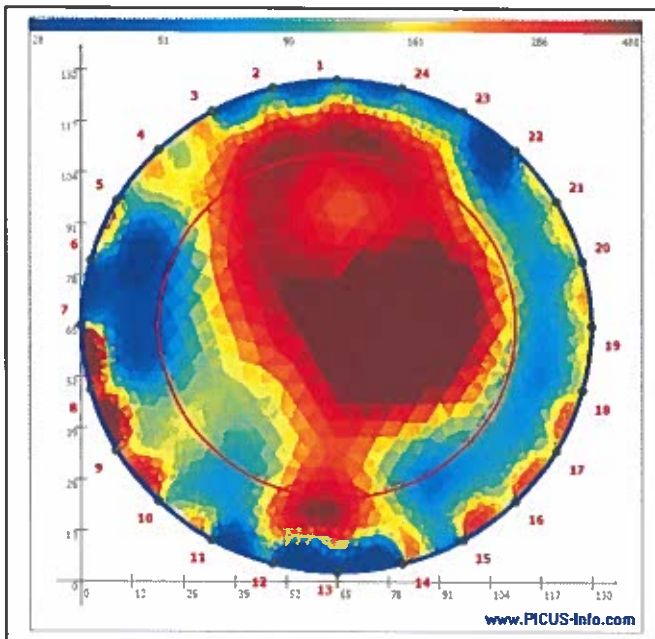
2011 Results

The results show the tree to have an area of elevated resistance or drying of the wood in the central section indicated red.

The additional red areas on the outside of the stem around sensor 7 to 10 and particularly sensors 15 to 18 indicate restrictions in sap flow likely a response to the competitive environment.

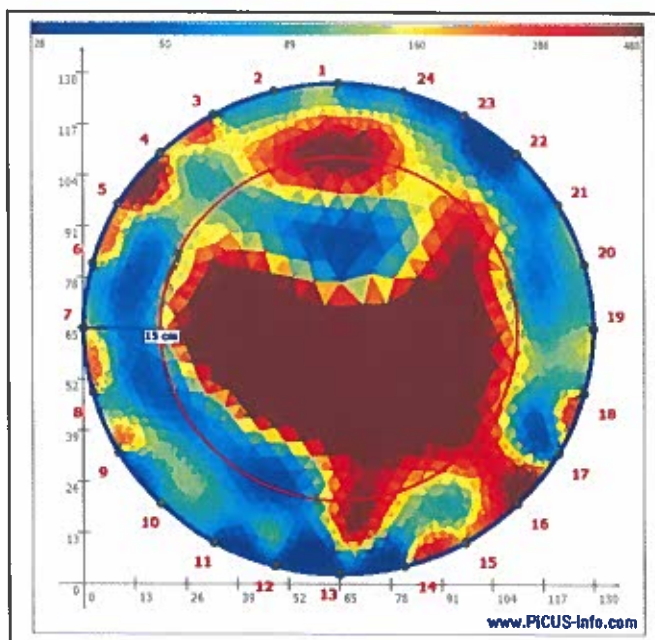
2012 Results

The central section of the stem has a significant elevation in drying, indicating the area is affected by advanced decay.

The outer stem has a higher moisture content which is assumed to be related to moisture storage during the dormant period.

The additional blue area in the northern stem is expected to be a response of elevated moisture content in the decayed element.

The area of elevated resistance (red) closely follows the pattern of decay shown in the sonic result of this year. Showing the central section of the stem has a significant elevation in drying, indicating the area affected by advanced decay.

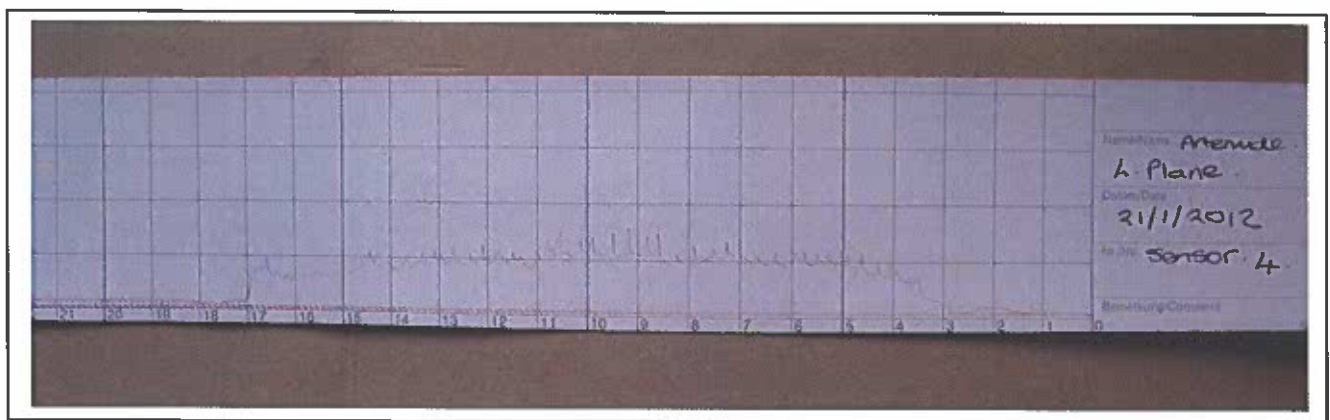
A third successful assessment was made on the western stem at sensor point 4 which was chosen as the most likely to have soft sections of the stem based upon the tomogram results and sounding with a mallet (this area of stem produced a distinct hollow sound when struck).

The results show the tree to have typical increasing wood quality through the bark and the vascular tissue from 3 cm on the trace, with relatively low quality wood extending to 17cm into the stem before hitting a cavity. This gives the tree a sound wall thickness of only 14cm and aligns well with the results on the tomographs above on which I have drawn a 15cm line on the represent the location of the Resistograph.

The decay in the lower stem has caused the stem to thin to 14cm at sensor 4 which leaves the tree predisposed to Euler buckling, which is a situation which is not manageable.

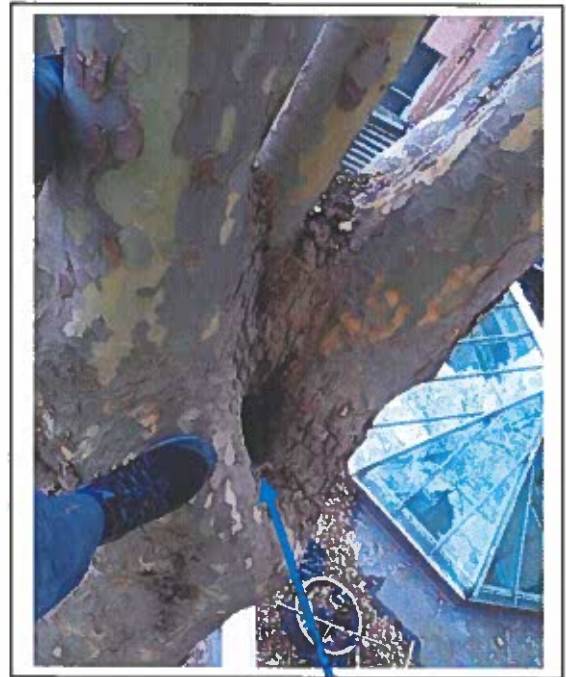
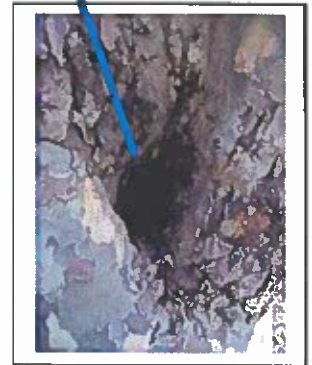
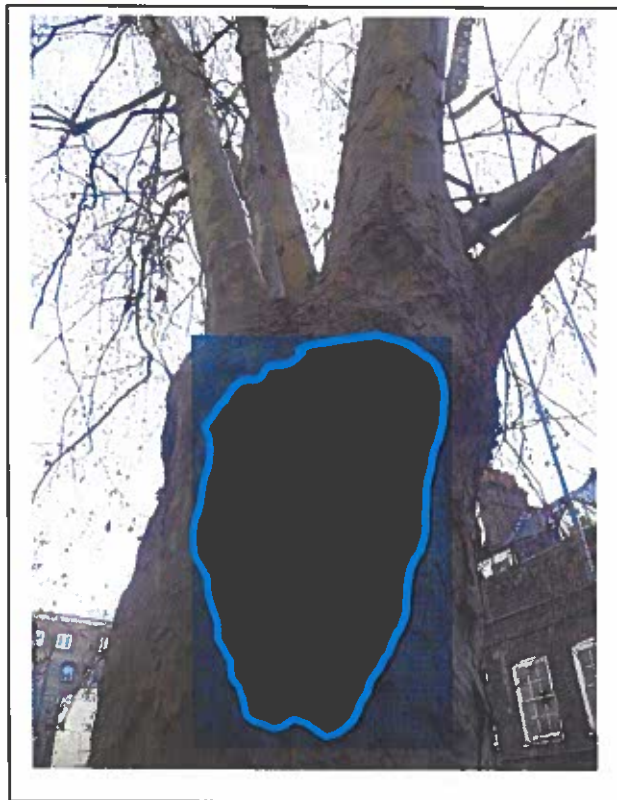
This shows a hole on the north western face of the stem, leading to a cavity that extends both below the main collection of branch attachments and down the stem to some 1200mm.

I have attempted to show the extent of the cavity on the photograph below indicated by the blue shading.

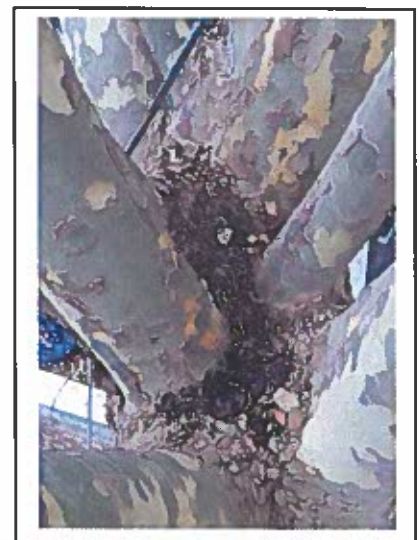
The main canopy attachments are typical of such a previously lopped tree with a slight depression which is filled with organic matter. The feature is typically congested and included unions can be expected to develop as the stems increase in diameter, leading to the formation of a series of tightly formed unions liable to collapse.

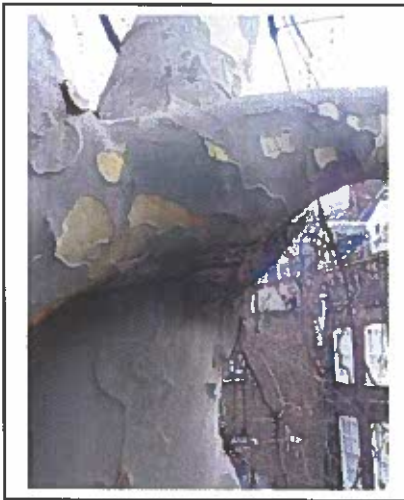
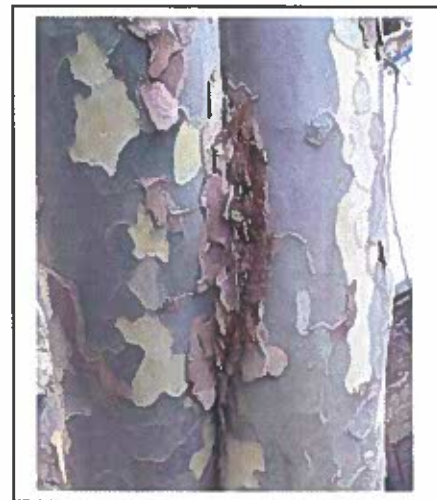
Elsewhere in the canopy a series of rubbing main leaders and crossing and rubbing main branches can be seen as shown in the photograph below. These can be expected to develop into abrasion wounds and become a site for pathogen entry, ultimately leading to branch failure.

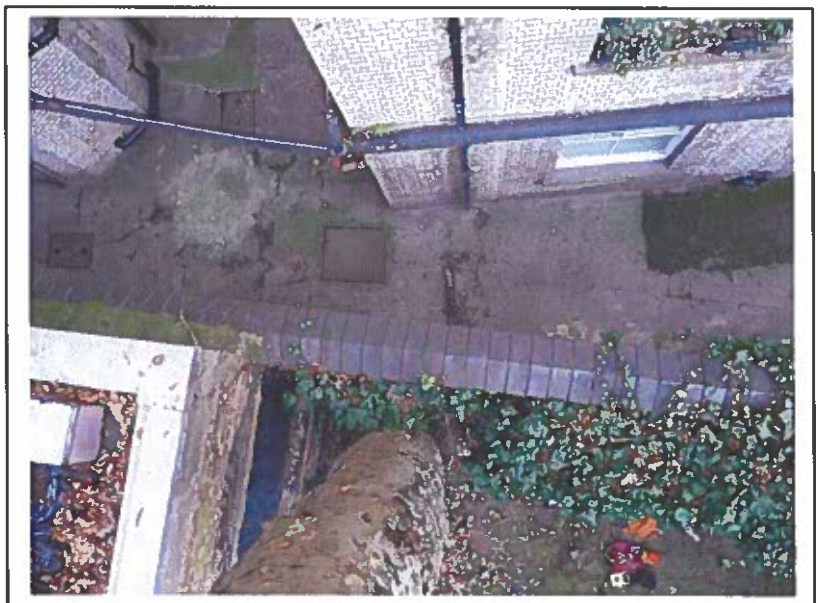
Whilst in the tree a quick visual assessment of the neighbouring land shows signs of direct root damage to the wall with the boundary wall being deflected out of position as shown opposite.

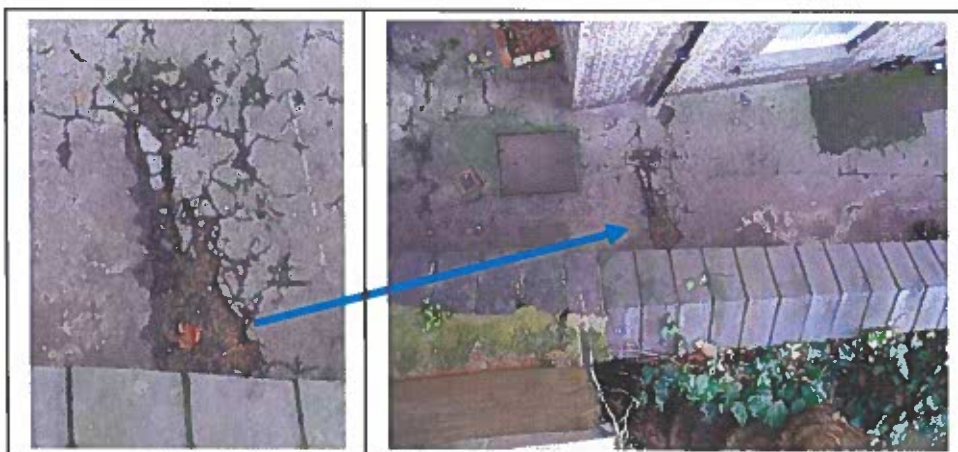
In addition to this the neighbouring footpath has suffered direct damage from tree roots as shown in the photograph opposite which could form a trip hazard.
