# GEOTECHNICAL

**Garden Flat/Flat B, 7 Camden Terrace, London, NW1 9BP**

Client: SMS (AVI, PRE)  
Client Contact: [REDACTED]  
Client Ref: IFS-AVI-SUB-22-0102275  
Policy Holder: 7 Camden Terrace Freehold Ltd  
Report Date: 16 October 2024  
Our Ref: C79010G34782

## Drainage Investigation Report

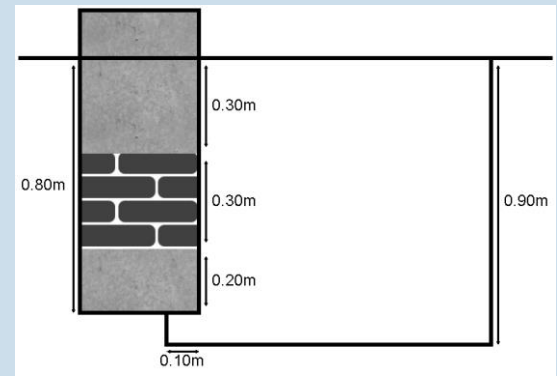
## ITP/BH1 Foundation Detail and Borehole Log

Internal wall foundation comprised of concrete to 300mm bgl, bearing on brickwork to 600mm bgl. In turn, bearing on concrete to 800mm bgl with a total projection of 0mm from the elevation. Underside of foundation (USF) was exposed to 100mm back from the face of the foundation and probed 400mm back from the face of the foundation.

At 0.80m bgl UNDERSIDE OF INTERNAL WALL FOUNDATION in ITP/BH1.

At 0.10m to 0.80m bgl rare roots of live appearance encountered in ITP/BH1.

At 0.80m to 1.60m bgl rare roots of live appearance encountered and sampled in ITP/BH1.

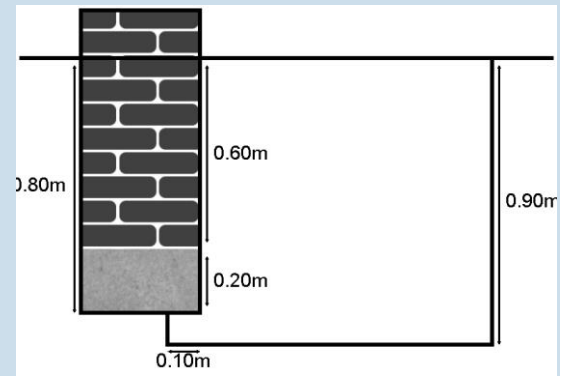
## ITP/BH2 Foundation Detail and Borehole Log

Internal wall foundation comprised of brick wall to 600mm bgl, bearing on concrete to 800mm bgl with no projection from the elevation. Underside of foundation (USF) was exposed to 100mm back from the face of the foundation and probed 400mm back from the face of the foundation.

At 0.80m bgl UNDERSIDE OF INTERNAL WALL FOUNDATION in ITP/BH2.

At 0.10m to 0.80m bgl occasional roots of live appearance encountered in ITP/BH2.

At 0.80m to 1.70m bgl occasional roots of live appearance encountered and sampled in ITP/BH2.

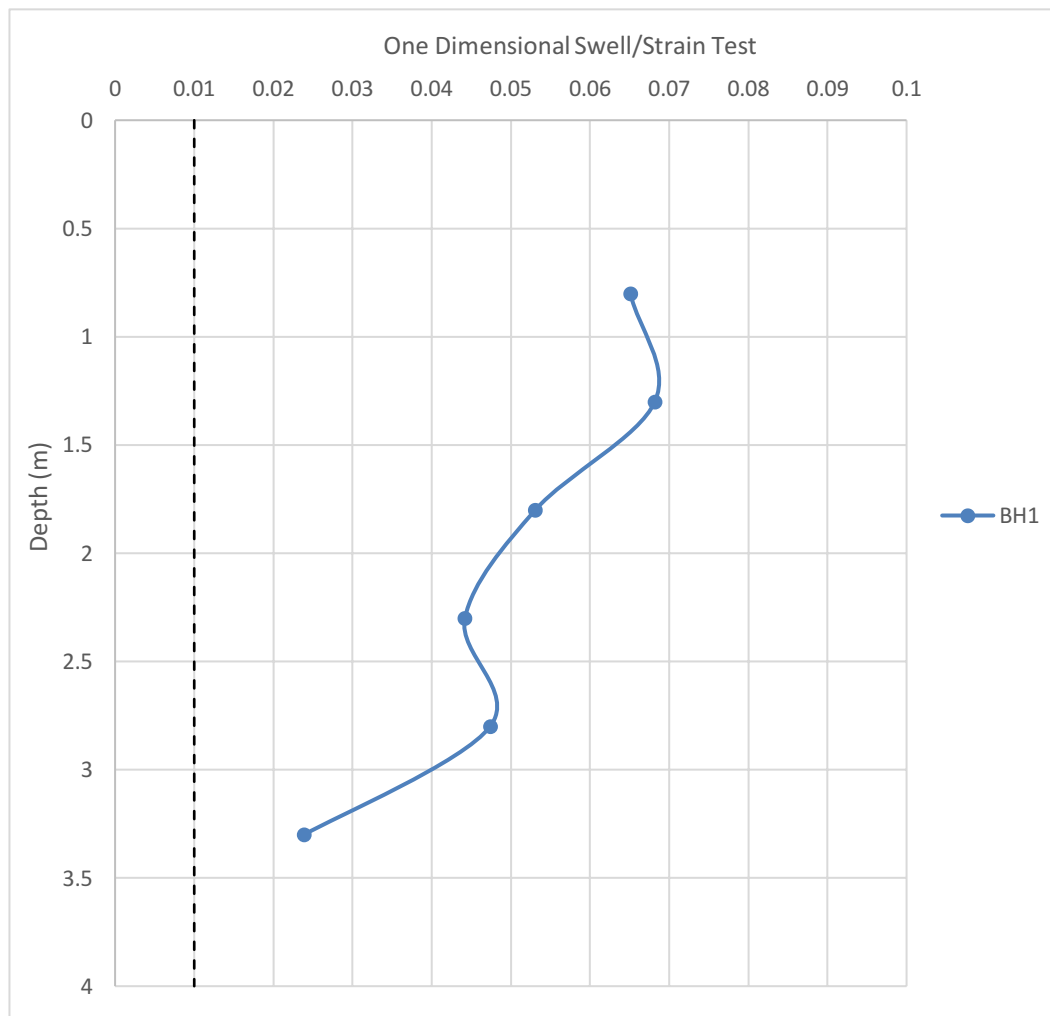
## Summary of Oedometer Testing for BH1

BH 1 estimate of heave

85mm

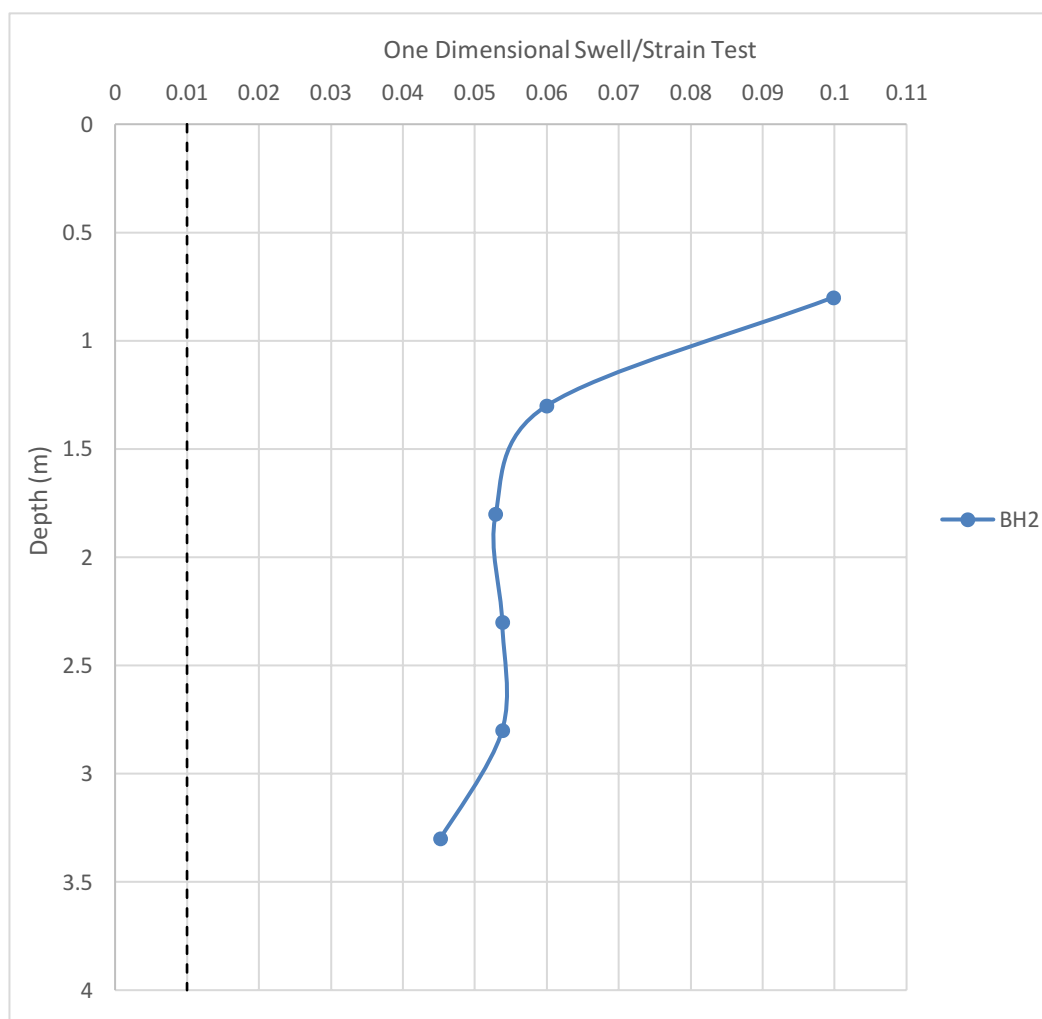
## Summary of Oedometer Testing for BH2

BH 2 estimate of heave

106mm
