**8 HOLLY TERRACE, LONDON
N6 6LX**

**Heritage report, incorporating
design and access.**

**Application for remedial works to
strip and re-slate the roof, repairs to
brick vaults, renovation of
windows, repairs to render and
balcony and alterations to internal
lighting.**

April 2025

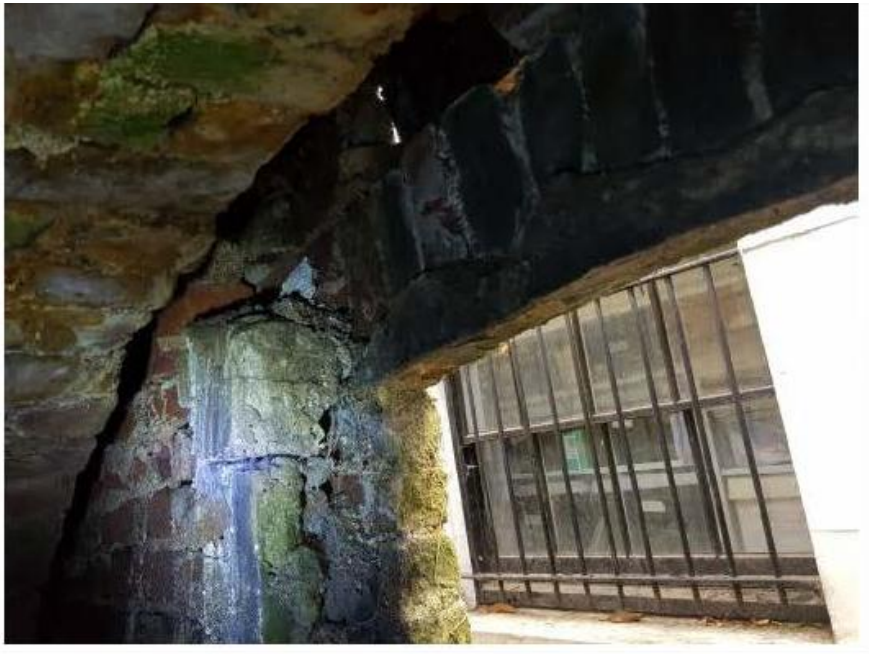
View A-joint between front wall and vault opened up and brick arch failing

The existing vaults are structurally unsafe. Both arches have failed; the front wall has come away from the remainder of the vault, and the brickwork is bowing considerably. This movement and damage are caused by the close proximity of tree roots. Carefully take down bowing and unsafe brickwork and failing arches. Clean off bricks and set aside for re-use. Front of vaults to be re-built in existing and matching brickwork, and incorporate new lintels and Helibar steel bars to tie front wall into existing walls of vaults-as Engineer’s details

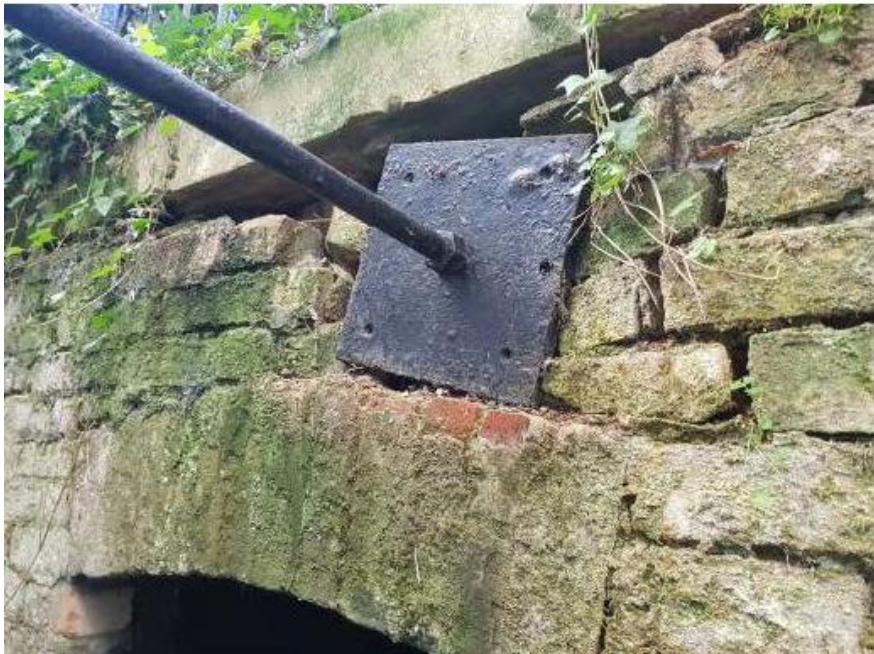
View B- brick arch has failed and joints in brickwork have opened up

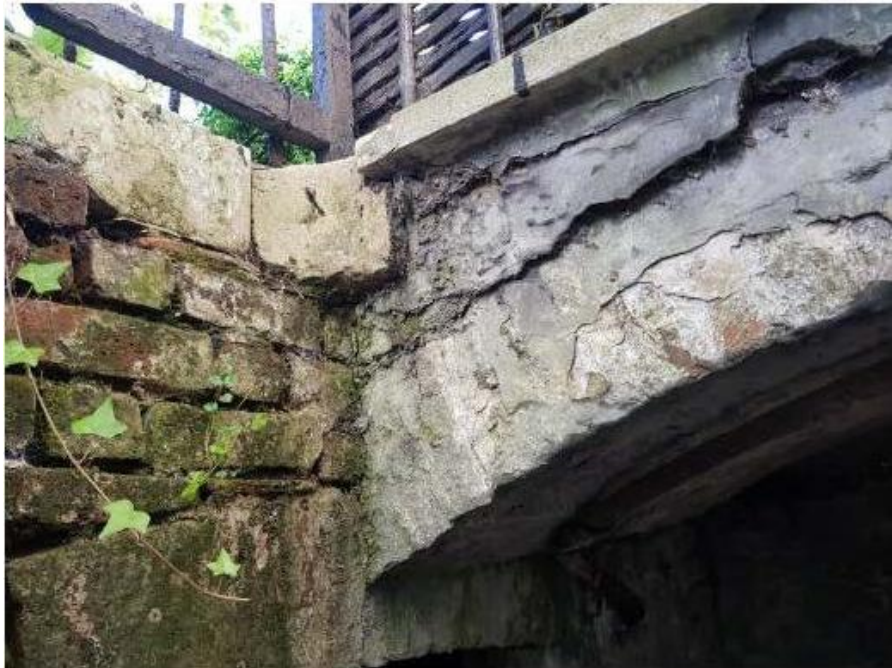
View C- cracked brickwork below balustrade and above arch

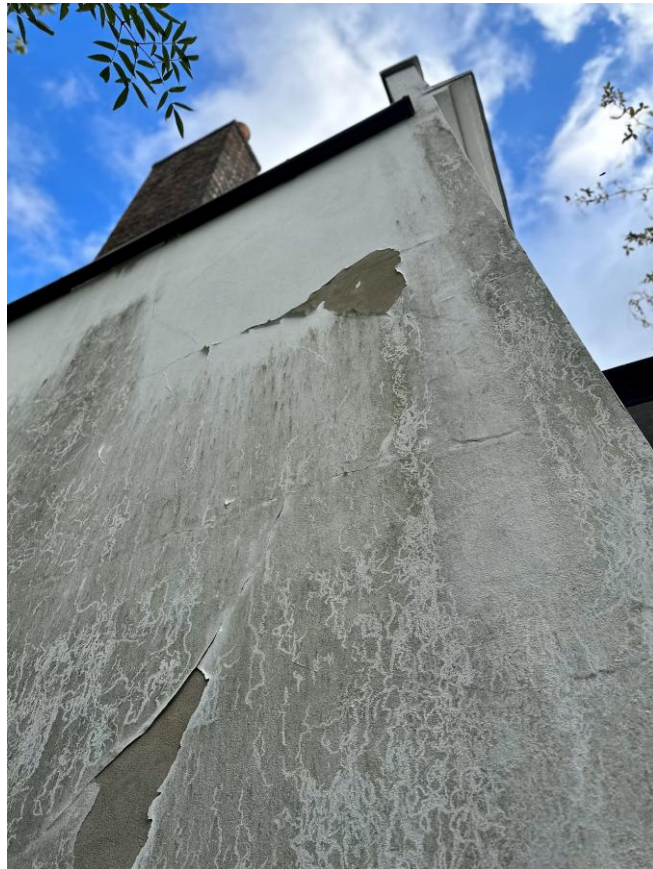
Render cracking and detaching from sub-base

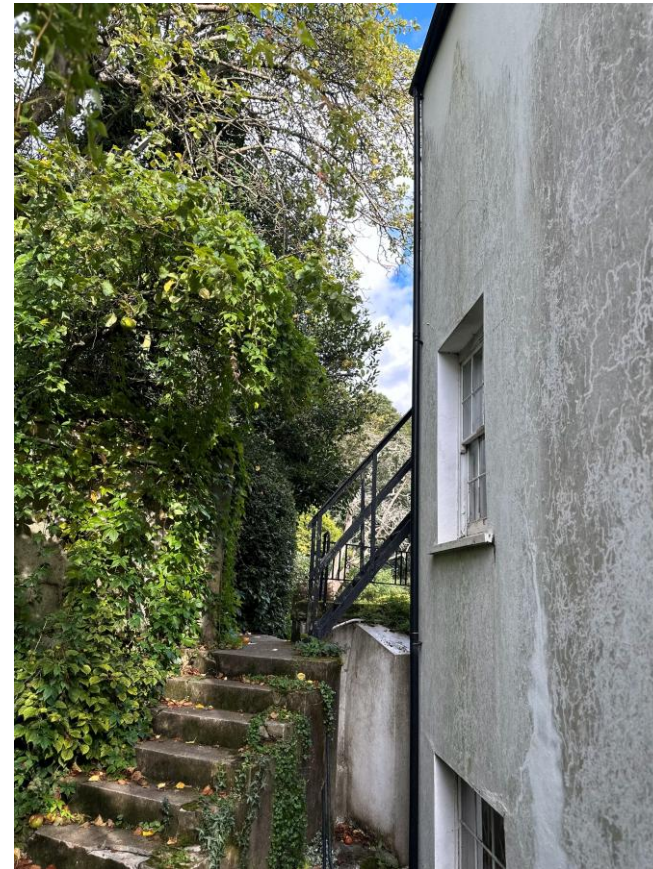
Render cracking and crazing

Detachment between coats (delamination)

Undercoat too weak to support finish coat. Finish coat too thick for backing (typically modelled detail) Lack of adequate keying between coats Salt crystallisation at the interface between render/plaster coats

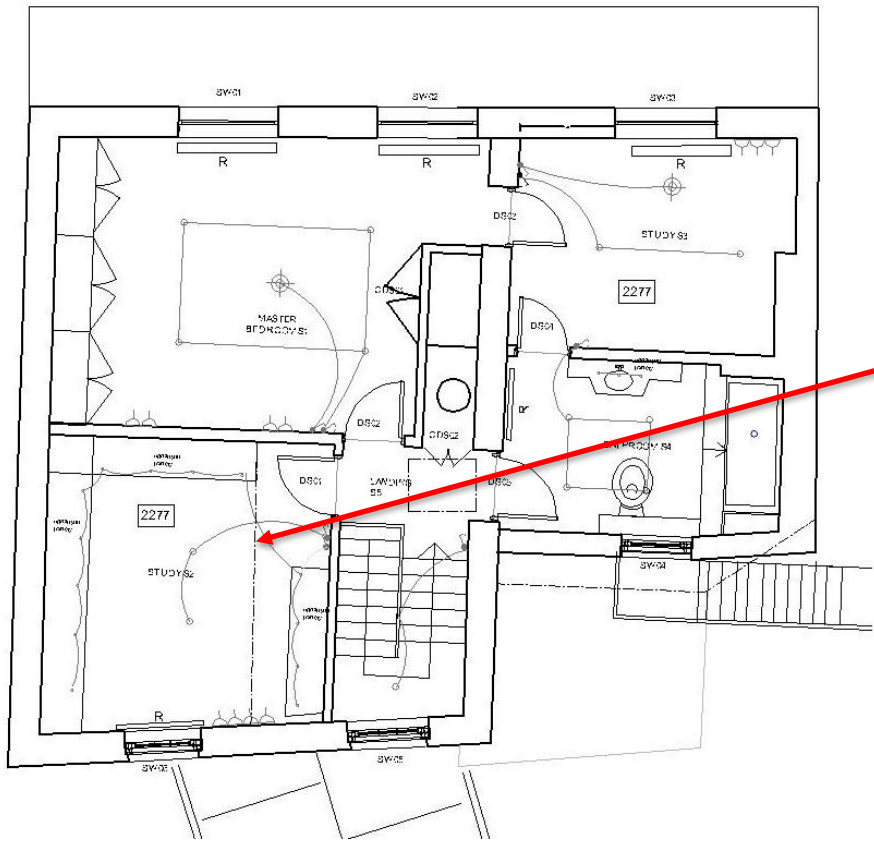
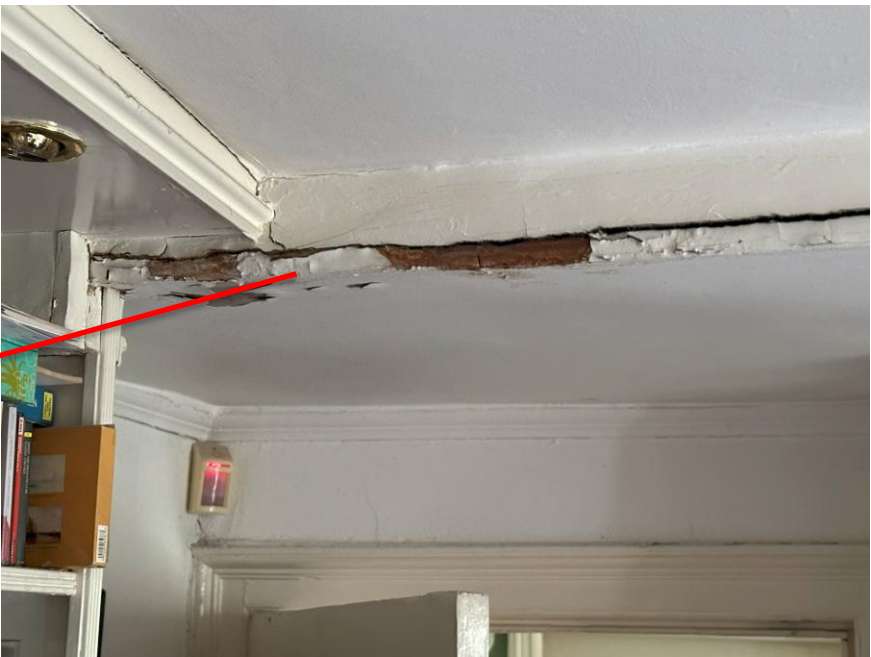
Damp coming through second-floor beam from leaking roof.
