STRUCTURAL ENGINEER'S REPORT

8 HOLLY TERRACE N6

PROJECT REF 5869
REV –
ISSUED 29/11/23

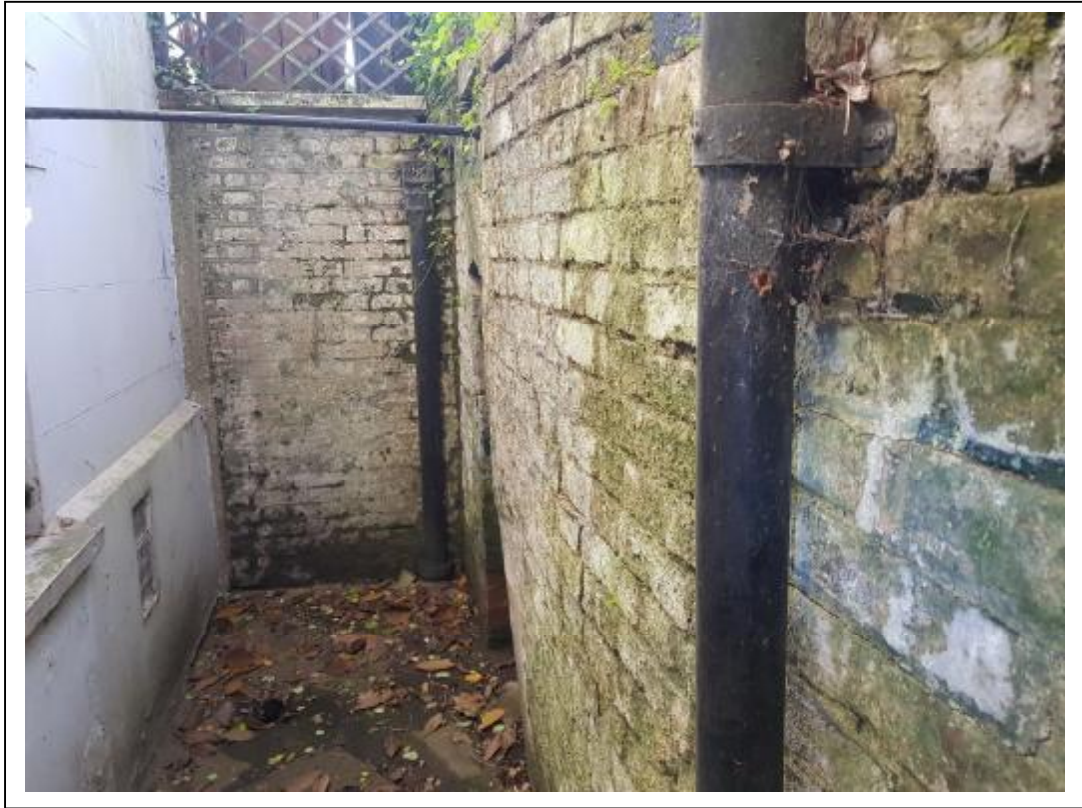
- 1) The light well wall is leaning and bowing inwards severely. See Photograph 1.
- 2) The head of the light well wall is restrained by two steel props against the main house. Both of these have resulted in a punching shear failure in the lightwell brickwork. See Photograph 2.

The front light well wall is in very poor structural condition. Movement of up to 100mm inwards towards the house has occurred, with the wall bowing severely and leaning inwards. Large areas of pointing and mortar are missing and there are numerous structural cracks. The wall has moved bodily away from the vaulted structures which act as the main retaining structures to the ground of the front garden. However, the close proximity of the Magnolia tree has undoubtedly had an adverse effect on the wall and its growth over the years will have been a primary contributing factor to the movement of the wall.

It is recommended that the front light well wall is largely rebuilt, the only exception to this being the corner near the party wall which carries a cast-iron column supporting the balcony and the support to the entrance portico, the arch of which is housed into the light well wall. The majority of the wall should be carefully taken down leaving toothed out sections each end. The supporting braces against the main house would need to be removed and set aside. Prior to commencing work the Magnolia tree should be propped to avoid destabilising more soil than necessary when the wall is dismantled. Localised areas of soil may be lost between the two brick vaults, but the vaults should be sufficient to adequately retain the garden during the works. Once the light well wall has been taken down, the foundation should be examined and if necessary, a new strip foundation cast. The wall should then be reconstructed in 215mm solid bond brickwork, and it is recommended that stainless steel ties be drilled and resin anchored into the end of the vaulted brickwork and built into the main front wall. Before completion all the cracks in the vaulted brickwork should be resin injected.

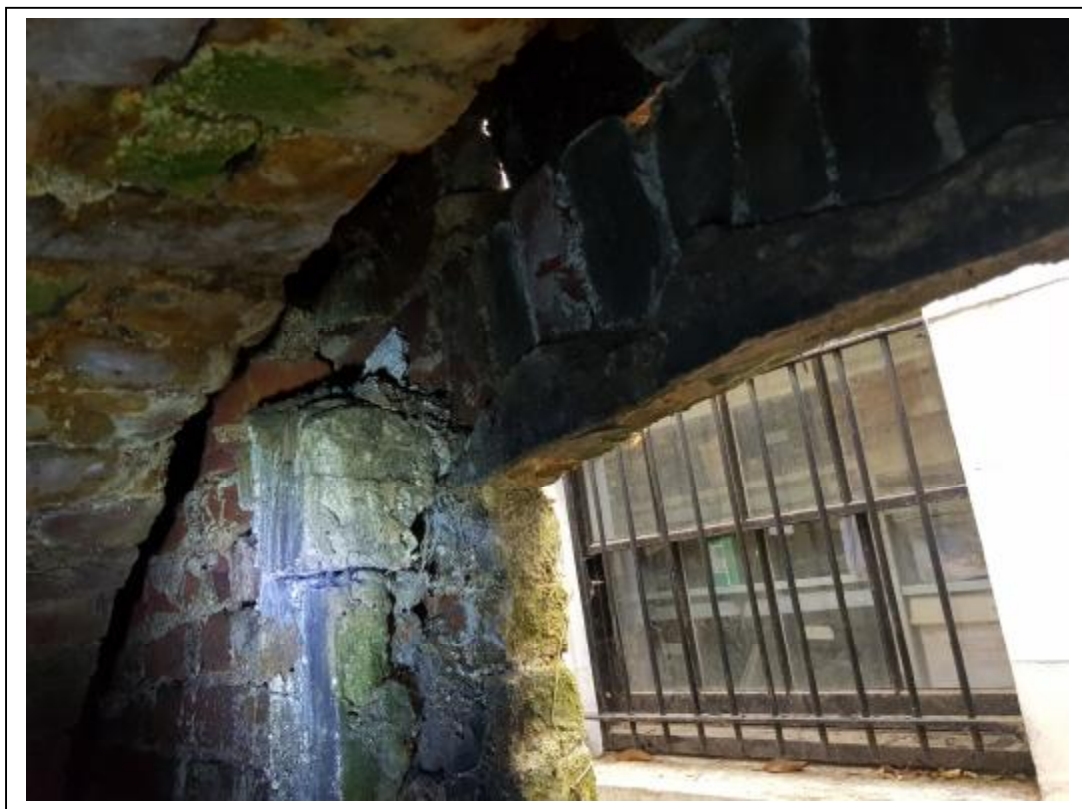
- 3) A clear gap can be seen between the front light well wall and the right side brick vaulted structure beneath the garden. See Photograph 3. The extent of movement reaches a maximum of approximately 100mm.

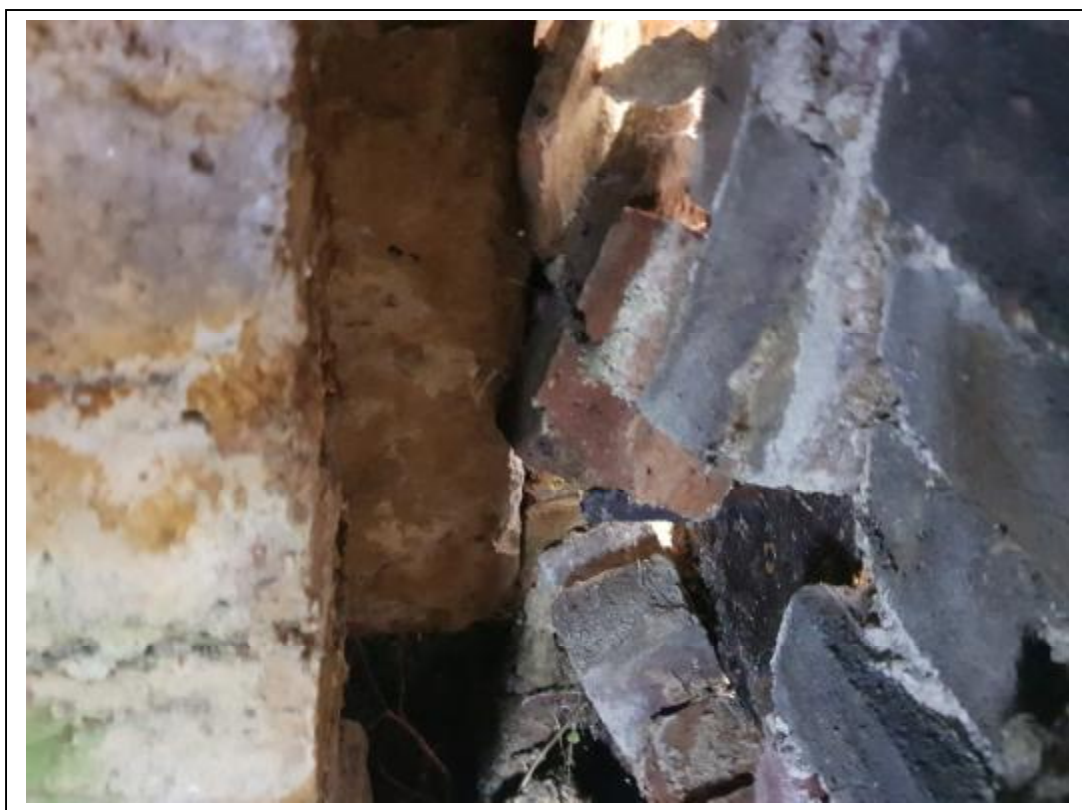
- 4) Parts of the inner half of the light well wall enclosing the right side vault have collapsed, leaving only the brick arch on the outer half. See Photograph 4.

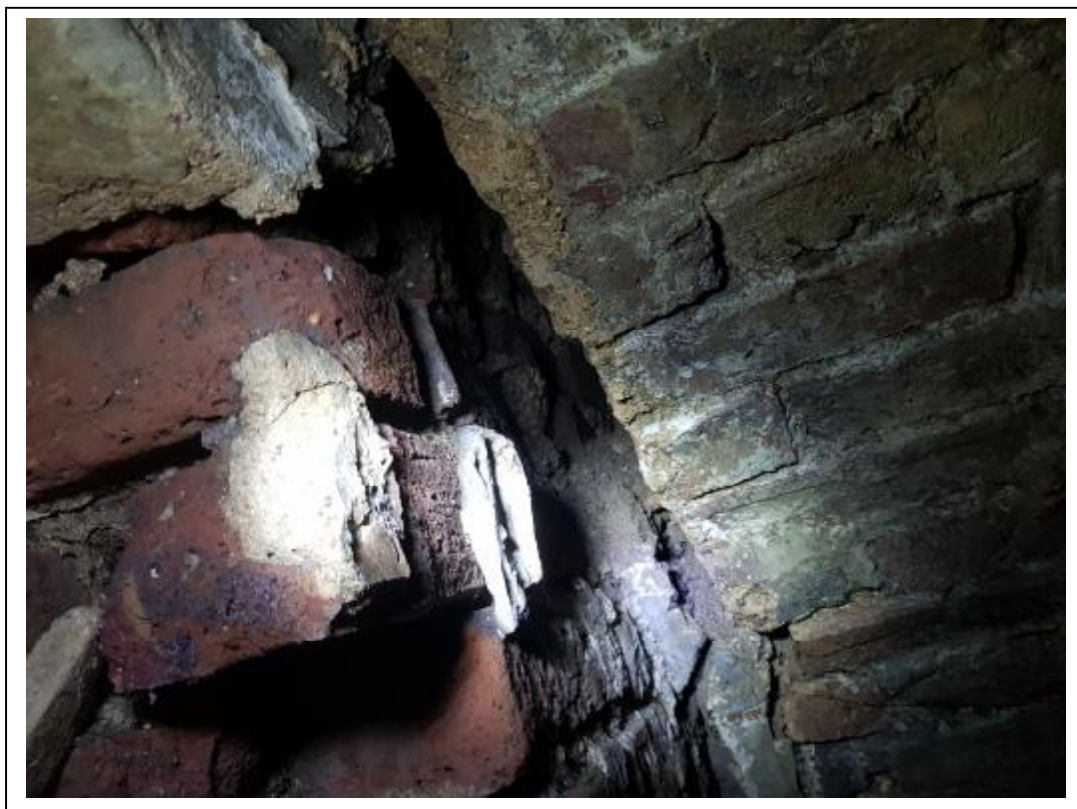
- 5) A similar gap can be seen between the left side vault and the light well wall. See Photograph 5.
- 6) The light well wall itself exhibits tension cracks near the centre due to the extended length as a result of bowing. See Photograph 6 and 7.

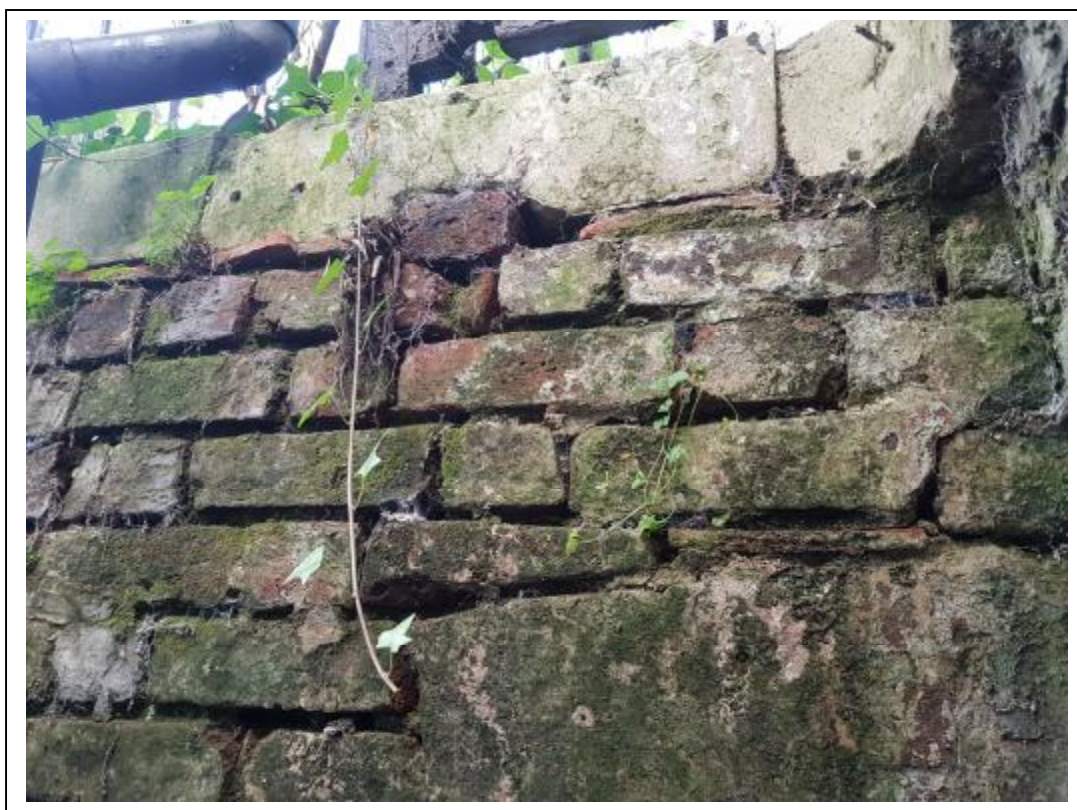
- 7) Areas of the wall have completely lost all pointing and much of the mortar has fallen out. See Photograph 8.
- 8) Deterioration in the masonry to the entrance porch was also noted, see Photograph 9 and inside the vaults there are various cracks through the vault brickwork, see Photograph 10.

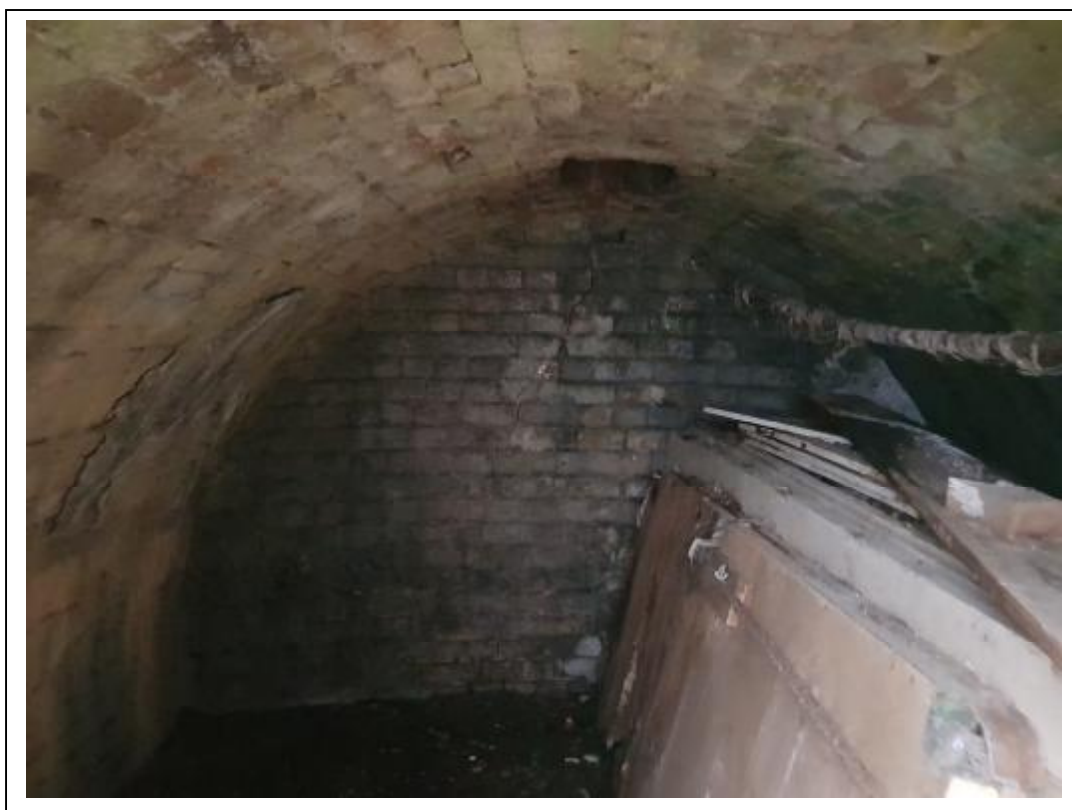
Photograph 10.

Fortunately, the brick vaulted structures are in relatively good condition with relatively manageable cracking, all of which could be repaired by means of resin injection. The light well wall however is considered to be entirely beyond repair and should be taken down and rebuilt.

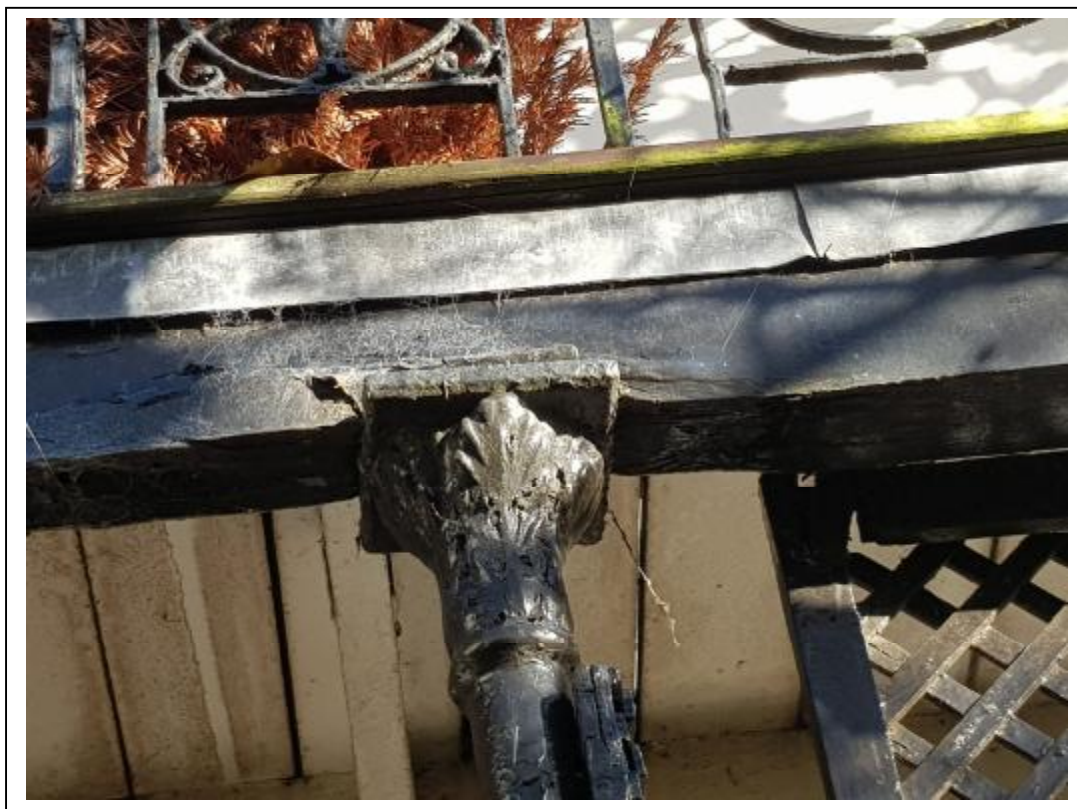
- 11) To the right of the entrance door, the timber edge beam is severely rotted with a screwdriver easily penetrating the underside by 75mm. See Photograph 11.

The main supporting edge beam to the front balcony has been badly affected by rot at the interior support close to the entrance door. Anecdotal evidence was given that this coincides with the position of a leaking gutter above. Being at the support, repair of the edge beam will not be a straightforward matter. The rot cannot be cut out and replaced as it will destroy the integrity of the beam. Repair may be possible, subject to identifying the full extent of rot, by means of reconstituting the beam and splicing with steel plates. The method of repair is described in principle in the next section but would be subject to more detailed investigation once full access to the edge beam is available on site.

Remedial works in principle would involve propping of the balcony edge beam remote from the supporting column where the timber is sound. The area should then be accessed and thoroughly examined, and the area affected by rot completely cut out. This section should be replaced with a hardwood block of equal size to the existing edge beam. Some jacking back up of the balcony structure may be required to accommodate the full size of the new timber. Once in place, the old and new sections of timber should be spliced using two long galvanised steel plates, one inside, one outside, and bolted right through to reintroduce the continuity of the beam.

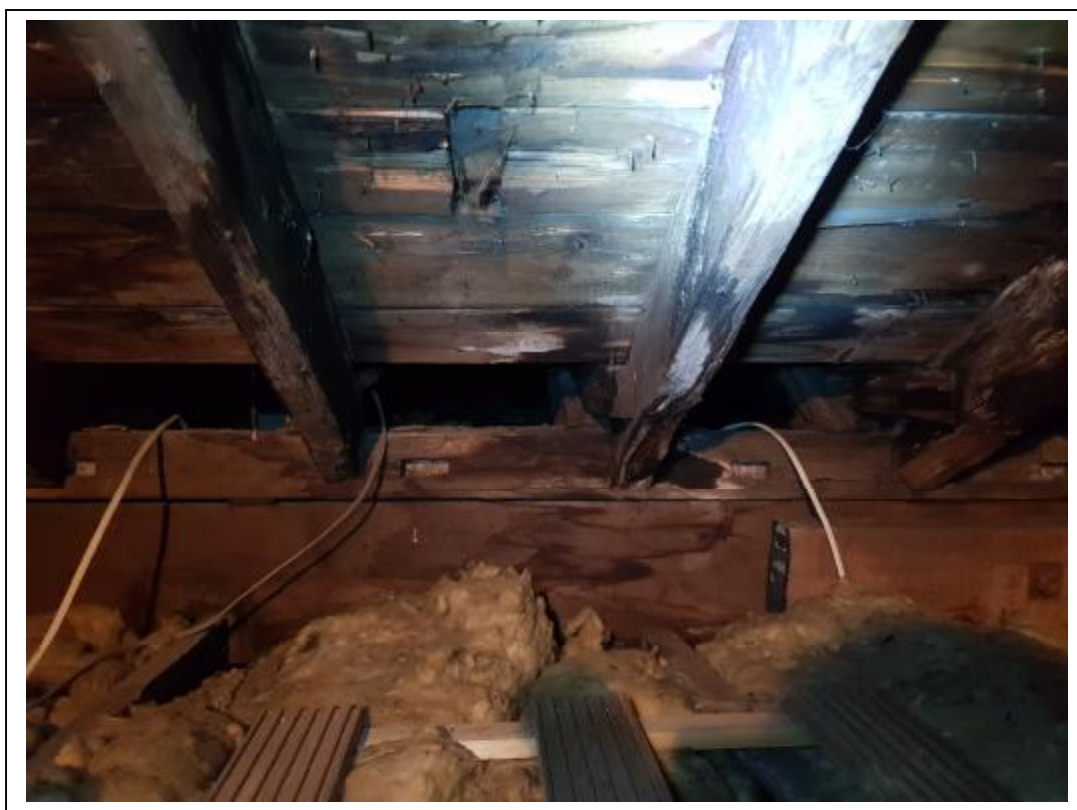
- 12) In the roof space to the right of the valley gutter there is evidence of damp penetration which has caused rot to the base of the rafters and supporting timber plate. See Photograph 12. A total of four affected rafters could be seen from the left side of the roof, close to the centre of the building.

The internal loadbearing spine wall of the building is constructed in timber over the top storeys, and this will shrink and compress over time due to the permanent loading. The result of this is that the centre of the building will drop slightly relative to the brick perimeter, and this is likely to have resulted in a back-fall on the valley gutter and ponding of the rainwater near the centre of the gutter. Leaking of the gutter near the centre is evident by staining on the ceiling, together with the areas of rot in the roof timbers as illustrated. Fortunately, the rot does not appear to have badly affected the valley beams themselves and it is likely that these could be treated and if necessary, strengthened rather than replaced. However, several of the rafters are undoubtedly affected with rot as well as the supporting plate on top of the valley beam. Only the left side of the roof was accessible, and it is probable that a similar situation exists on the right side of the roof.

It is assumed from evidence of leakage of the valley gutter that the lining of this will need to be replaced. In doing so it is assumed that the lower courses of slates will need to be lifted and, if indeed the roof covering is in poor condition, the entire roof may need to be re-clad. Once exposed by such works the areas of rotten timber should be cut out and the remaining timbers thoroughly treated. Areas of defective wall plate could simply be replaced and screwed down onto the tops of the valley beam. Rafter ends affected by rot should be cut back and the rafters, re-extended, by bolting on similar timber sections, possibly one each side of the rafter to avoid imbalance and bolting through the sound timber to form a splice connection.

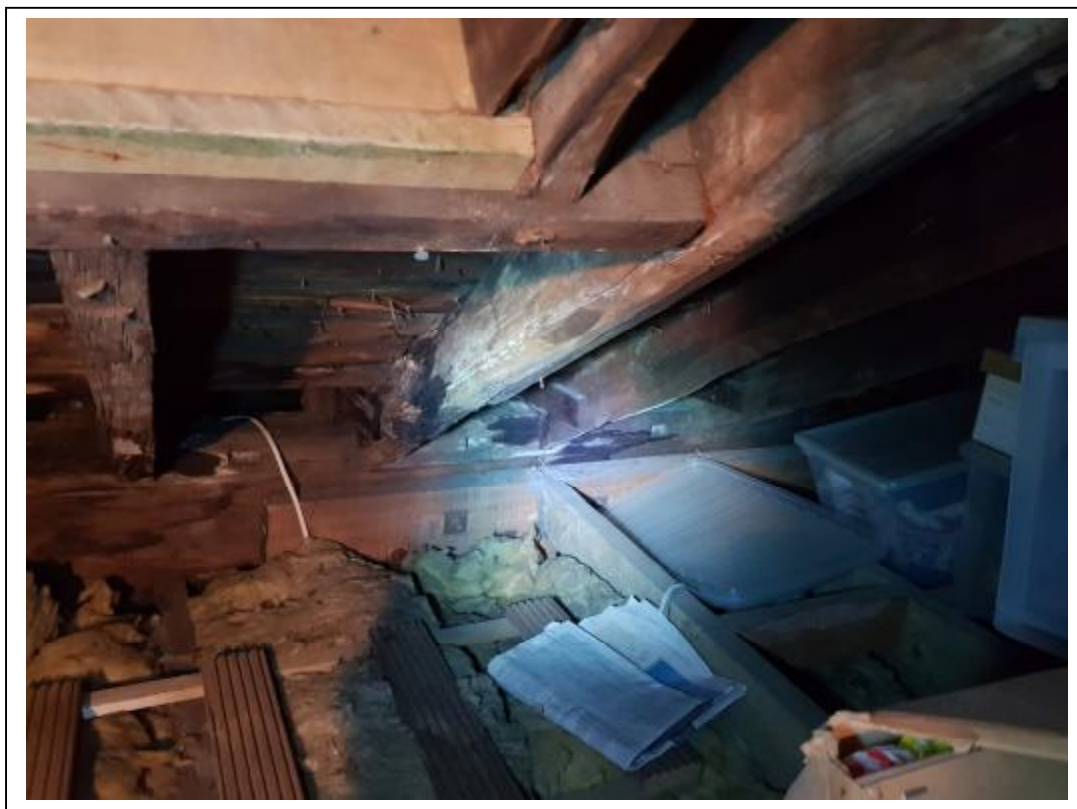
- 13) There is evidence of water damage staining to the main valley beam and potential onset of rot. It was noted that some ceiling joists have been replaced in the past and a timber beam planted on the side of the valley beam, potentially strengthening it towards the front. See Photograph 13.

If, once full access is available, it is discovered that sections of the valley beams have become affected by rot, these areas should be neutralised with a timber preservative. If the extent of rot is so much that it has impaired the structural adequacy of the valley beams, the valley beams could be augmented by bolting on of new timbers in the way that has already been done in the past towards the front.

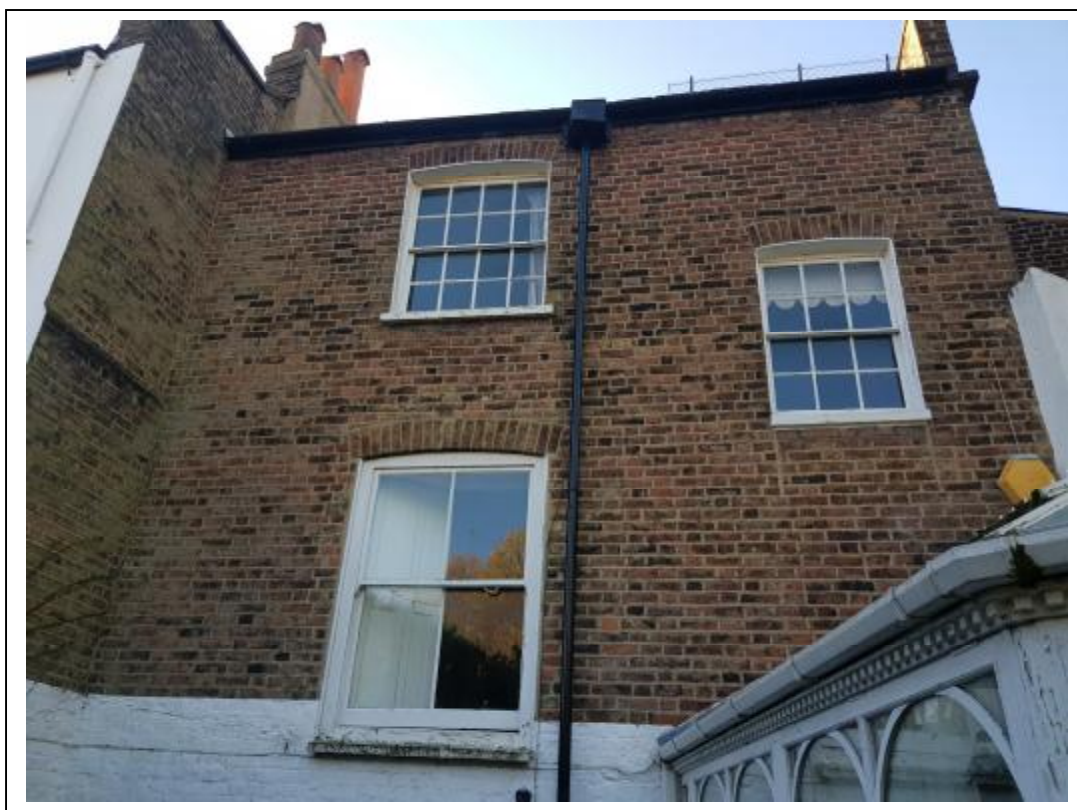
Photograph 14.

- 14) The general condition of the main external walls of the building appeared relatively sound. See Photograph 14, 15 and 16.
