## Appendix A: Site Walkover Records

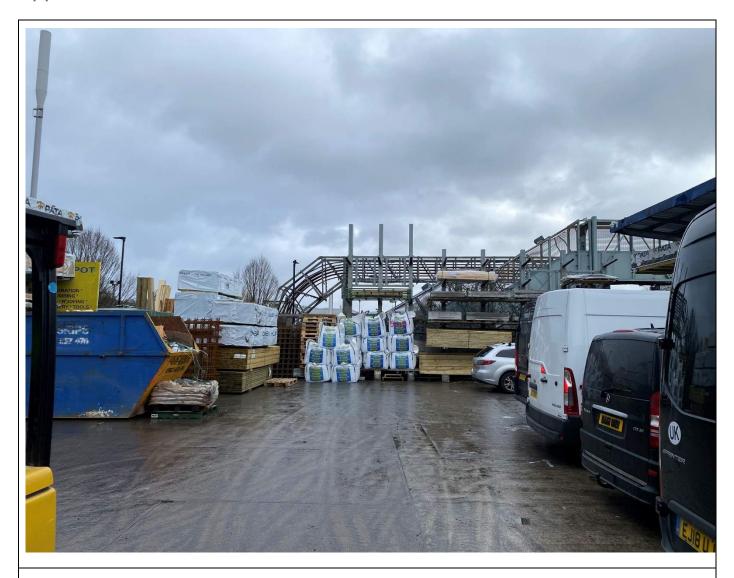
**Image 1**: Eastern portion of the Site which is used vehicle parking and used for the storage of timber. Note that there is a skip which contains domestic waste.

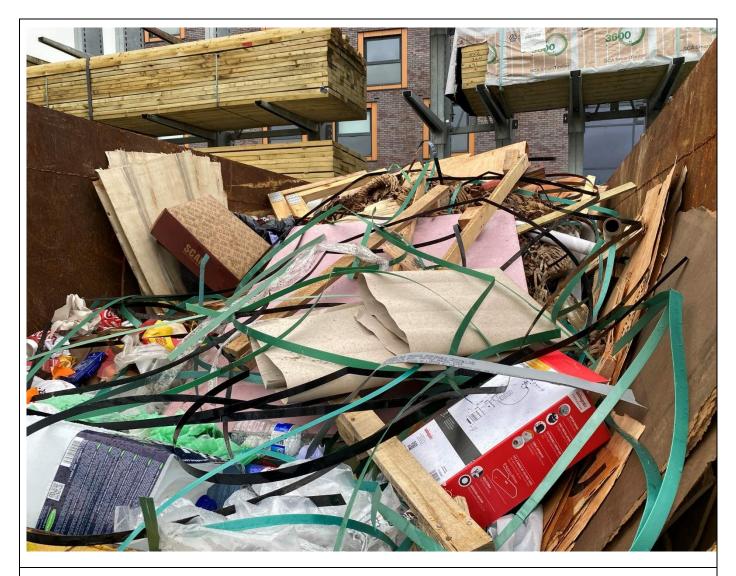
Image 2: Contents of the skip.

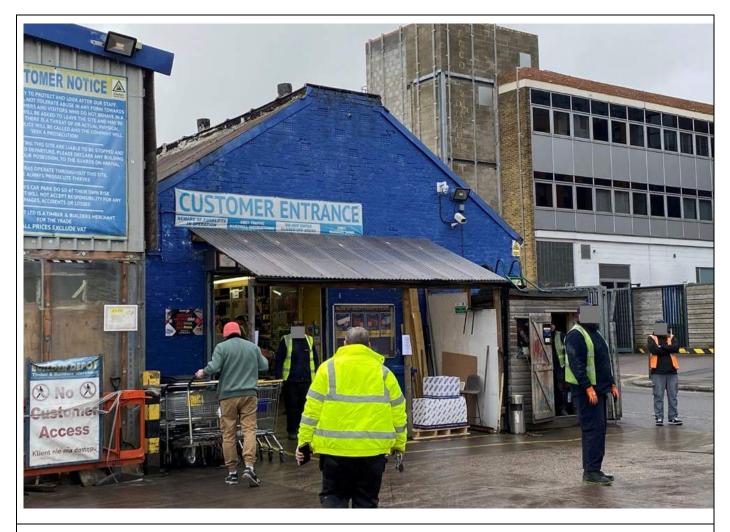
Image 3: Storefront of the current builders' merchants.

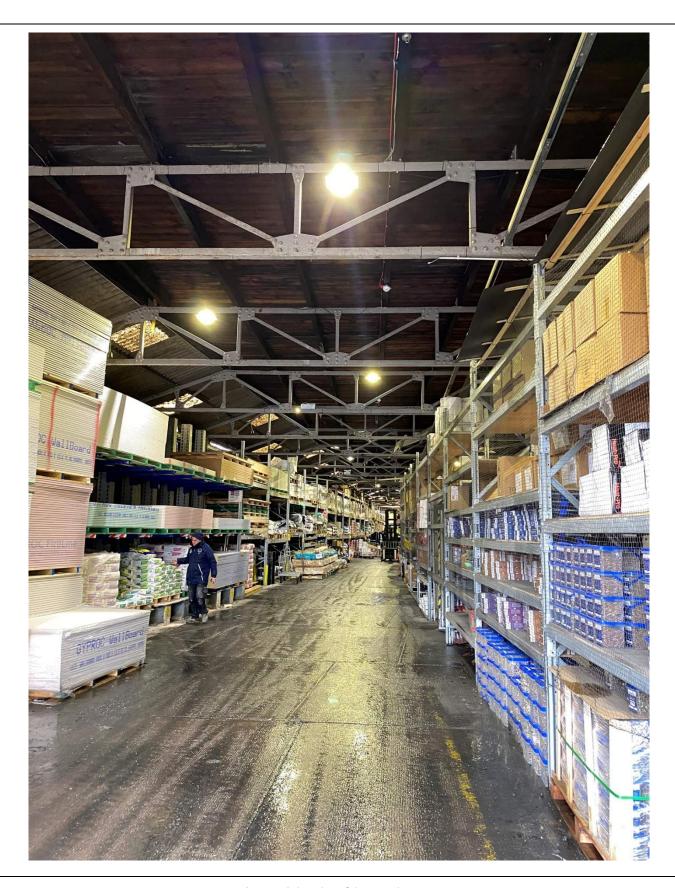
Image 4: Interior of the warehouse.

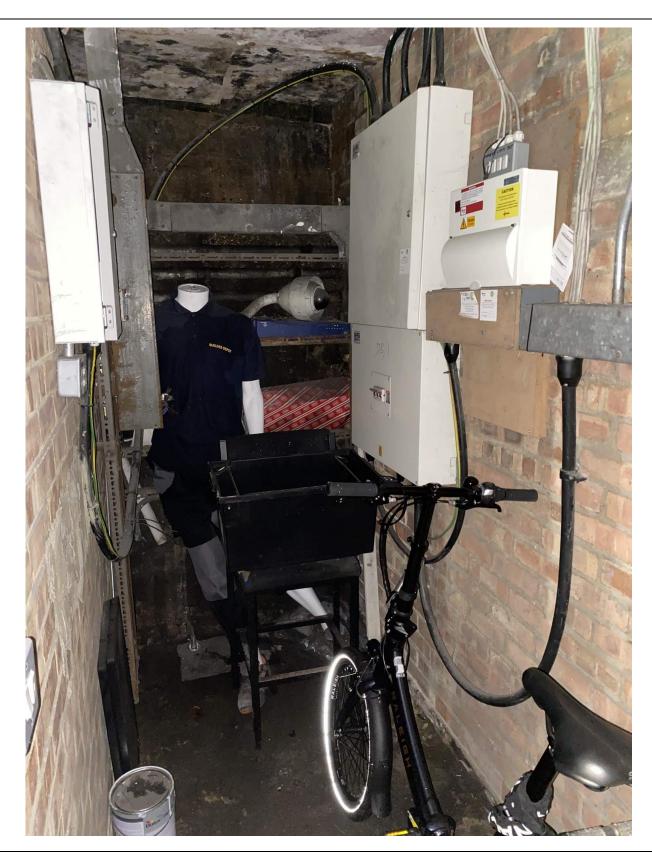
Figure 5: Electrical Switchroom.

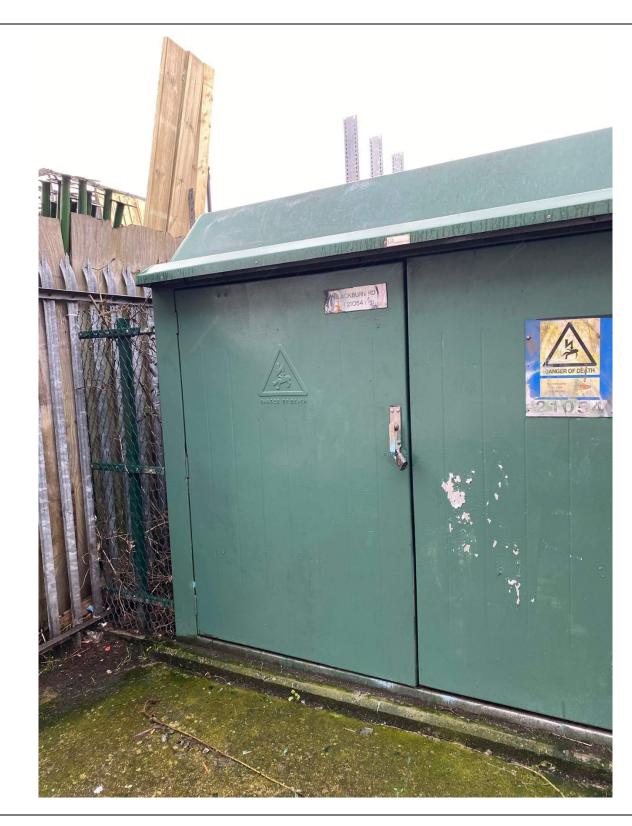
Image 6: Electrical Substation at the northeastern corner of the Site.
