**Project Name:** HAPPY DRAINS Flat 1 18 Platts Lane NW3 7NS - C1013264  
**Project Description:** CCTV Survey  
**Project Status:** Issued  
**Project Date:** 23/10/2024  
**Inspection Standard:** MSCC5 Sewers & Drainage GB (SRM5 Scoring)

FLAT 1, PLATTS LANE  
HAMPSTEAD  
LONDON  
NW3 7NS

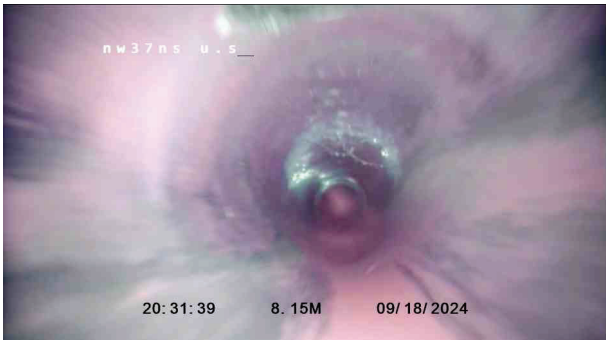
1035e34e-b20a-47e5-a1c4-b78ced69edcd.png, 00:00:38, 8.15 m  
Connection other than junction at 11 o'clock, 100mm dia

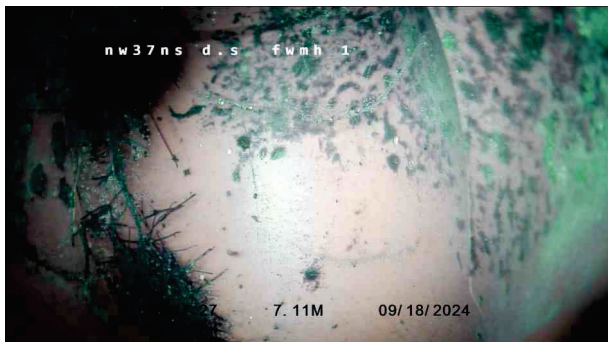
6d2dfc35-97b3-4dc0-83ae-87758a451ba8.png, 00:00:35, 7.11  
m  
Line deviates down

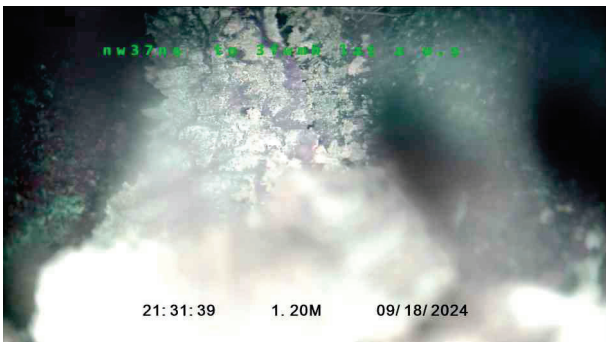
87a894b7-0156-42bd-9139-5314e2be234a.png, 00:00:09, 1.20  
m  
Settled deposits, fine, 15% cross-sectional area loss

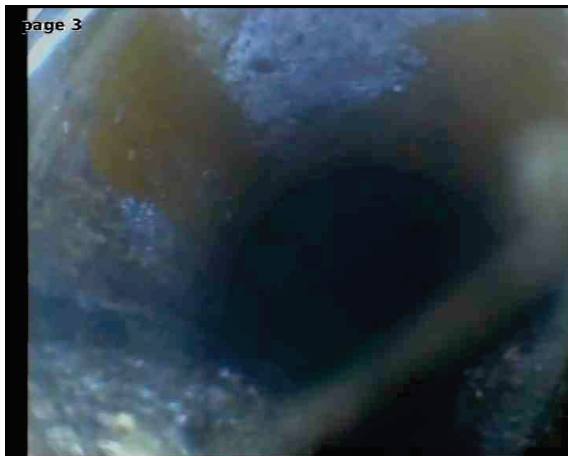
FWMH4X\_94a2c97c-eaee-4857-9370-c830deef467\_20241007\_013211\_693.jpg, 00:00:17, 0.00 m  
Attached deposits, grease from 12 o'clock to 12 o'clock, 15% cross-sectional area loss, start

| <b>Recommendations:</b> | HPWJ to remove Grease | | | | |

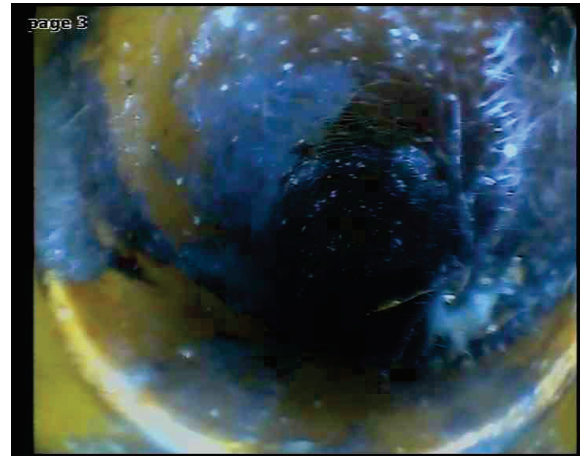
FWMH5X\_4012fe3c-2693-4359-b224-8d47829c168f\_20241007\_013558\_121.jpg, 00:00:11, 0.50 m  
Roots, mass at joint, 20% cross-sectional area loss

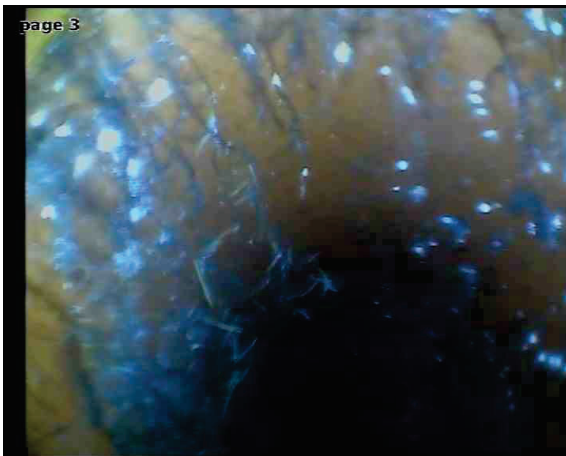
FWMH5X\_b43a86fe-5da2-4c1a-85a0-939ac1816a89\_20241007\_013630\_449.jpg, 00:00:14, 0.60 m  
Roots, fine, start

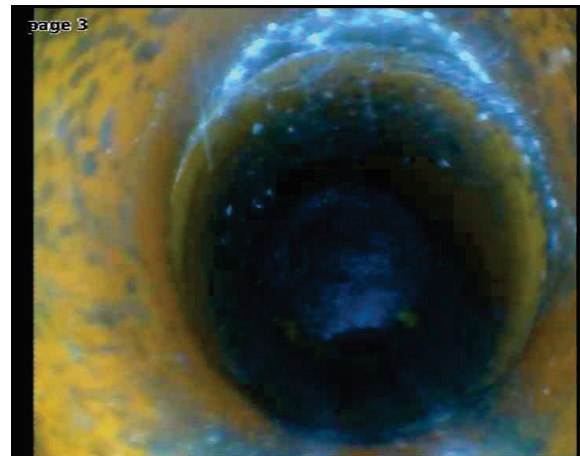
FWMH5X\_8aaea2d5-d64c-4bc7-8aee-dac7876d4129\_20241007\_013734\_189.jpg, 00:00:36, 6.00 m  
Roots, fine at joint

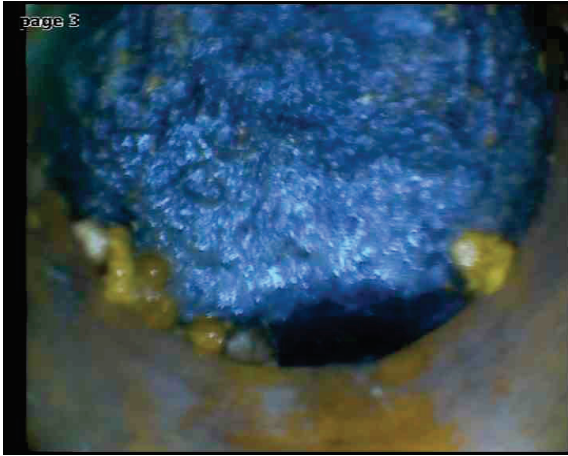
FWMH5X\_da81ad58-43de-48ab-ac0c-af8977441448\_20241007\_013825\_178.jpg, 00:00:53, 7.90 m  
Roots, mass, 90% cross-sectional area loss
