United Grand Lodge of England
Freemasons Hall
60, Great Queen Street
London WC2B 5AZ

Report on a visual survey of the inner courtyard brickwork.

Project Number: 6895

April 2025

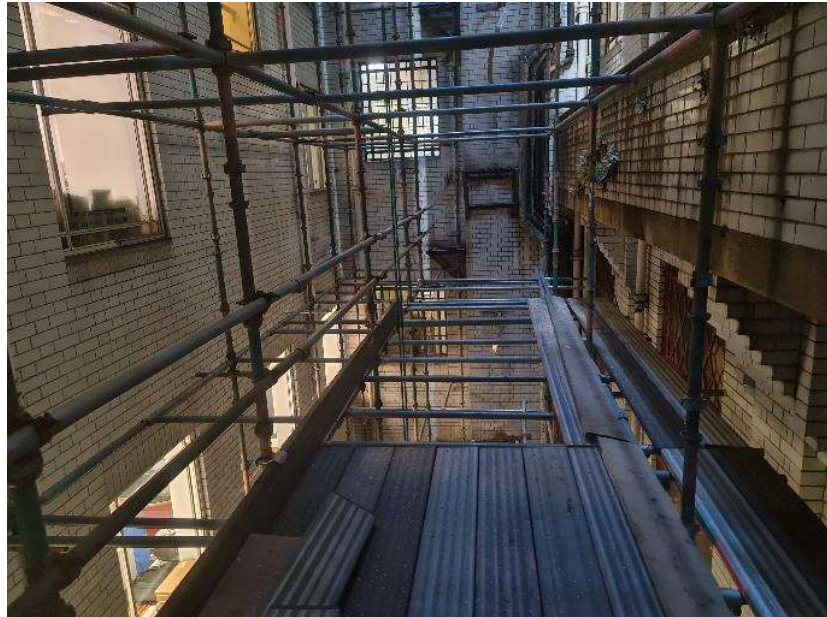
1.0 Access scaffolding in the lightwell

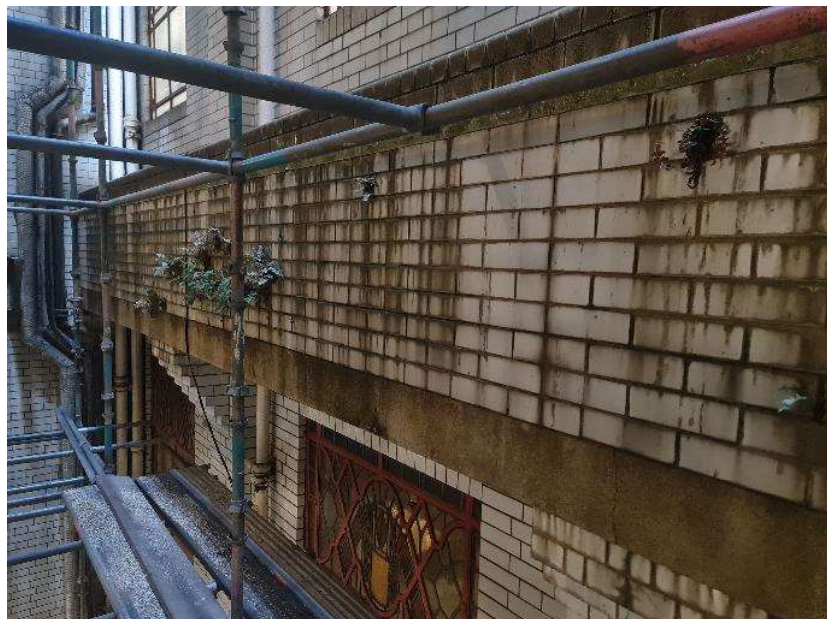
- Rust staining could be seen on the face of some brickwork.
- Some bricks are cracked and spalled other than on the line of the steel members.
- The parapet brickwork over the plant room area has horizontal cracking and is leaning inwards

2.0 Staining of the brickwork.

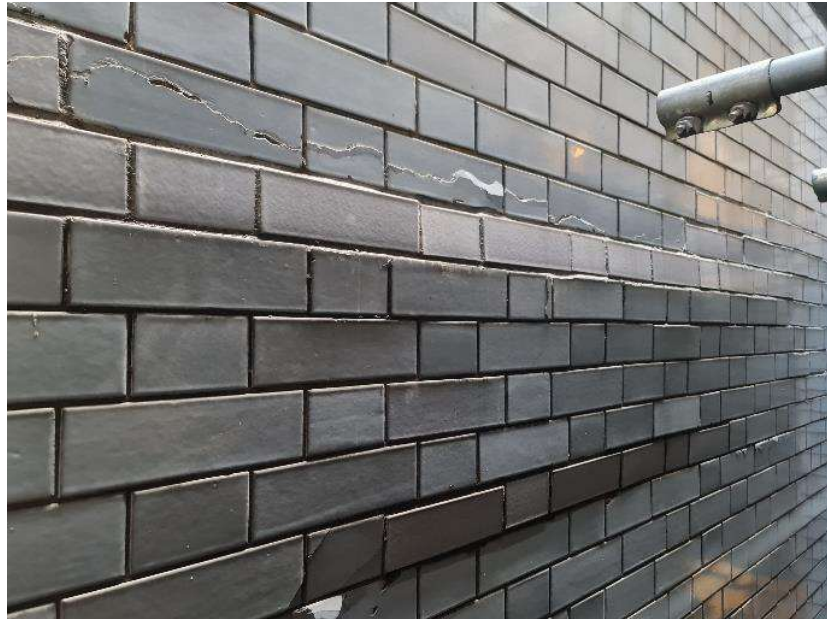
- Along the lines of horizontal steelwork, the brickwork is displaced, pushed out, and there is horizontal cracking.
- There are vertical cracks on the side of projecting brick piers. Some piers have cracks on both sides. The front of the piers also has vertical cracking.

The action of the structural steel frame rusting and consequently expanding has applied a force to the adjacent brick panels. This is known as 'Regent street disease'. The brickwork has therefore pushed out and cracked. Bulges of the brickwork can be seen in several locations along the lines of steel members. Cracks can generally be seen also along the lines of the steel members.

3.0 Example of bulging and cracked brickwork.

Whilst the scaffolding is in place repairs to the brickwork are recommended. The scaffolding also offers some protection for material falling from the building.

In the first instance, a full detailed survey of the courtyard walls needs to be undertaken. All defects noted on the brickwork are to be recorded. The survey is to be undertaken in conjunction with the Structural Engineer and the results agreed.

Repair works can then be undertaken. A detailed repair specification will be prepared under separate cover. It is anticipated that some areas, possibly some projecting brick piers will need to be removed and completely re-built. Non-ferrous repair materials will be required to avoid interference with the cathodic protection system.

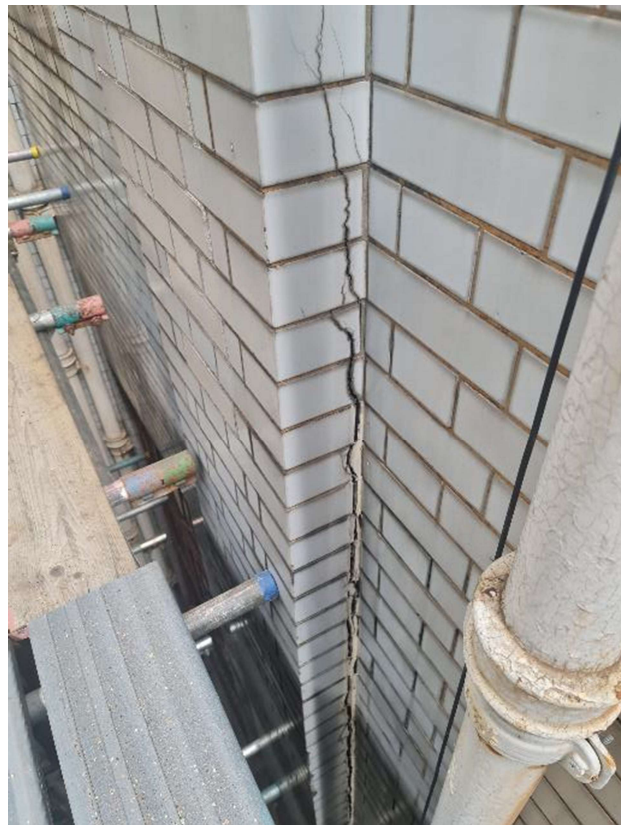
4.0 Vertical crack on the side of a projecting brick pier.

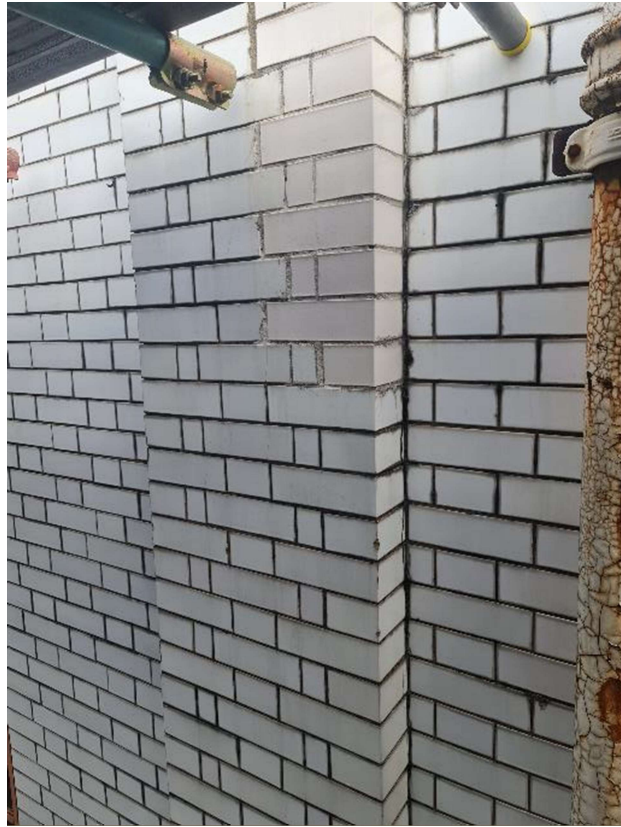
5.0 Face of a brick pier cracked.

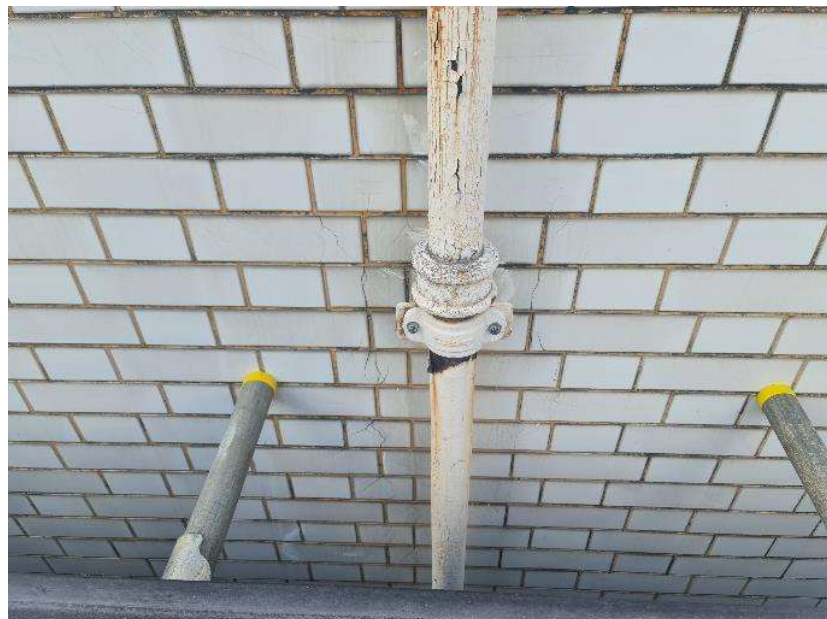
6.0 Cracking on a brickwork face.

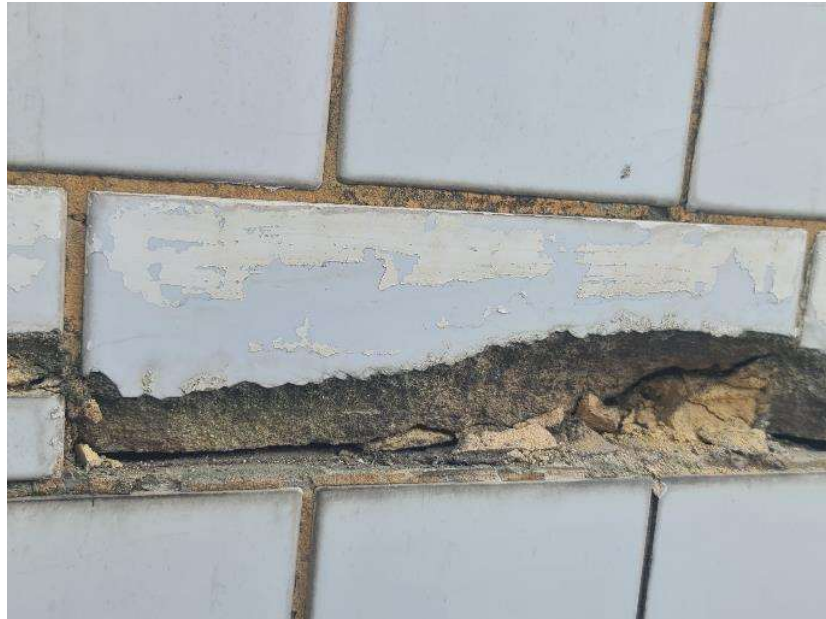
There has also been some weathering which has worsened the situation and also affected other parts of these walls. These areas are also cracked and spalled. Once a crack or spall starts to appear then the weathering will make the situation worse.

7.0 Spalling brickwork.

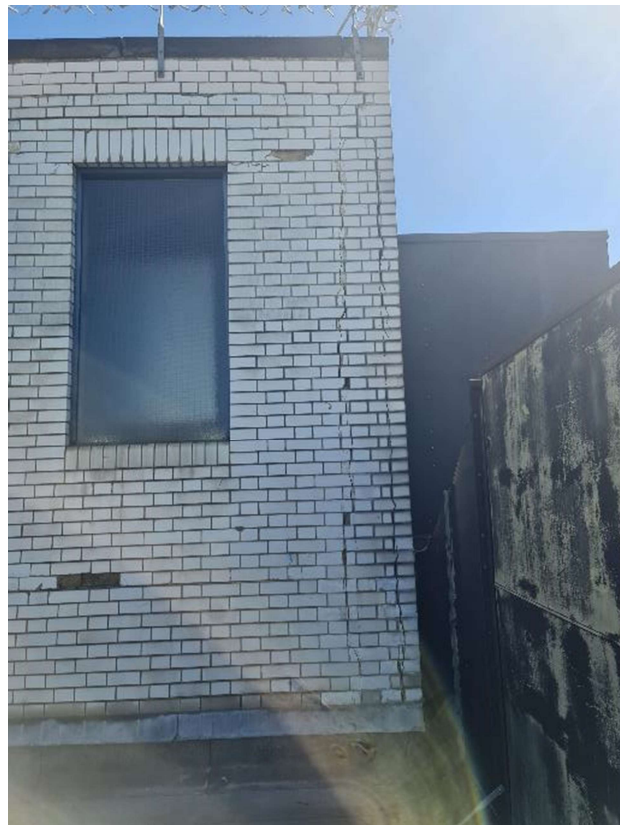
8.0 Vertical cracks near the end of a wall panel.

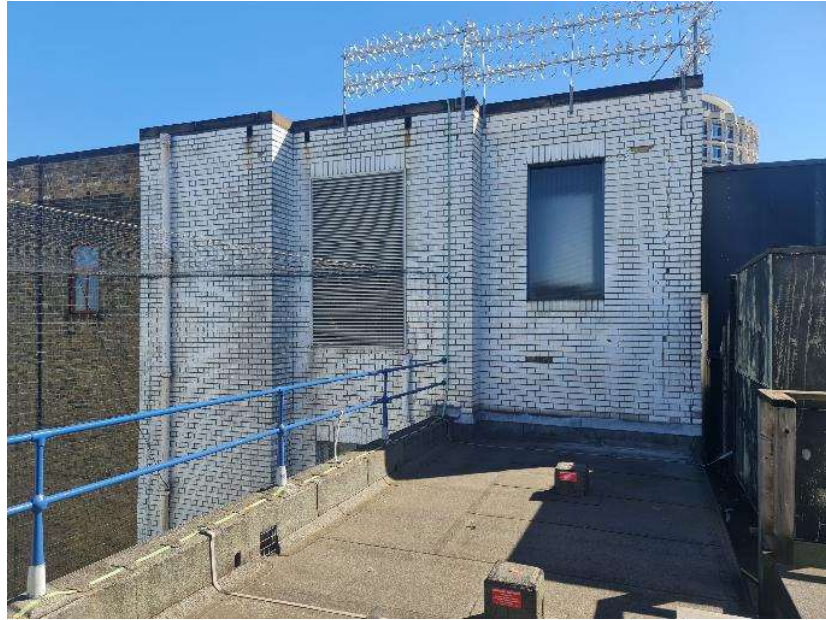
9.0 Brick parapet wall is cracked and leaning inwards.

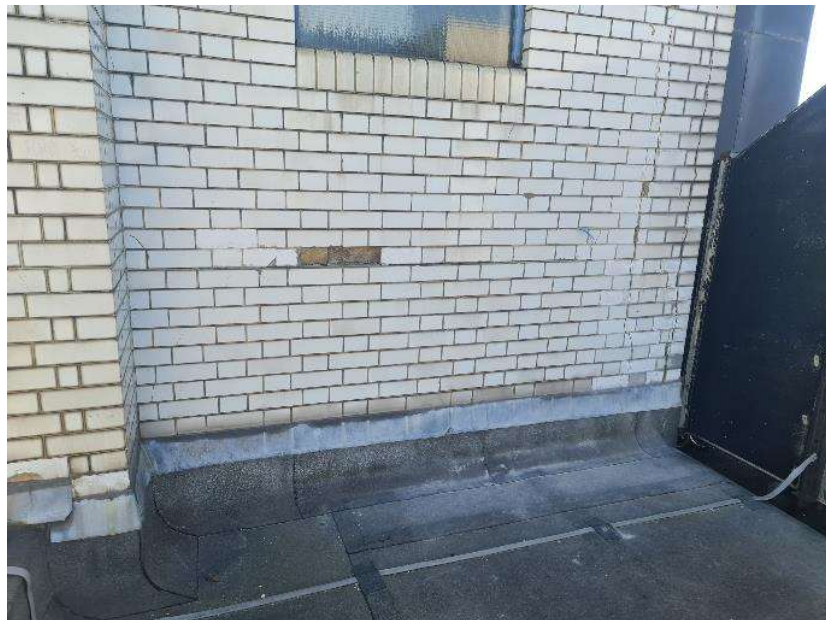
10.0 Spalled brickwork.
