# Site Investigation Report

101134.1.BSI

Client	Crawford & Co
Client ref	SU1904991
Visit date	02/01/2020
Report date	06/01/2020

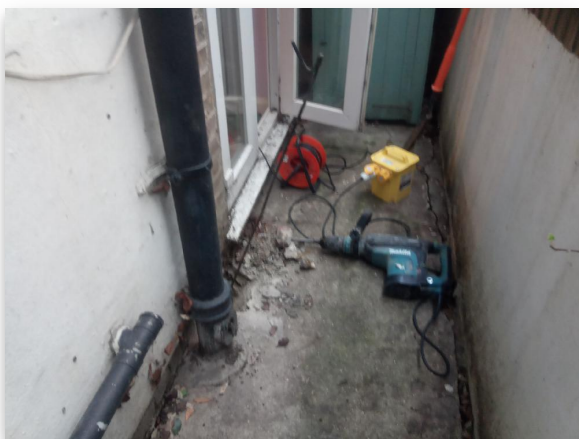
Fig 3.1: Trial Hole 3 Location

We were unable to collect root samples from TH3 because no roots were located within the trial hole.

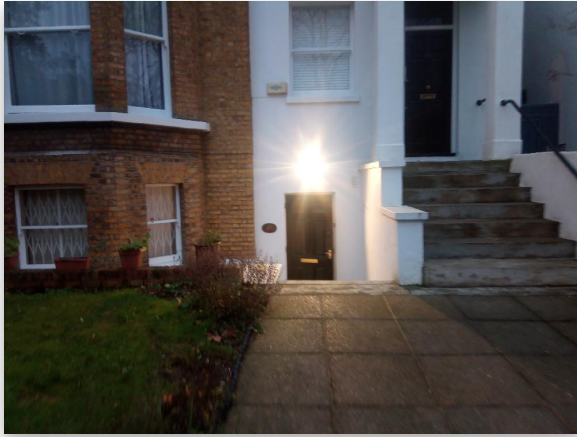
It should also be noted that there was a manhole located beneath the front set of stairs. This was over 2m deep and was a very tight manhole, due to this we could not survey any drainage lines entering it. If the LA wishes for this to be surveyed then 2 men will be required to attend site with confined space entry equipment which will come at a considerable cost. We believe that the drainage at the customers property is all accounted for and runs to the rear manhole.

Fig 7.1: Steps which MH is located beneath

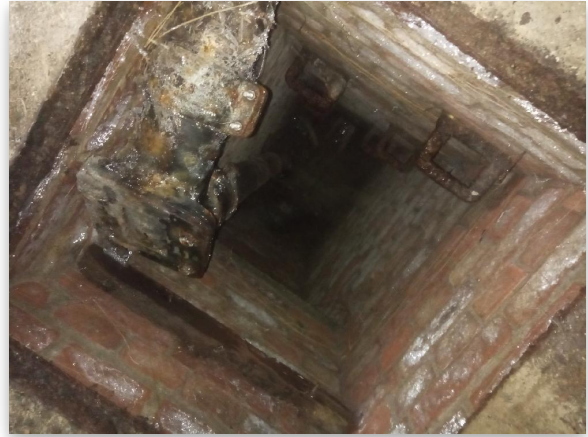
Fig 7.2: Deep MH
