**ADDENDUM ARBORICULTURAL REPORT**

**SUBSIDENCE CLAIM**

**180 Camden Road, London, NW1 9HG**

28 November 2024

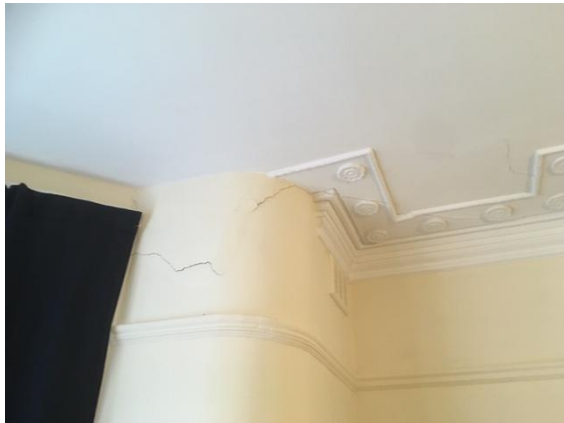
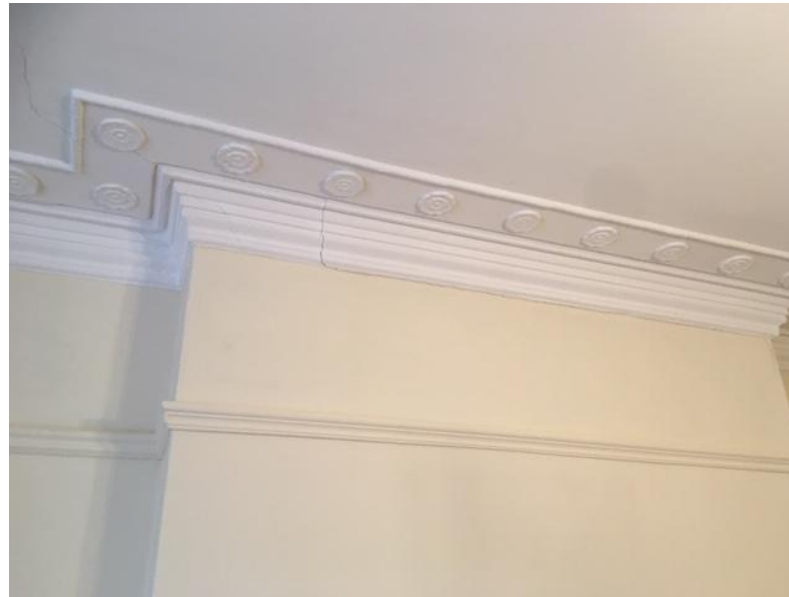
Cracks to first floor flat

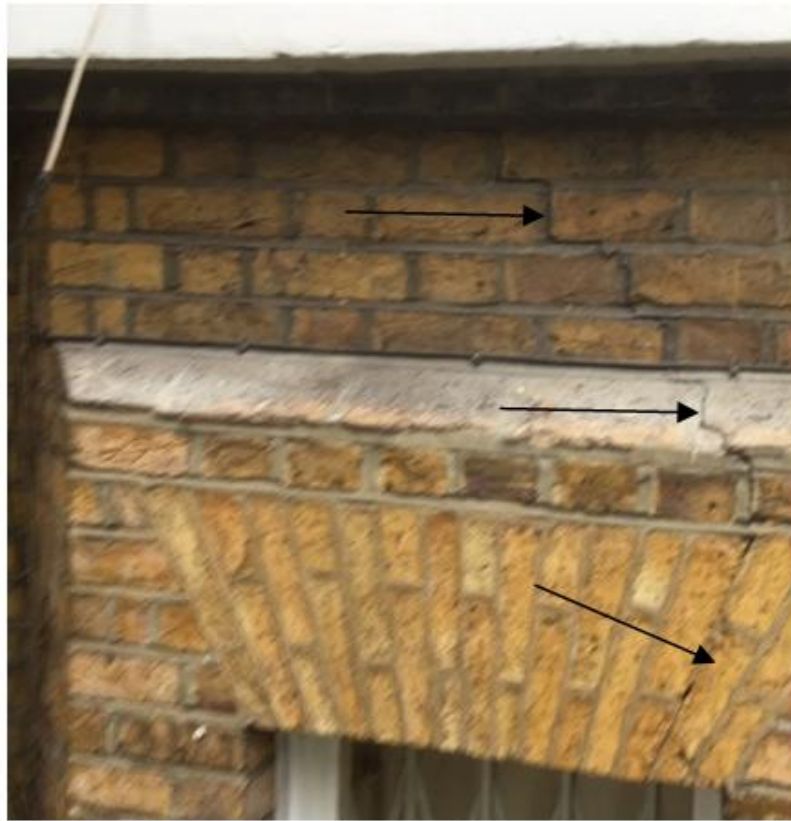
Cracking to bay

- Stepped cracking / displacement of flat brick lintels were noted to the left hand return wall of the bay.

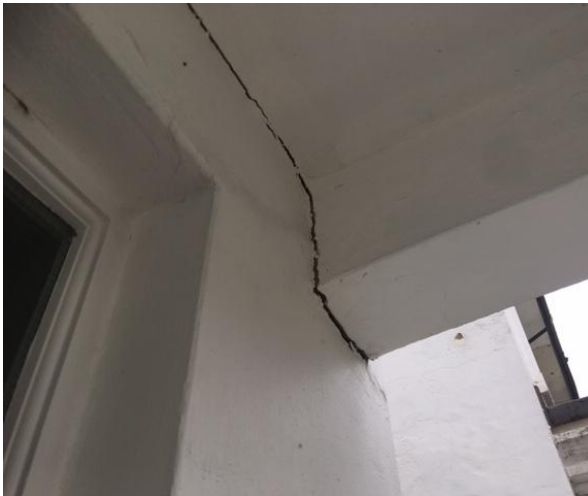
- Cracking, upto 10-15mm in width, was noted at the junction between the porch and main house/extension.
- Stepped cracking, upto 6mm in width was noted the right hand wall of the porch.

Cracking to porch

In structural terms, with reference to Table 1, Building Research Establishment<sup>1</sup> Digest 251, the damage is categorised as Moderate (>5 but <15 mm) with maximum crack widths of 15mm.

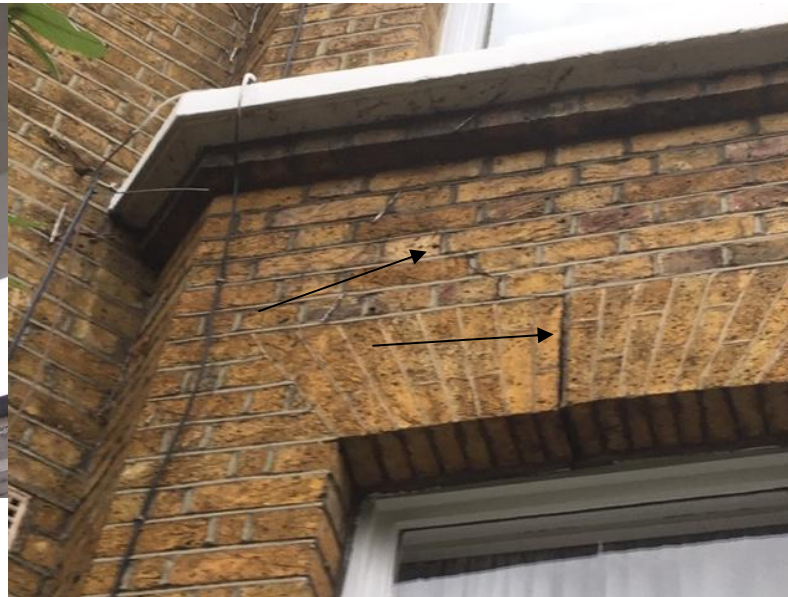
Cracking to bay

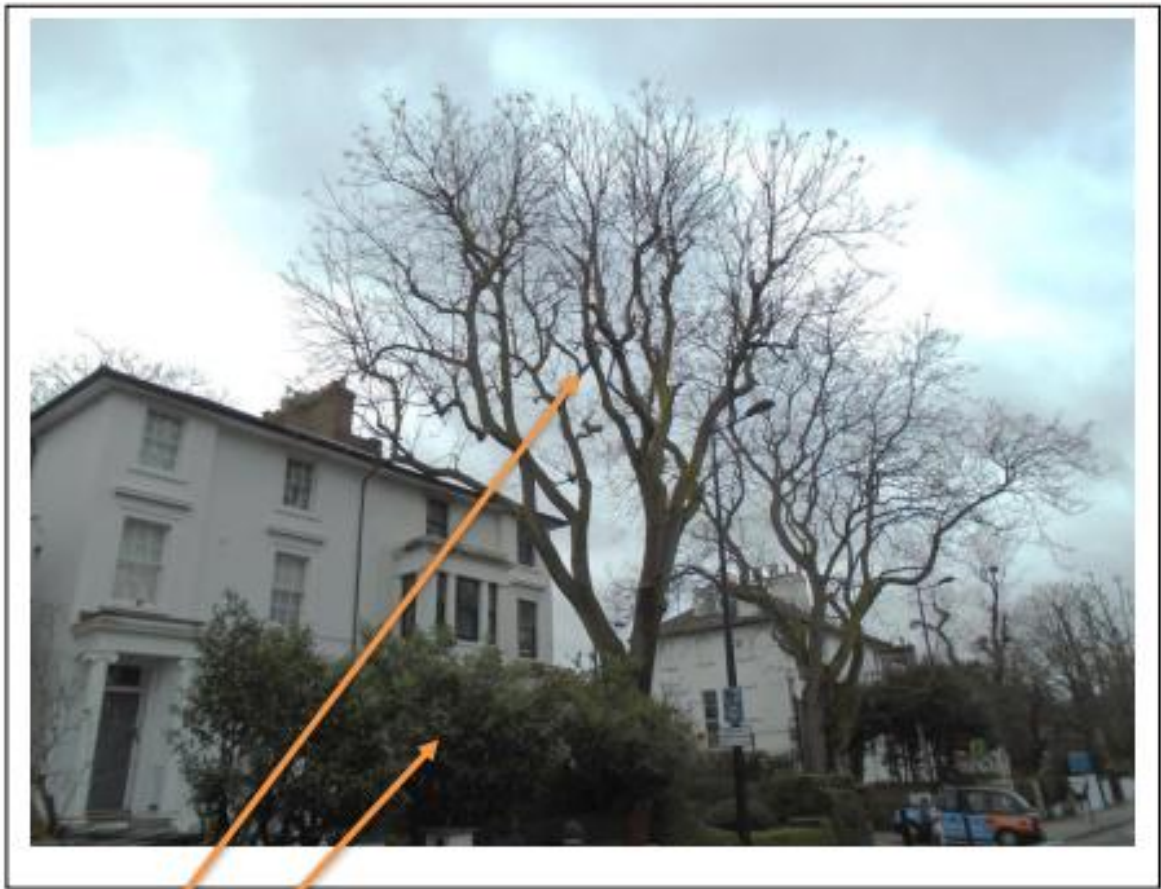
View of T7 and SG2

*Ailanthus* T7 at 17m height and 12m distance is therefore within its species' potential rooting and influencing distance of the building and would be capable of causing seasonal soil drying beneath foundations.

Tree No.	Species	Ht (m)	Dia (mm)	Crown Spread (m)	Dist. to building (m)	Age Classification	Ownership
T7	Tree of Heaven	17 *	650 *	13 *	12 *	Younger than Property	Third Party 178 Camden Road NW1 9HG
Management history		Subject to past management/pruning.					
Recommendation		Remove (fell) to near ground level and grind out stump to inhibit regrowth.					
T8	Cherry	9*	200 *	5*	6*	Younger than Property	Third Party 182 Camden Road NW1 9HG
Management history		Subject to past management/pruning.					
Recommendation		Remove (fell) to near ground level and grind out stump to inhibit regrowth.

The grinding of the stump of T7 has been recommended due to the translocation risk if herbicide treatment was to be used as roots from the adjacent Ailanthus to T7 are likely to have grafted to roots from T7.

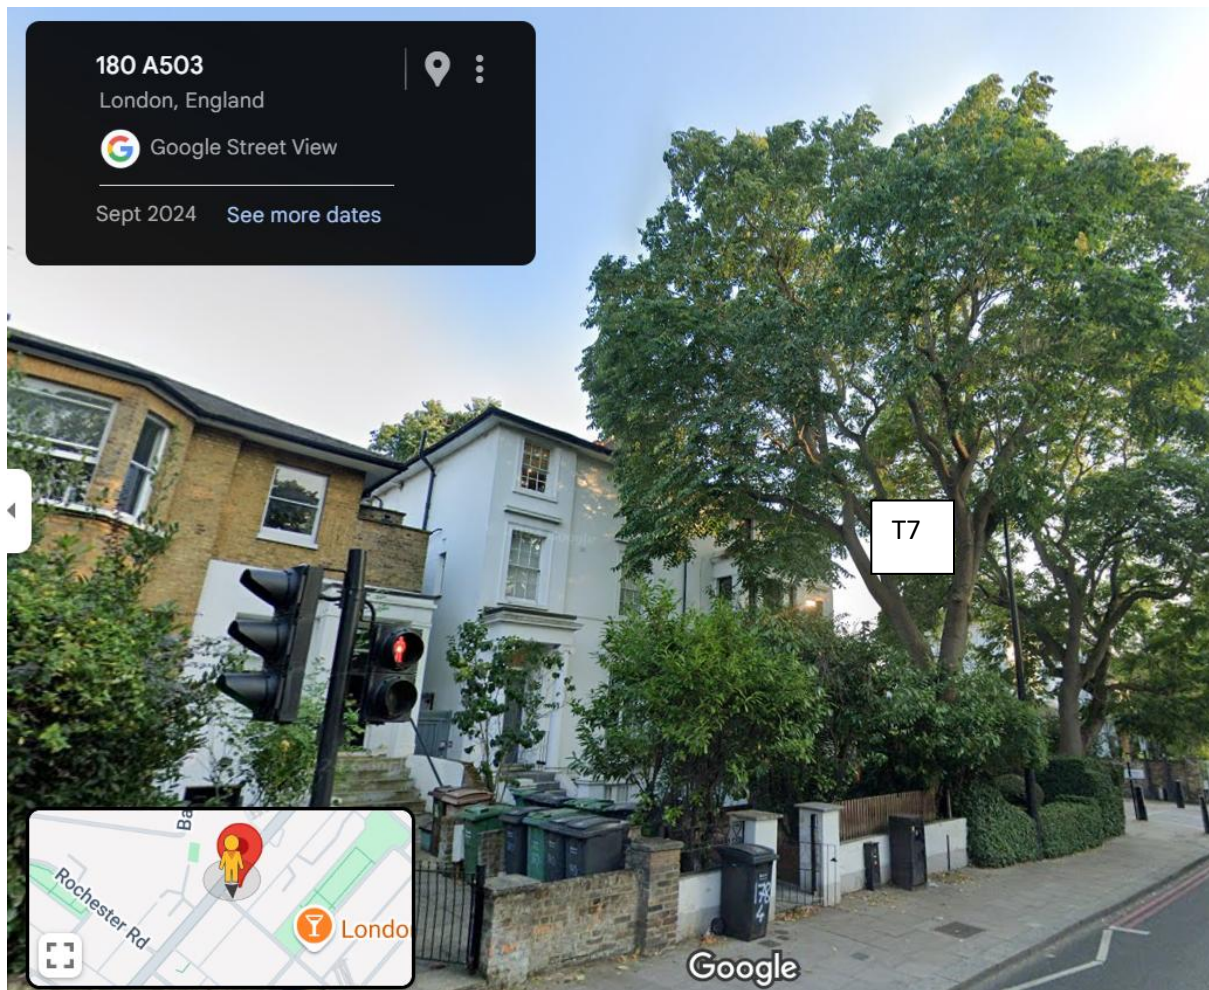
**T7 in September 2024, note a further Ailanthus within a neighbouring front garden adjacent T7.**

**Previous crown reduction of T7 has failed to reduce its water use and roots from this tree have continued to cause seasonal foundation movement within a short period of time since it was substantially reduced in size.**

As per the recommendations of the Arboricultural Report and Government guidance, the Ailanthus tree T7 requires removal. The implicated tree benefits from Tree Preservation Order and an application should be made to allow the recommended works to be carried out.

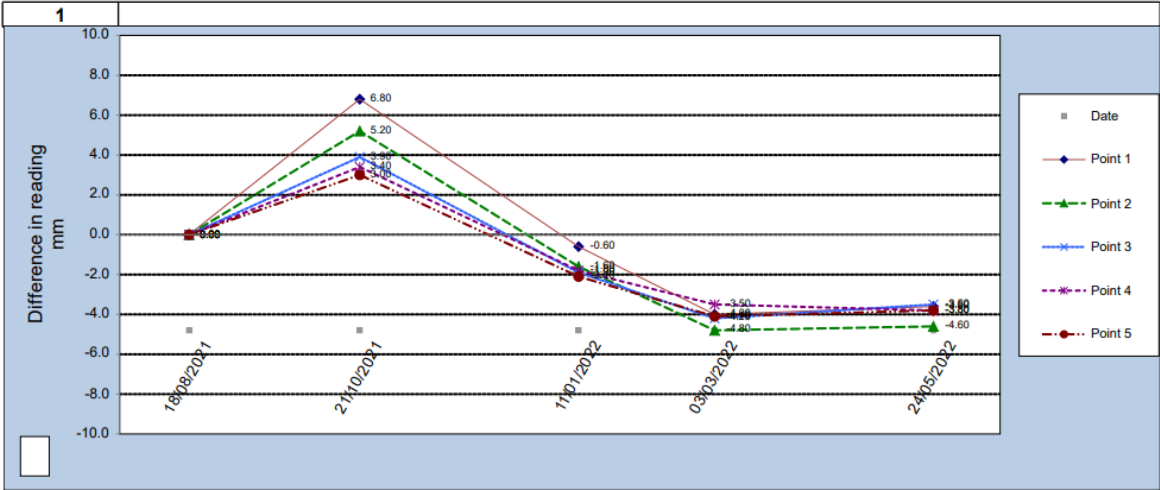
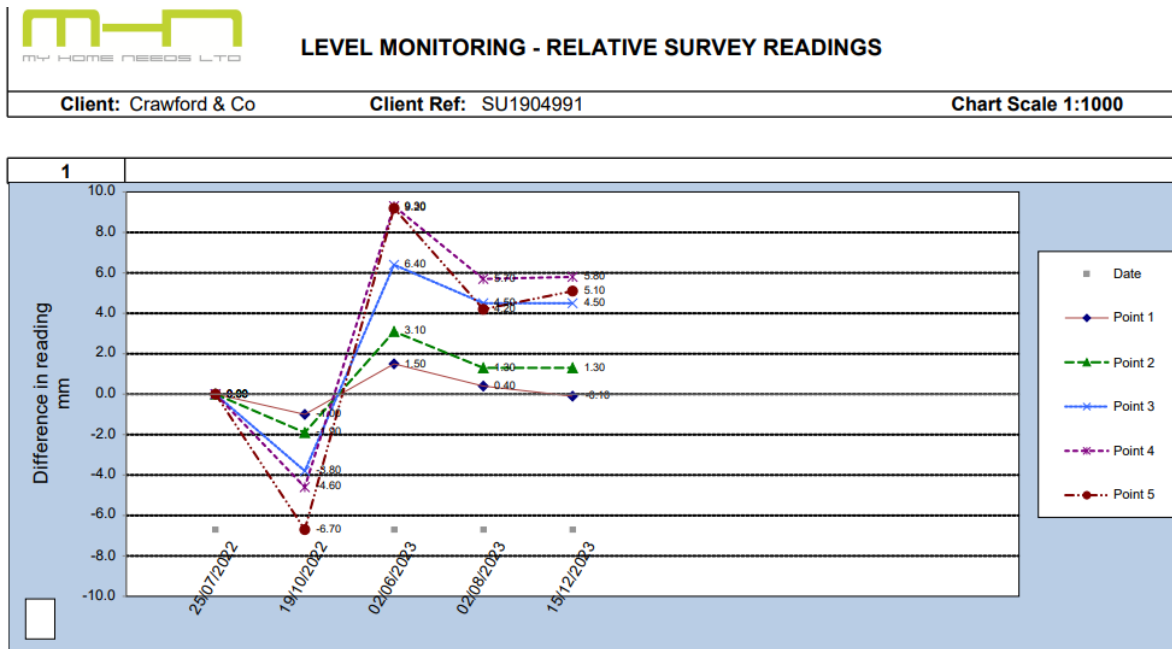
LEVEL MONITORING - RELATIVE SURVEY READINGS

The level monitoring indicates a clear seasonal and cyclical pattern of movement consistent with root induced clay shrinkage with the greatest amplitude of movement being consistent with the location of Ailanthus T7. Downward foundation movement also occurred during the wet summer of 2023.

The level monitoring indicates a cyclical pattern of movement which shows both downwards movement during the drier summer months; when trees are in leaf and actively demanding moisture from the ground; and subsequent recovery and upward movement during the wetter winter months when the trees lose leaf and become dormant. Patterns of movement such as those observed at the risk address are consistent with clay shrinkage subsidence and are only consistent with the effects of shrinking and swelling of clay soils exacerbated by the presence of roots.
