**TECHNICAL REPORT ON A SUBSIDENCE CLAIM**

**Crawford Reference: SU1904991**

**180 Camden Road  
London  
NW1 9HG**

**SUBSIDENCE CLAIM**

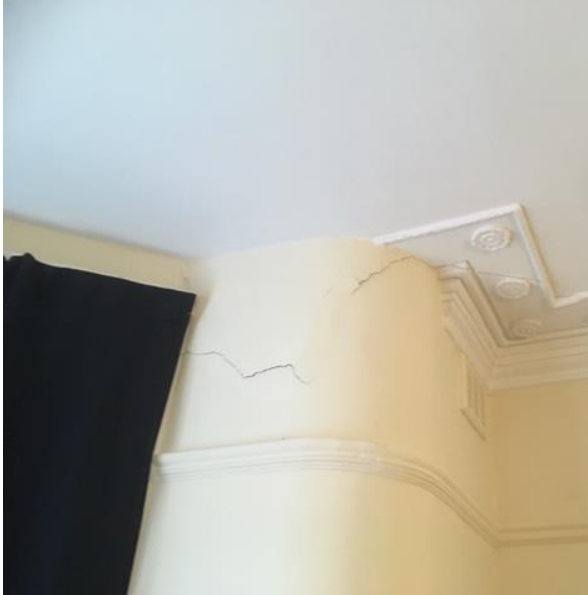
Cracking to first floor flat

- Slight cracking was noted to the left hand side of the bay at its junction with the main house.
- To the right hand dividing wall, a slight diagonal crack was noted to the front corner which extends up to the rear.

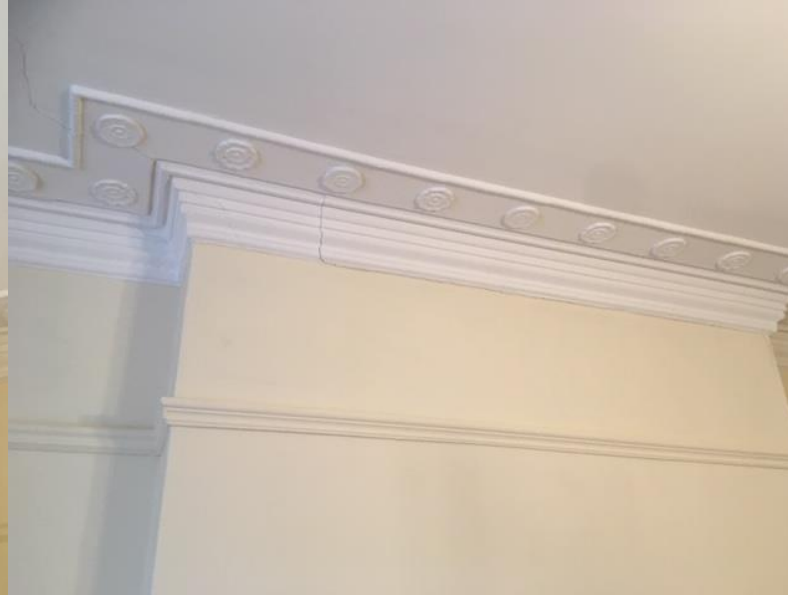
Cracking to first floor flat

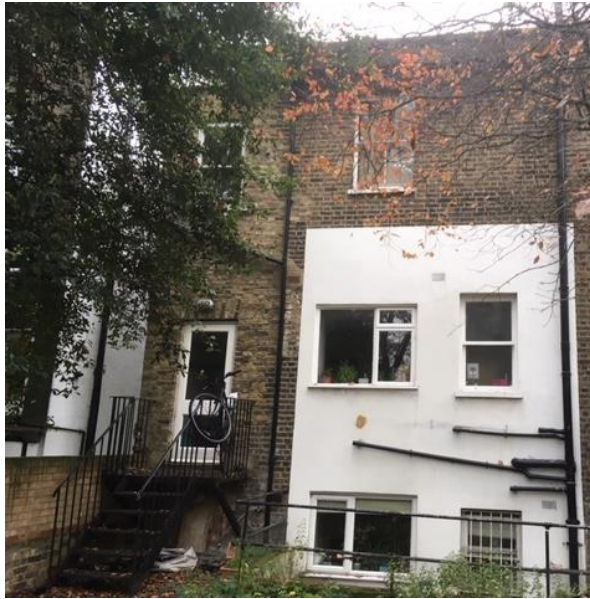
Rear elevation

- Diagonal / stepped cracking was noted to above and below door and window openings.

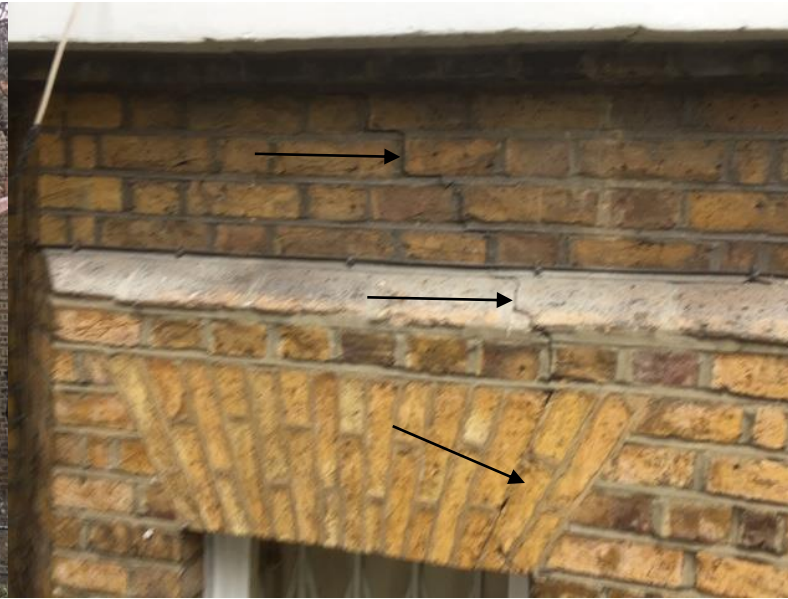
Cracking to bay

- Stepped cracking / displacement of flat brick lintels were noted to the left hand return wall of the bay.

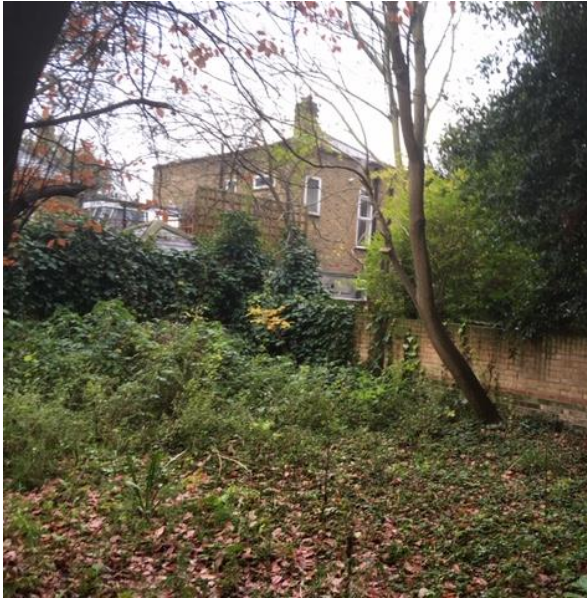
Trees at rear

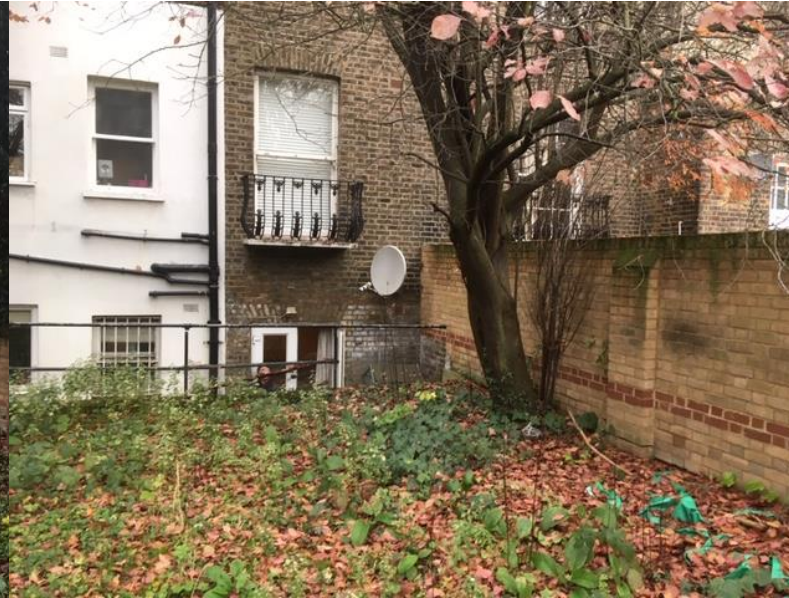
Trees at rear

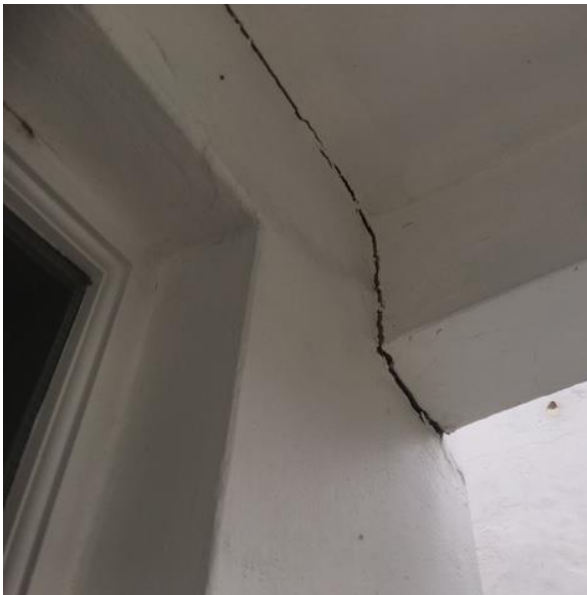
- Cracking, up to 10-15mm in width, was noted at the junction between the porch and main house/extension.
- Stepped cracking, up to 6mm in width was noted the right hand wall of the porch.

Cracking to porch

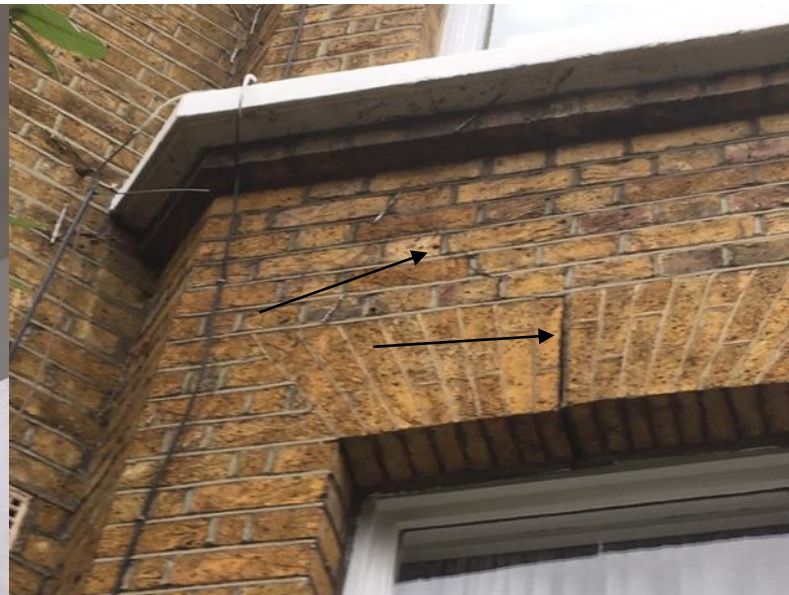
Cracking to bay

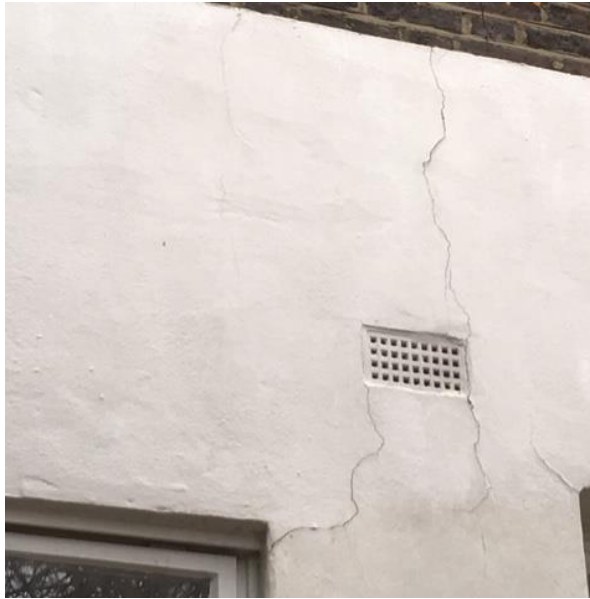
Cracking to rear elevation

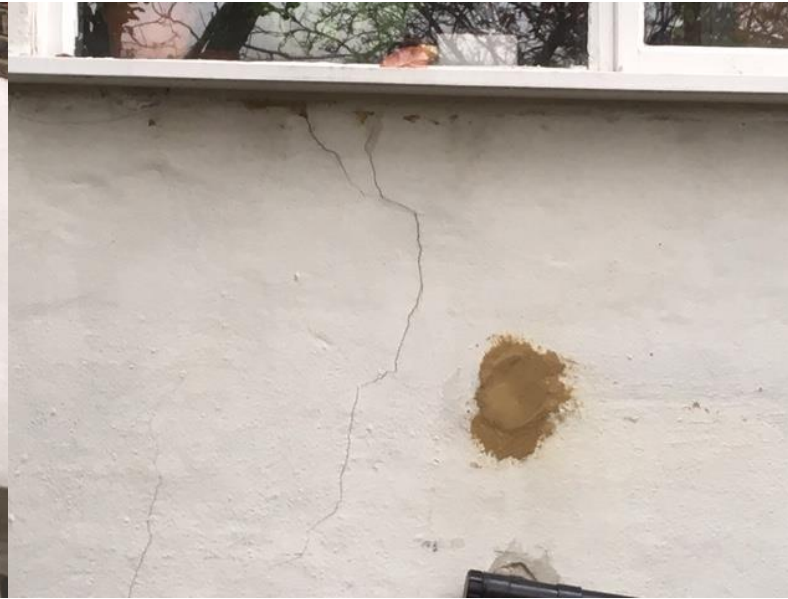
Cracking to rear elevation

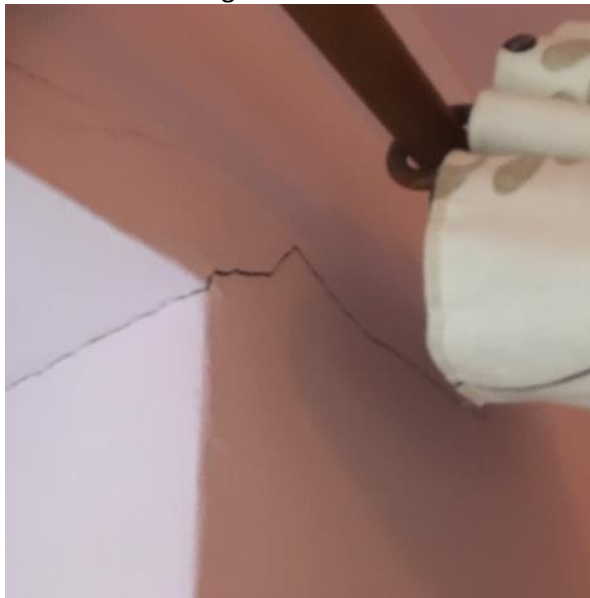
Rear Bedroom - Garden floor flat - rear wall

- To the right hand wall slight cracking was noted above the corridor door (seen both sides).
- To the rear wall, 3mm wide cracking was noted to the top right of the window.

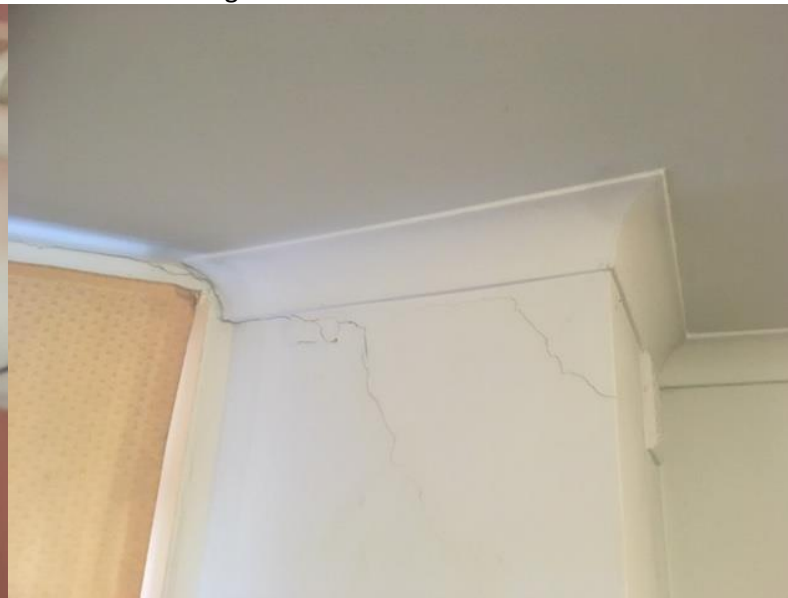
Garden flat - Lounge

- Slight cracking was noted to the left hand side of the bay at its junction with the main house.
- To the right hand wall cracking was noted either side of the hall door head.
