# No.67 to 70 Great Russell Street

## Structural Engineering Report on Stairs

November 2024

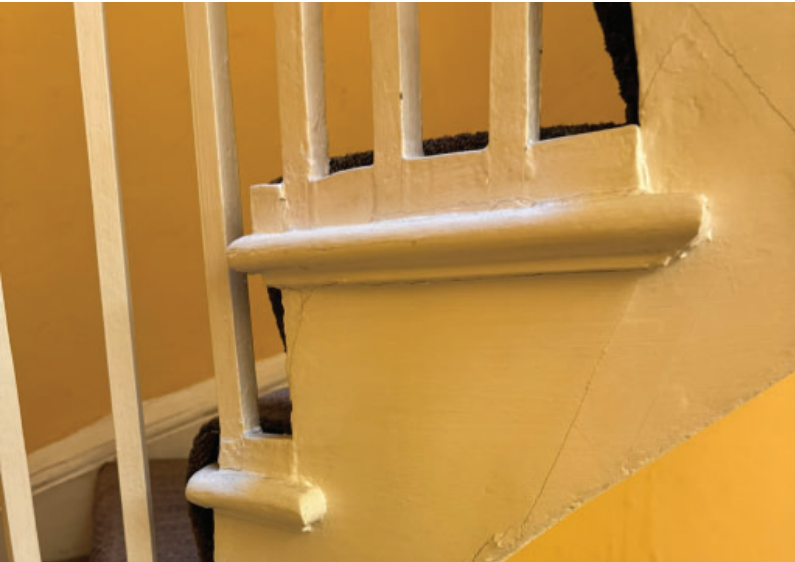
During our visit, we observed that the staircase in each property is out of level, with the inside edge of the stair being lower than the outside. This lean is most pronounced in the staircase of No. 70 between the ground and first floor, where the total level difference between the inside and outside edges is approximately 50mm In this area, timber furring pieces have been installed over the treads in the past to level the treads, (see Photo 01).

Photo 01 (Above)  
No.70. Non-original furring piece over the existing tread.

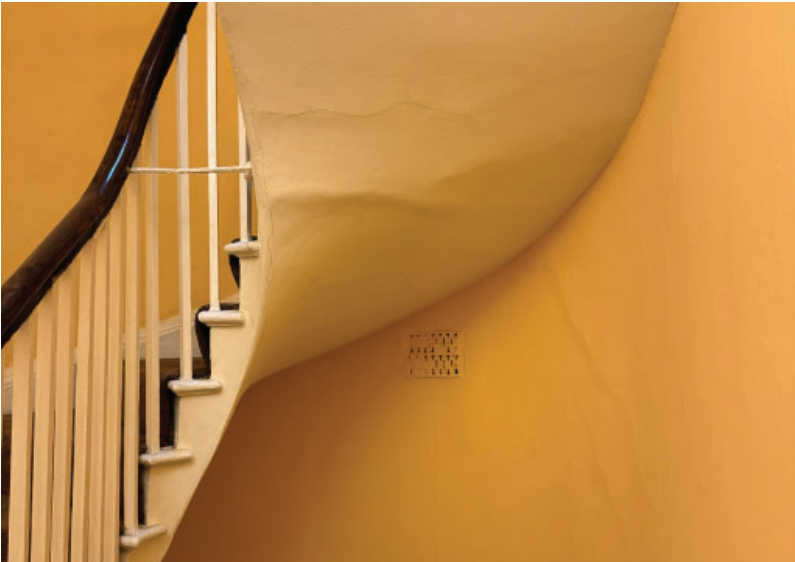
In each property, cracks were observed on the soffit of the stairs, primarily concentrated around the transition between the straight and curved sections. In some areas, these cracks extended into the supporting walls both above and below the staircase (see Photos 02 and 03).

Photo 02 (Above)  
No.70. Cracking to ceiling and wall below stair.

This movement also explains other observed defects: cracks on the soffit and opened connections from differential movement between curved and straight sections, and handrail distortion from the outer string pulling away from the landing, placing tension on the balustrade.

Evidence of previous repairs suggests that cracks have been periodically patched, but their recurrence indicates ongoing movement.

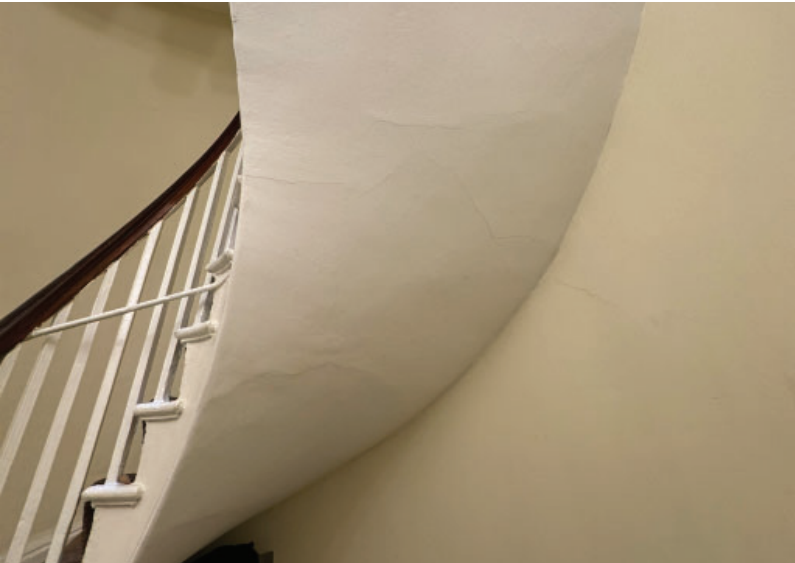
Photo 03 (Above)  
No.68 Cracking to ceiling and wall below stair.

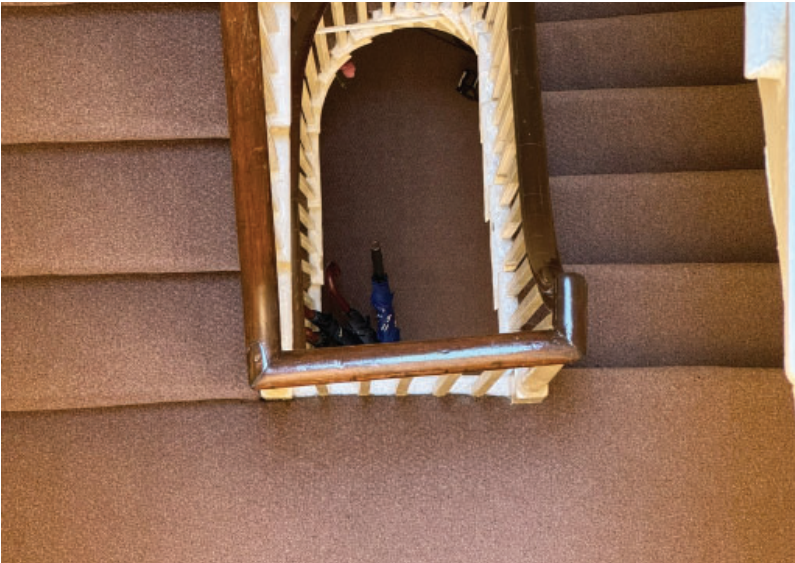
In several instances, we noted that the connection between the handrail and landing had opened, with the newel post below leaning out of plumb towards the stairwell. This distortion was most pronounced in Nos. 70 and 68 (see Photo 04).

Photo 04 (Above)  
No.67. Distortion of Balustrade

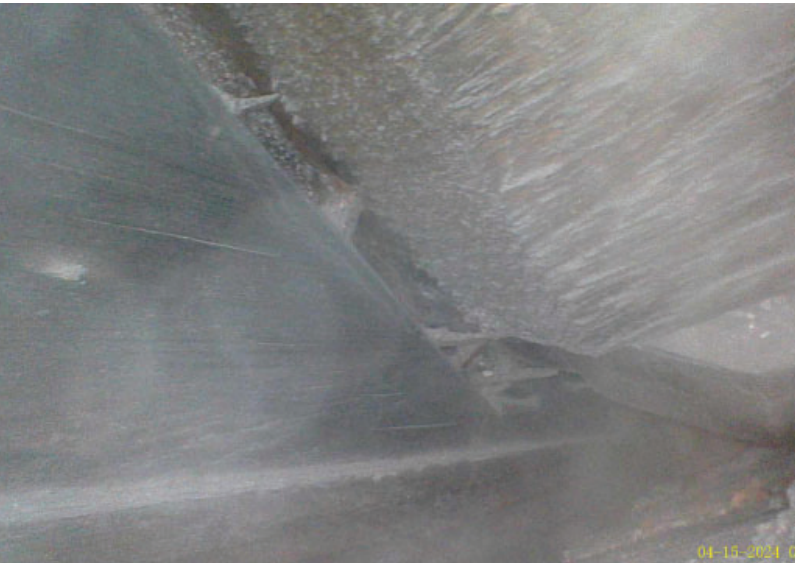
In No. 70, borescope investigations of the stair between the ground and first floor levels revealed that several connections between the timber elements—such as the treads to the outer stringer and the rough stringer to the pitching piece—had pulled opened (see Photos 05).

Photo 05 (Above)  
No.70. Opening of Connection between Outer String and Tread/Riser

The performance of the staircase structure relies heavily on tight connections between timber elements to transfer compressive forces, particularly around the curved section, where bearers and pitching pieces are wedged into the surrounding walls and supported by the wreathing piece. Timber's natural tendency to shrink and expand with changes in moisture content can loosen these wedged connections, causing rotation and tip deflection of bearers and pitching pieces. This deflection, exacerbated by the loads from strings above and below, likely explains the observed movement (illustrated in Figure 04). This movement may also have been extubated by differential movement primary and secondary structural walls around the stair.

Based on the defects observed during our site visit, we suggest that investigations are undertaken to confirm the condition of the key connections in the stair structure and, if necessary, install localised and targeted strengthening works to be undertaken to improve the robustness of the stair. On similar projects, this has involved installing proprietary steel angle brackets and well-seasoned hardwood wedges/packers to enhance the robustness of the connections and enhance the connections strength and load transfer capacity.
